SITE NUMBER AND NAME: <b>S058 Spring Hill Slide</b>		HIGHWAY & KM: 505:04, 21.110	PREVIOUS INSPECTION DATE: July 8, 2021	INSPECTION DATE: <b>May 19, 2022</b>
LEGAL DESCRIPTION: 15-29-04-23 W4M	NAD 83 COORDINATES: UTM Northing Easting 12 5466599 350117		RISK ASSESMENT: PF: 7 CF: 6 TOTAL: 42	
AVERAGE ANNUAL DAILY TRAFFIC (AADT): 570 (east) & 530 (west) (Reference No. 93050 & 99030)			CONTRACTOR MAINTENANCE AREA (CMA): 25

**PRIMARY SITE ISSUE:** Deep-seated earth slide within coulee side slope. The head scarp extends into the roadway and is impacting the pavement and south shoulder of the embankment.

PROJECT SOUTHERN REGION GEOHAZARD RISK MANAGEMENT PROGRAM		
TITLE Site Plan S058 - Spring Hill Slide Hwy 505:04, km 21.110		
SCALE 1:6,000	PROJECT No. A05116A03	FIG No. 1

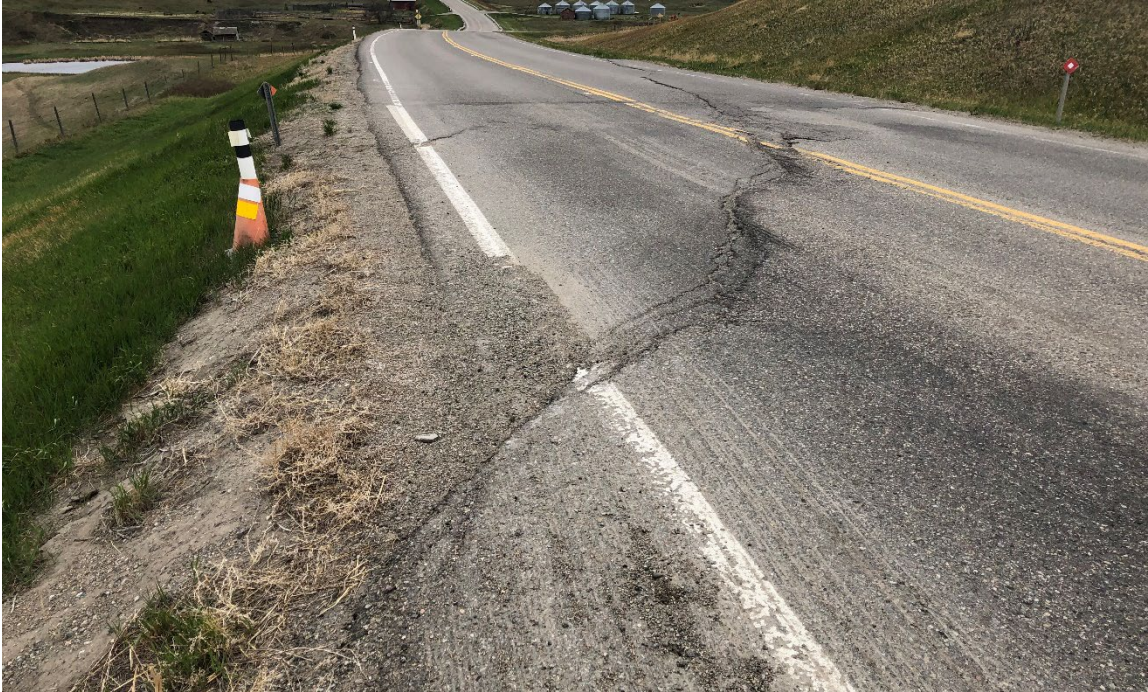
The pavement cracking extends westward through the recent overlay (Photo 1 and 2) and there is possible tension cracking between the highway and the fence line along the side of the coulee. The cracking has extended downhill and appears to have worsened when compared to 2021 inspection photos. There is no visible instability on the slope north of the highway.

The pavement cracking lines up with tension cracking along the wall of the coulee (Photo 1 and 2).

**Photo 1** Pavement cracking and settlement due to head scarp of slide on coulee slope south of highway. Photo taken May 19, 2022, facing northwest.

- Additional hazard signs should be installed to give more warning to motorists of the area of settlement in the highway.
- The site should be resurfaced (i.e., milled and repaved to not add any additional loading on the slide).
- A site investigation should be completed to investigate the drainage pipe. The outlet should be cleared to increase drainage capacity.

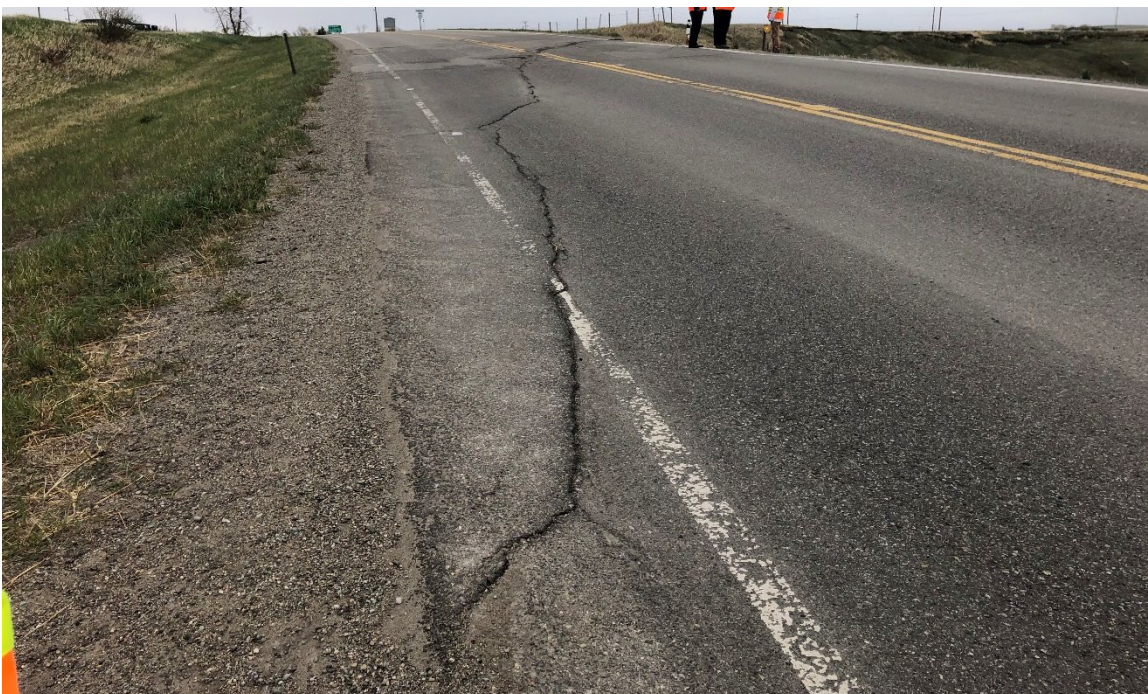
**Photo 2** Pavement patching and milling due to ongoing slope movement. Cracking has extended through the overlay. Photo taken May 19, 2022, facing east.

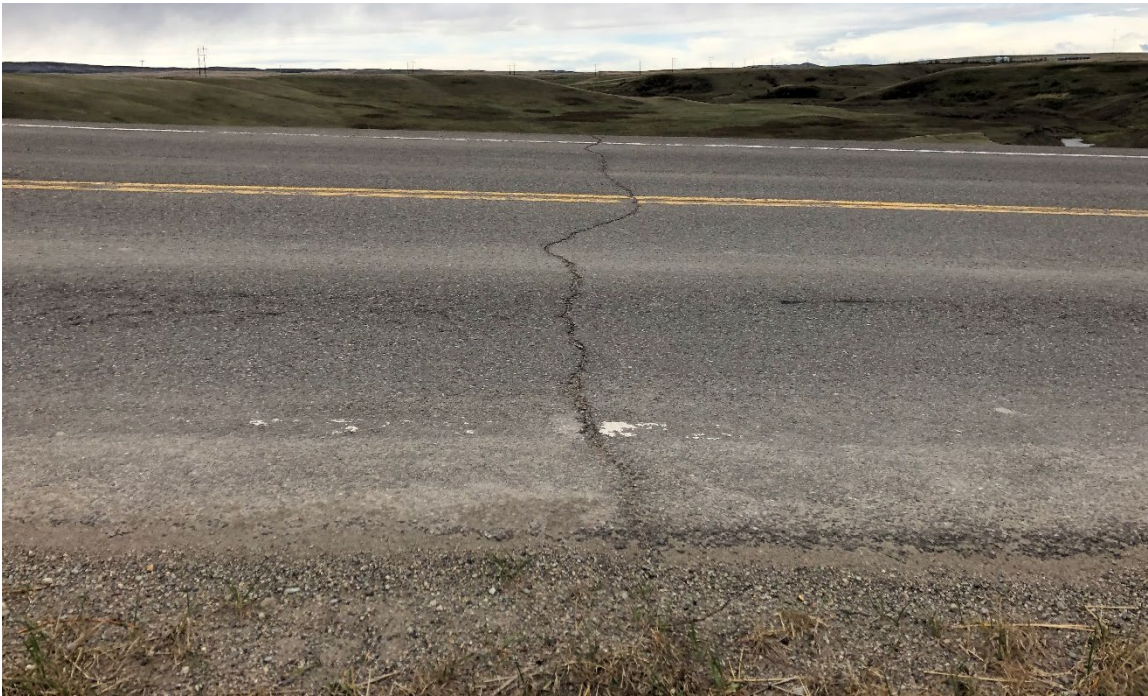
A transverse pavement crack was observed west of the pavement cracking and milling (WP 145) (Photo 3).

**Photo 3** Transverse pavement crack (WP 145) to the west of the pavement cracking and milling shown in Photo 1 and 2. Photo taken May 19, 2022, facing south.

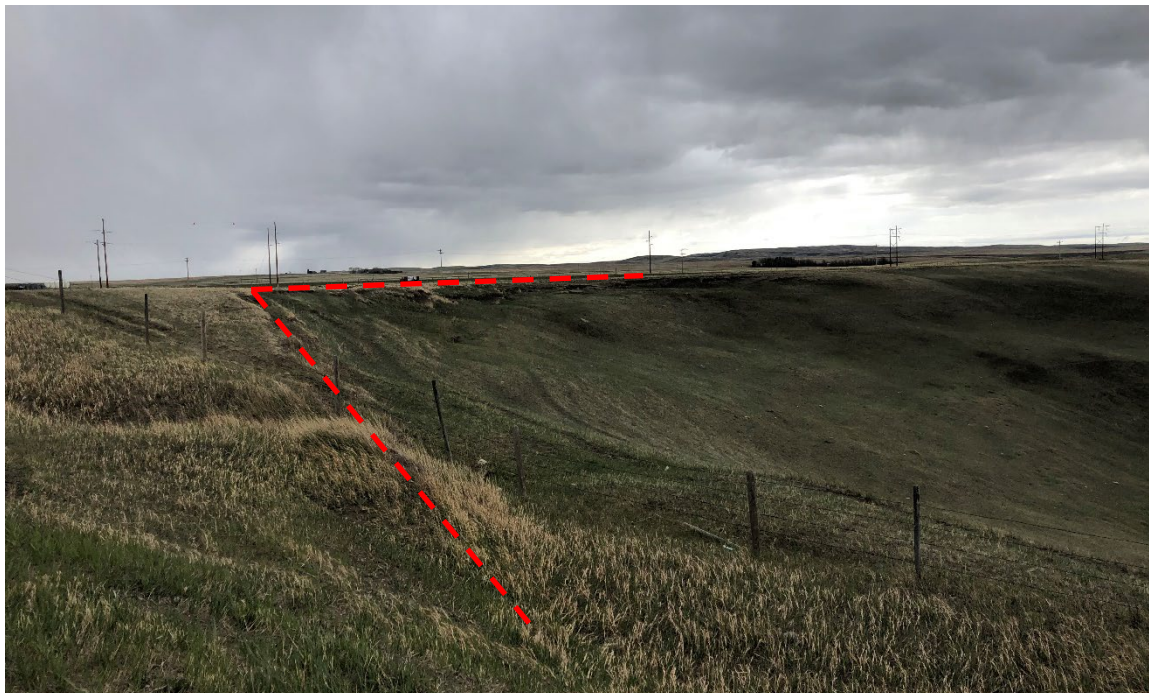
**Photo 4** Head scarp of slide on coulee slope south of highway. Photo was taken May 19, 2022, facing southeast.
