SITE NUMBER AND NAME: <b>S058 Spring Hill Slide</b>		HIGHWAY & KM: 505:04, 21.110	PREVIOUS INSPECTION DATE: May 19, 2022	INSPECTION DATE: <b>May 29, 2024</b>
LEGAL DESCRIPTION: 15-29-04-23 W4M	NAD 83 COORDINATES: UTM Northing Easting 12 5466599 350117		RISK ASSESMENT: PF: 7 CF: 6 TOTAL: 42	
AVERAGE ANNUAL DAILY TRAFFIC (AADT): 660 (east) & 520 (west) (Reference No. 93050 & 99030)			CONTRACTOR MAINTENANCE AREA (CMA): 25

PROJECT  
 SOUTHERN REGION GEOHAZARD RISK MANAGEMENT PROGRAM

TITLE  
 Site Plan  
 S058 - Spring Hill Slide  
 Hwy 505:04, km 21.110

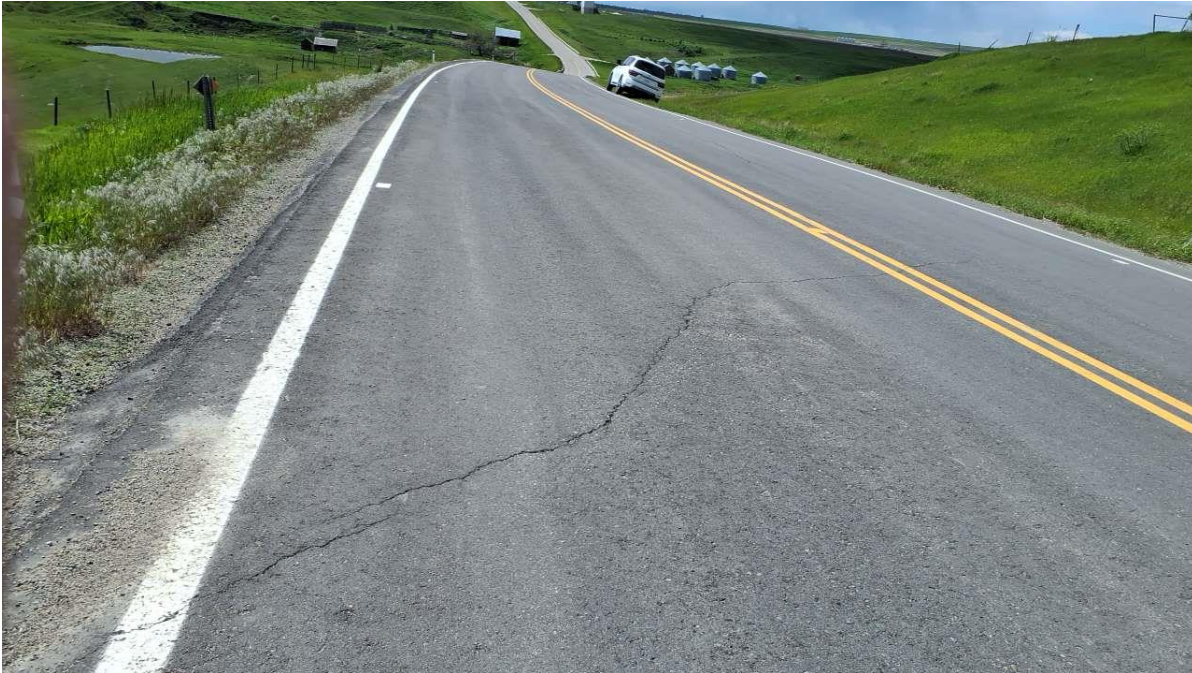
<b>COMMENTS</b>
The pavement cracking extends westward through the recent overlay and there is possible tension cracking between the highway and the fence line along the side of the coulee. There is no visible instability on the slope north of the highway.
The pavement cracking lines up with tension cracking along the wall of the coulee.
There is a possible toe bulge at the base of the valley, near to the old creek alignment. The creek appeared dry during the 2024 inspection.
The vertical HDPE pipe in the north (westbound) ditch may be plugged.
A high-pressure pipeline was marked in the shoulder on the north side of the highway.
<u>Maintenance/Repair/Monitoring Recommendations:</u>
<u>Short-Term:</u>
<ul style="list-style-type: none"> <li>A site investigation should be completed to investigate the drainage pipe. The outlet should be cleared to increase drainage capacity.</li> </ul>

**Photo 1** Pavement cracking and settlement due to head scarp of slide on coulee slope south of highway. Photo taken May 29, 2024, facing northwest.

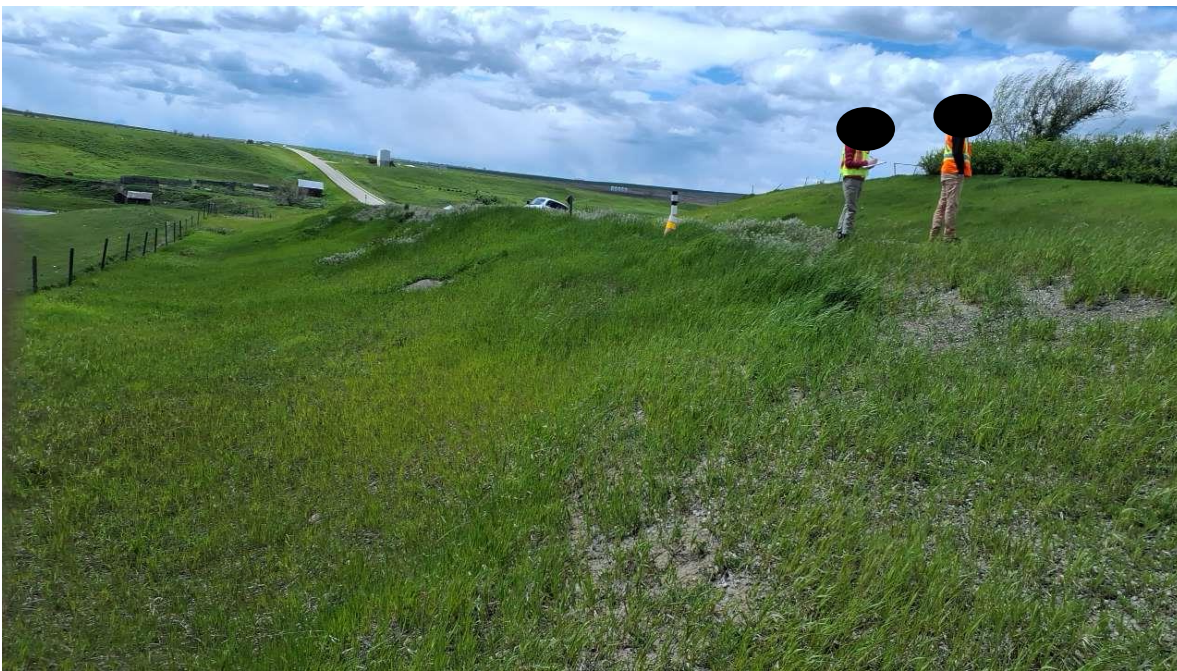
**Photo 2** Downslope highway embankment. Photo taken May 19, 2022, facing northwest.

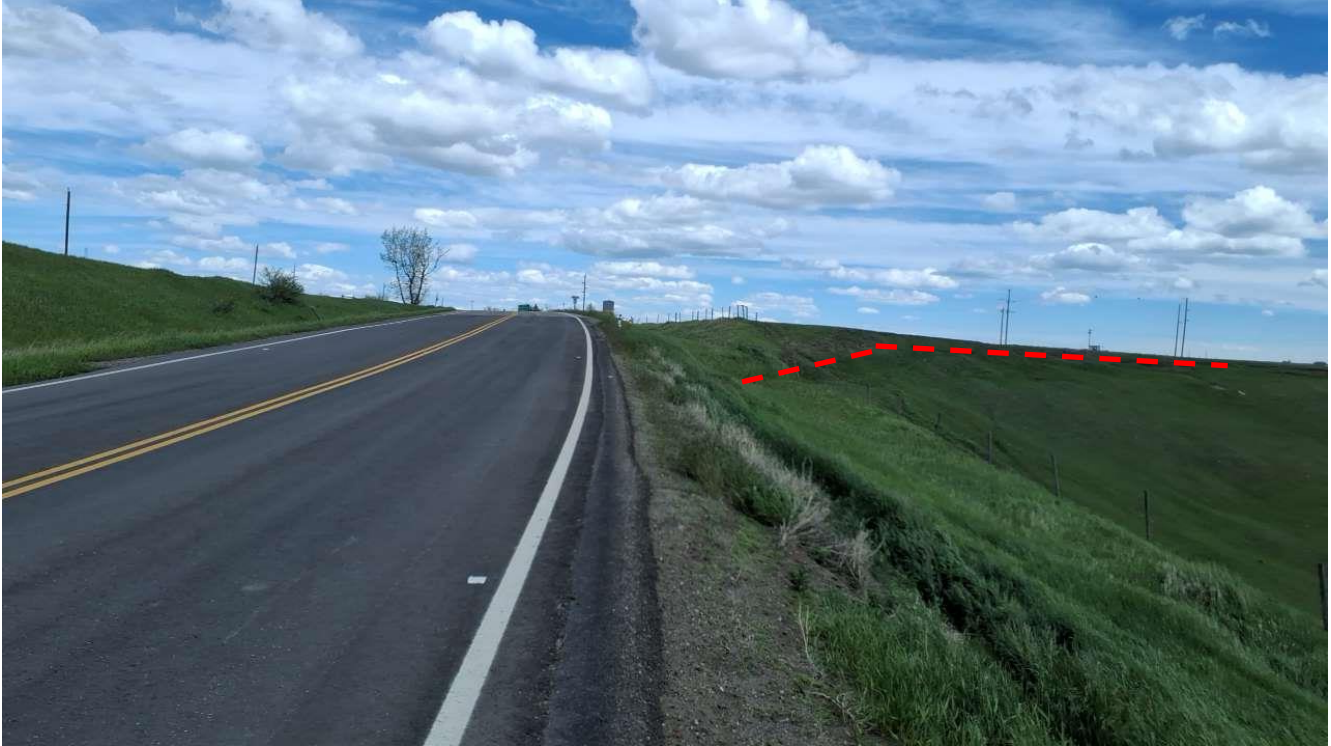
**Photo 3**      **Head scarp of slide on coulee slope south of highway. Photo was taken May 19, 2022, facing east.**
