SITE NUMBER AND NAME S051 Pekisko Creek Erosion		HIGHWAY & KM 540:02, 4.591	PREVIOUS INSPECTION DATE June 8, 2020	INSPECTION DATE July 9, 2021
LEGAL DESCRIPTION 08-14-017-02 W5M	NAD 83 COORDINATES UTM Northing Easting 11 5590158 701158		RISK ASSESSMENT PF: 11 CF: 10 TOTAL: 27	
AVERAGE ANNUAL DAILY TRAFFIC (AADT): 720 (east), (Ref. No. 71130)			CONTRACTOR MAINTENANCE AREA (CMA): 27

NOTES: 1. HORIZONTAL DATUM: NAD83 2. GRID ZONE: UTM Zone 11N 3. IMAGE SOURCE: World Imagery from ESRI ArcGIS Online. Source date September 14, 2016	CLIENT 	PROJECT SOUTHERN REGION GEOHAZARD RISK MANAGEMENT PROGRAM
		TITLE Site Plan S051 Pekisko Creek Hwy 540:02, km 4.591
	SCALE 1:2,531	PROJECT No. A05116A03
		FIG No. 1

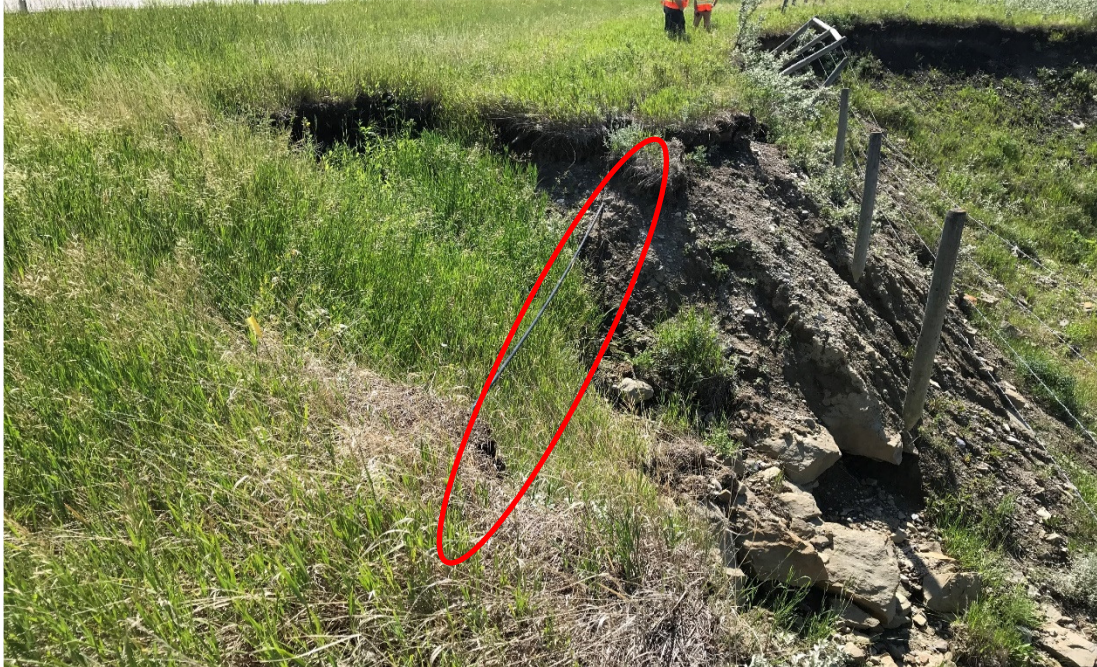
One black utility cable is exposed in the erosion gully. KCB to determine owner of utility cable.

Photo 1 Creek erosion extending into highway ditch. Utility cable hanging across failure (red circle). Photo was taken facing southwest on July 9, 2021.

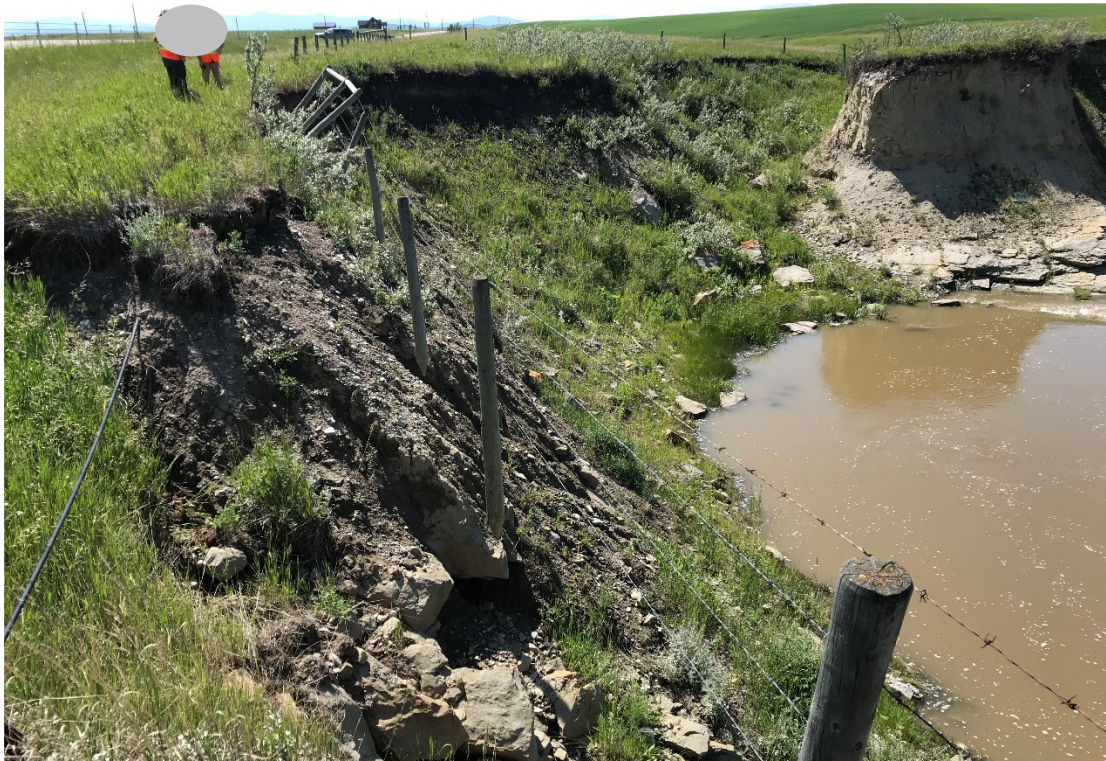
Photo 2 Bank erosion on the outside of a sharp meander bend. Fence line undermined. Photo was taken facing southwest on July 9, 2021.

- Ditch reconstruction will require slope reconstruction.
- Slope reconstruction using geogrid reinforced gravel. Longitudinal Peaked Stone Toe Protection or traditional riprap armoring to protect the toe from additional erosion.
- The highway ditch should be re-established with a swale, with armoring near the landowner's gate.

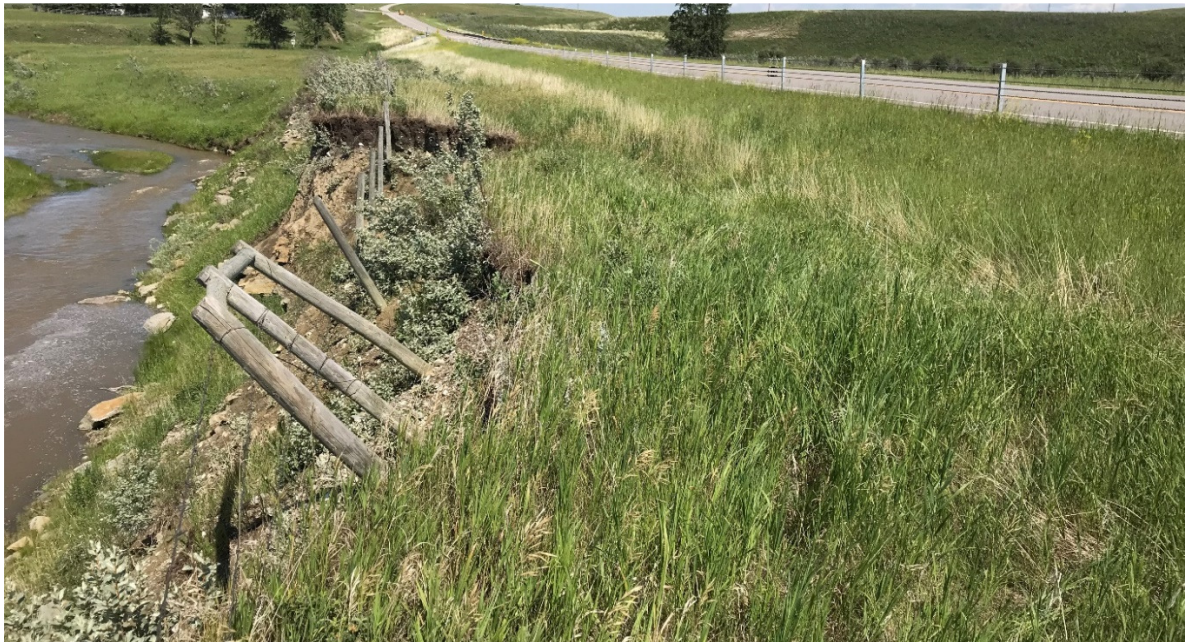
Photo 3 Erosion has extended into the highway drainage and surface runoff is discharging onto the slide zone. Photo was taken facing northeast on July 9, 2021.

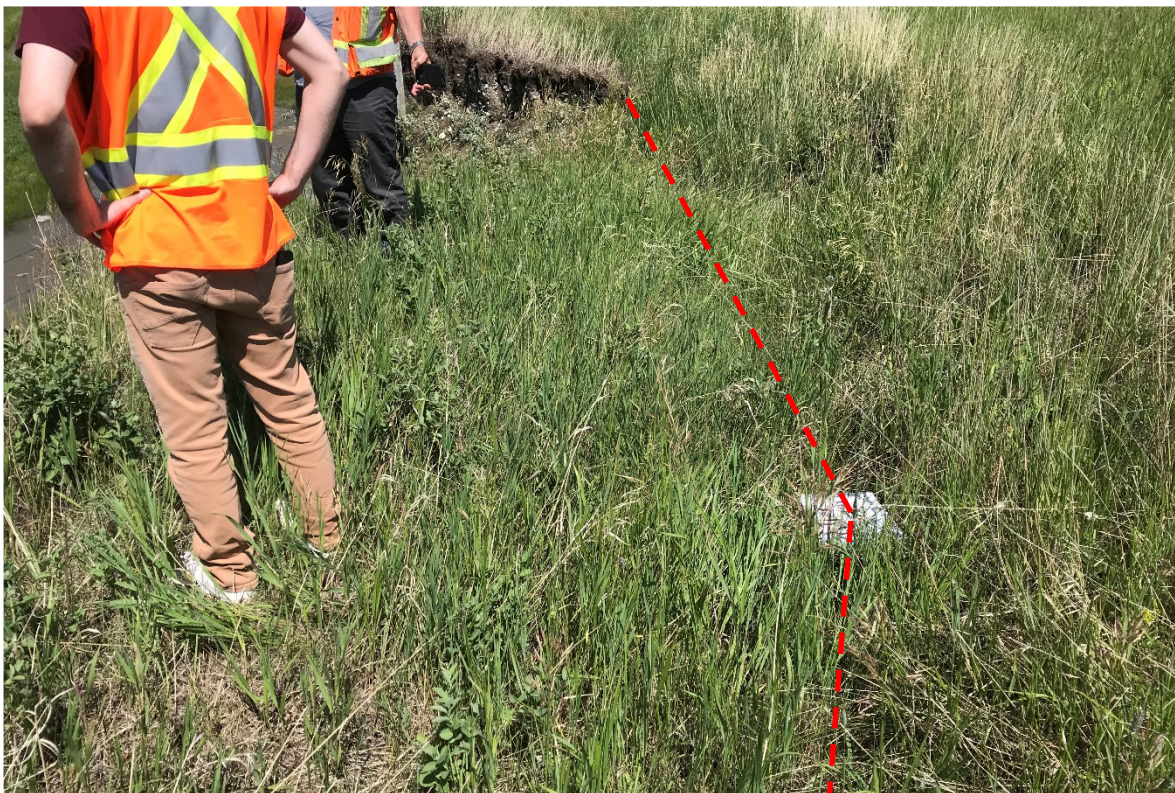
Photo 4 Tension cracking (red line) in highway right-of-way on the west flank of the erosion feature. Photo was taken facing northeast on July 9, 2021.
