SITE NUMBER AND NAME S051 Pekisko Bank Erosion		HIGHWAY & KM 540:02, 4.624	PREVIOUS INSPECTION DATE July 9, 2021	INSPECTION DATE May 16, 2022
LEGAL DESCRIPTION 08-14-17-02 W5M	NAD 83 COORDINATES UTM Northing Easting 11 5590158 701158		RISK ASSESSMENT PF: 11 CF: 10 TOTAL: 110	
AVERAGE ANNUAL DAILY TRAFFIC (AADT): 720 (east) (Ref. No. 71130)			CONTRACTOR MAINTENANCE AREA (CMA): 27

PROJECT SOUTHERN REGION GEOHAZARD RISK MANAGEMENT PROGRAM		
TITLE Site Plan S051 - Pekisko Bank Erosion Hwy 540:02, km 4.591		
SCALE 1:2,500	PROJECT No. A05116A03	FIG No. 1

Inspection Photographs

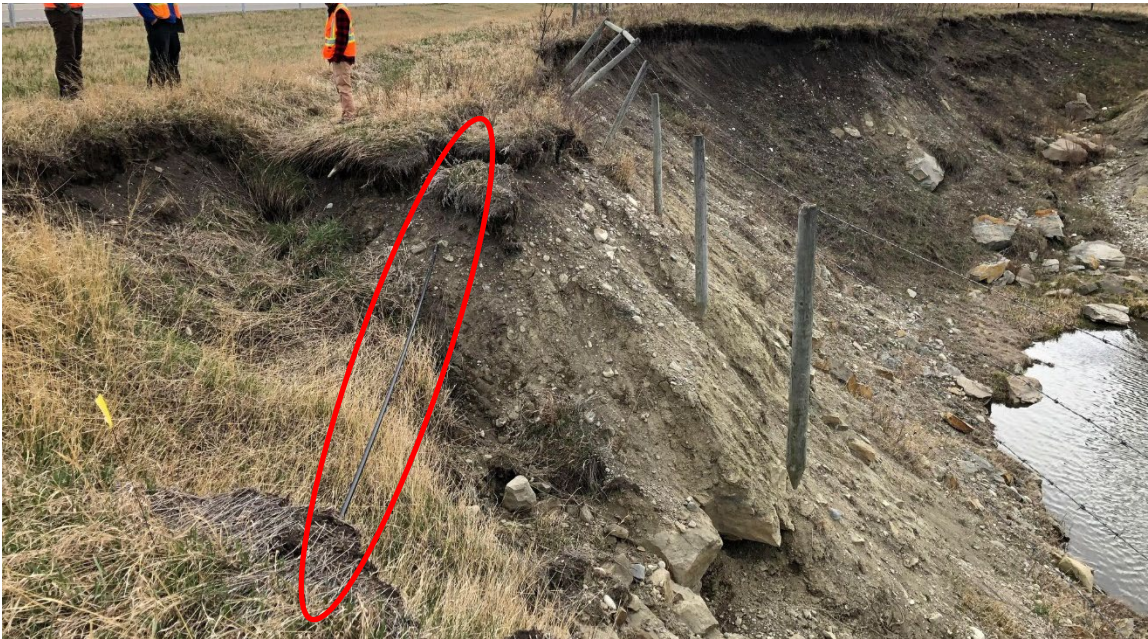
COMMENTS
No distress in pavement has been observed.
The height of the embankment is approximately 5 m to 6 m.
The erosion feature appears to have enlarged between the 2021 and 2022 inspections. The head scarp has extended towards the highway past the fence (undermining the fence) (Photo 1) and is impacting the north (westbound) ditch (Photo 2 and 3). The erosion extending into the ditch is redirecting surface water flows into the failure zone, exacerbating erosion.
During the 2022 inspection, eight fence posts had been undermined and are hanging (Photo 1 through 3); an increase of two since the 2020 inspection, indicating the erosion is lengthening. The fence is undermined for approximately 24 m.

The erosion has exposed a black utility cable (Photo 1 through 3) that is believed to be owned by TELUS. KCB does not know if it is an active or inactive line.

The 10 m to 15 m wide slide block observed during the 2021 inspection had collapsed by the 2022 site visit. Multiple smaller slide blocks appear to be forming near the fence line and are expecting to eventually slide into the erosion feature, which will enlarge the erosion site and cause additional retrogression towards the highway (Photos 1 through 4).

- Photo 1** Bank erosion is retrogressing towards the highway, impacting the north (westbound) ditch and undermining the fence. A utility cable is hanging where the erosion has extended furthest towards the highway (indicated by red circle). Photo taken May 16, 2022, facing southwest.

- A repair design has been prepared. The slope should be rebuilt using geogrid reinforced fill and the creek bank should be armoured (e.g., riprap). The north (westbound) ditch should be re-established during the repair and the fence repaired.

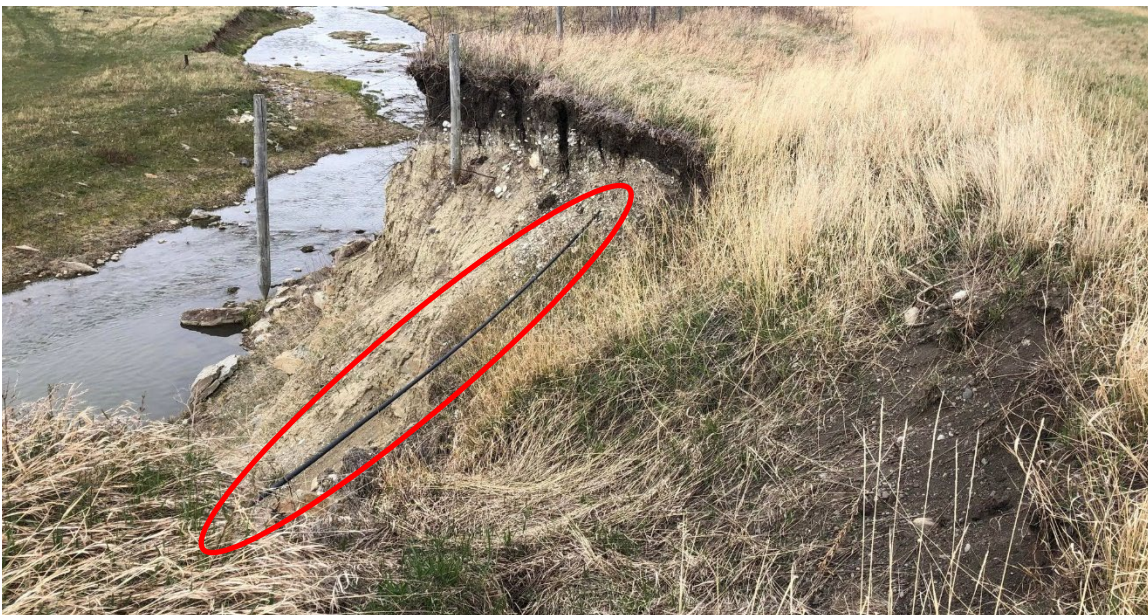
- Photo 2** Bank erosion, undermined fence, and exposed utility cable (indicated by red circle). Photo taken May 16, 2022, facing northeast.

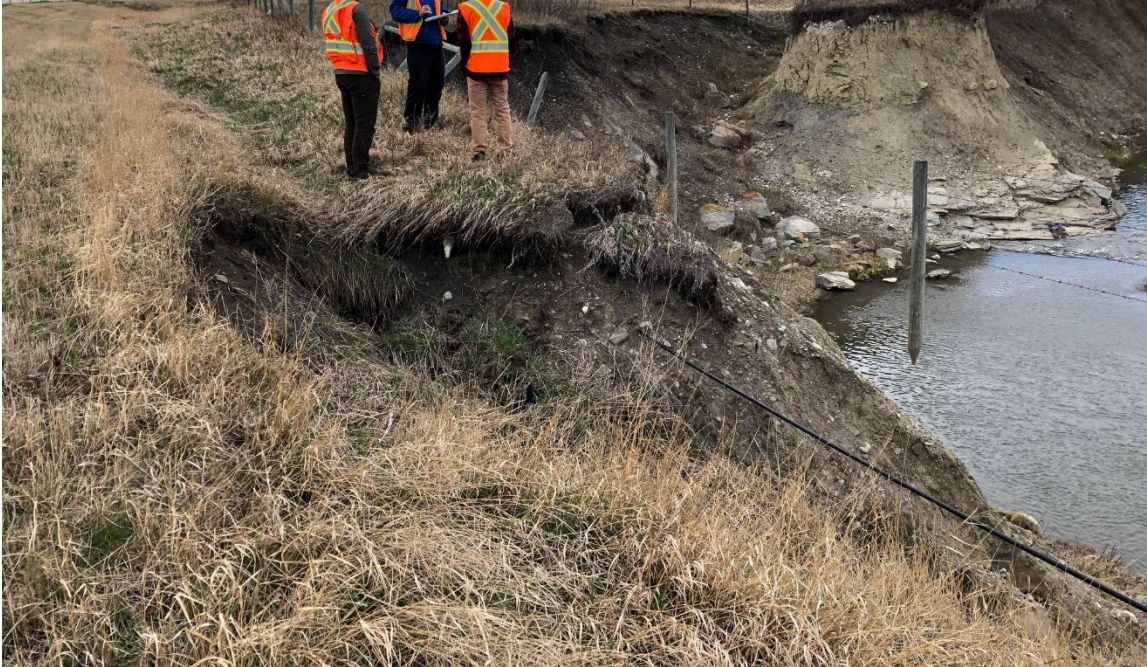
Photo 3 Erosion has retrogressed into the north (westbound) ditch and surface water runoff is discharging onto the erosion/slide zone. Photo taken May 16, 2022, facing southwest.

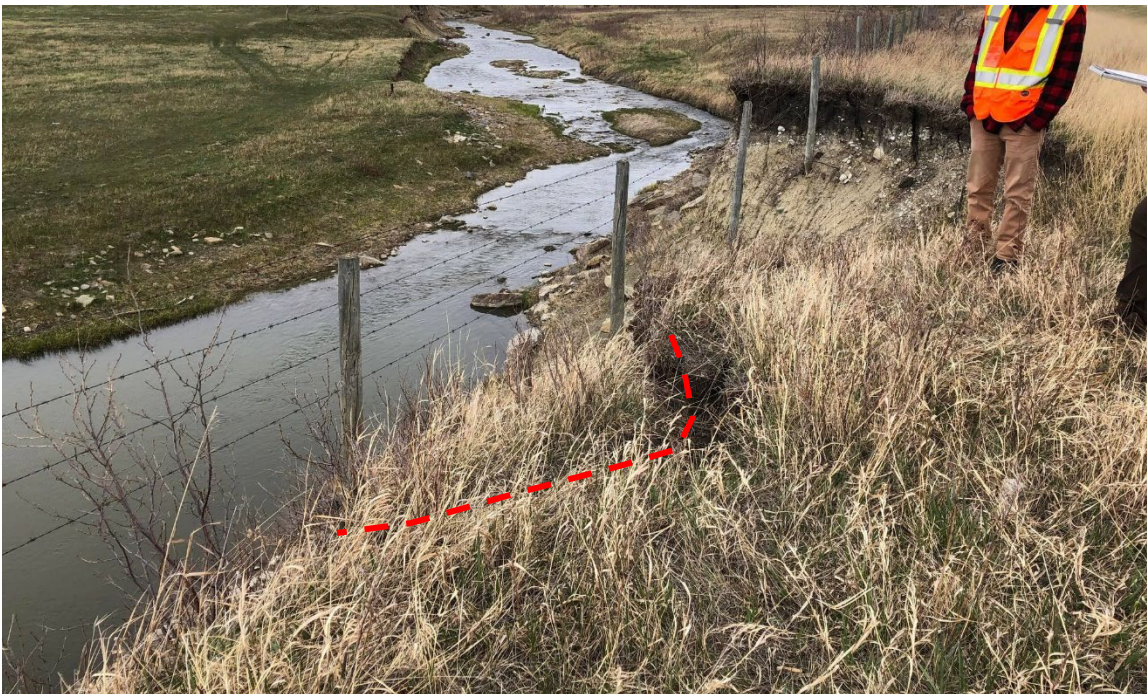
A tension crack was observed near the west extent of the site (Photo 4).

Photo 4 Tension cracking (indicated by red dashed line) near the fence and west end of the site. Photo taken May 16, 2022, facing northeast.
