| SITE NUMBER AND NAME S051 Pekisko Bank Erosion | | HIGHWAY & KM 540:02, 4.624 | PREVIOUS INSPECTION DATE May 16, 2022 | INSPECTION DATE May 9, 2023 |

| PRIMARY SITE ISSUE: Bank erosion on the outside of a sharp (110° attack angle) meander bend. The head scarp has encroached onto highway right-of-way and undermined the highway ditch re-directing ditch flows onto the failed slopes. | |

| PROJECT SOUTHERN REGION GEOHAZARD RISK MANAGEMENT PROGRAM | | |
| TITLE Site Plan S051 - Pekisko Bank Erosion Hwy 540:02, km 4.591 | | |

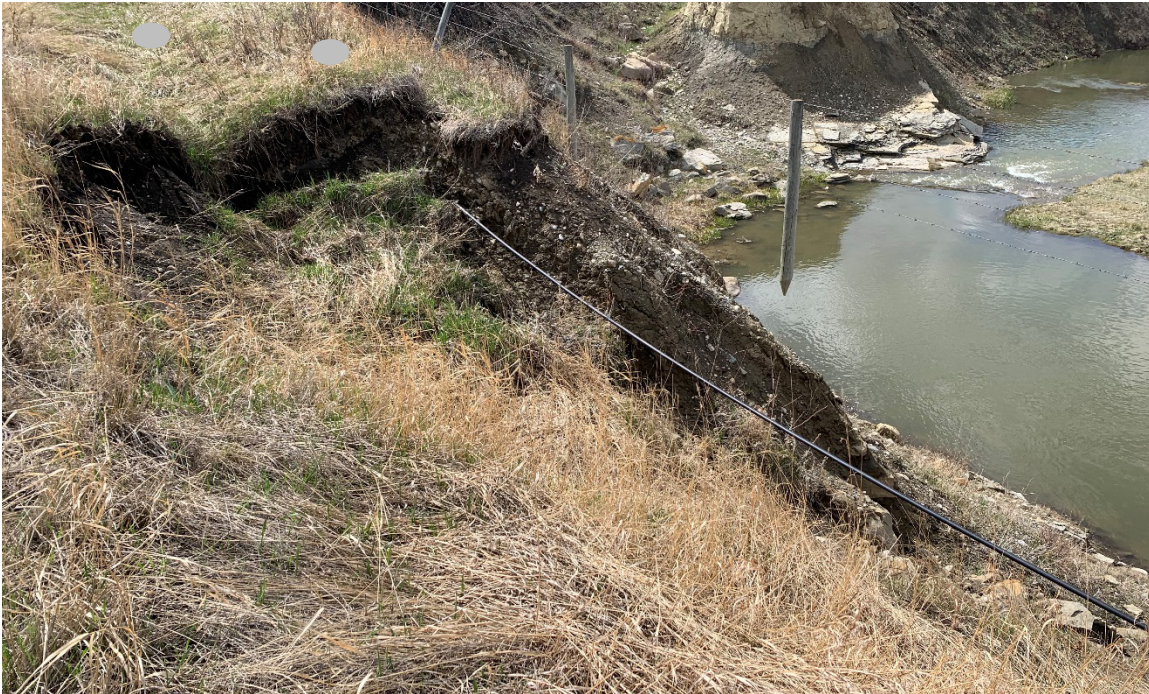
| The erosion feature appears to have enlarged between the 2022 and 2023 inspections. The head scarp has extended towards the highway past the fence (undermining the fence) and is impacting the north (westbound) ditch. The erosion extending into the ditch is redirecting surface water flows into the failure zone, exacerbating erosion. |

| <p>The erosion has exposed a black utility cable that is owned by TELUS.</p> |

Photo 1 Creek erosion extending into highway ditch. Utility cable hanging across failure
Photo was taken facing south on May 9, 2023.

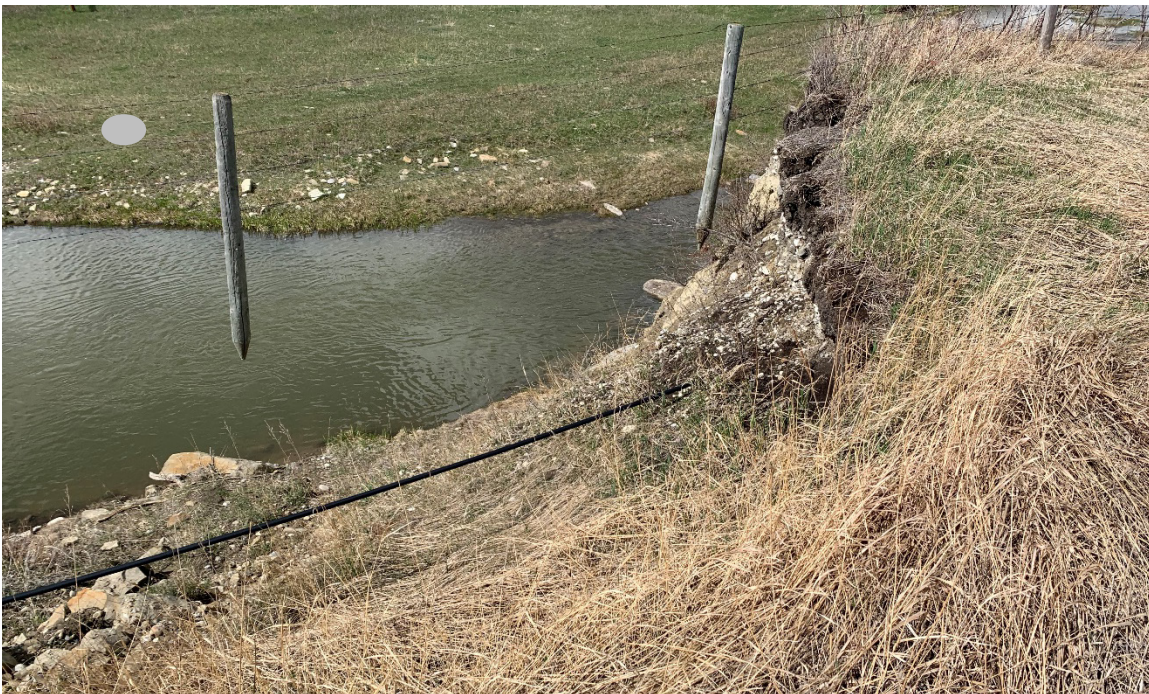
| During the 2023 inspection, eight fence posts had been undermined and are hanging; an increase of two since the 2020 inspection, but the same amount since 2022. The fence is undermined for approximately 24 m. |

Photo 2 Bank erosion on the outside of a sharp meander bend. Fence line undermined. Utility cable exposed. Photo was taken facing west on May 9, 2023.

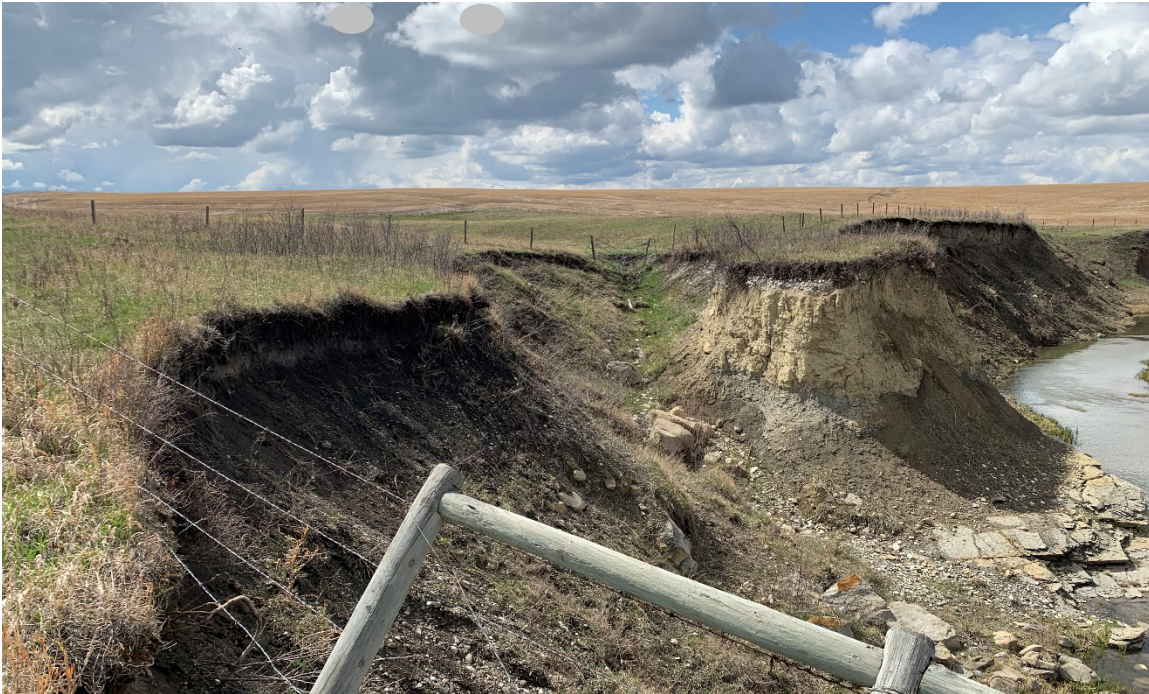
Photo 3 Erosion extending along the meandering bend in the river. Note exposed bedrock near river level. Photo was taken facing southwest on May 9, 2023.

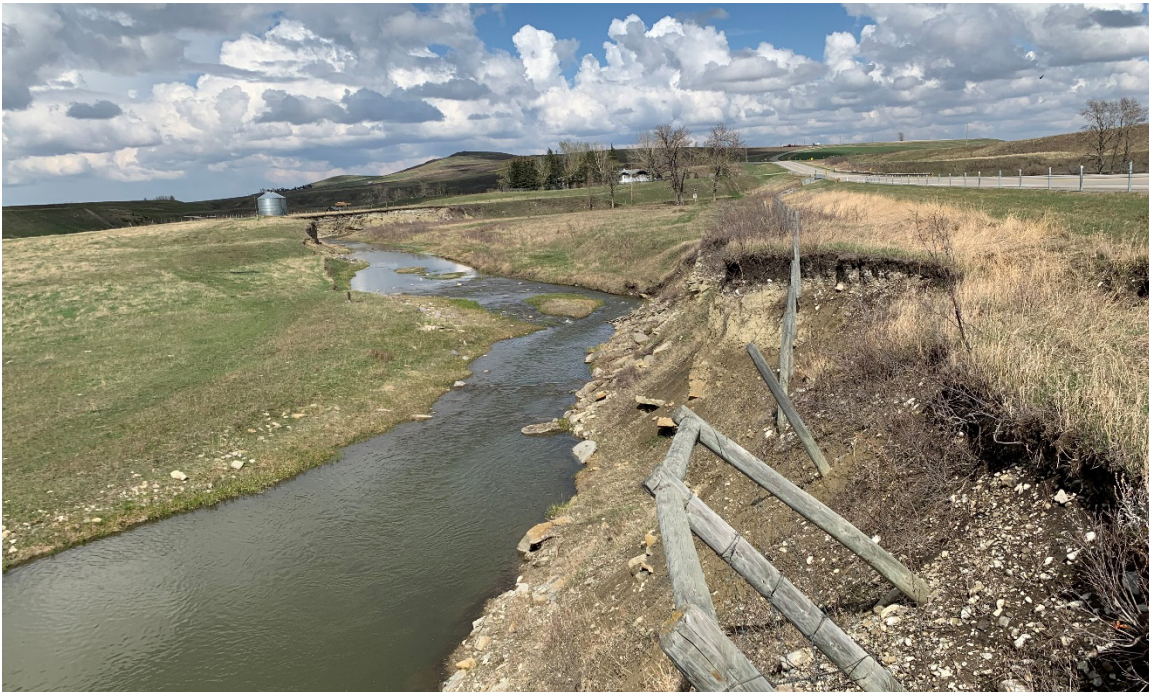
Photo 4 View of erosion north of fence undermining. Ditch flows discharge into erosion area. Photo was taken facing north on May 9, 2023.

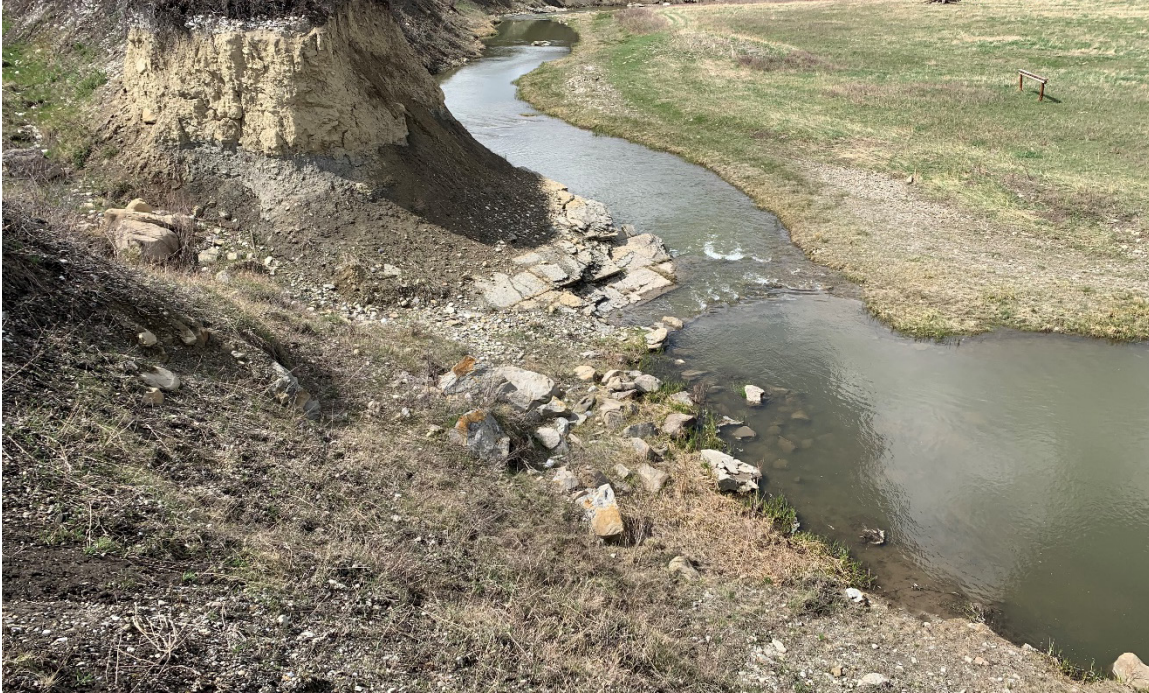
Photo 5 Erosion feature. Photo was taken facing southwest on May 9, 2023.
