<b>SITE NUMBER AND NAME</b> S051 Pekisko Bank Erosion		<b>HIGHWAY &amp; KM</b> 540:02, 4.624	<b>PREVIOUS INSPECTION DATE</b> May 9, 2023	<b>INSPECTION DATE</b> <b>May 28, 2024</b>
<b>LEGAL DESCRIPTION</b> 08-14-17-02 W5M	<b>NAD 83 COORDINATES</b> UTM    Northing    Easting 11      5590158    701158		<b>RISK ASSESSMENT</b> PF: 10    CF: 10    TOTAL: 100	
<b>AVERAGE ANNUAL DAILY TRAFFIC (AADT):</b> 780 (east) (Ref. No. 71130)			<b>CONTRACTOR MAINTENANCE AREA (CMA):</b> 27

**PRIMARY SITE ISSUE:** Bank erosion on the outside of a sharp (110° attack angle) meander bend. The head scarp has encroached onto highway right-of-way and undermined the highway ditch re-directing ditch flows onto the failed slopes.

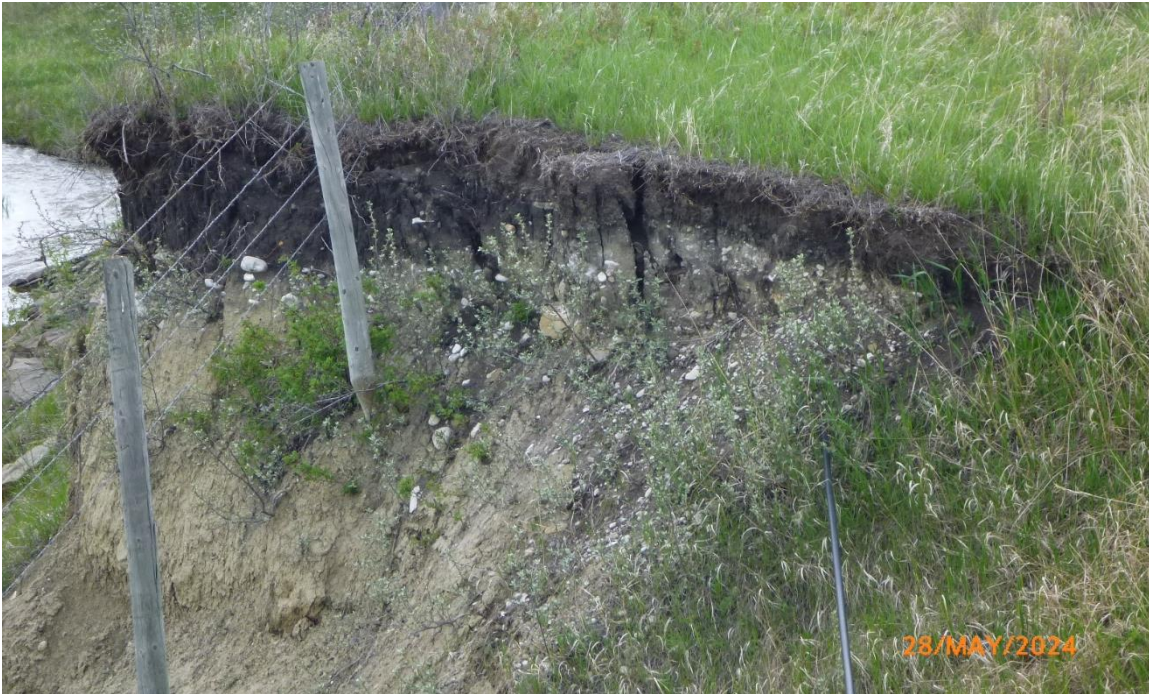
**Photo 1** Creek erosion extending into highway ditch. Blocks falling into erosion feature. Photo was taken facing north on May 28, 2024.

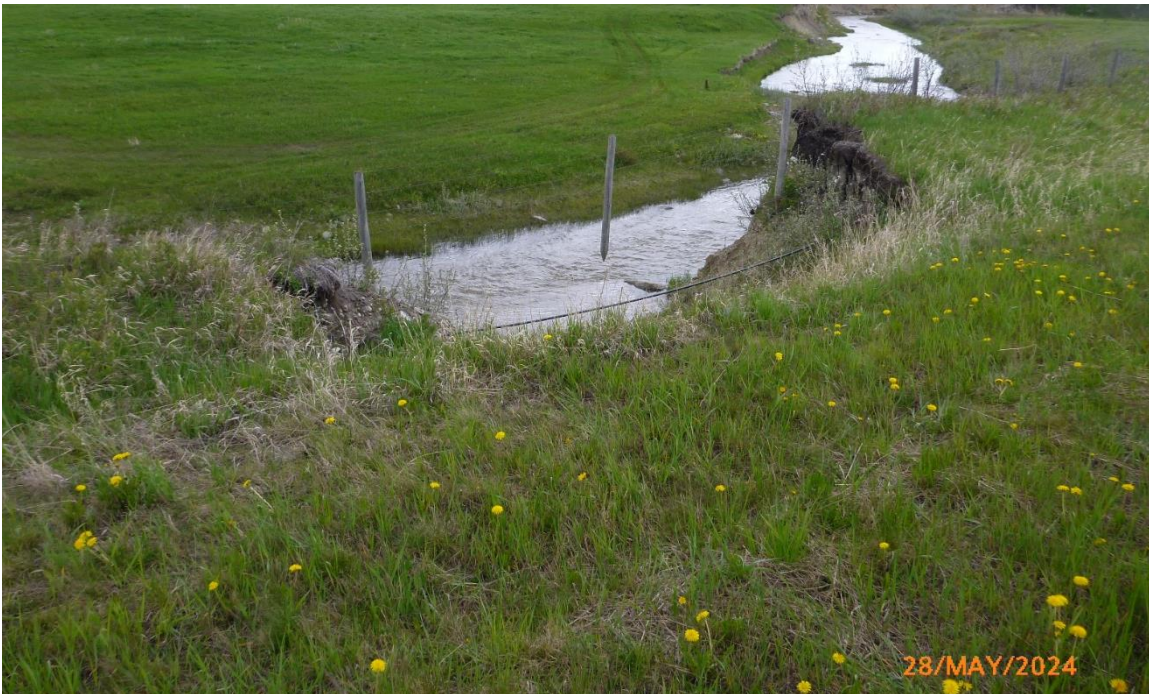
**Photo 2** Bank erosion on the outside of a sharp meander bend. Fence line undermined. Utility cable exposed. Photo was taken facing west on May 28, 2024.

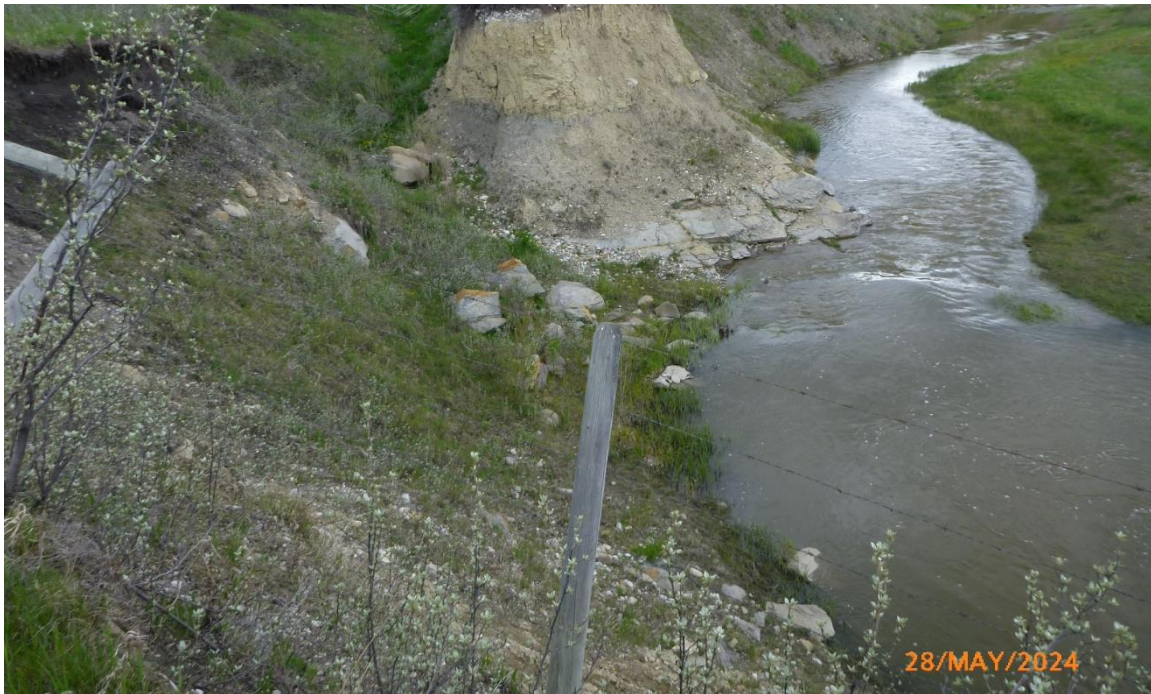
**Photo 3** Erosion extending along the meandering bend in the river. Note exposed bedrock near river level. Photo was taken facing southwest on May 28, 2024.

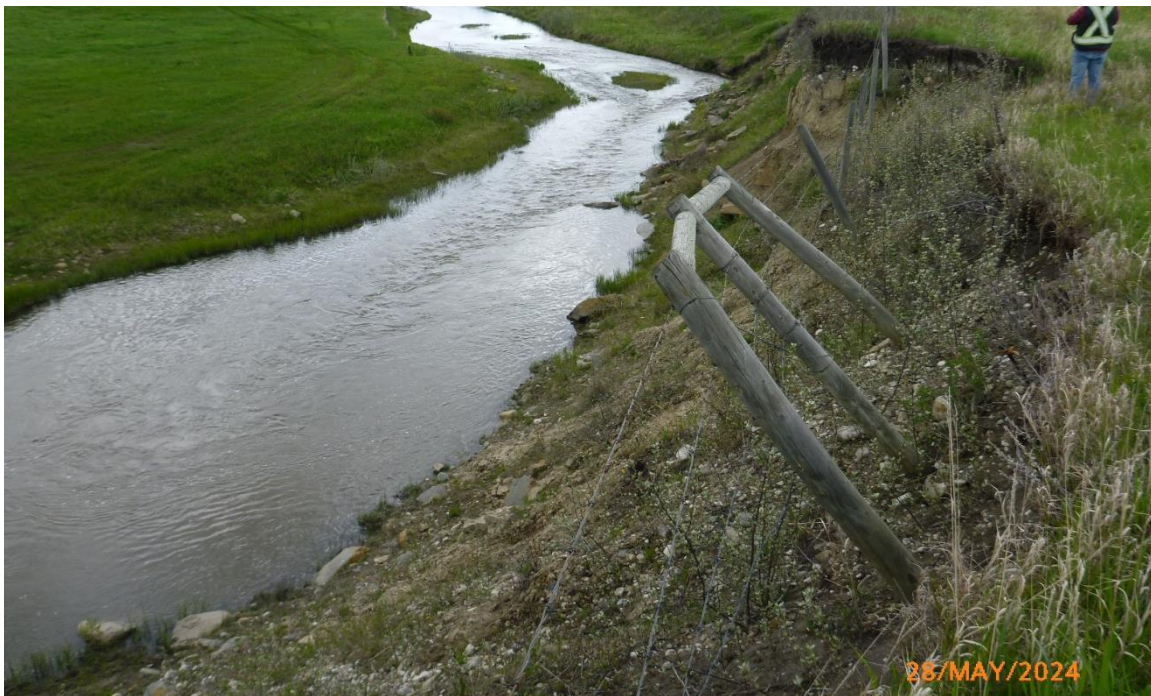
**Photo 4** View of erosion north of fence undermining. Ditch flows discharge into erosion area. Photo was taken facing north on May 28, 2024.
