SITE NUMBER AND NAME S051 A, B, & C - Pekisko Creek Erosion and Slides		HIGHWAY & KM 540:02, 5.649 & 4.591	PREVIOUS INSPECTION DATE April 30, 2018	INSPECTION DATE May 6, 2019
LEGAL DESCRIPTION 08-14-017-02 W5M 12-13-017-02 W5M	NAD 83 COORDINATES UTM Northing Easting 11 5590542 701680		RISK ASSESSMENT Site A & B: PF: 9 CF: 4 TOTAL: 36 Site C: PF: 10 CF: 3 TOTAL: 30	
AVERAGE ANNUAL DAILY TRAFFIC (AADT): 540 (east), (Ref. No. 71130)			CONTRACTOR MAINTENANCE AREA (CMA): 27

PROJECT SOUTHERN REGION GEOHAZARD RISK MANAGEMENT PROGRAM		
TITLE Site Plan S051 A, B, & C - Pekisko Creek Hwy 540:02, km 4.712		
SCALE 1:5,000	PROJECT No. A05115A03	FIG No. 1

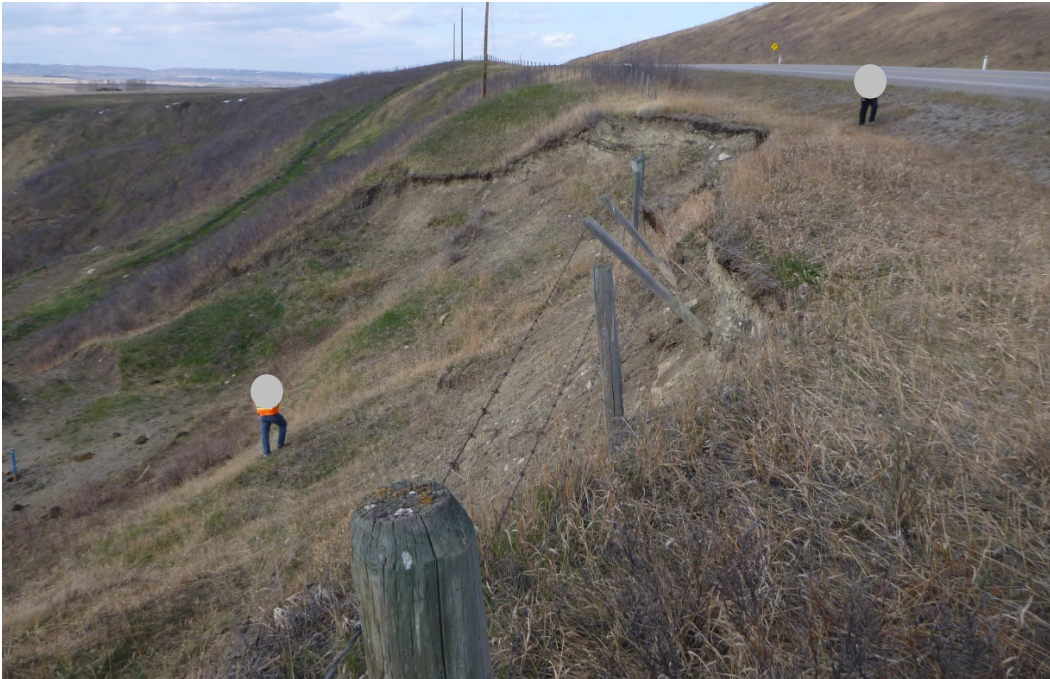
Photo 1 **Site A: Head scarp undermining fence line and ditch. Photo was taken facing north on May 6, 2019.**

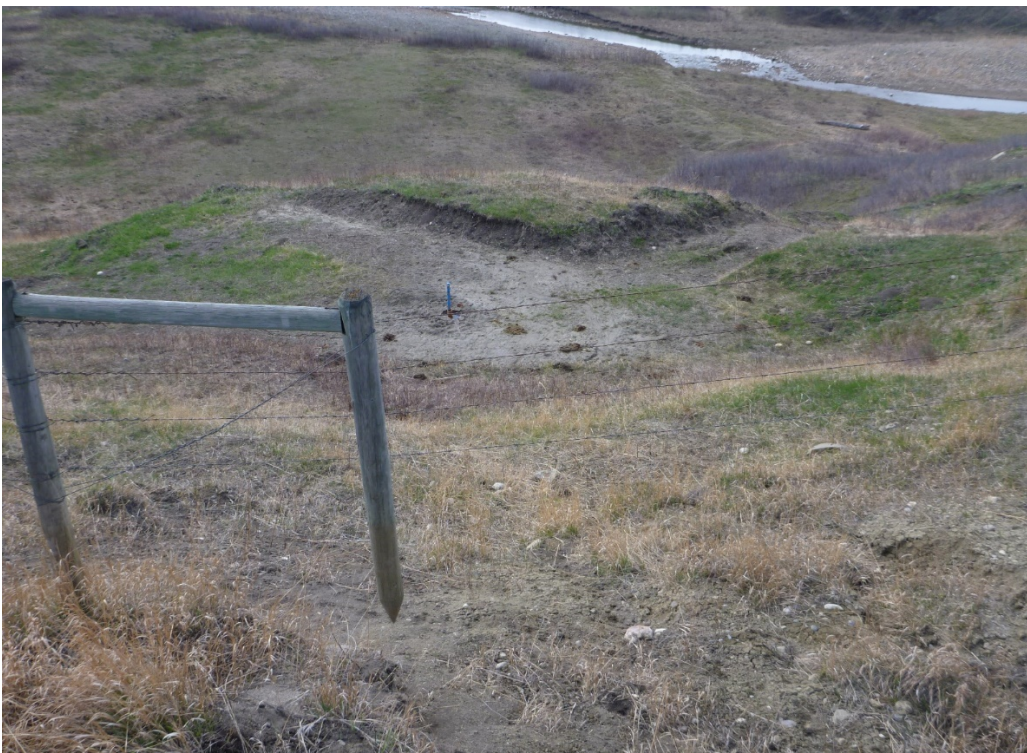
Photo 2 **Site A: Instrumentation bench at mid slope of slide. Area around SI is wet. Photo was taken facing west on May 6, 2019.**

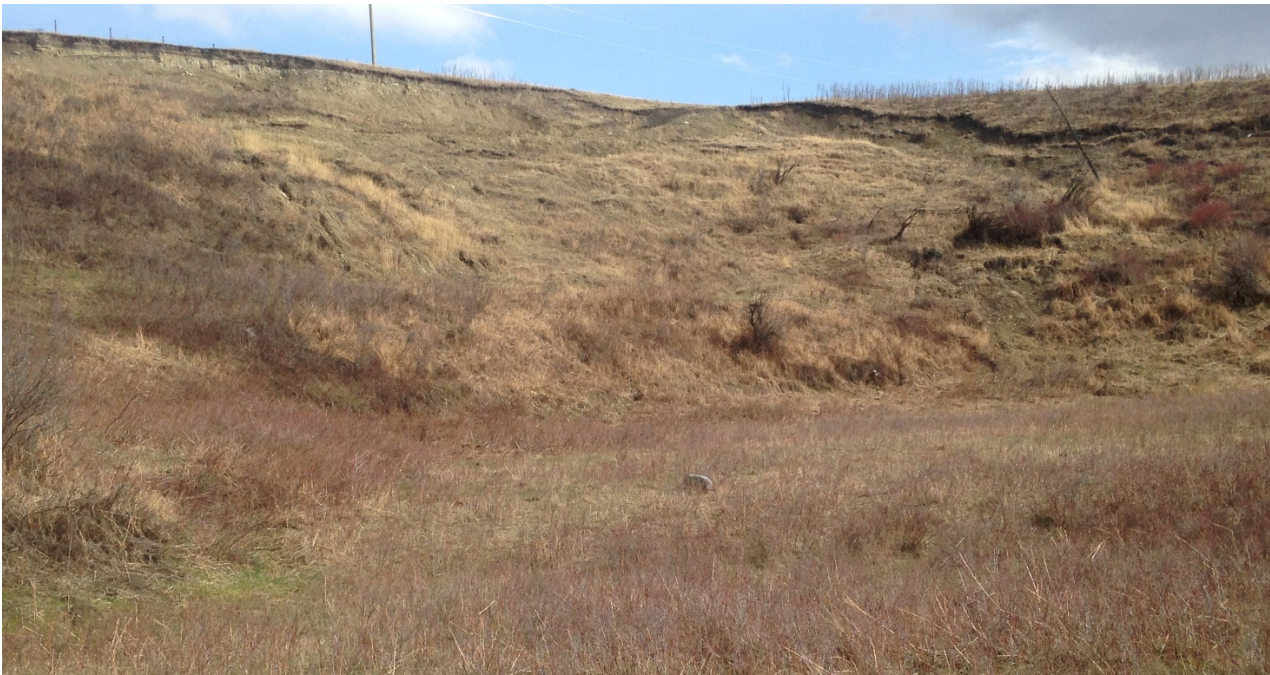
Photo 3 **Site A: View from mid-slope looking up slope. Head scarp at the southern end of Site A has not progressed to the fence line. Photo was taken facing east on May 6, 2019.**

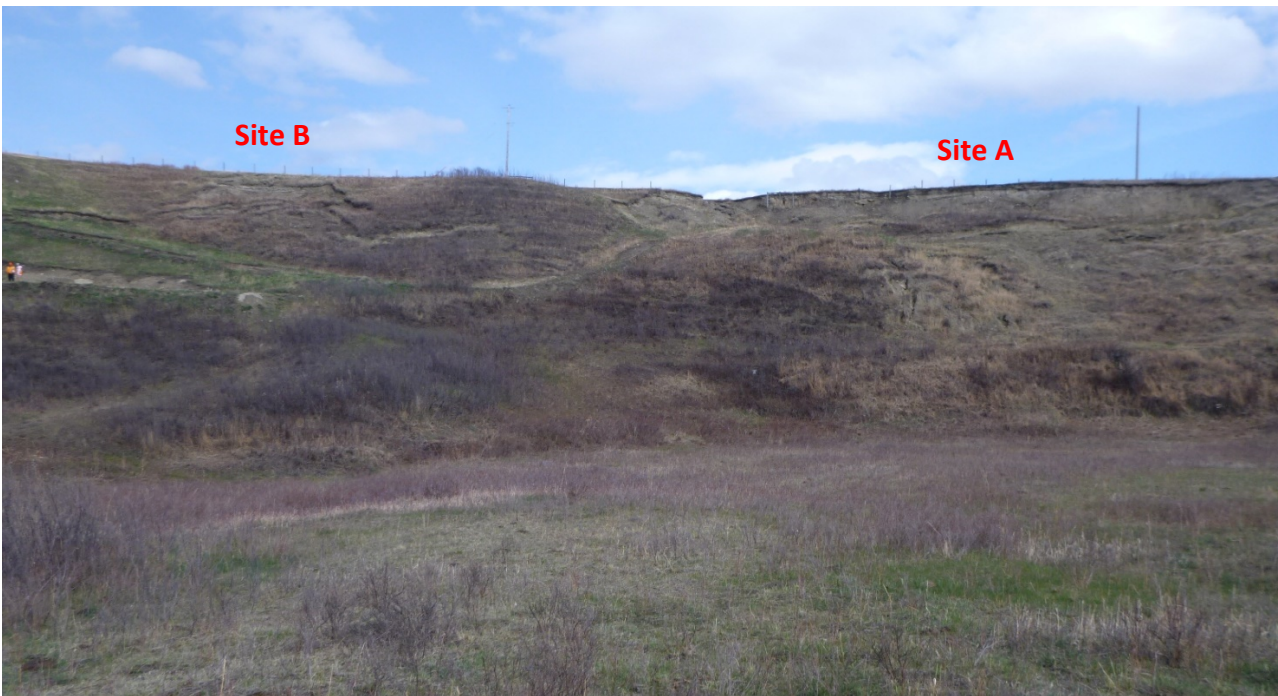
Photo 4 **Site A and Site B: View of head scarps. Photo was taken facing east on May 6, 2019.**

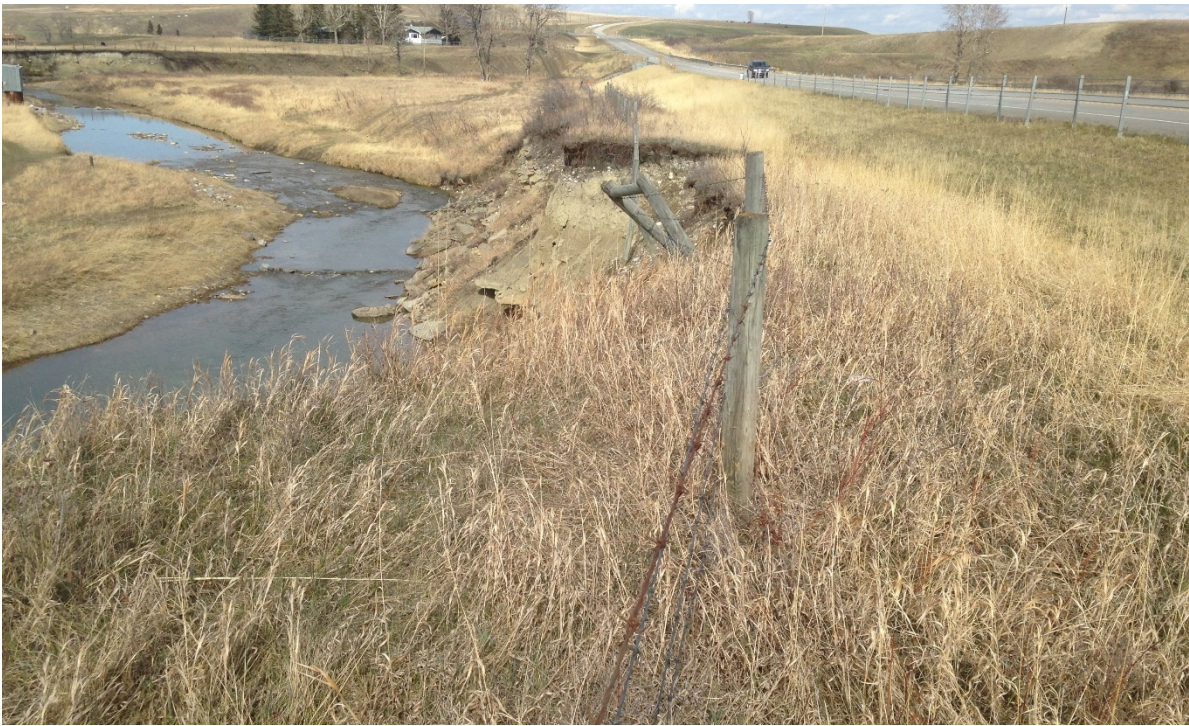
Photo 5 **Site C: Slope erosion extending past fence line. Photo was taken facing northeast on May 6, 2019.**

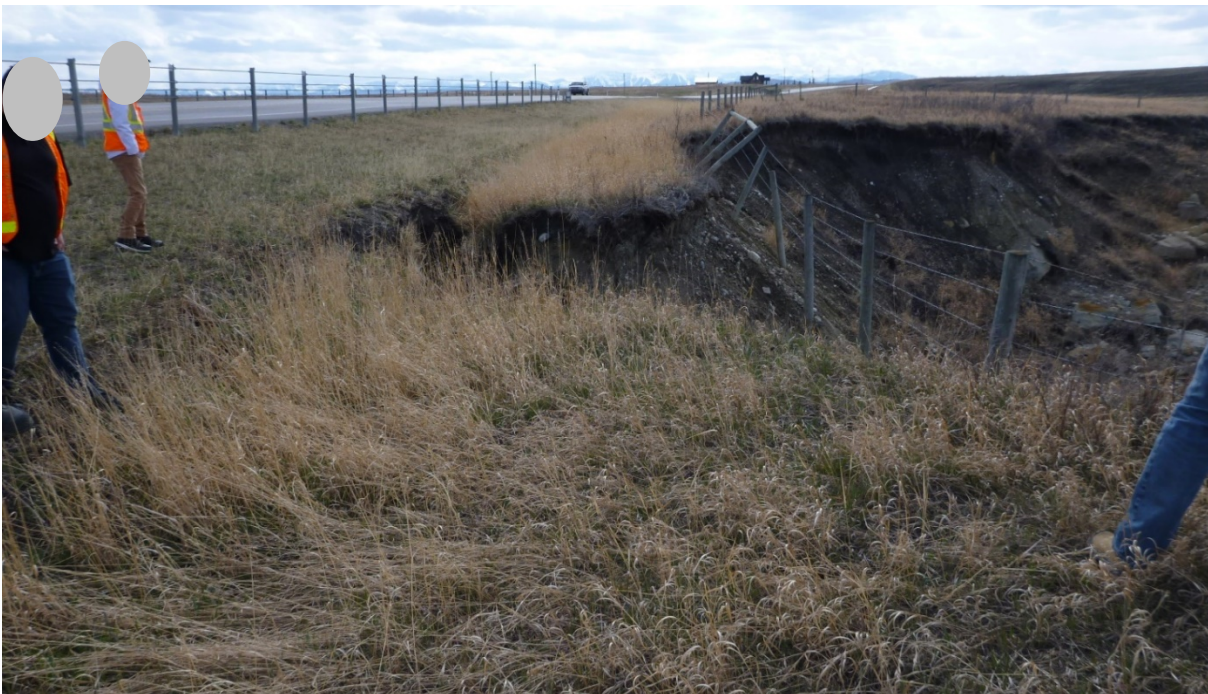
Photo 6 **Site C: Creek erosion failure extending into highway ditch. Utility cable hanging across failure. Photo was taken facing southwest on May 6, 2019.**
