SITE NUMBER AND NAME S051 A & B - Pekisko Creek Slides		HIGHWAY & KM 540:02, 5.649	PREVIOUS INSPECTION DATE May 6, 2019	INSPECTION DATE June 8, 2020
LEGAL DESCRIPTION 12-13-017-02 W5M	NAD 83 COORDINATES UTM Northing Easting 11 5590917 701863		RISK ASSESSMENT PF: 9 CF: 2 TOTAL: 18	
AVERAGE ANNUAL DAILY TRAFFIC (AADT): 720 (east), (Ref. No. 71130)			CONTRACTOR MAINTENANCE AREA (CMA): 27

PROJECT SOUTHERN REGION GEOHAZARD RISK MANAGEMENT PROGRAM		
TITLE Site Plan S051 A, B, & C - Pekisko Creek Hwy 540:02, km 4.712		
SCALE 1:5,000	PROJECT No. A05115A03	FIG No. 1

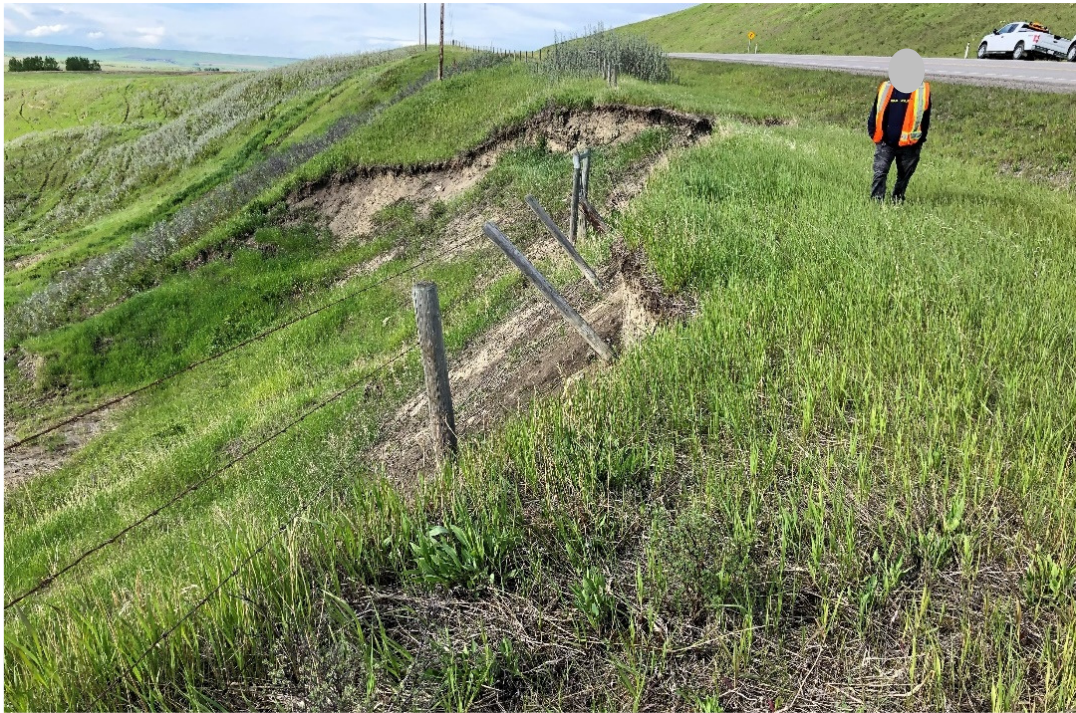
Photo 1 **Site A: Head scarp undermining fence line and ditch. Photo was taken facing north on June 8, 2020.**

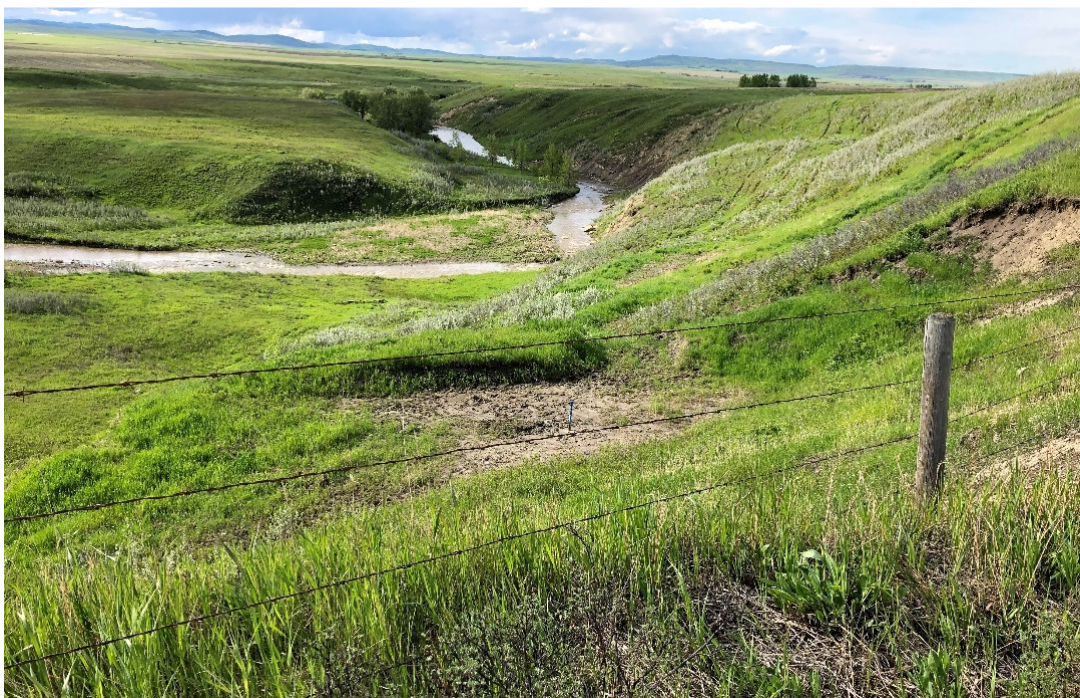
Photo 2 **Site A: Instrumentation bench at mid slope of slide. Area around SI is wet. Photo was taken facing west on June 8, 2020.**

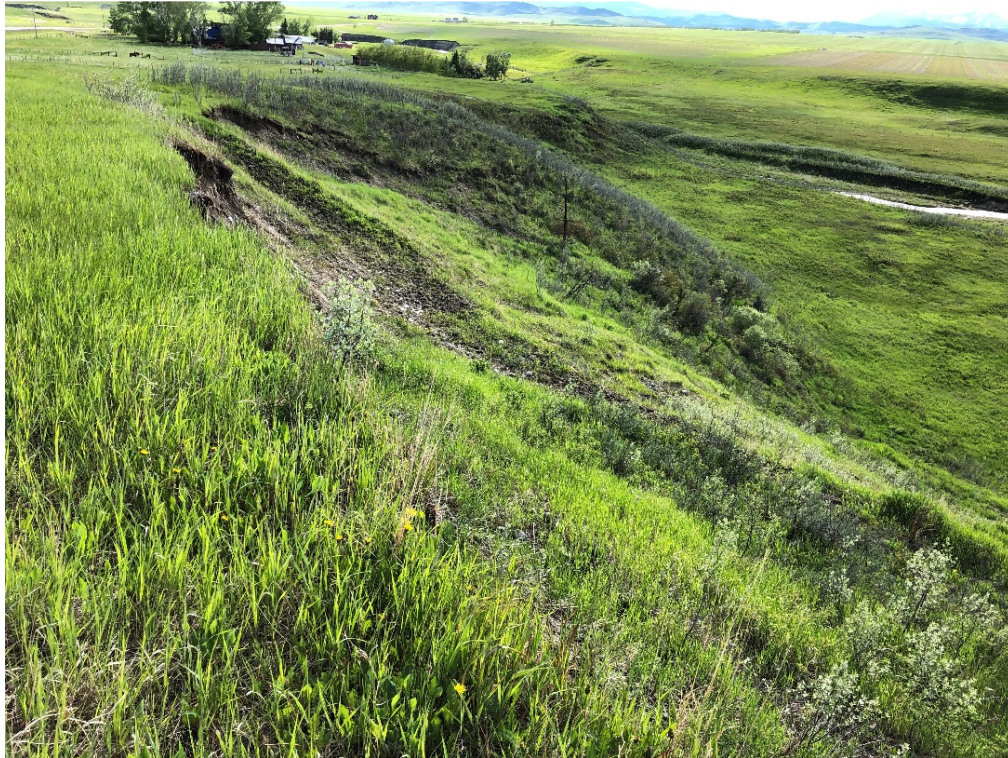
Photo 3 **Site A: View of left flank from near middle of head scarp. Photo was taken facing southwest on June 8, 2020.**
