SITE NUMBER AND NAME S075 - Pekisko Creek Slides		HIGHWAY & KM 540:02, 5.772	PREVIOUS INSPECTION DATE June 8, 2020	INSPECTION DATE May 9, 2023
LEGAL DESCRIPTION 12-13-017-02 W5M	NAD 83 COORDINATES UTM Northing Easting 11 5590917 701863		RISK ASSESSMENT PF: 9 CF: 4 TOTAL: 36	
AVERAGE ANNUAL DAILY TRAFFIC (AADT): 700 (east), (Ref. No. 71130)			CONTRACTOR MAINTENANCE AREA (CMA): 27

PROJECT SOUTHERN REGION GEOHAZARD RISK MANAGEMENT PROGRAM		
TITLE Site Plan S075 - Pekisko Slides Hwy 540:02, km 5.772		
SCALE 1:1,000	PROJECT No. A05116A03	FIG No. 1

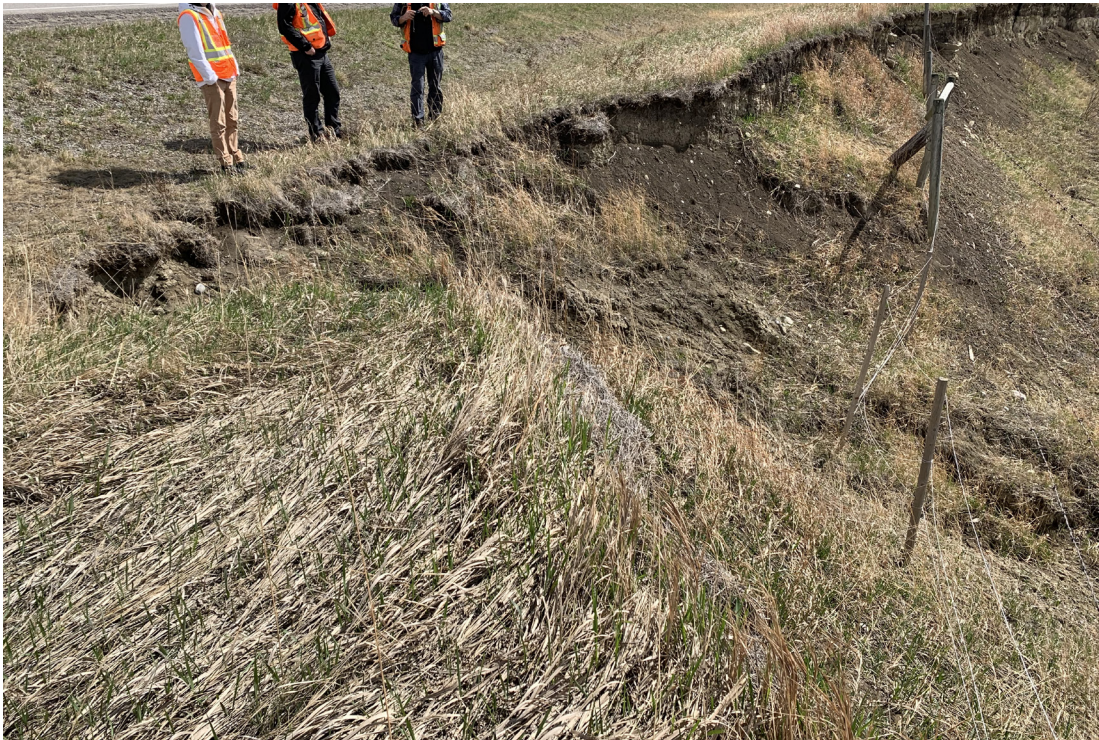
The head scarp at Site A appears to have retrogressed approximately 0.5 m since 2020, 6.5 m from the white line on the highway compared to 7.0 m in 2020. Eight fence posts are hanging at Site A (unchanged from 2020). A broken utility cable is visible in the Site A slope failure. Between Site A and B is an existing section of slope and a power pole.

The back slope at Site A appeared saturated with visible seepage flow in the erosion channel. Recent displaced topsoil and grass was noted at the head scarp at Site A.

Photo 1 Head scarp at Site A. Photo was taken facing south on May 9, 2023.

- Short-Term
 - Monitor location during and after high flows and significant antecedent rain or snow melt.
 - Ditch-flow containment should be re-established with a ditch berm. The base of the ditch should be lined with a membrane covered by gravel; the liner should extend over the edges of the ditch.

- Long-Term
 - A pile wall with geosynthetic-reinforced fill may be required to stabilize the upper slide mass and minimize potential for further retrogression. Slope stabilization repairs should include subsurface drainage with provision for conveying water to toe of slope without causing erosion. Another option is to construct a gravel shear key and geosynthetic reinforced slope on stable soil or bedrock.

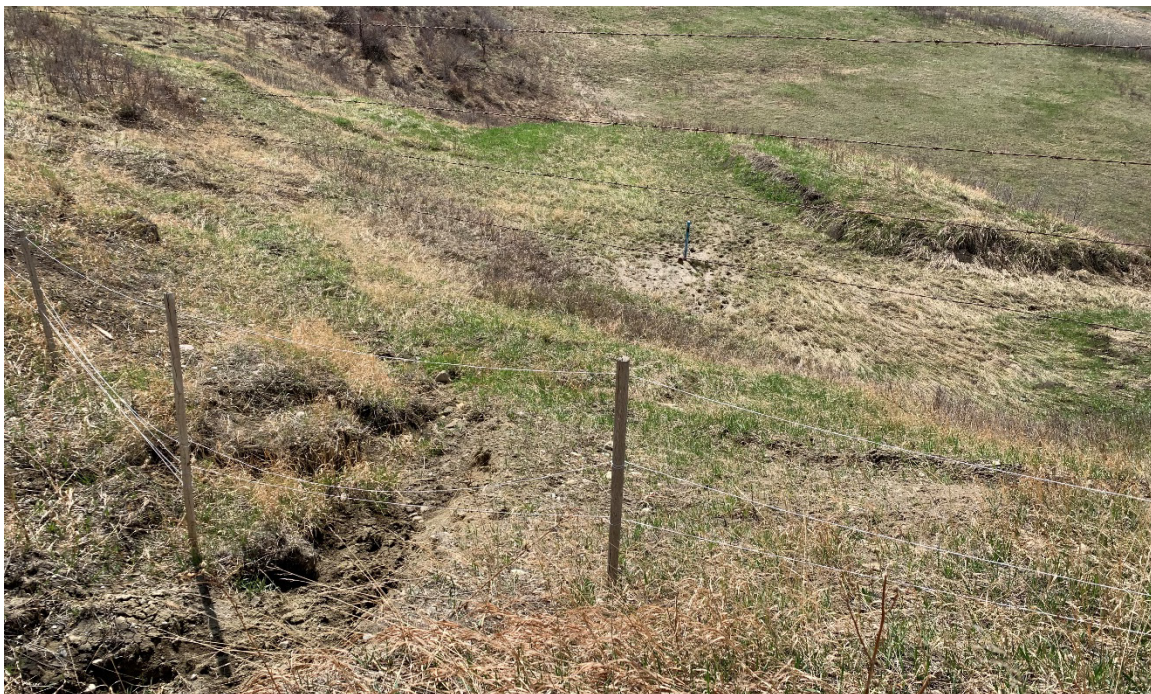
The east portion of the Site A slide area is a rotational-block failure, and the midslope bench looks like it is rotated by 15°. The west portion of the Site A slide area is shallow and translational (estimated depth of failure of 4 to 5 m). The failure scarp has extended past the fence line and undermined the highway ditch, redirecting ditch flows into the failure zone.

Photo 2 Site A looking downslope. Photo was taken facing southwest on May 9, 2023.

- A toe berm may also be possible but will require a large volume of fill. A borrow area for bridge construction is present in the valley bottom, near the creek. The volume of fill available from the borrow should be assessed if a toe berm is selected.

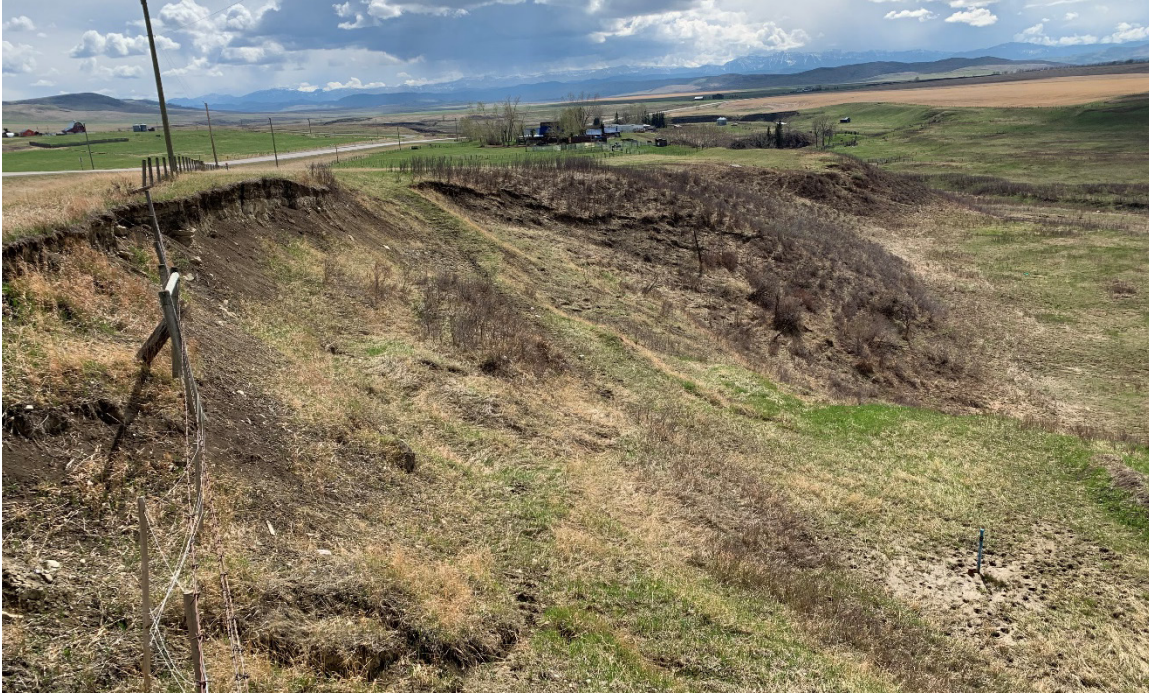
Photo 3 Site A, fence undermined. Photo was taken facing south on May 9, 2023.

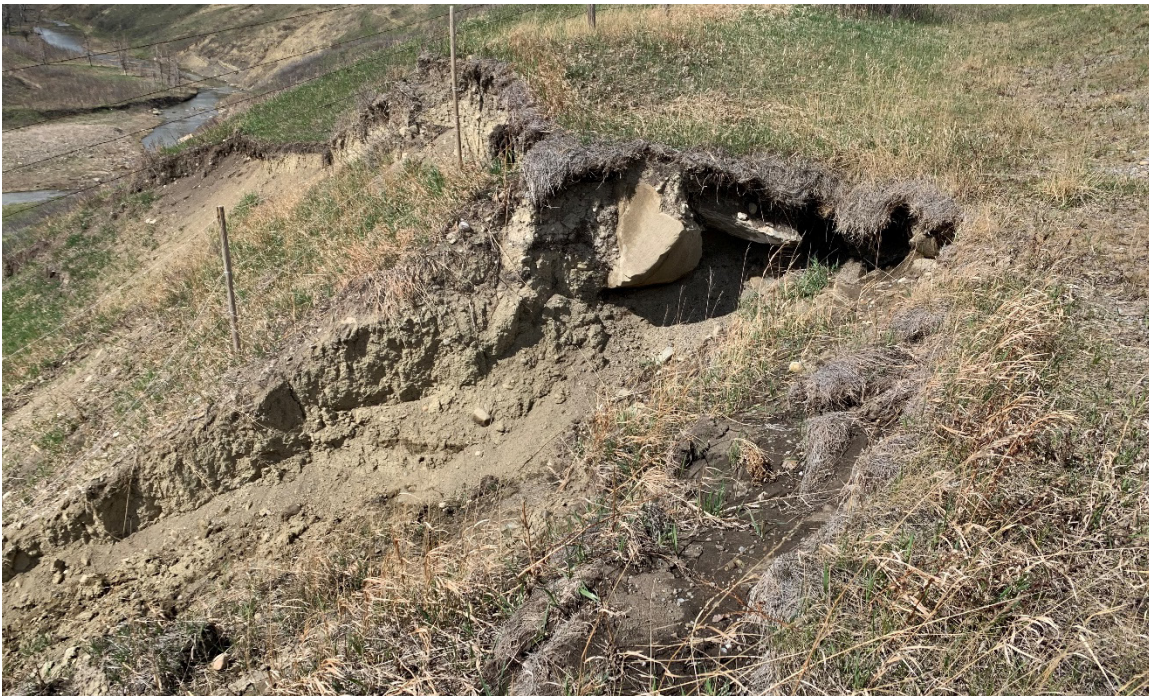
The head scarp of Site B slide area is 1.70 m away from the fence line (no change from 2020). The ditch at the head of the slide is well defined and ditch flows are conveyed past the slide area.

Photo 4 Head scarp Site B. Photo was taken facing north on May 9, 2023.

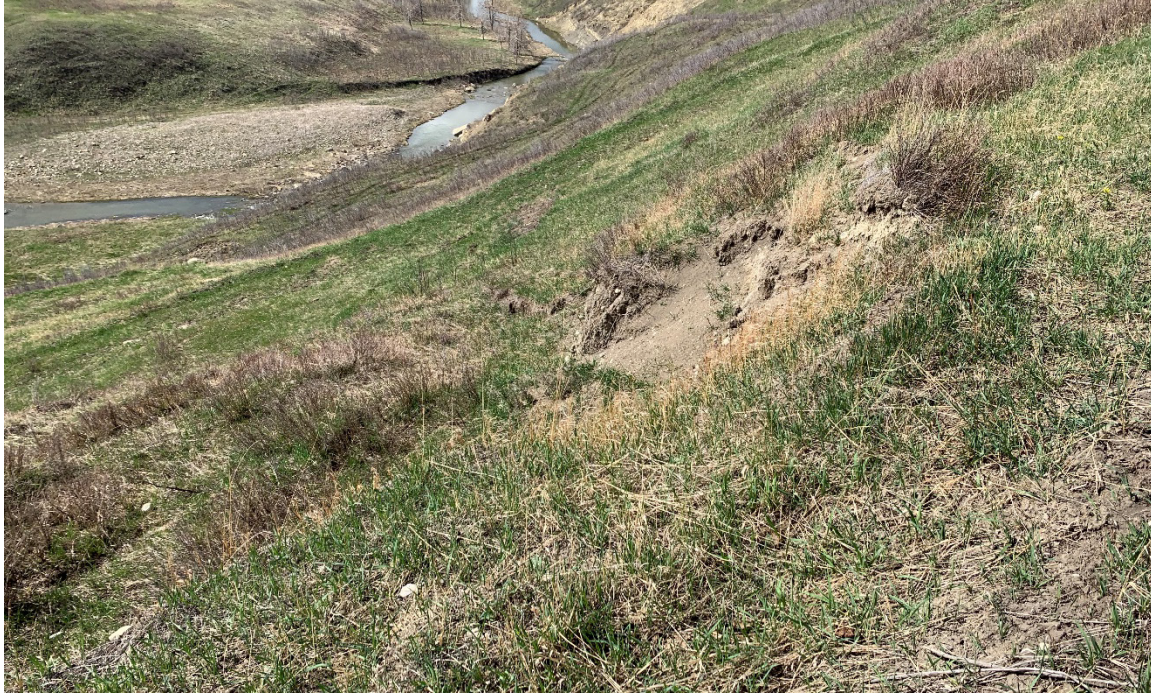
Photo 5 **Site B slope. Photo was taken facing north on May 9, 2023.**
