July 14, 2023

**CON0022161 Southern Region GRMP Instrumentation Monitoring
Site S075; H540:02, km 5.720 Pekisko Creek Slides
Section C – 2023 Spring Readings**

2023 S075 Spring Report.docx
A05116A03

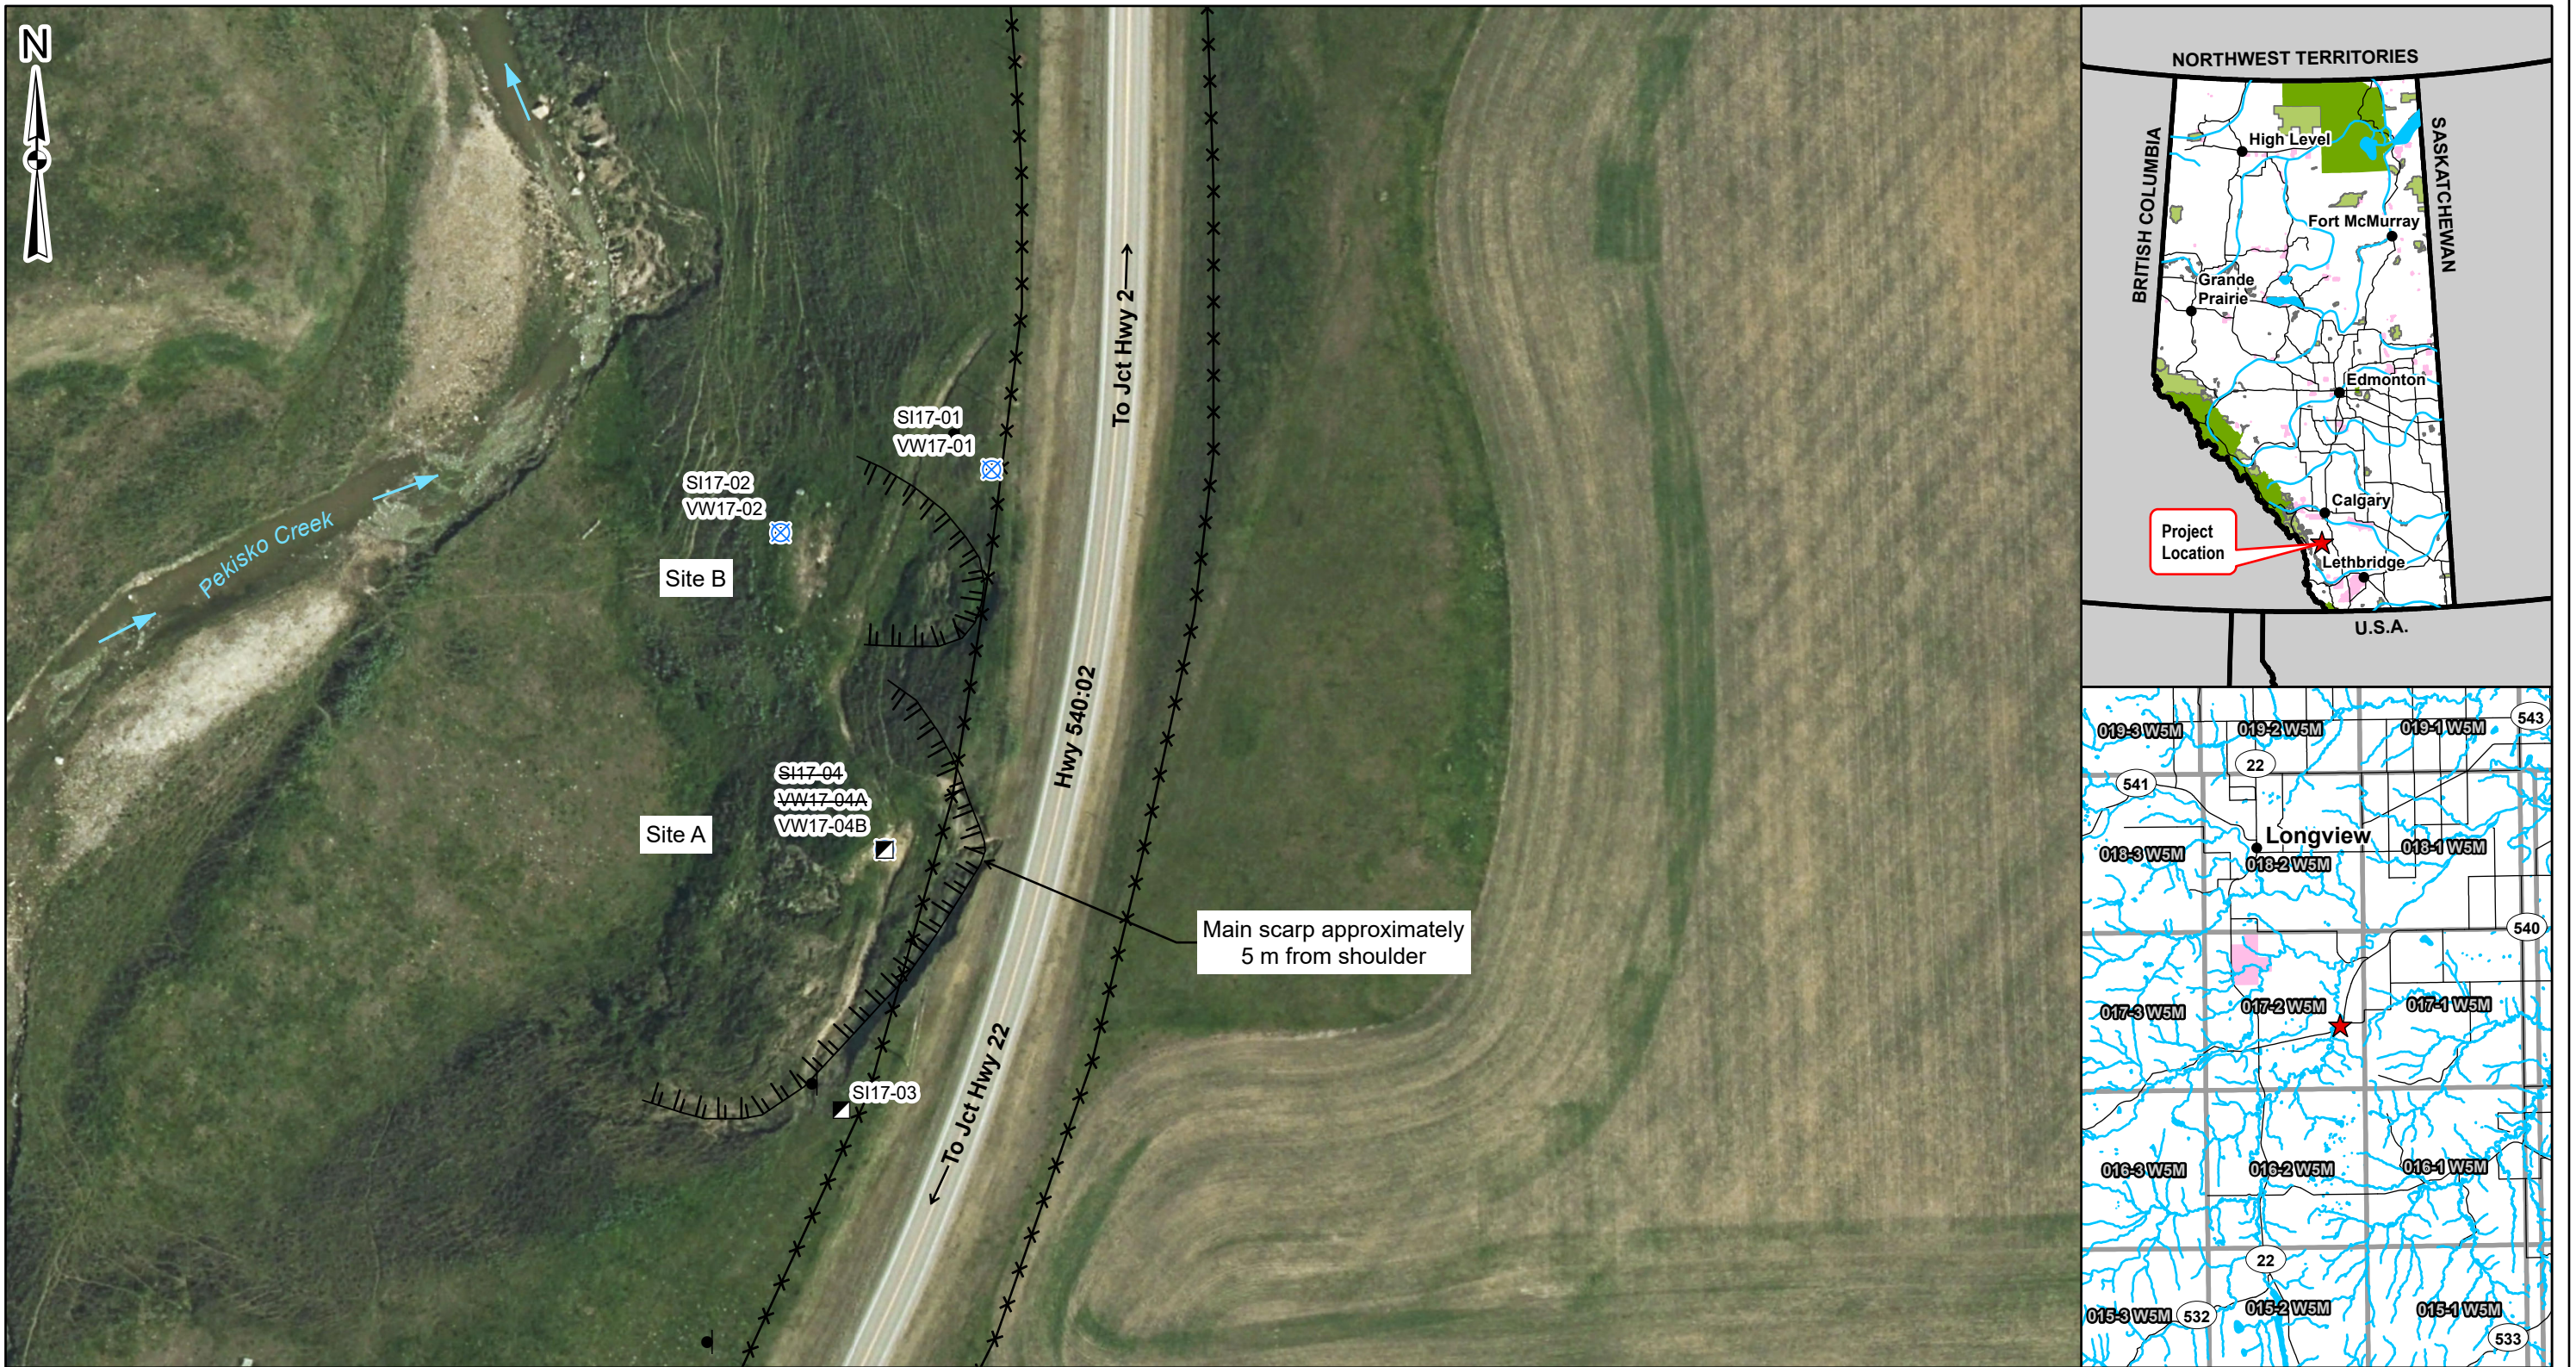
SCALE 1:1,500 PROJECT No. A05116A03 FIG No. 1

The geohazard at the S075 site consists of two adjacent landslides located approximately 30 m apart, denoted as Site A and B, along the west (southbound) lane of Hwy 540:02. Previously, this site was included with a riverbank erosion site located approximately 1.1 km southwest along Hwy 520:02. In early-2022, KCB and AT separated the riverbank erosion and landslide sites, with the landslide site (Site A and B) becoming the S075 site and riverbank erosion site retaining the original S051 site number.

Movement has been recorded in SI17-03 from an approximate depth of 15 m to 20 m below ground surface (approximately El. 1201 m to El. 1196 m). SI17-03 is located at the crest of the slope outside of the identified slide mass.

Before becoming inoperable in 2019, distributed movement had been recorded in SI17-04 from ground surface to an approximate depth of 8 m below ground surface (approximately El. 1200 m) and discrete movement at an approximate depth of 14 m to 22 m below ground surface. SI17-04 is located midslope within the slide mass.

Movement has been recorded in SI17-01 from an approximate depth of 6 m to 12 m below ground surface (approximately El. 1211 m to El. 1216 m). SI17-01 is located near the crest of the slide.

Movement has been recorded in SI17-02 from an approximate depth of 4 m to 5 m and 8 m to 11 m below ground surface (approximately El. 1194 m to El. 1195 m and El. 1188 m to 1191 m). SI17-02 is located near the toe of the slide.

Preliminary engineering, final design, and tendering should be carried out before the slides retrogress further towards the highway and begin impacting the highway surface.

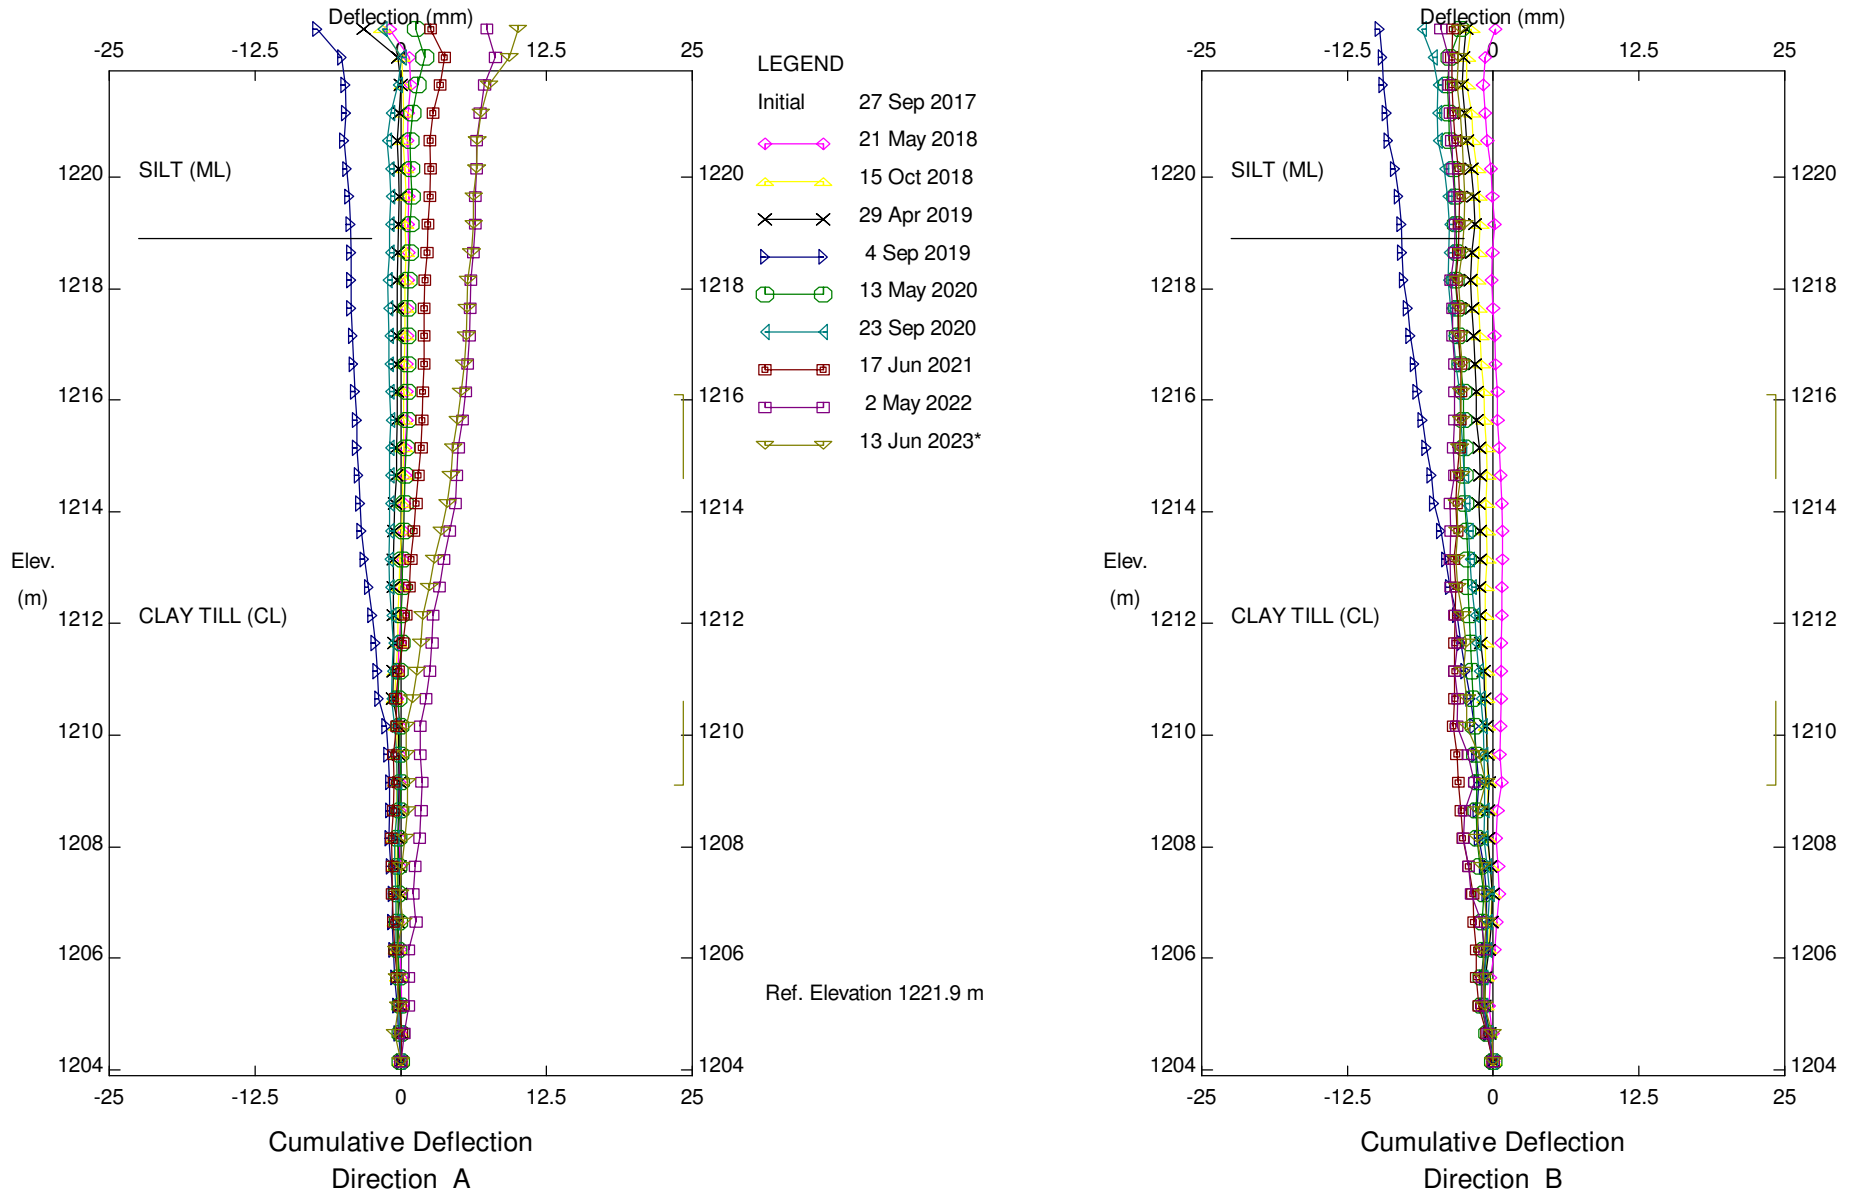
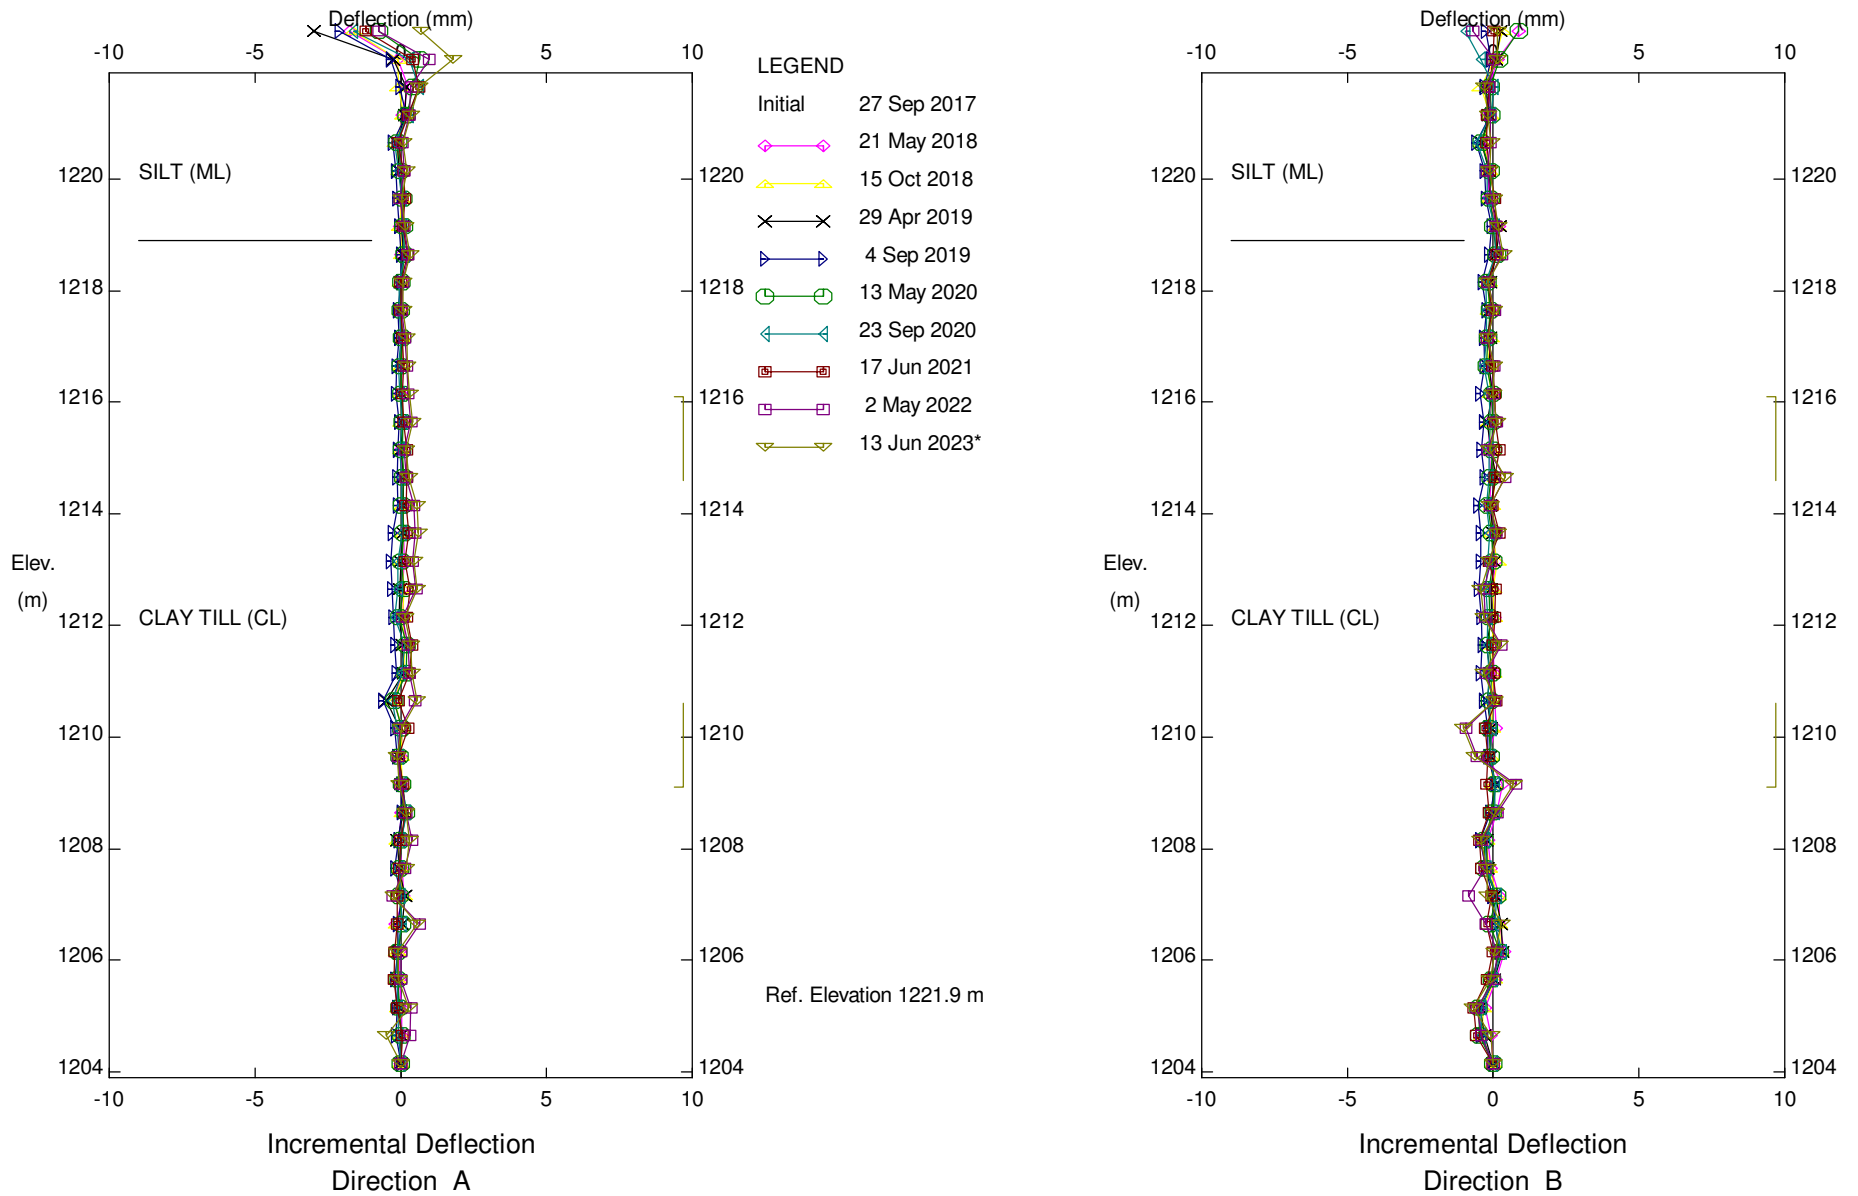
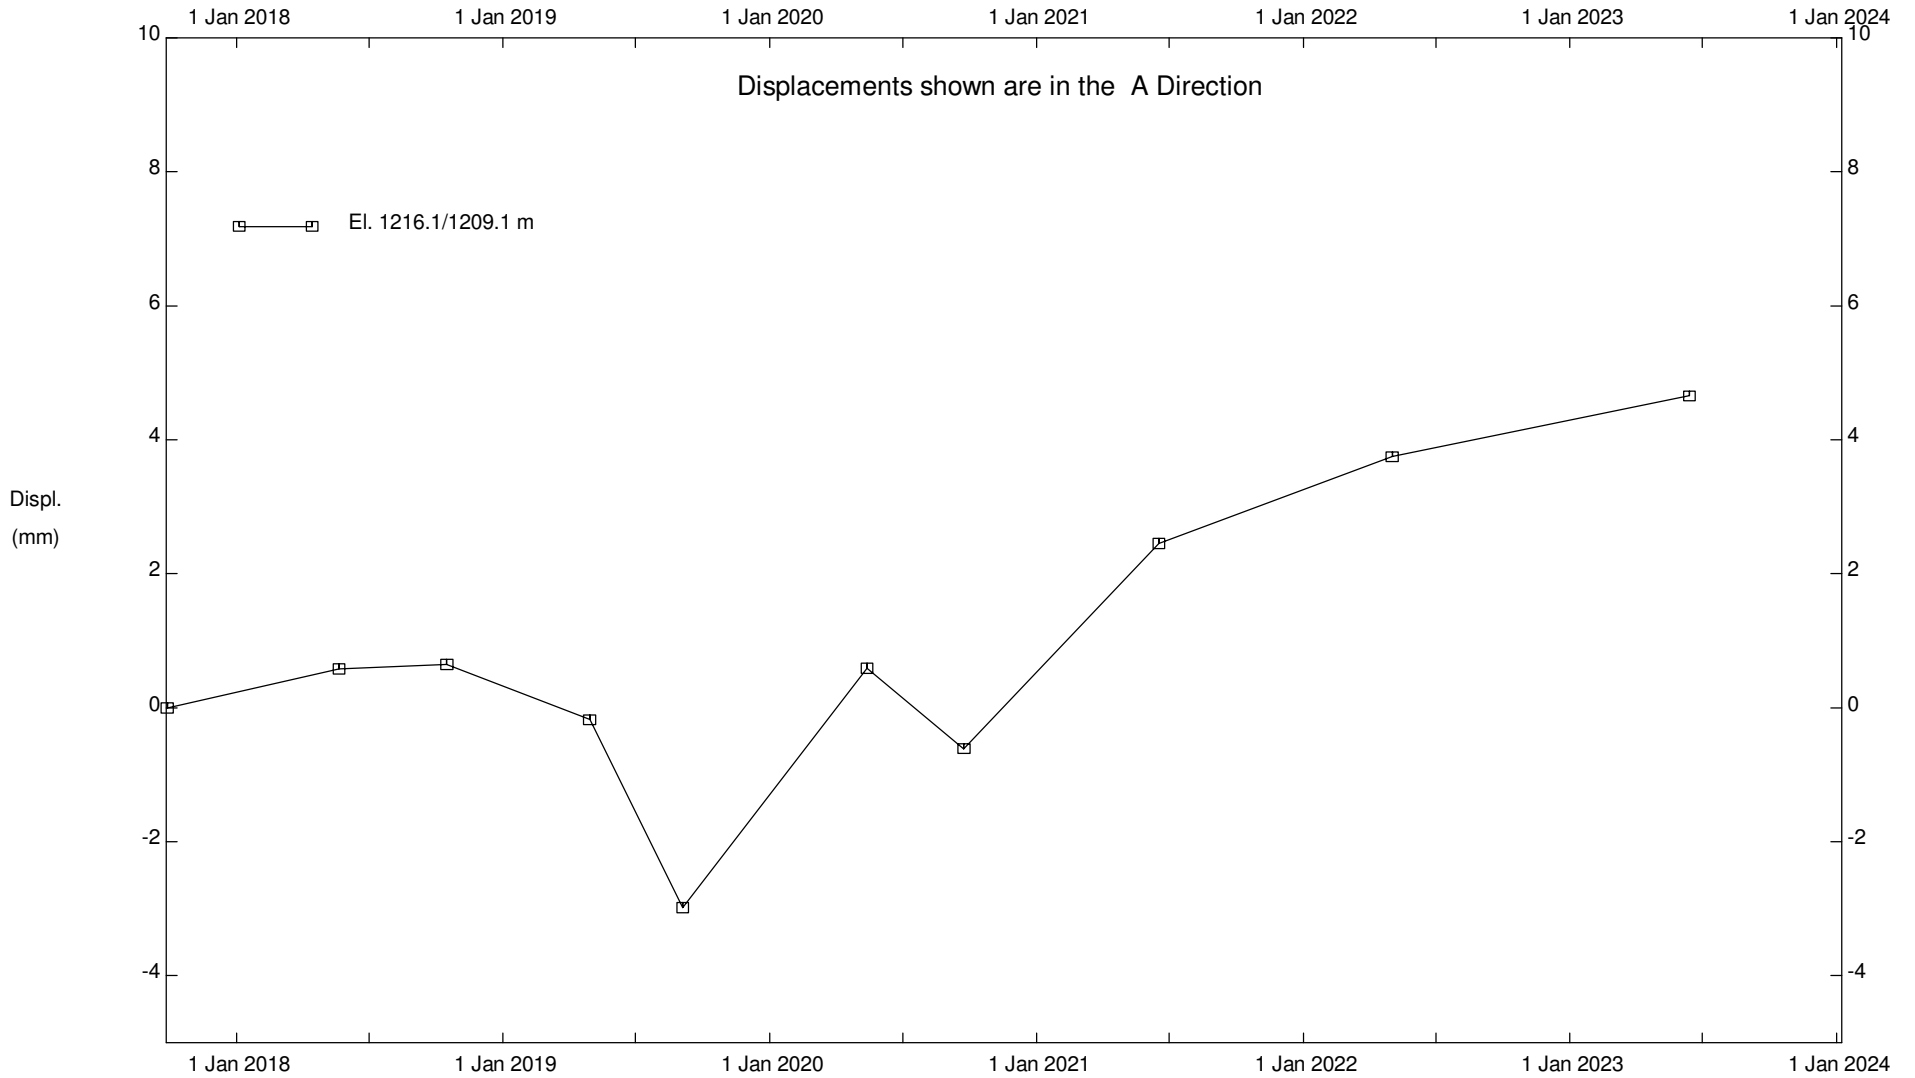
S075; H540:02 - Pekisko Creek, Inclinometer SI17-01

Since installation in 2017, a slow rate of movement (less than 2 mm/year) has been recorded in SI17-01 in the clay till (an approximate depth of 6 m to 12 m below ground surface). Between the fall 2021 and spring 2022 readings, some movement was recorded between 6 m and 16 m below ground surface. This movement could be due to a small data shift caused by KCB changing the SI reading equipment when the old equipment became inoperable. The small rate of movement being recorded in the SIs makes the data sensitive to changes in equipment. More data is needed to assess.

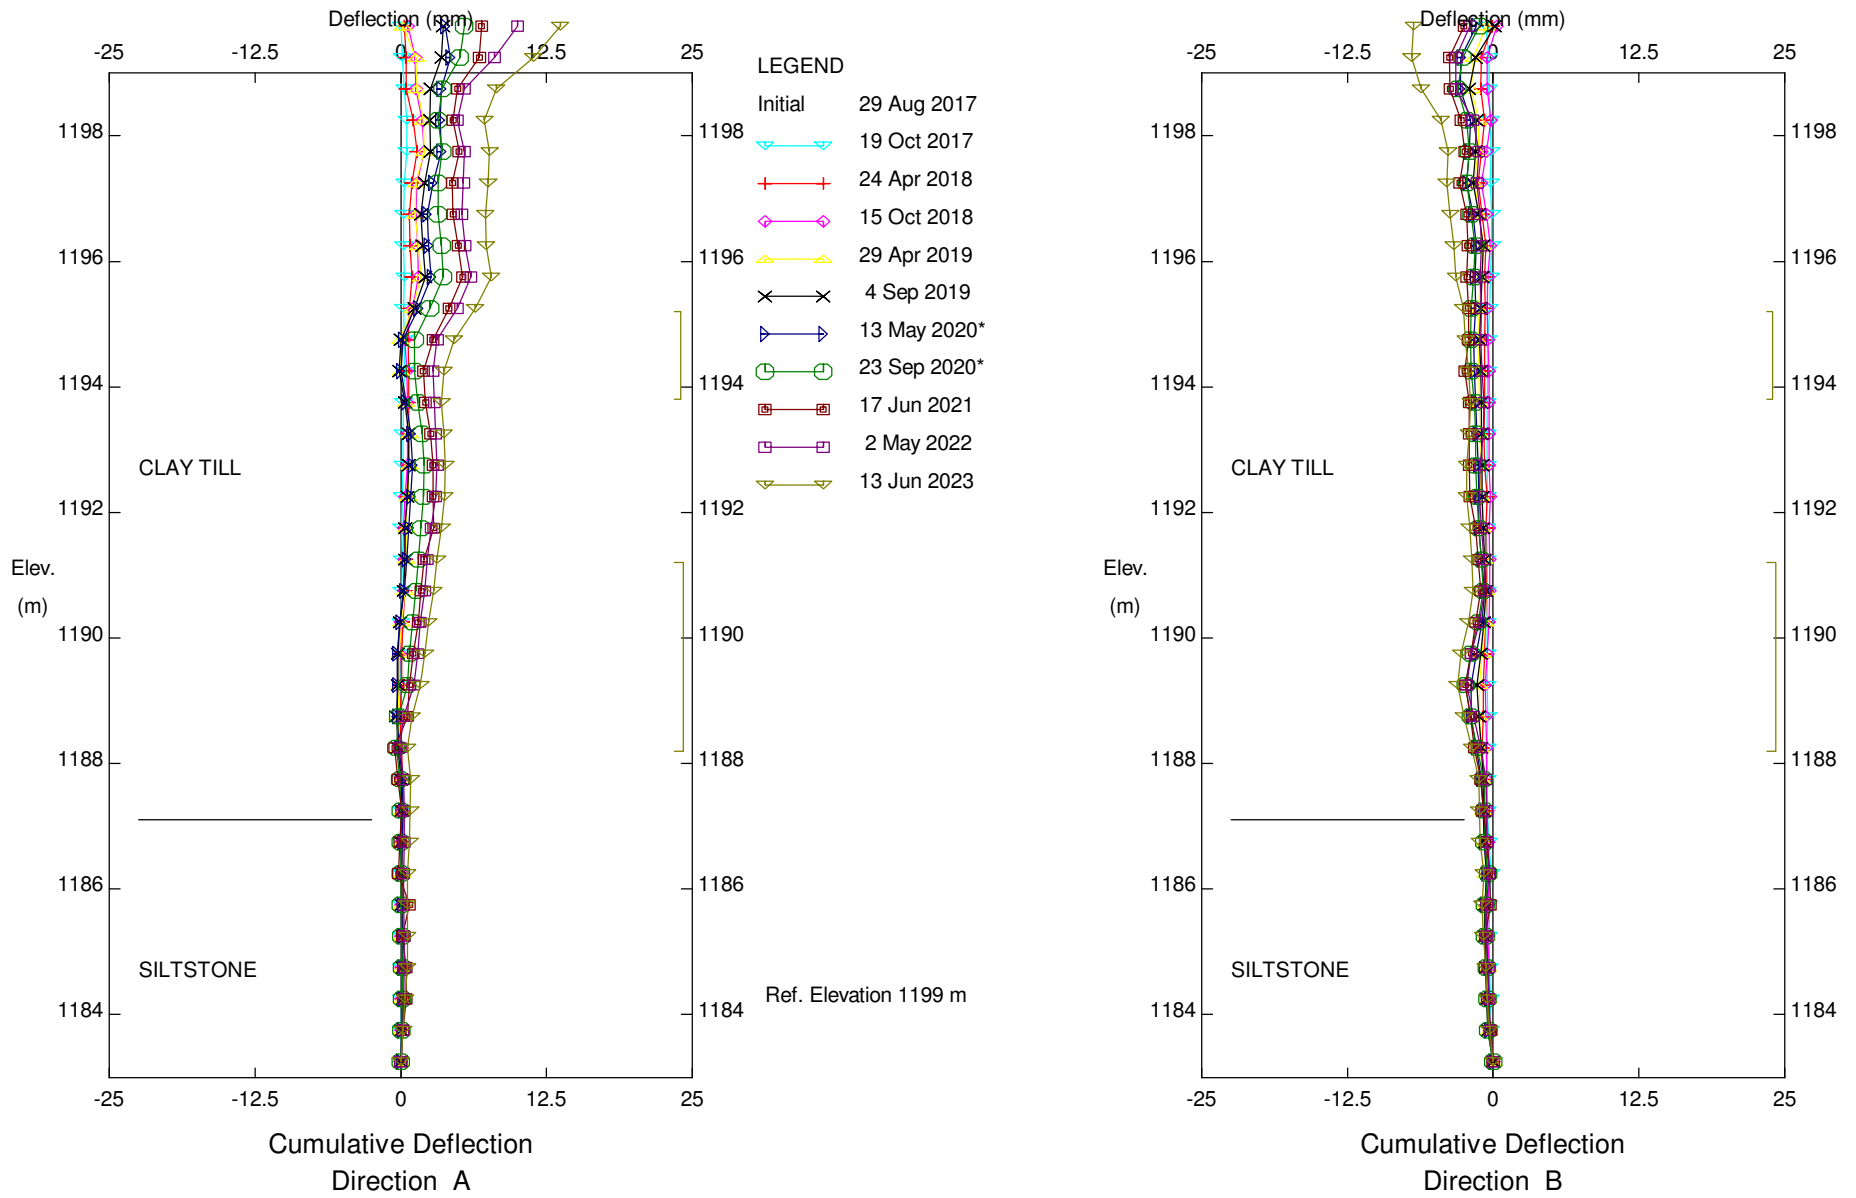
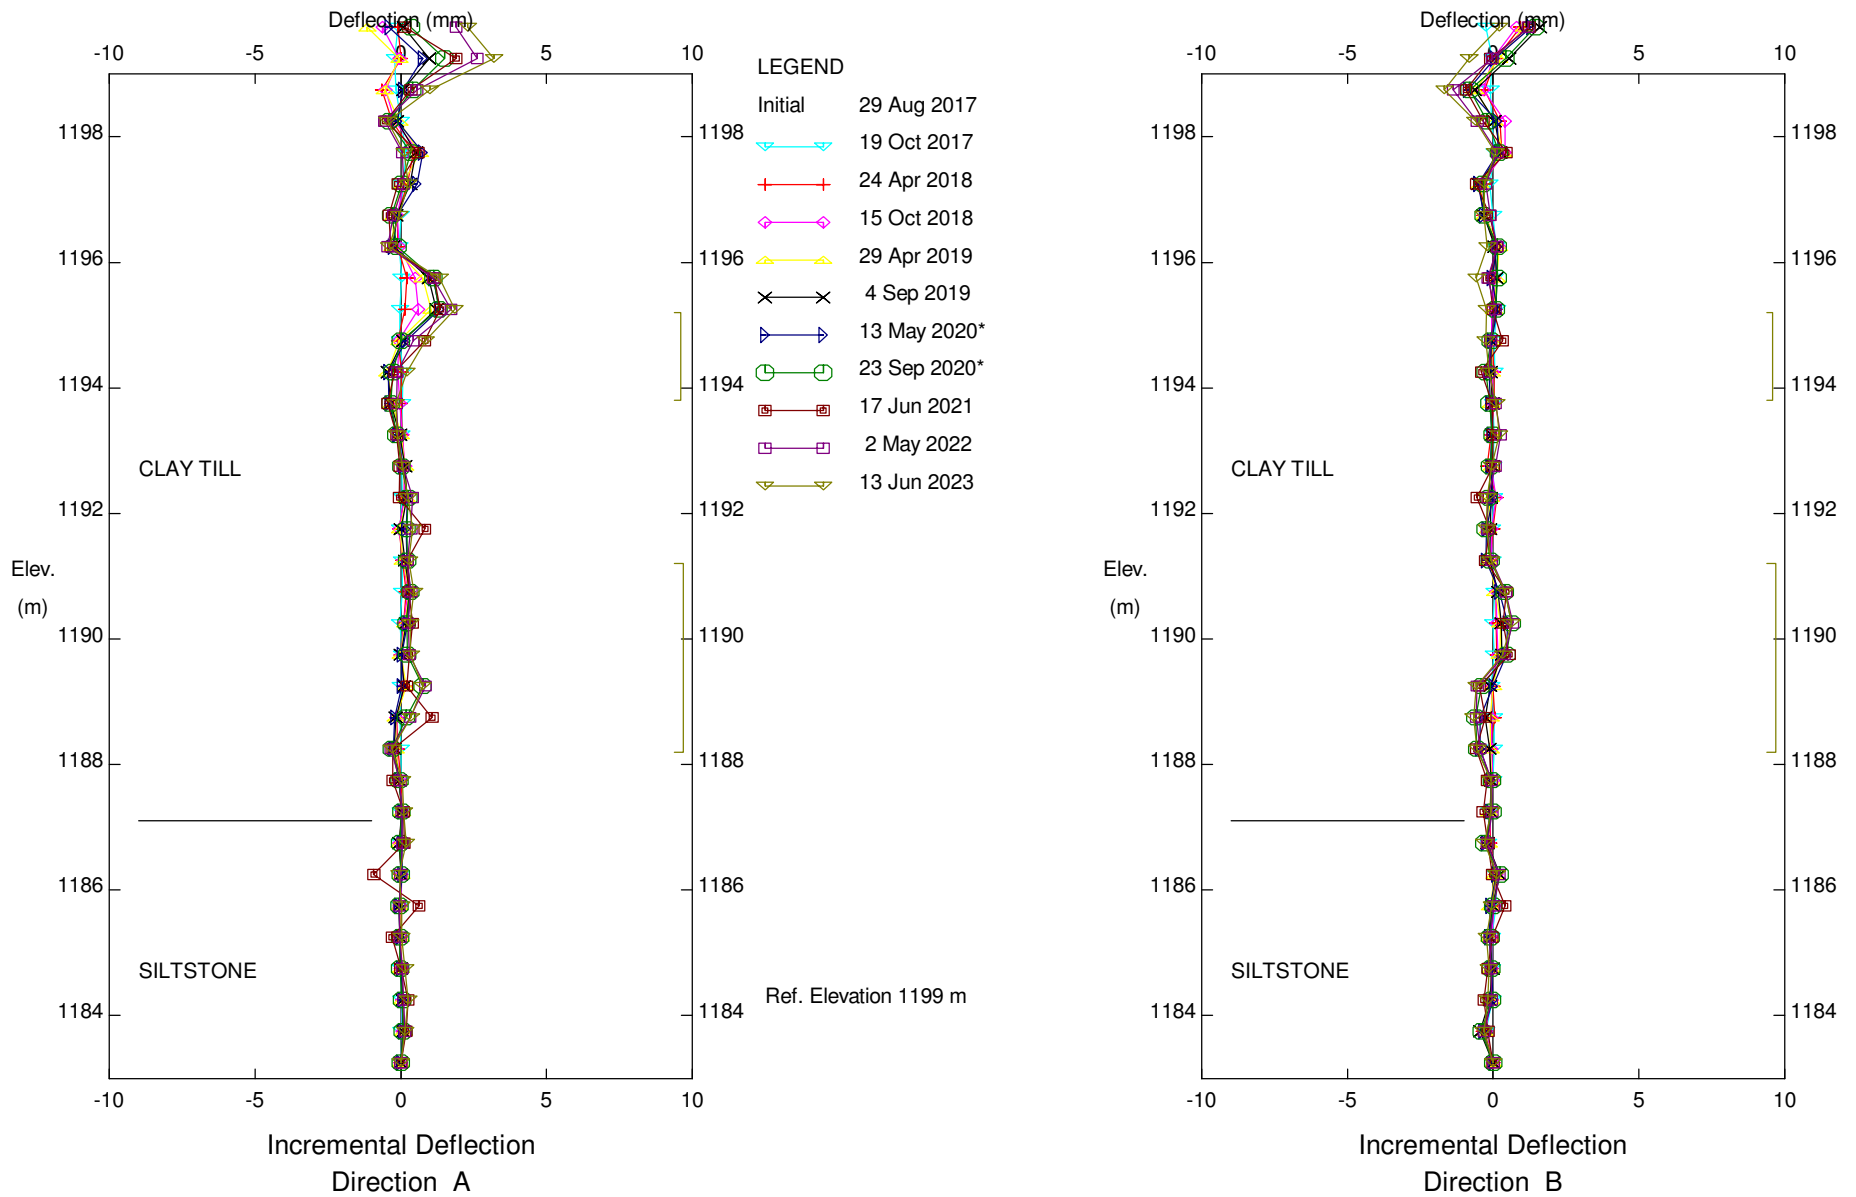
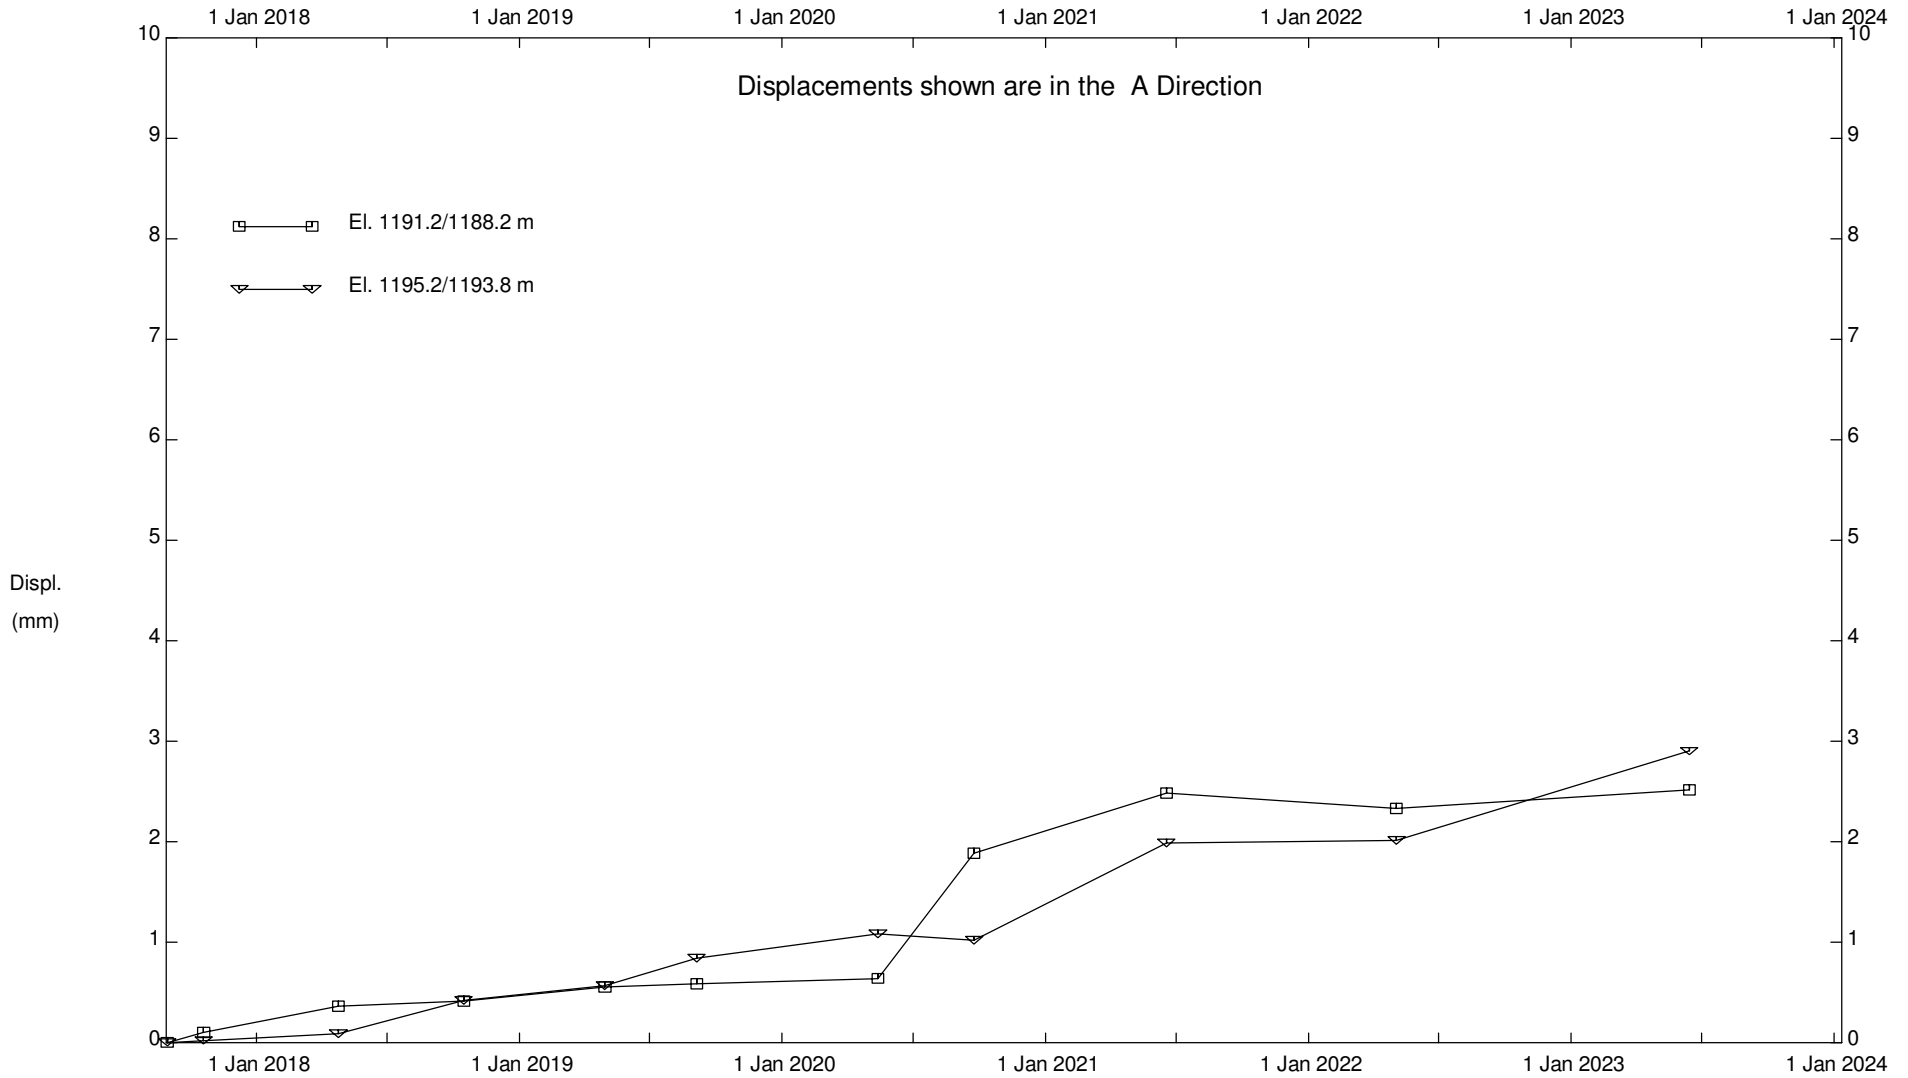
S075; H540:02 - Pekisko Creek, Inclinometer SI17-02
 Alberta Transportation

Slow, steady movement (less than 1 mm/year) has been recorded in SI17-02 since it was installed in 2017. The movement is occurring from an approximate depth of 4 m to 5 m and 8 m to 11 m below ground surface in the clay till. The instrument is located at the toe of the slide at Site B, and the depth of movement is consistent with site observations.
