July 14, 2023

**CON0022161 Southern Region GRMP Instrumentation Monitoring
Site S075; H540:02, km 5.720 Pekisko Creek Slides
Section C – 2023 Spring Readings**

2023 S075 Spring Report.docx
A05116A03

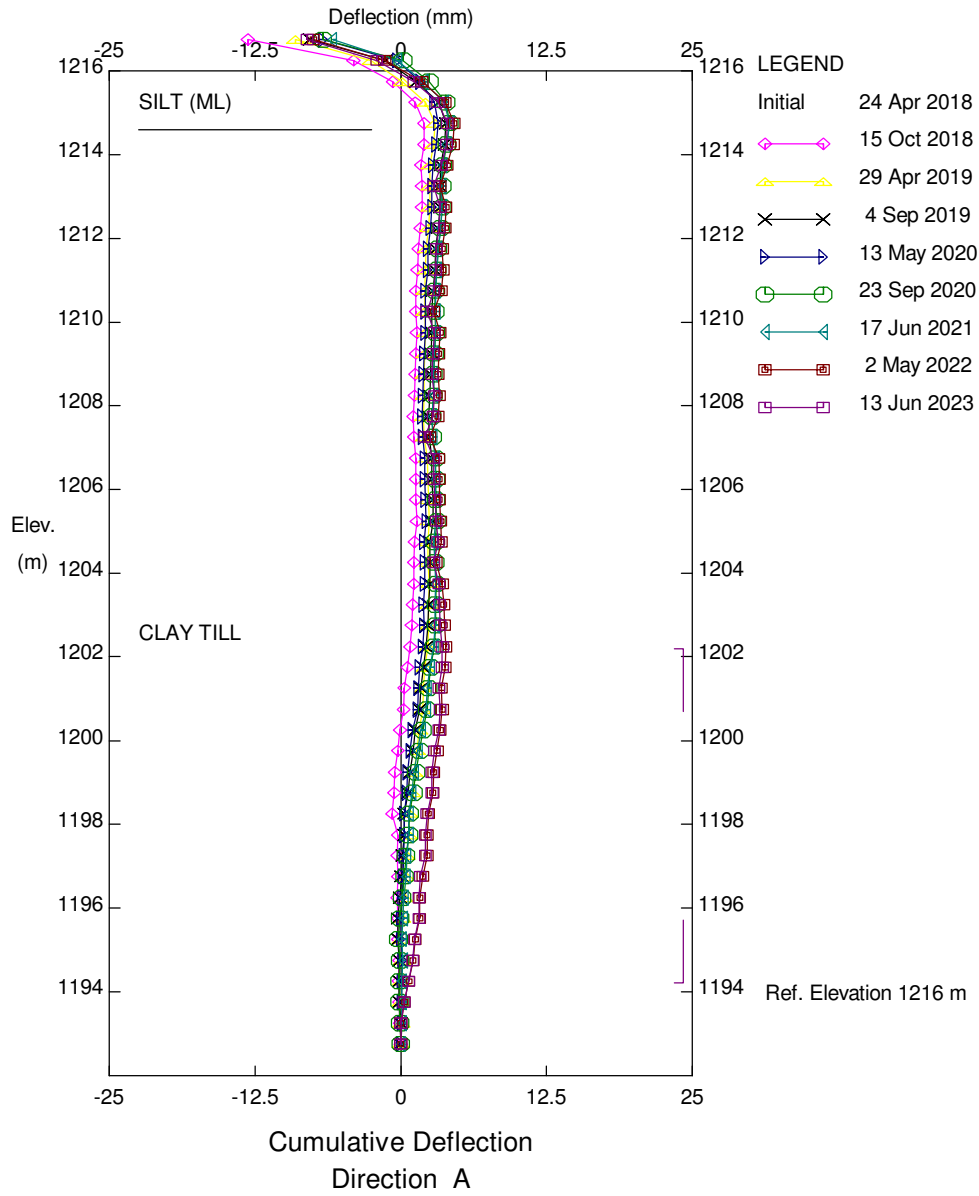
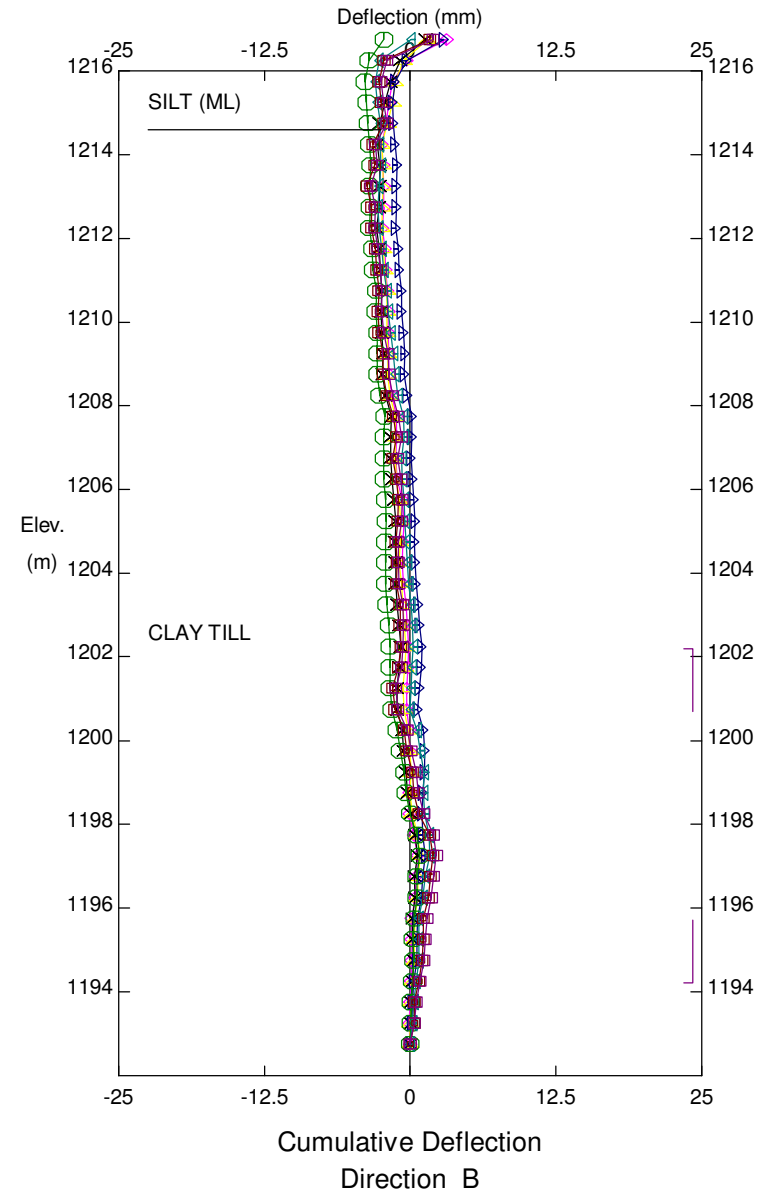
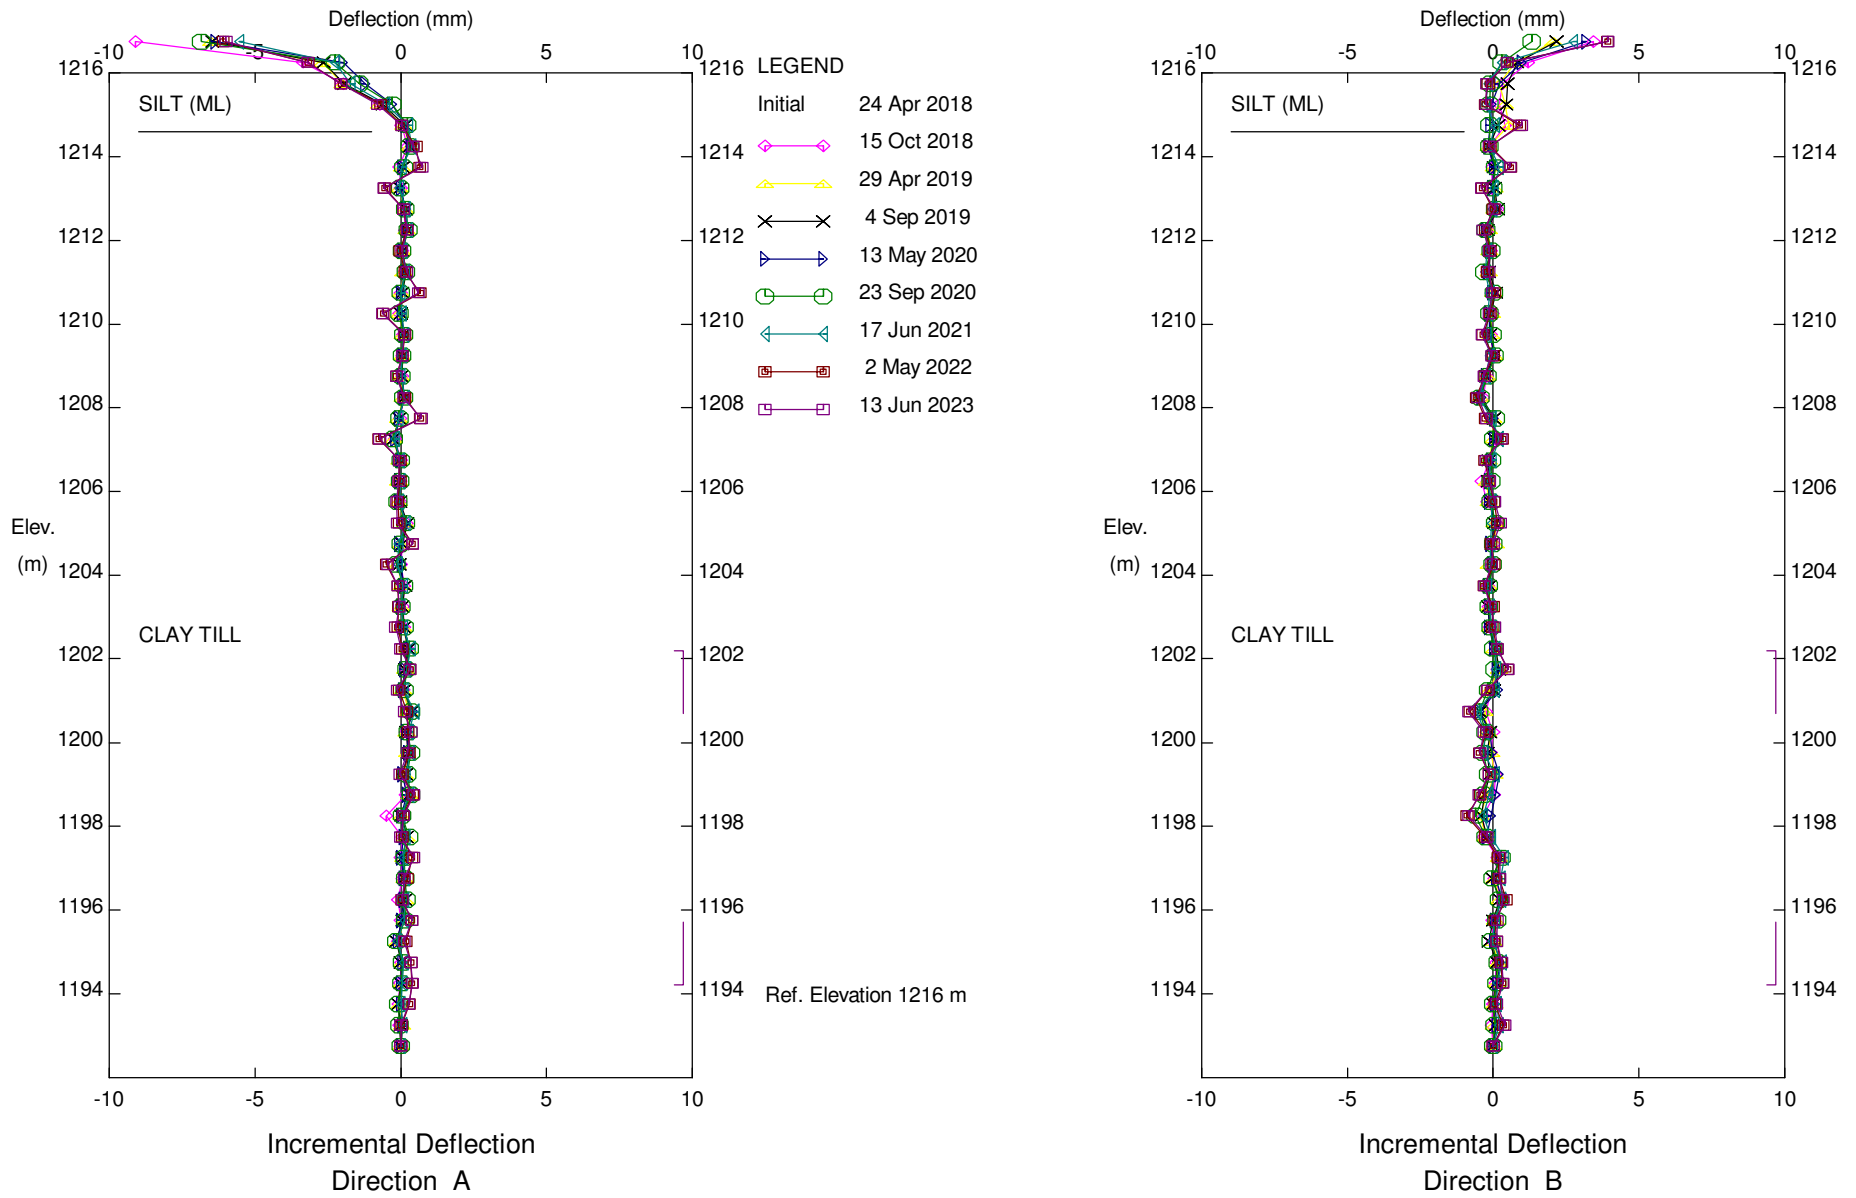
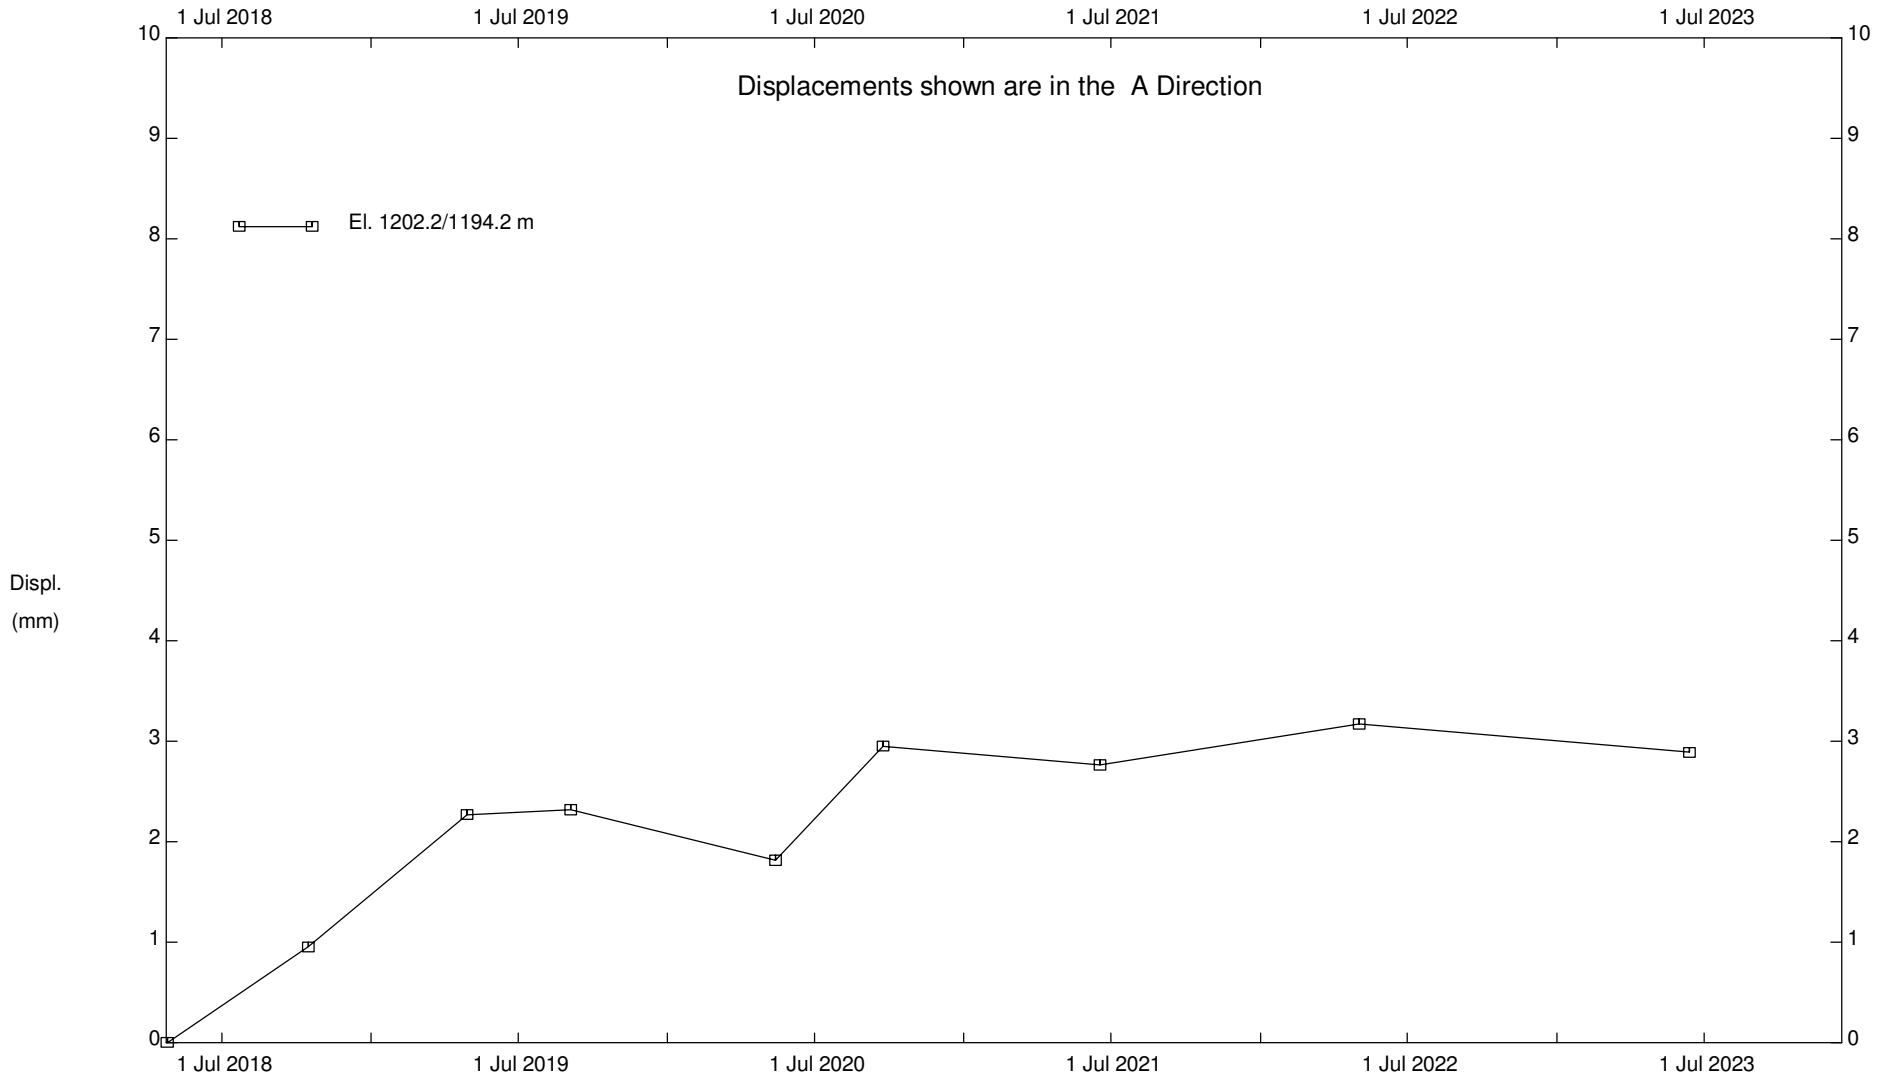
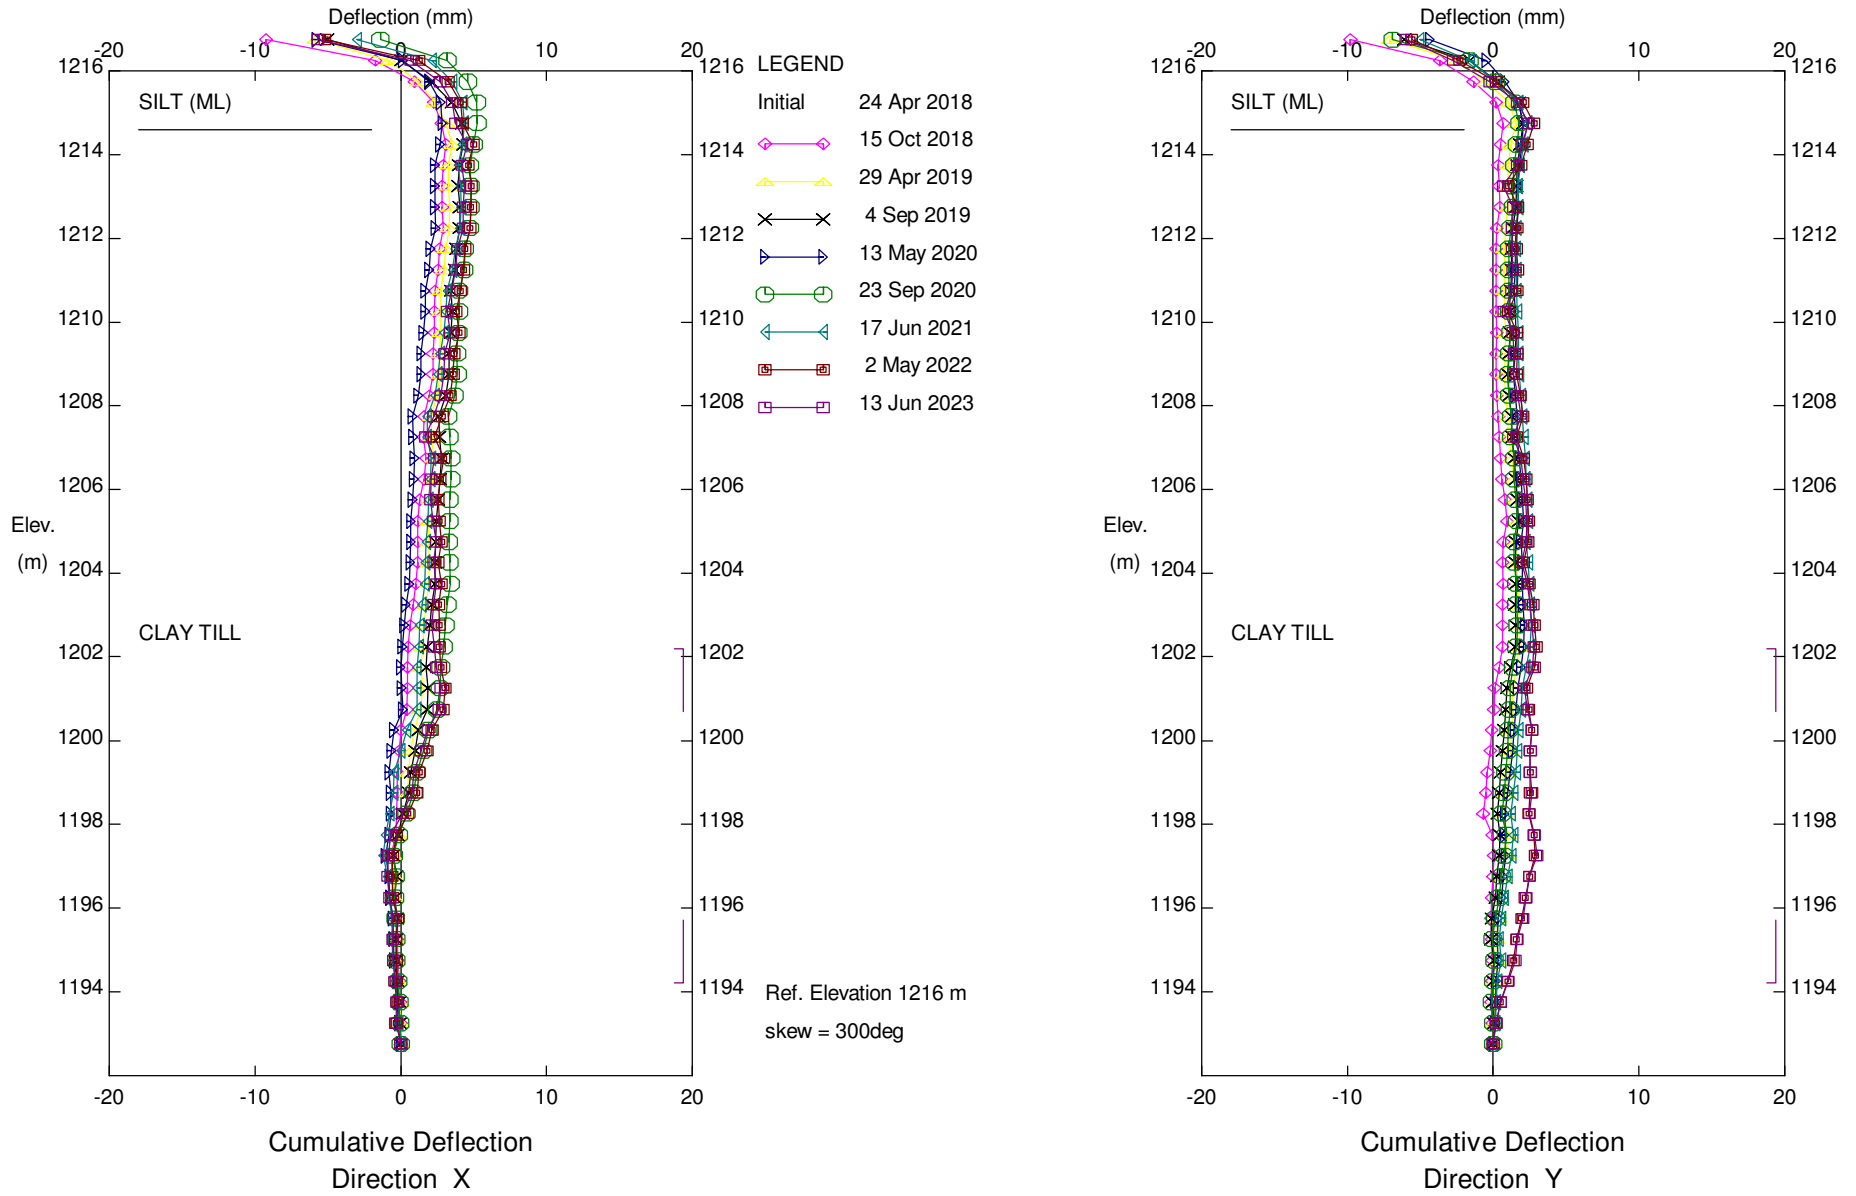
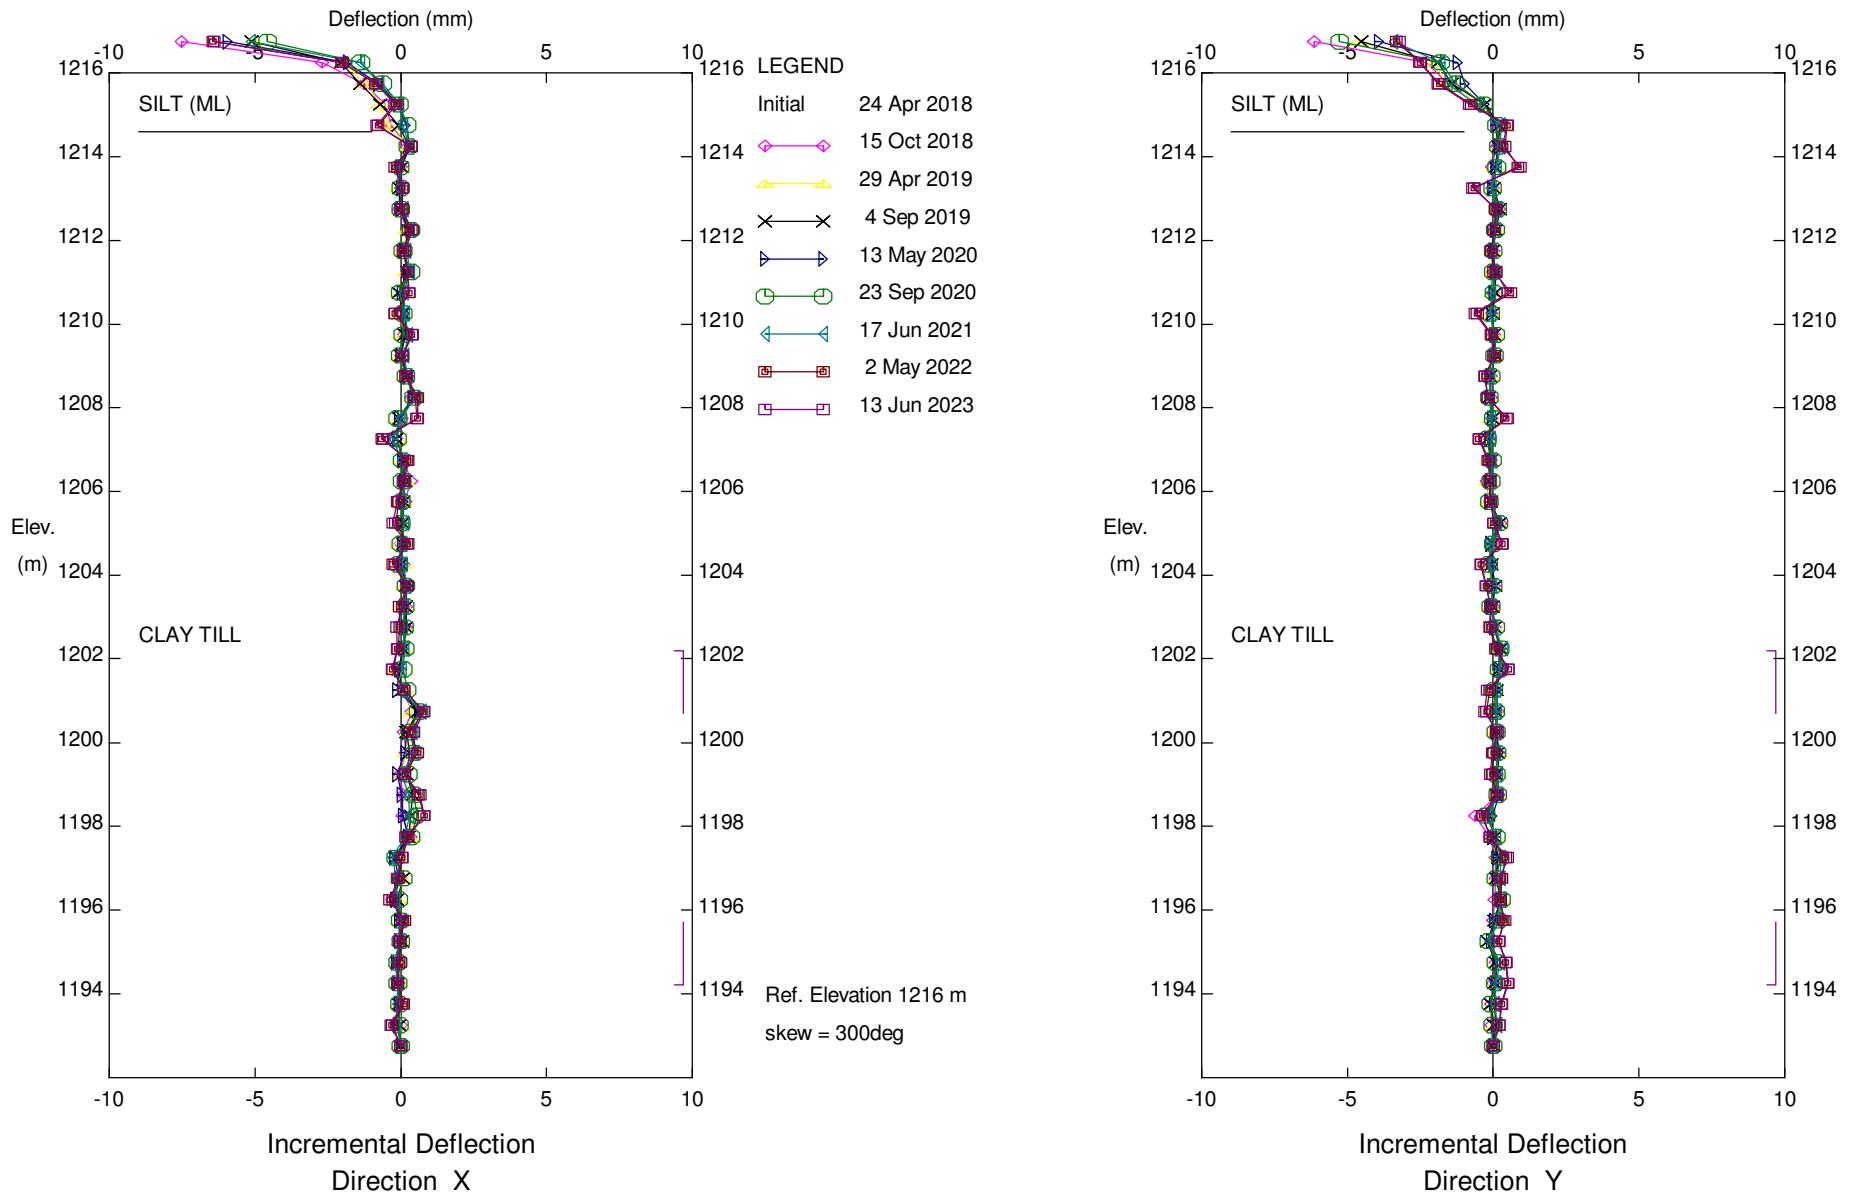
S075; H540:02 - Pekisko Creek, Inclinometer SI17-03
 Alberta Transportation

Prior to SI17-03 being re-initialized in April 2018 and SI17-04 becoming inoperable in 2018, settlement or buckling was observed in both instruments, which could indicate the instruments were poorly grouted with possible grout voids. The interpretation of the SI data is complicated by the potential for settlement or buckling of the SI casing in the poorly grouted casing segment. The instrument was re-initialized to remove possible noise associated with this zone. Overall data quality has improved since the instrument was re-initialized, but settlement or buckling of the casing may still be occurring at this depth. The rate of settlement or buckling has slowed since the first few months following installation and has been generally negligible since the instrument was re-initialized. If the settlement or buckling begins to impact the interpretation of the SI data again, the instrument may need to be re-initialized.

Since the SI17-03 was re-initialized to April 2018 reading, an overall slow rate of movement (less than 2 mm/year) has been recorded in SI17-03. The negative rate of movement recorded in this instrument during some readings indicates the rate of movement is within the accuracy of the reading equipment.

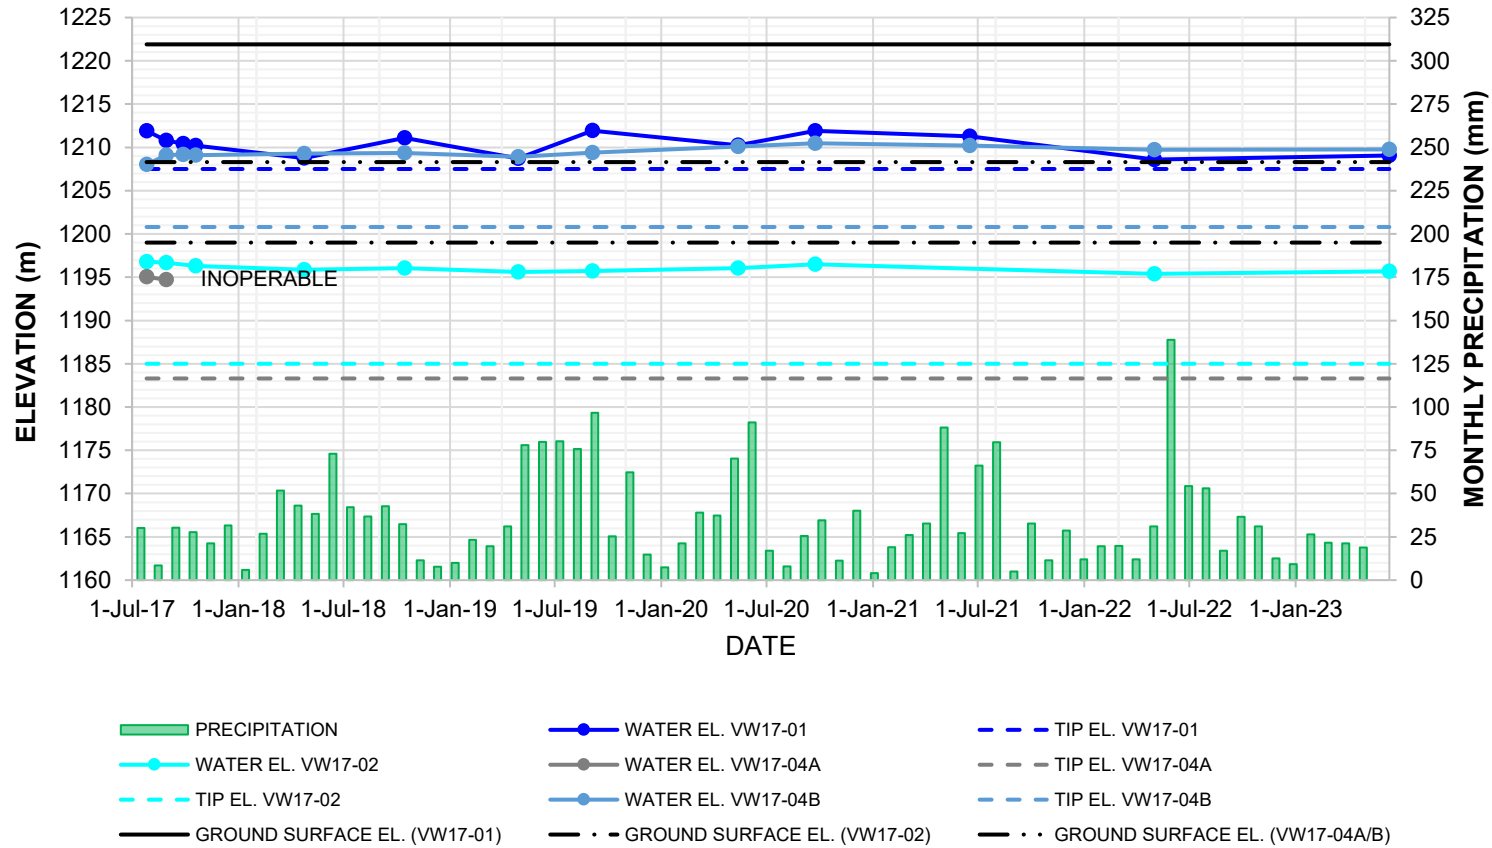
Piezometer Data
S075 - Pekisko Creek Slides
Hwy 540:02, km 5.72

VW17-04B was installed 7.5 m below ground surface (approximately El. 1201 m) in the clay till. Relatively small and steady water level increases were recorded in VW17-04B since installation to September 23, 2020 (total increase of 2.5 m). The water level has since steadily decreased by 0.9 m between September 2020 and June 2023. The water level recorded in VW17-04B is above-ground, indicating artesian groundwater conditions at this instrument.

Since installation, water levels recorded in VW17-01 (installed in the clay till) have fluctuated between 10.0 m and 13.3 m below ground surface. Before the reading frequency of the instrument was decreased from twice to once per year in 2020, water levels recorded in this instrument appeared to fluctuate seasonally, with the spring readings being lower than fall readings.

Water levels recorded in VW17-02 (installed in the bedrock) have been relatively steady since installation between an approximate depth of 2.2 m and 3.6 m below ground surface.

Overall, the June 2023 reading of VW17-01 and VW17-02 were consistent with rainfall and historical trends observed in these instruments.
