July 10, 2024

CON0022161 Southern Region GRMP Instrumentation Monitoring
Site S075; H540:02, km 5.720 Pekisko Creek Slides
Section C – 2024 Spring Readings

2024 S075 Spring Report.docx
A05116A03

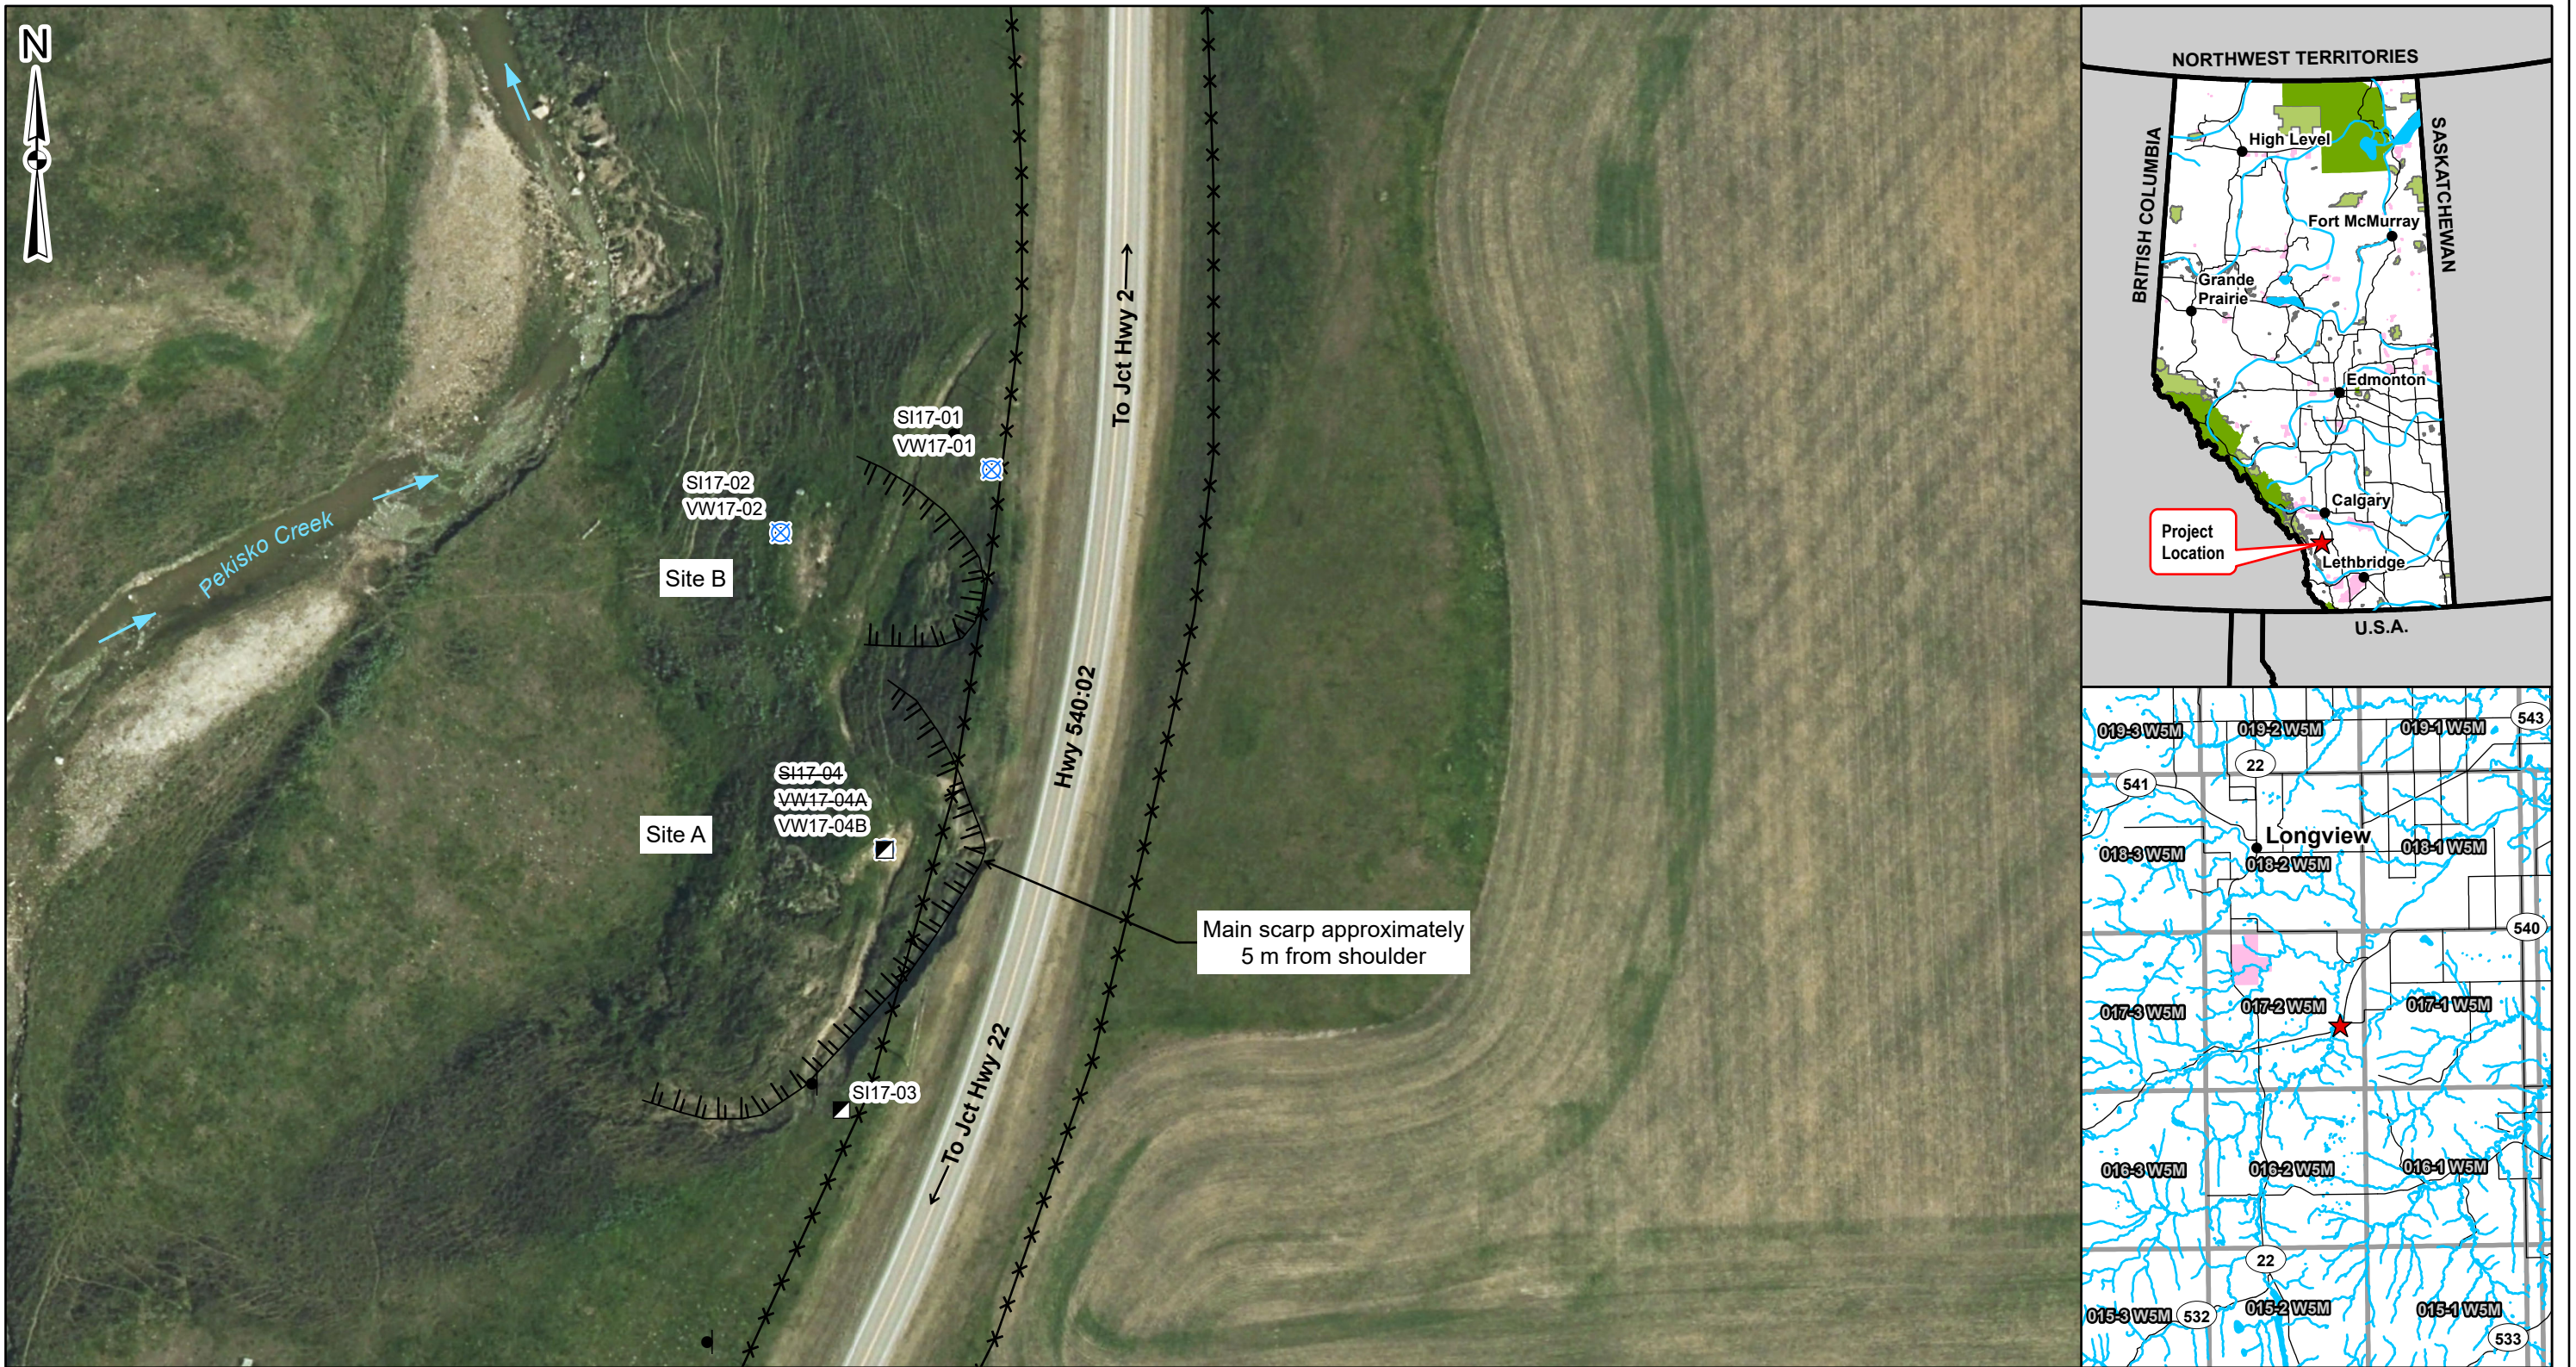
SCALE 1:1,500 PROJECT No. A05116A03 FIG No. 1

The geohazard at the S075 site consists of two adjacent landslides located approximately 30 m apart, denoted as Site A and B, along the west (southbound) lane of Hwy 540:02. Previously, this site was included with a riverbank erosion site located approximately 1.1 km southwest along Hwy 520:02. In early-2022, KCB and AT separated the riverbank erosion and landslide sites, with the landslide site (Site A and B) becoming the S075 site and riverbank erosion site retaining the original S051 site number.

Instrumentation installation details are tabulated in Table 1.1. Instrument locations are shown in Figure 1.

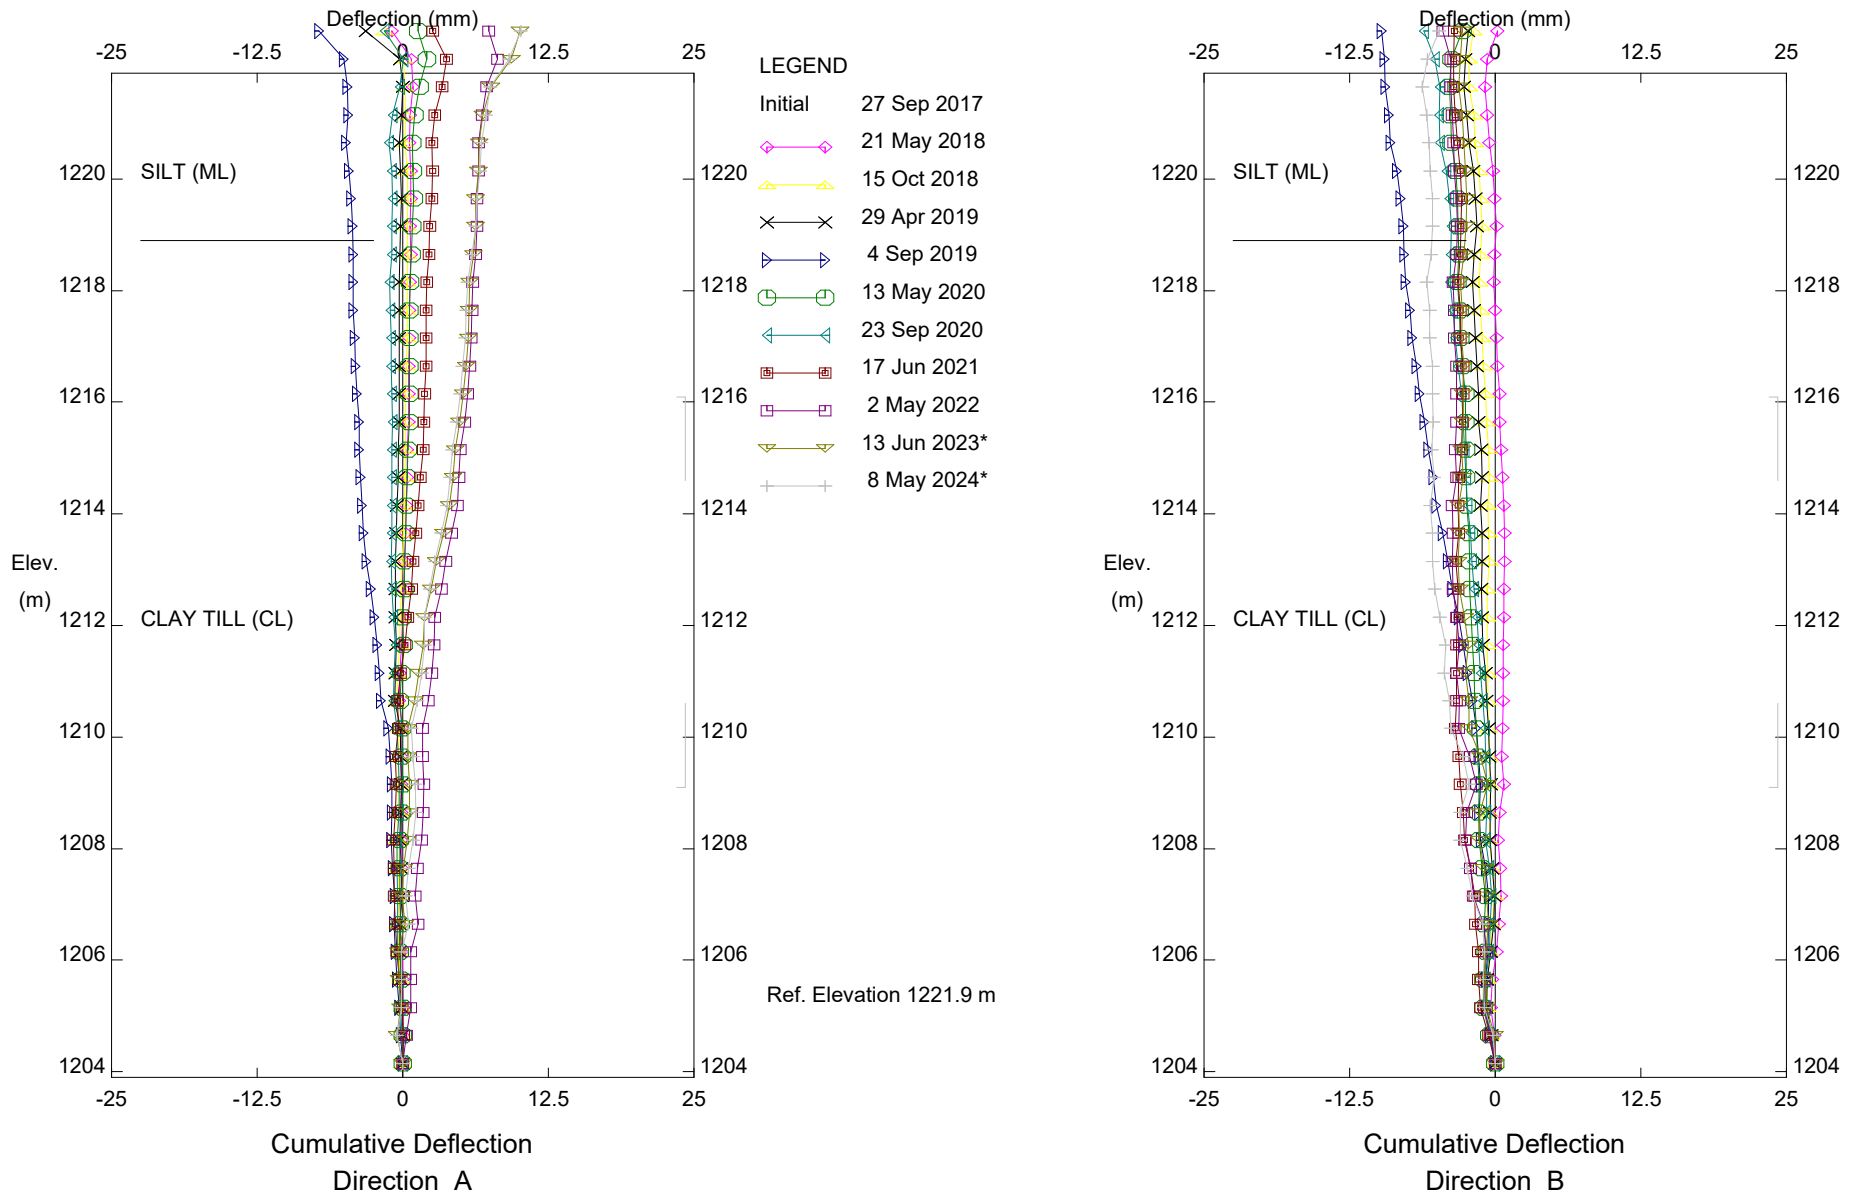
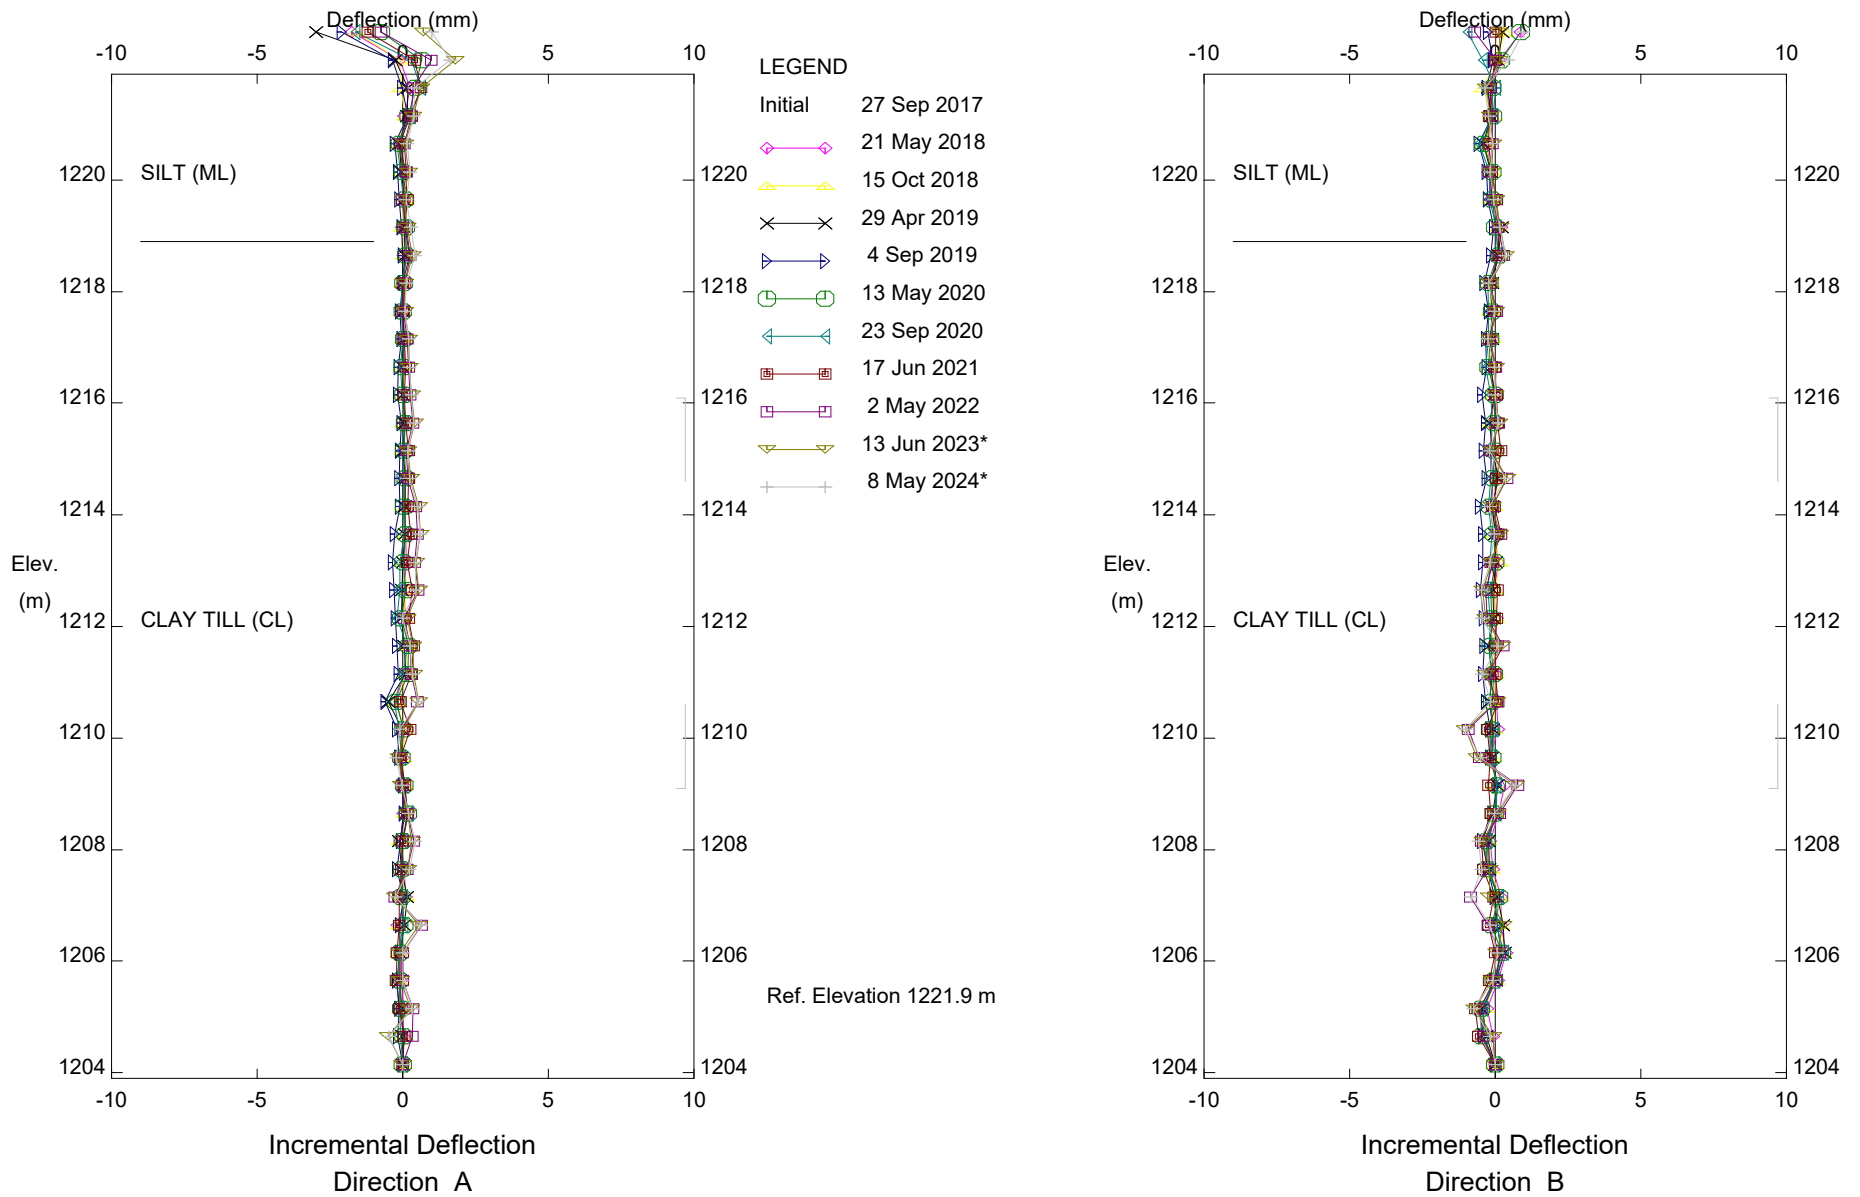
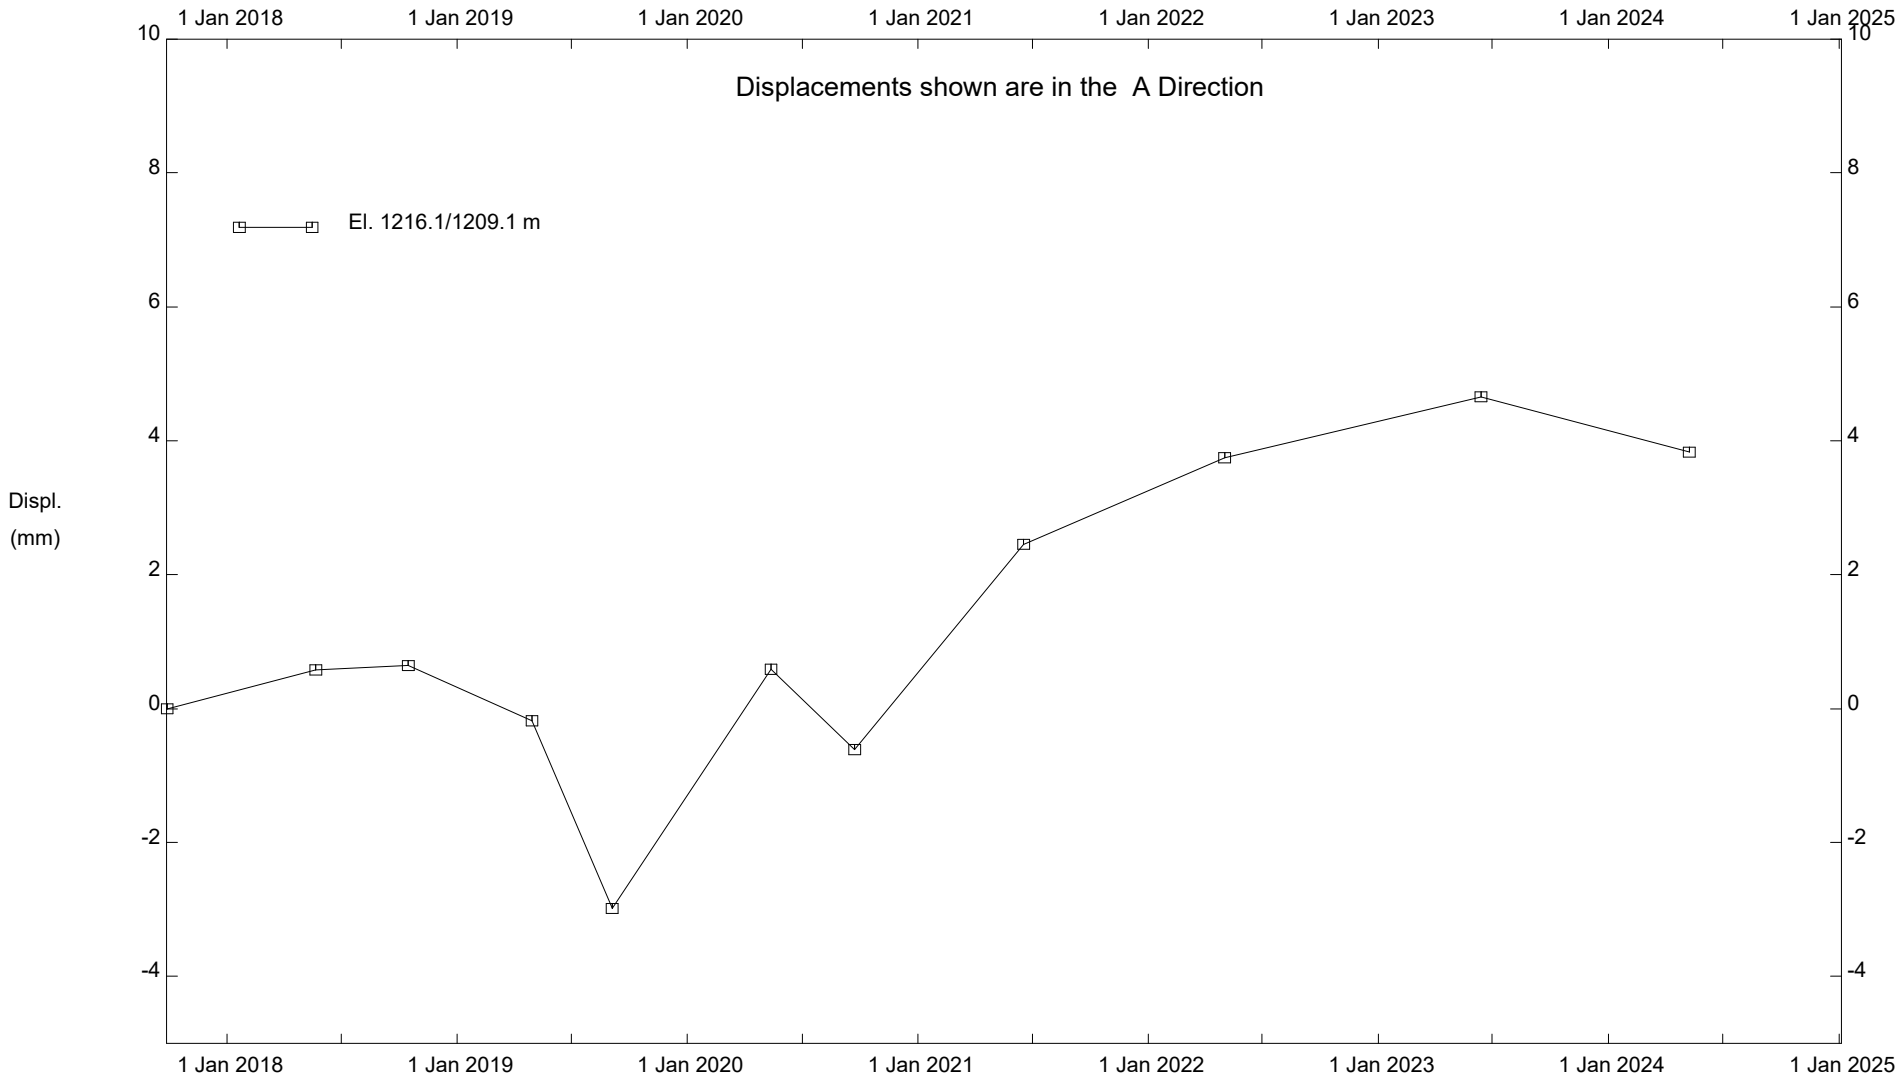
S075; H540:02 - Pekisko Creek, Inclinometer SI17-01

Movement has been recorded in SI17-01 from an approximate depth of 6 m to 12 m below ground surface (approximately El. 1211 m to El. 1216 m). SI17-01 is located near the crest of the slide.

Since installation in 2017, a slow rate of movement (less than 2 mm/year) has been recorded in SI17-01 in the clay till (an approximate depth of 6 m to 12 m below ground surface). Between the fall 2021 and spring 2022 readings, some movement was recorded between 6 m and 16 m below ground surface. This movement could be due to a small data shift caused by KCB changing the SI reading equipment when the old equipment became inoperable. The small rate of movement being recorded in the SIs makes the data sensitive to changes in equipment. More data is needed to assess.

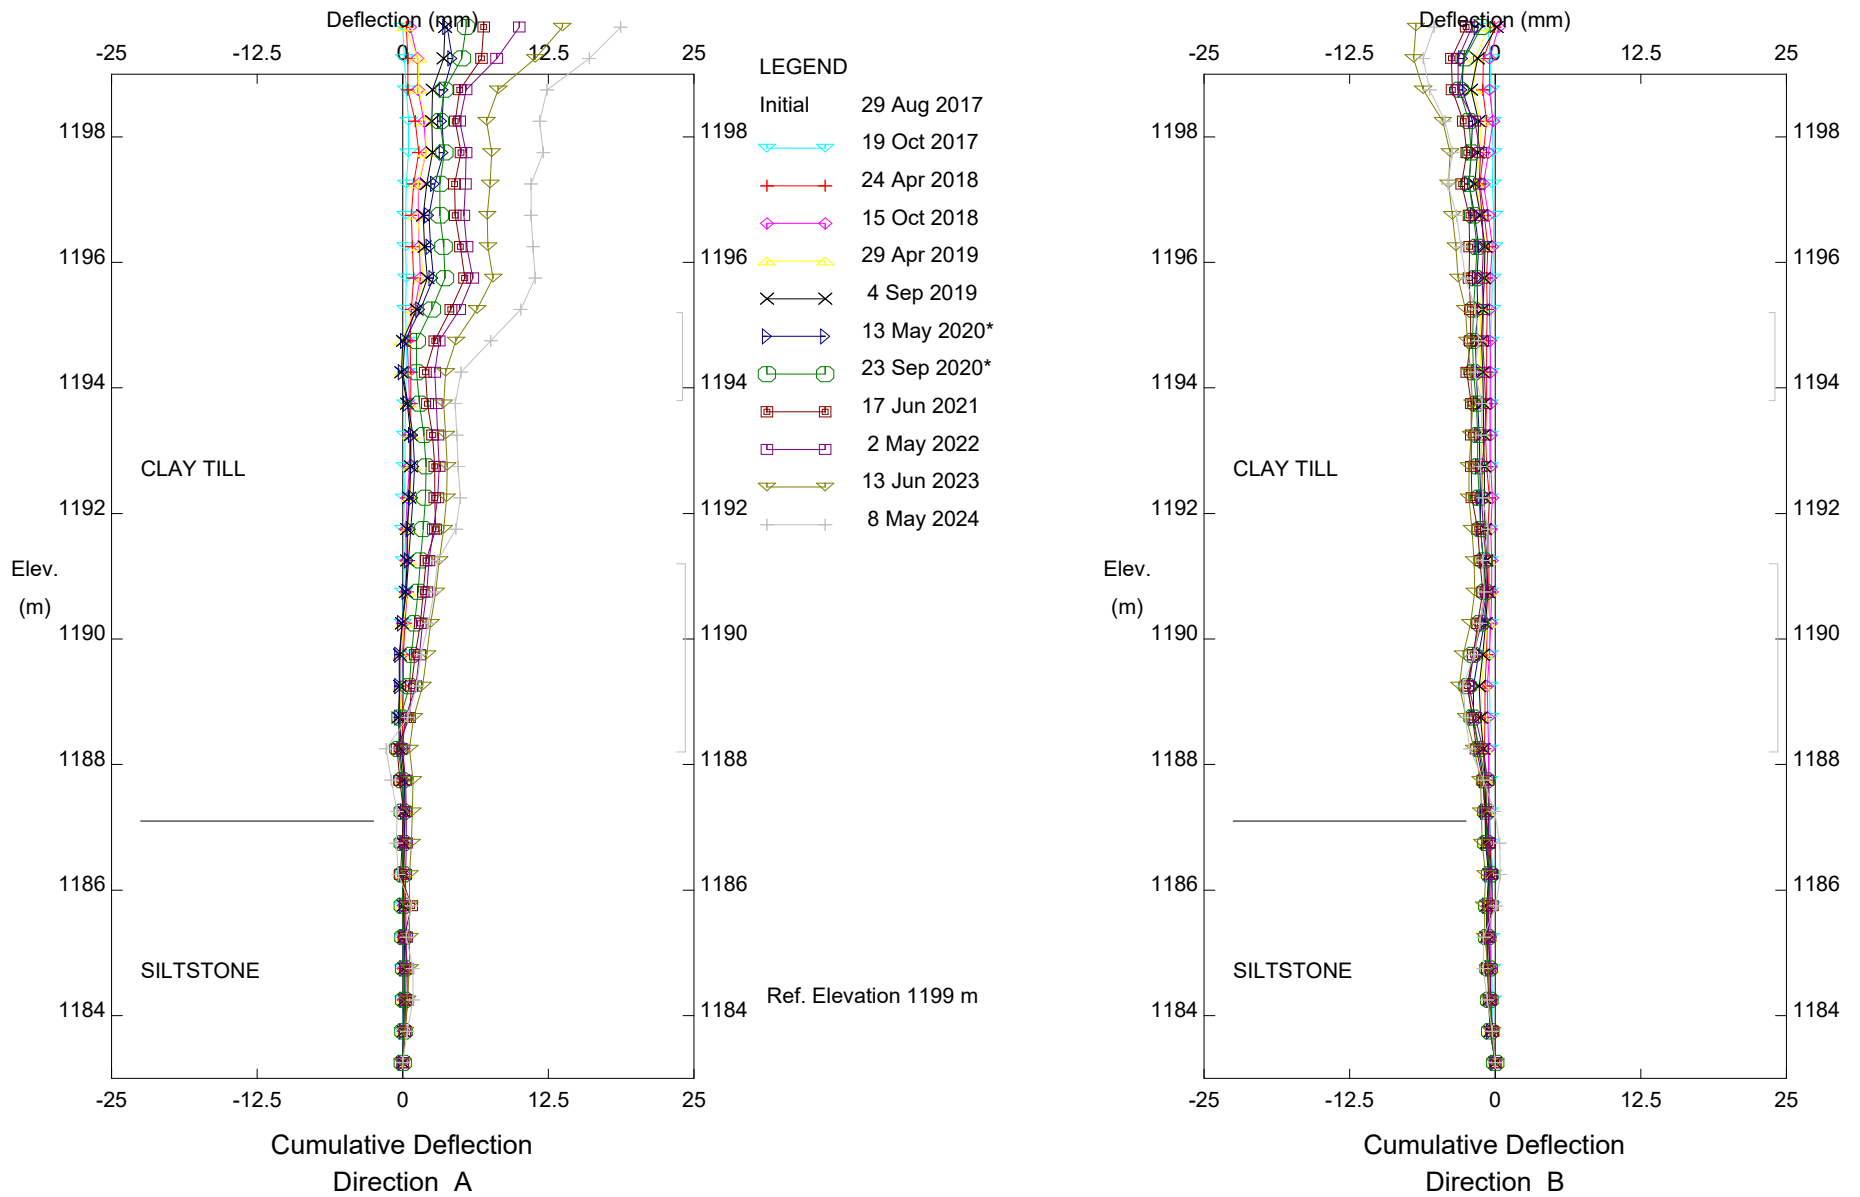
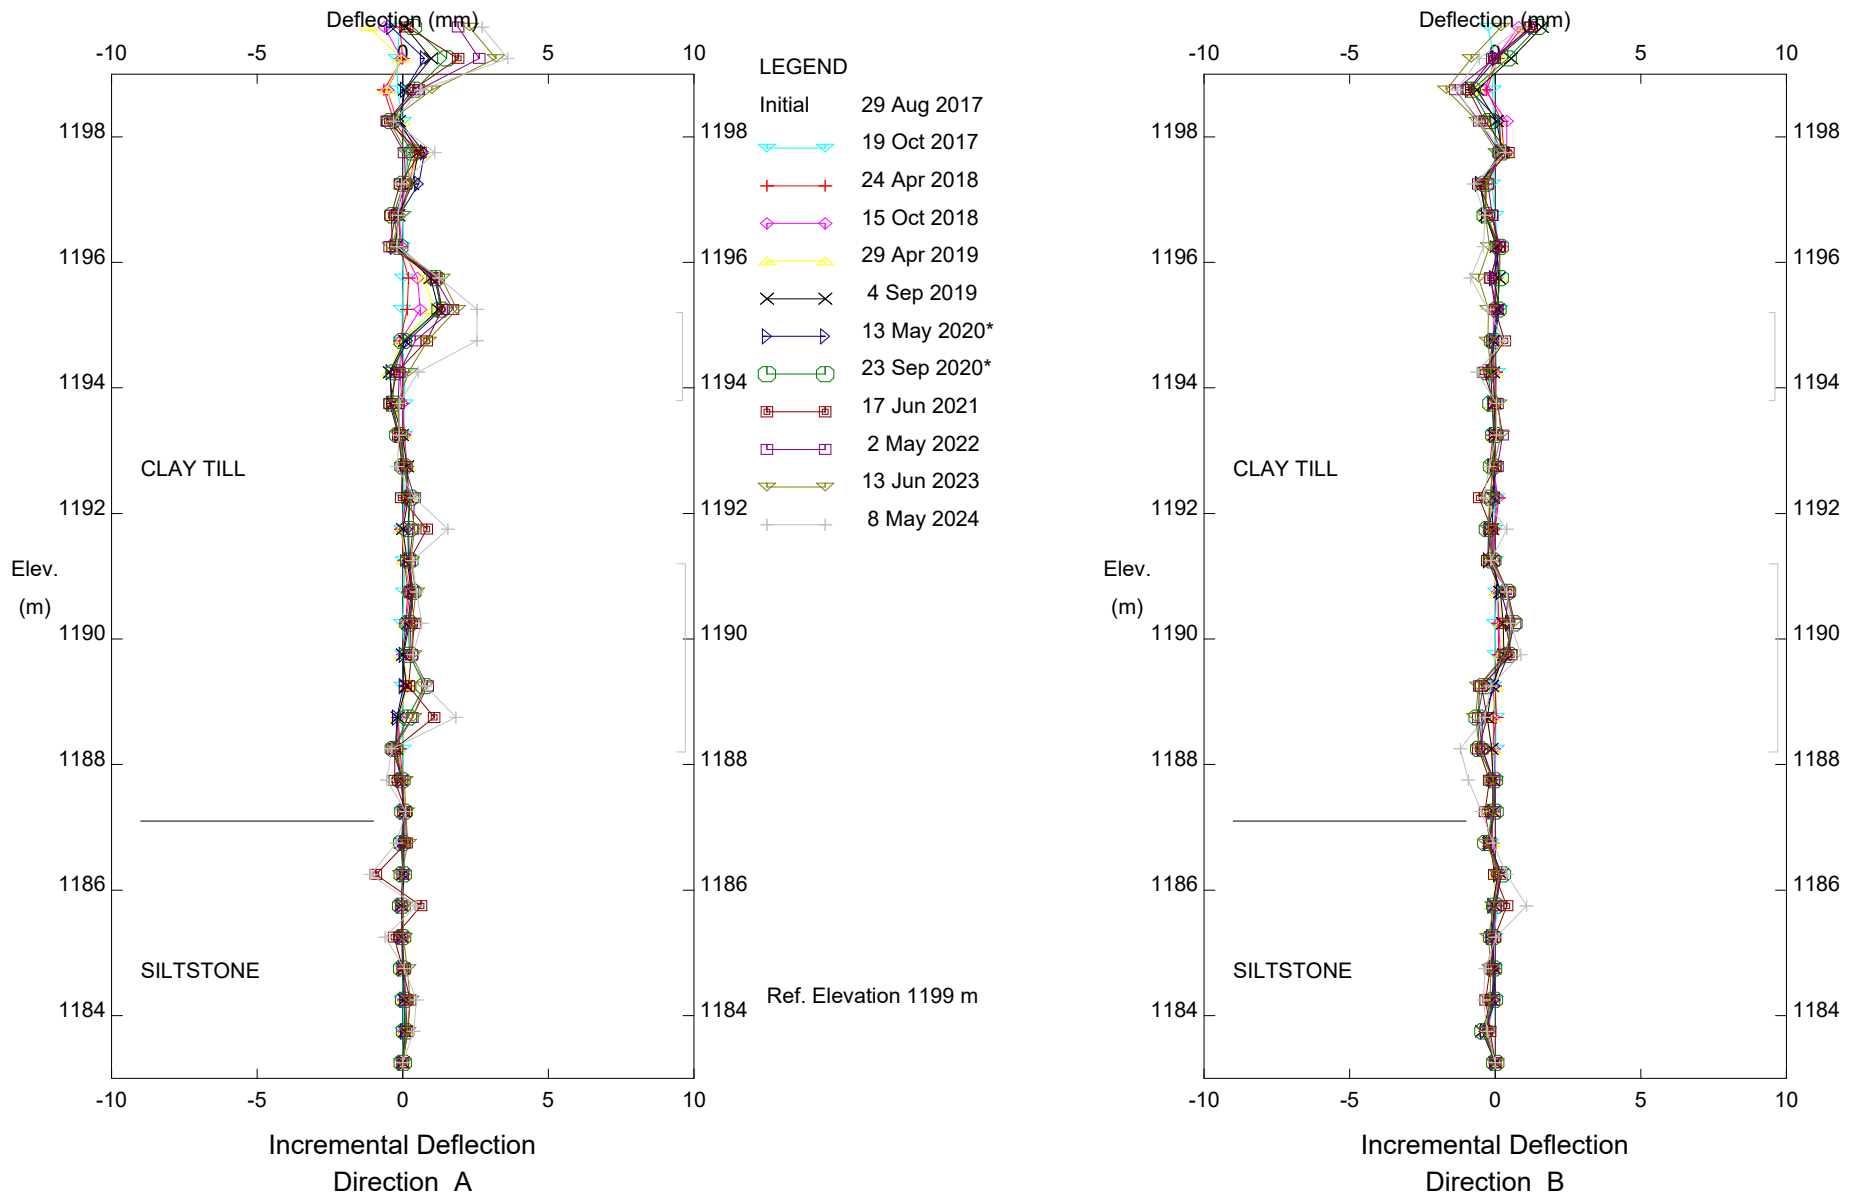
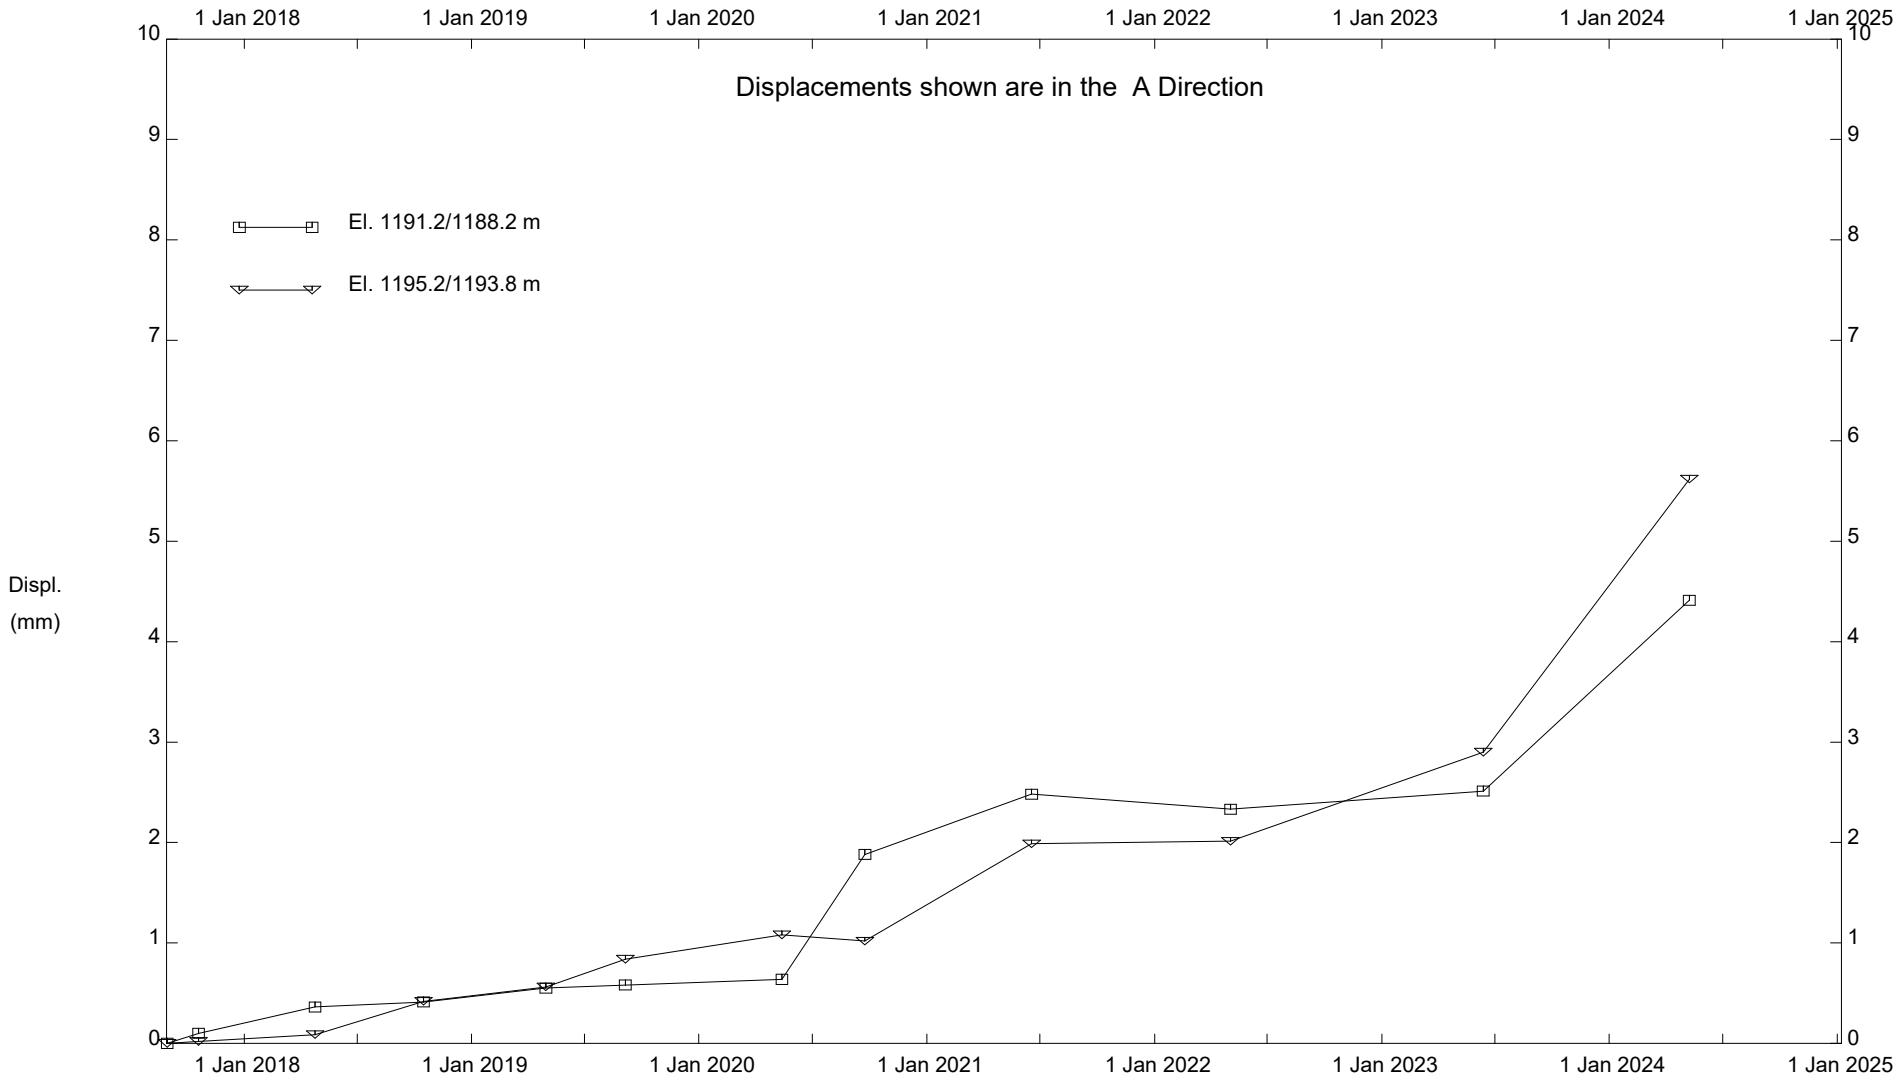
S075; H540:02 - Pekisko Creek, Inclinometer SI17-02

Movement has been recorded in SI17-02 from an approximate depth of 4 m to 5 m and 8 m to 11 m below ground surface (approximately El. 1194 m to El. 1195 m and El. 1188 m to 1191 m). SI17-02 is located near the toe of the slide.

Slow, steady movement (less than 1 mm/year) has been recorded in SI17-02 since it was installed in 2017. The movement is occurring from an approximate depth of 4 m to 5 m and 8 m to 11 m below ground surface in the clay till. The instrument is located at the toe of the slide at Site B, and the depth of movement is consistent with site observations.
