July 10, 2024

CON0022161 Southern Region GRMP Instrumentation Monitoring
Site S075; H540:02, km 5.720 Pekisko Creek Slides
Section C – 2024 Spring Readings

2024 S075 Spring Report.docx
A05116A03

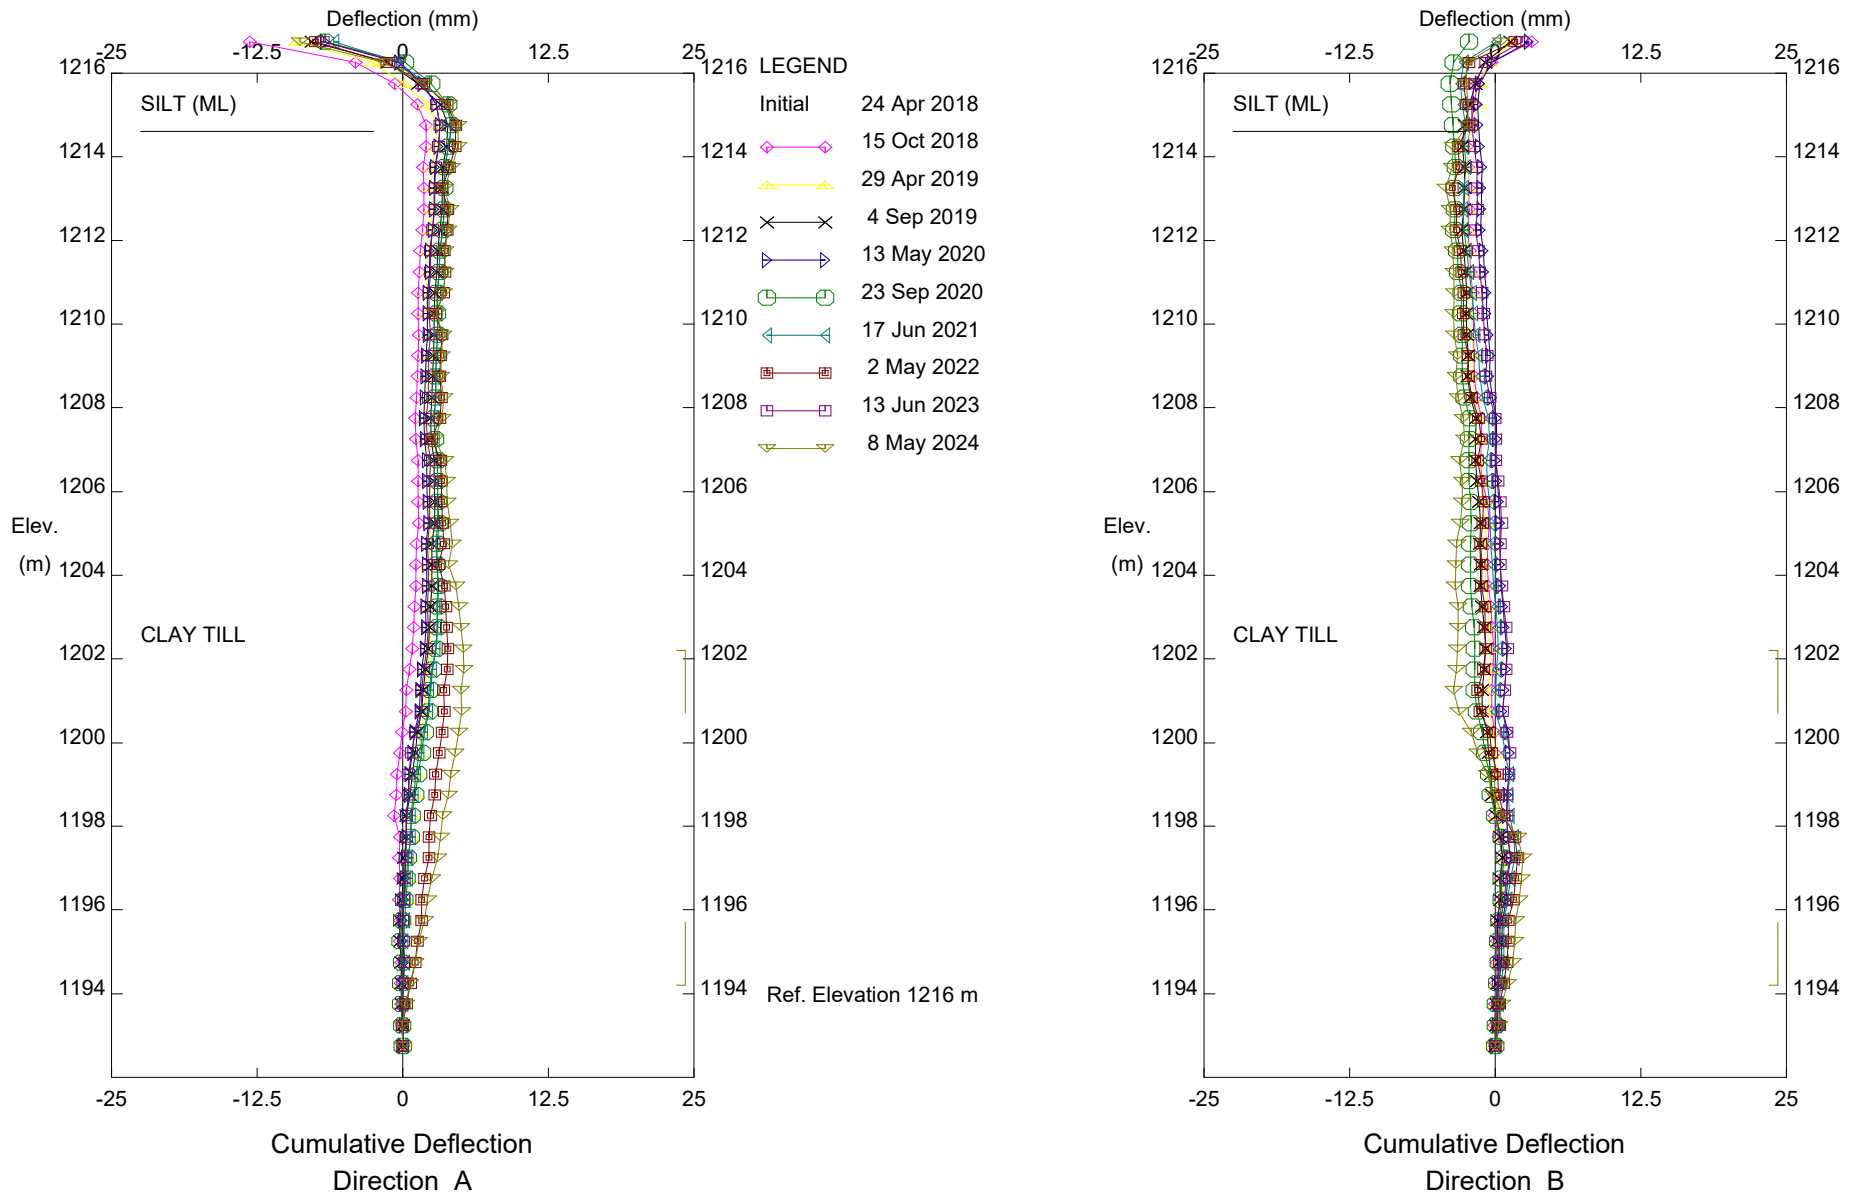
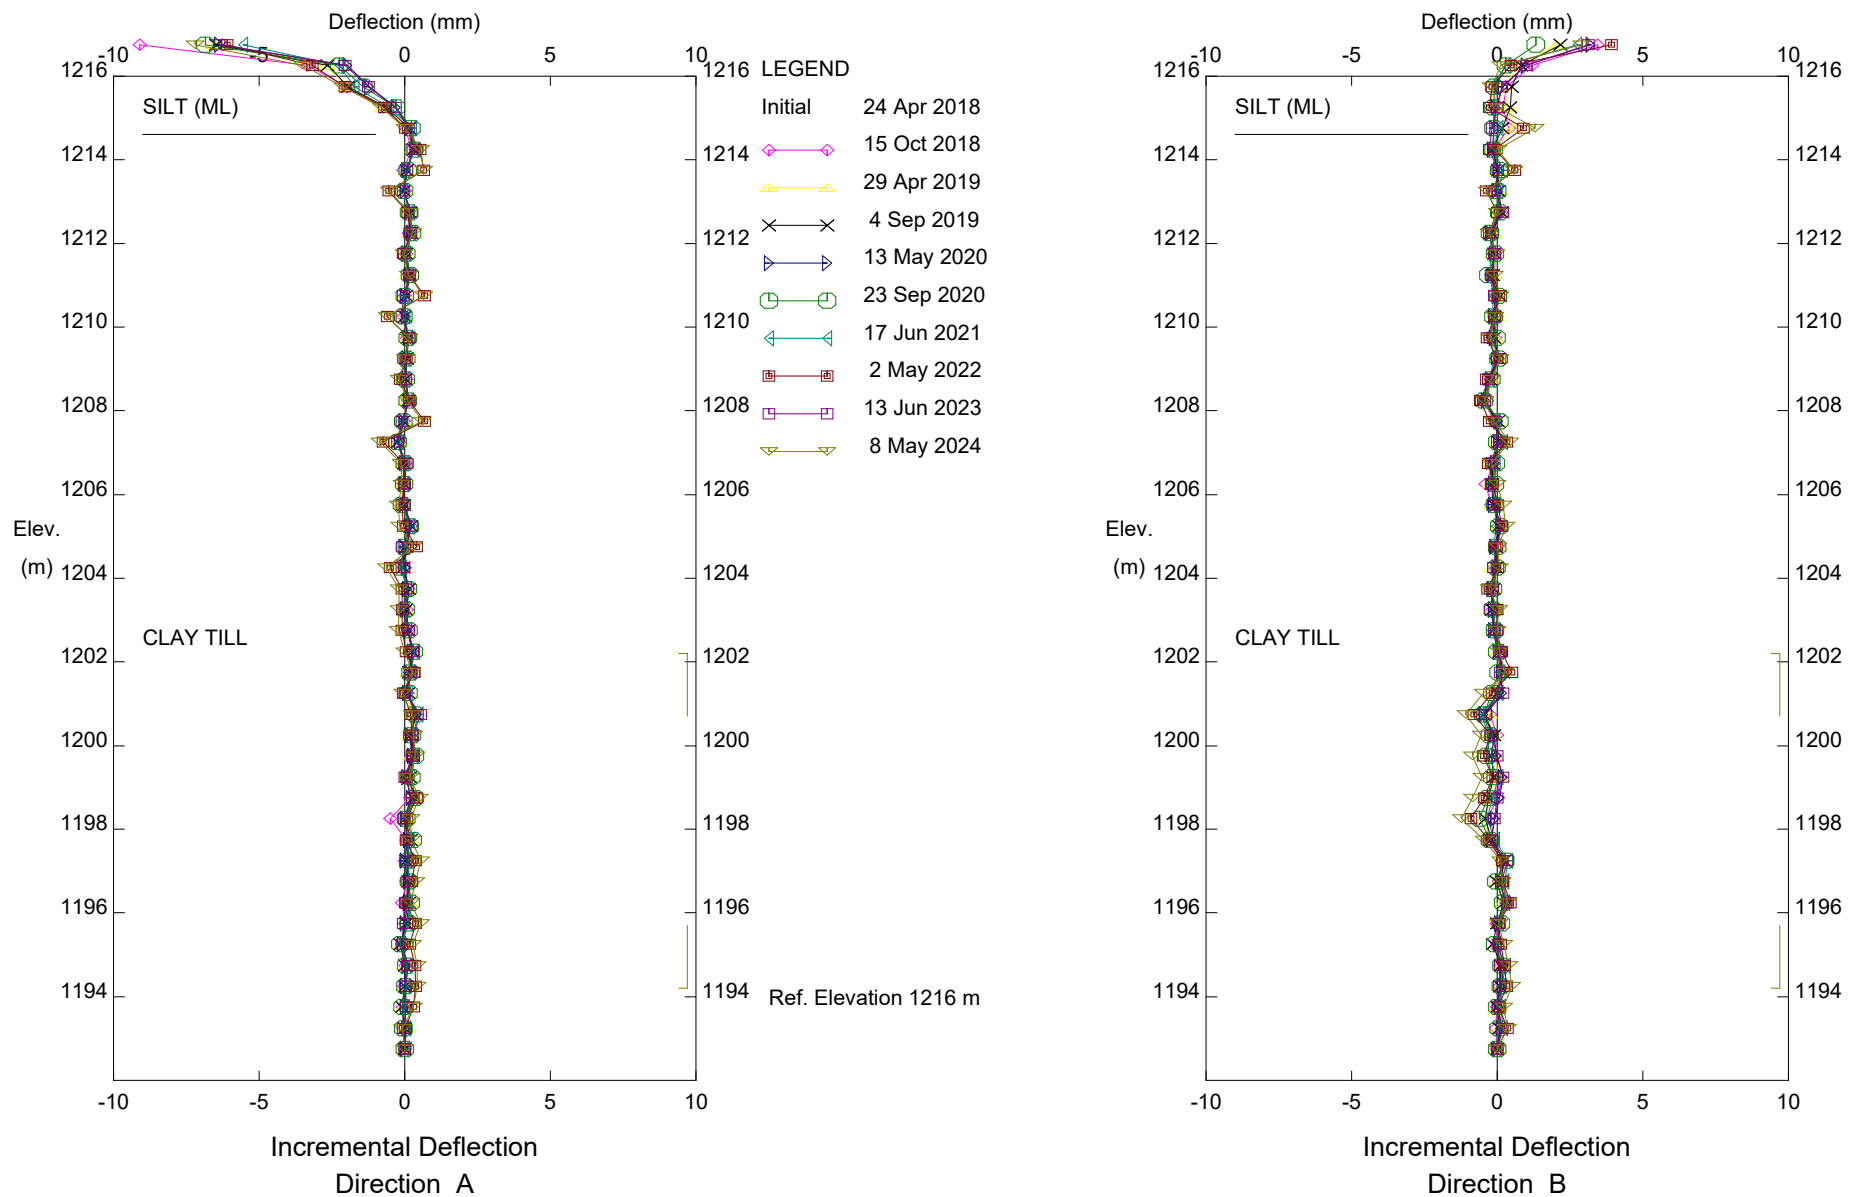
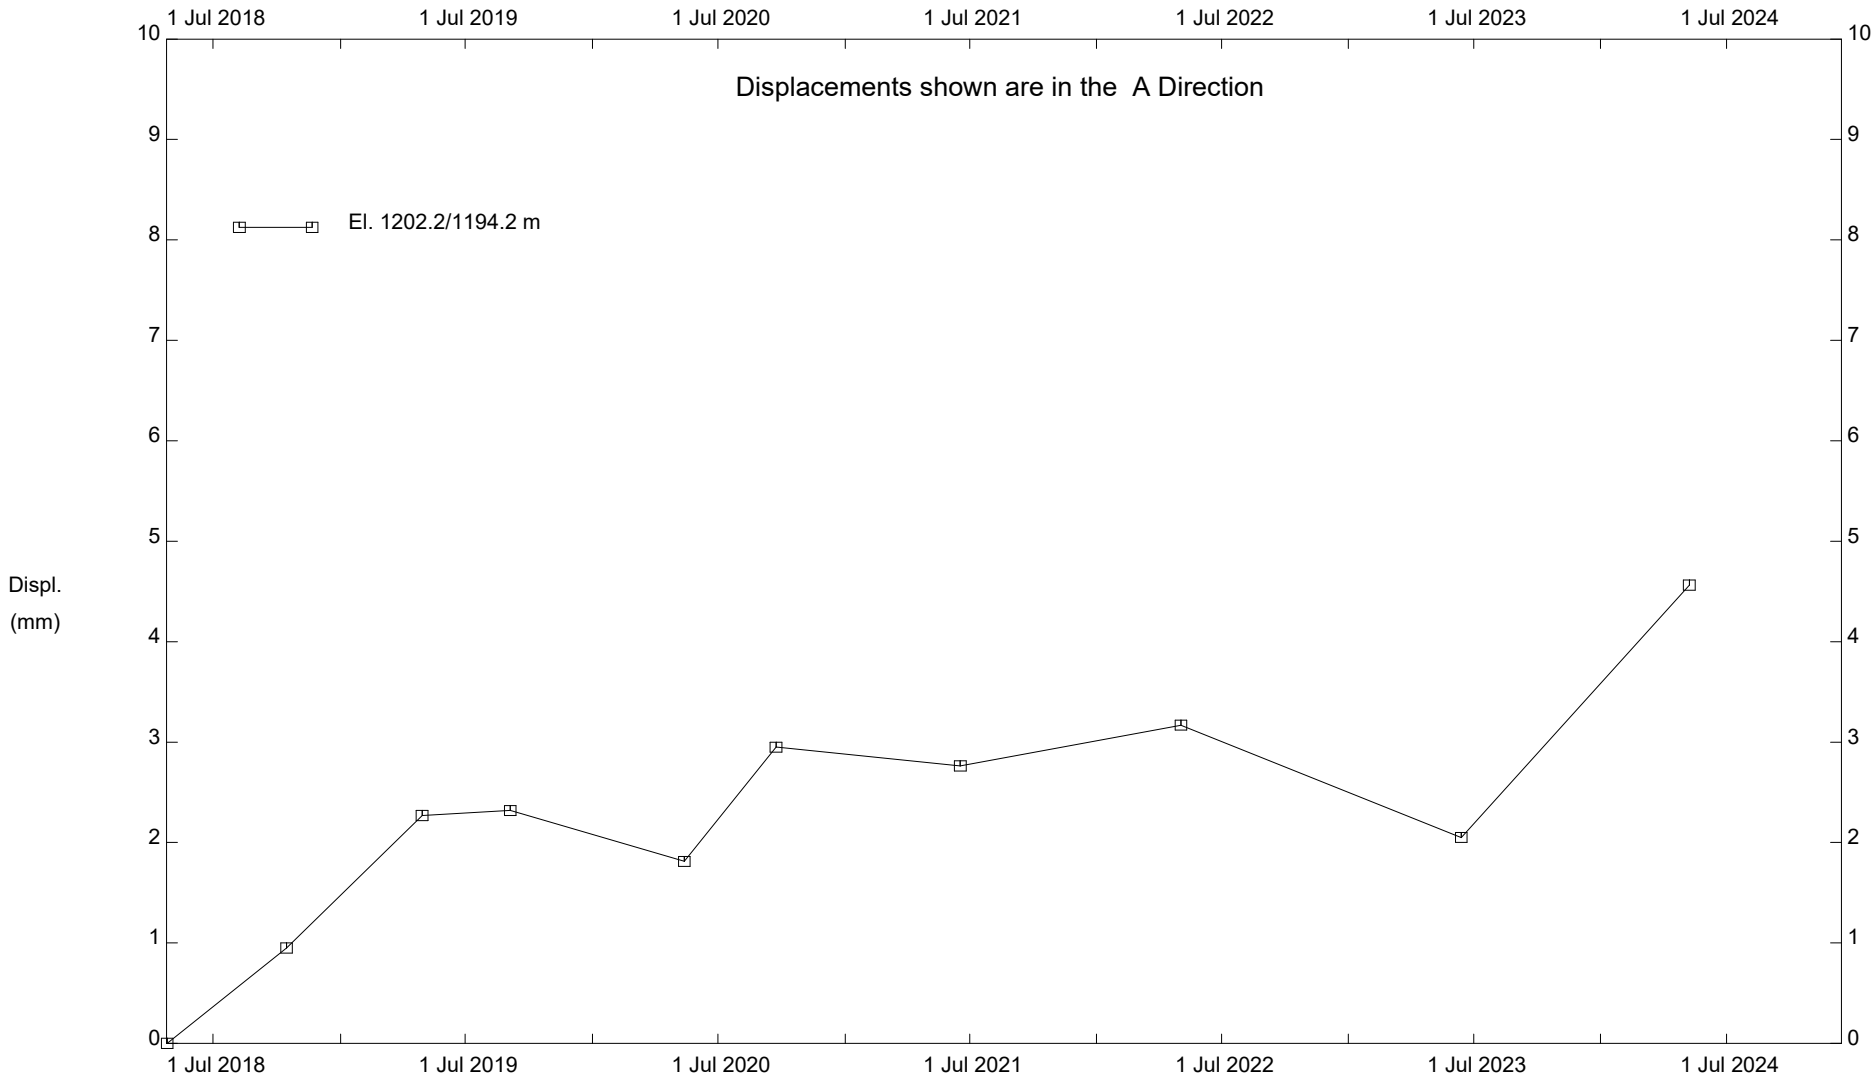
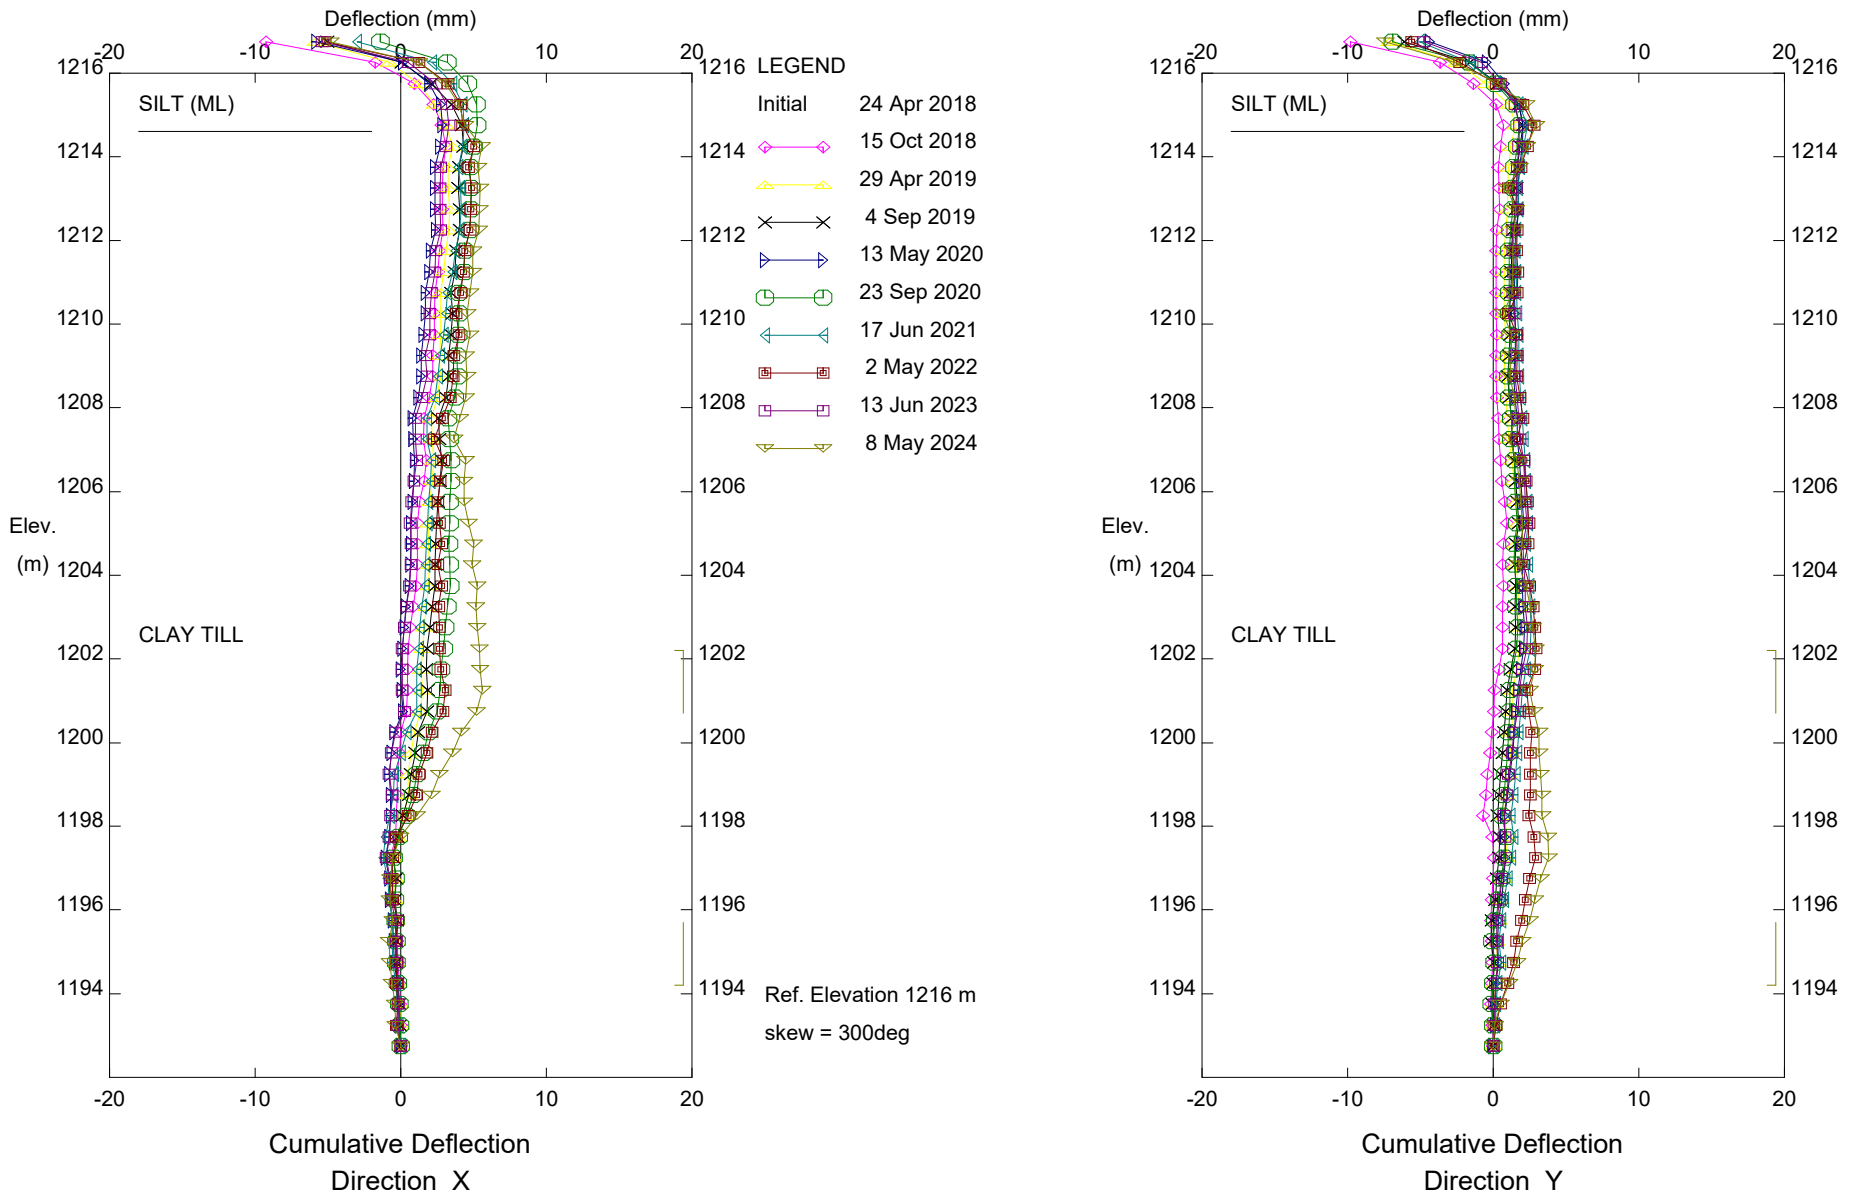
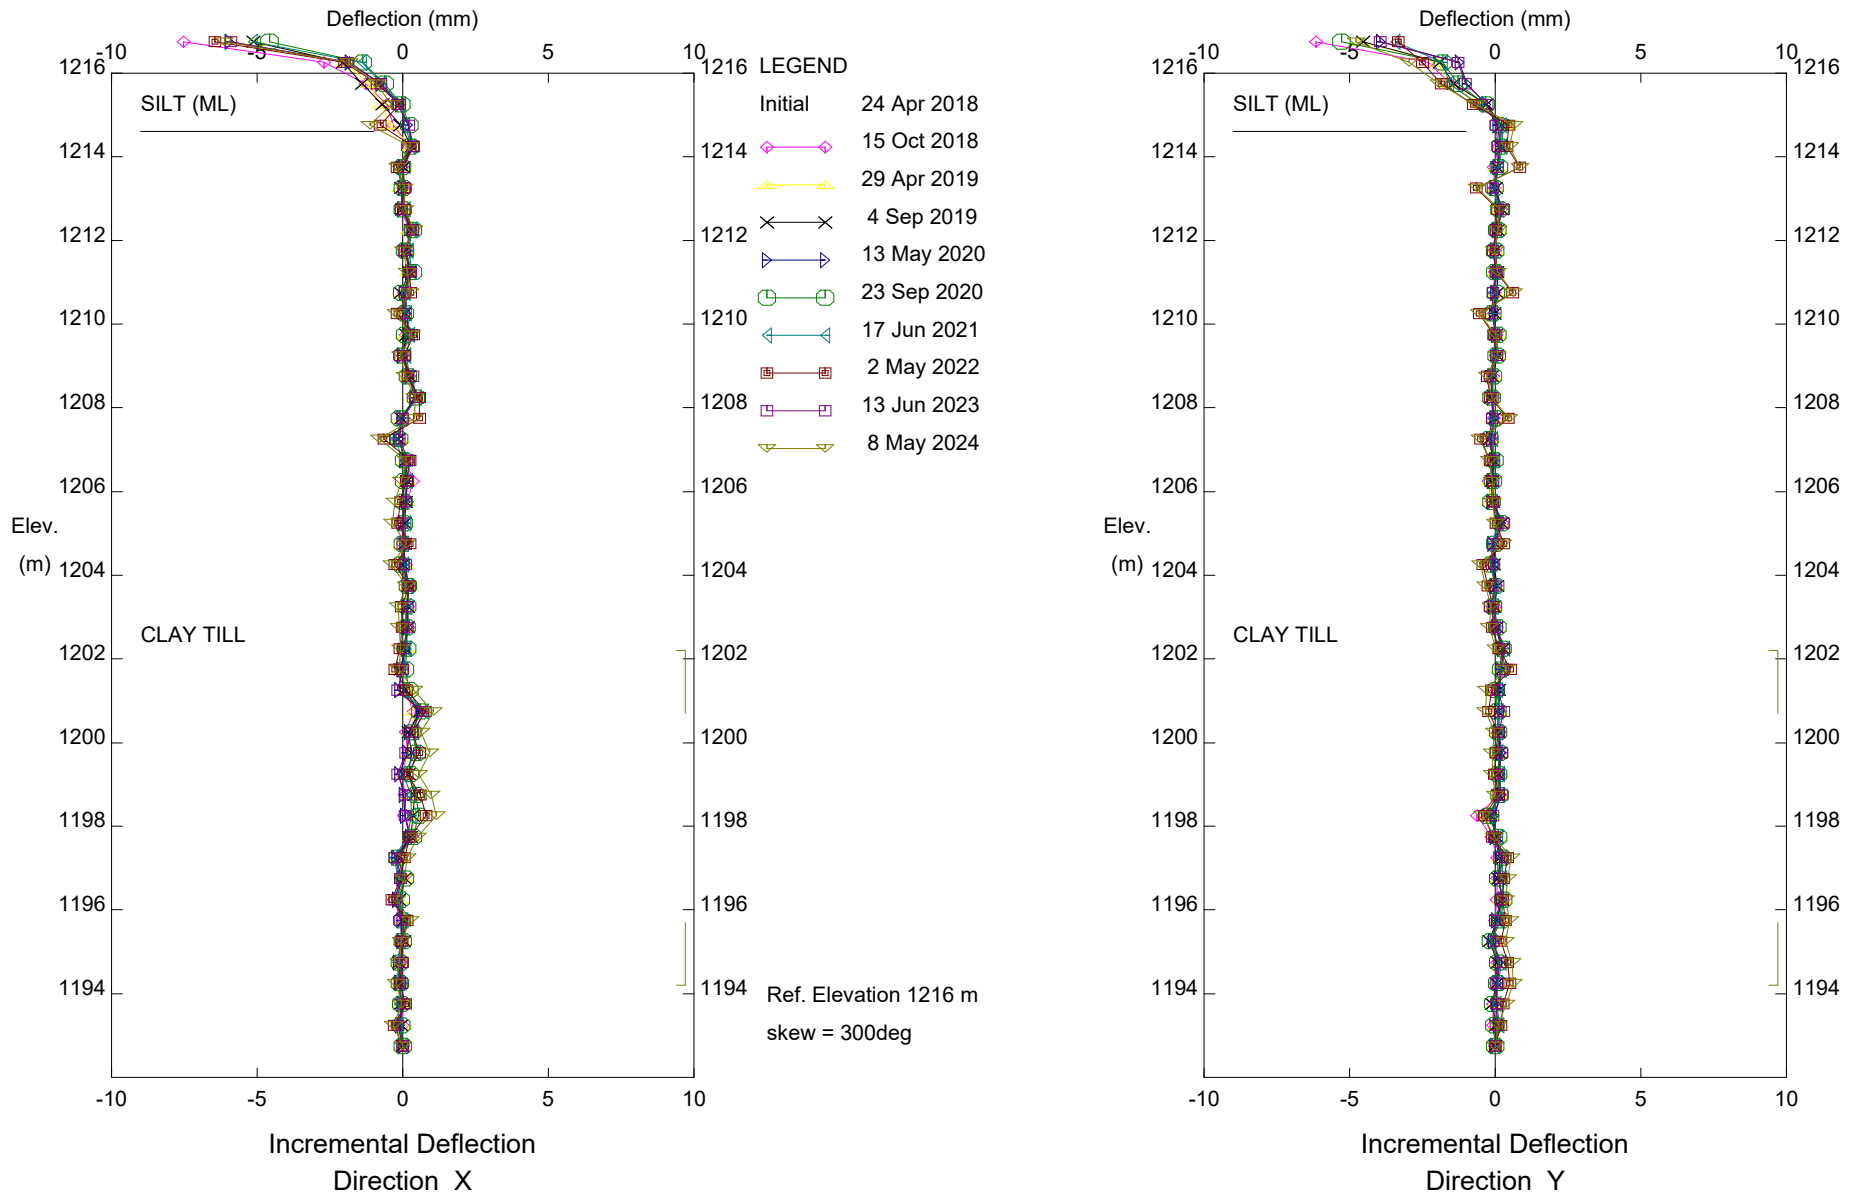
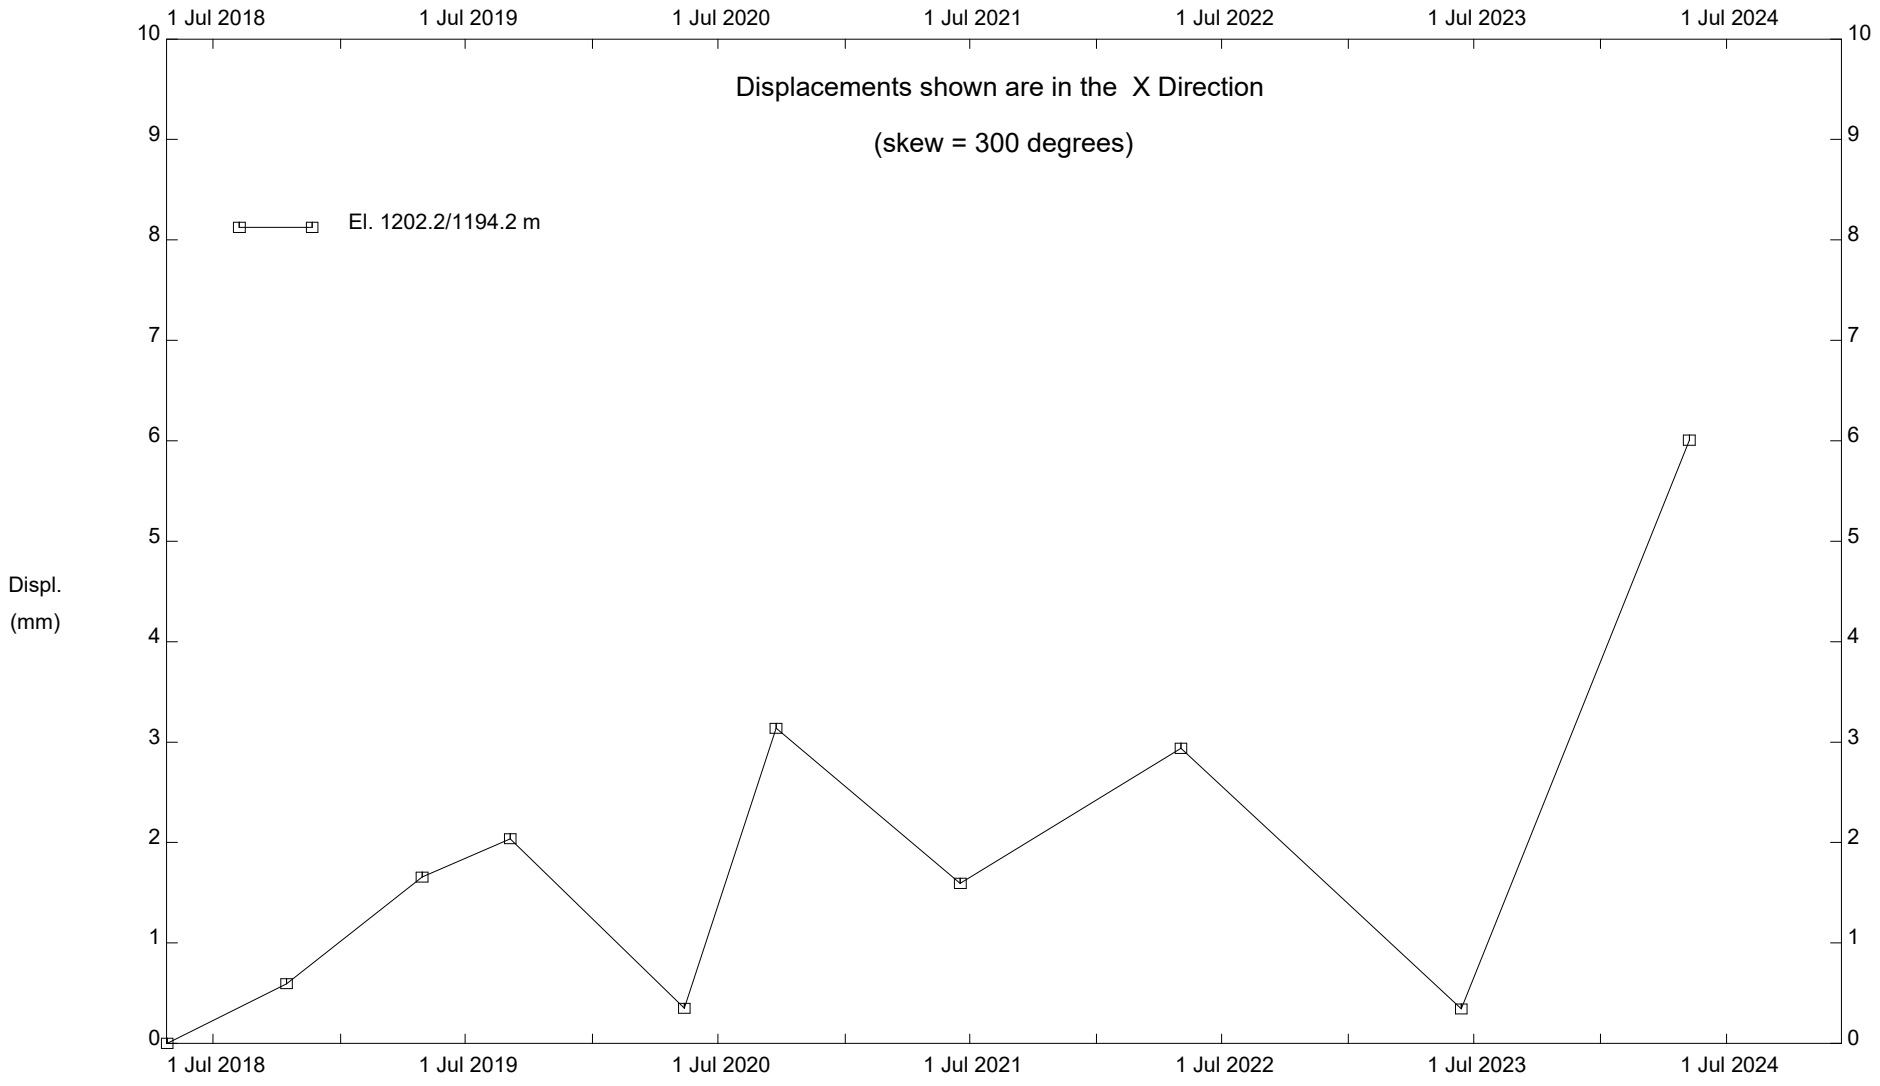
S075; H540:02 - Pekisko Creek, Inclinometer SI17-03
 Alberta Transportation

Movement has been recorded in SI17-03 from an approximate depth of 15 m to 20 m below ground surface (approximately El. 1201 m to El. 1196 m). SI17-03 is located at the crest of the slope outside of the identified slide mass.

Prior to SI17-03 being re-initialized in April 2018 and SI17-04 becoming inoperable in 2018, settlement or buckling was observed in both instruments, which could indicate the instruments were poorly grouted with possible grout voids. The interpretation of the SI data is complicated by the potential for settlement or buckling of the SI casing in the poorly grouted casing segment. The instrument was re-initialized to remove possible noise associated with this zone. Overall data quality has improved since the instrument was re-initialized, but settlement or buckling of the casing may still be occurring at this depth. The rate of settlement or buckling has slowed since the first few months following installation and has been generally negligible since the instrument was re-initialized. If the settlement or buckling begins to impact the interpretation of the SI data again, the instrument may need to be re-initialized.

Since the SI17-03 was re-initialized to April 2018 reading, an overall slow rate of movement (less than 3 mm/year) has been recorded in SI17-03. The negative rate of movement recorded in this instrument during some readings indicates the rate of movement is within the accuracy of the reading equipment.

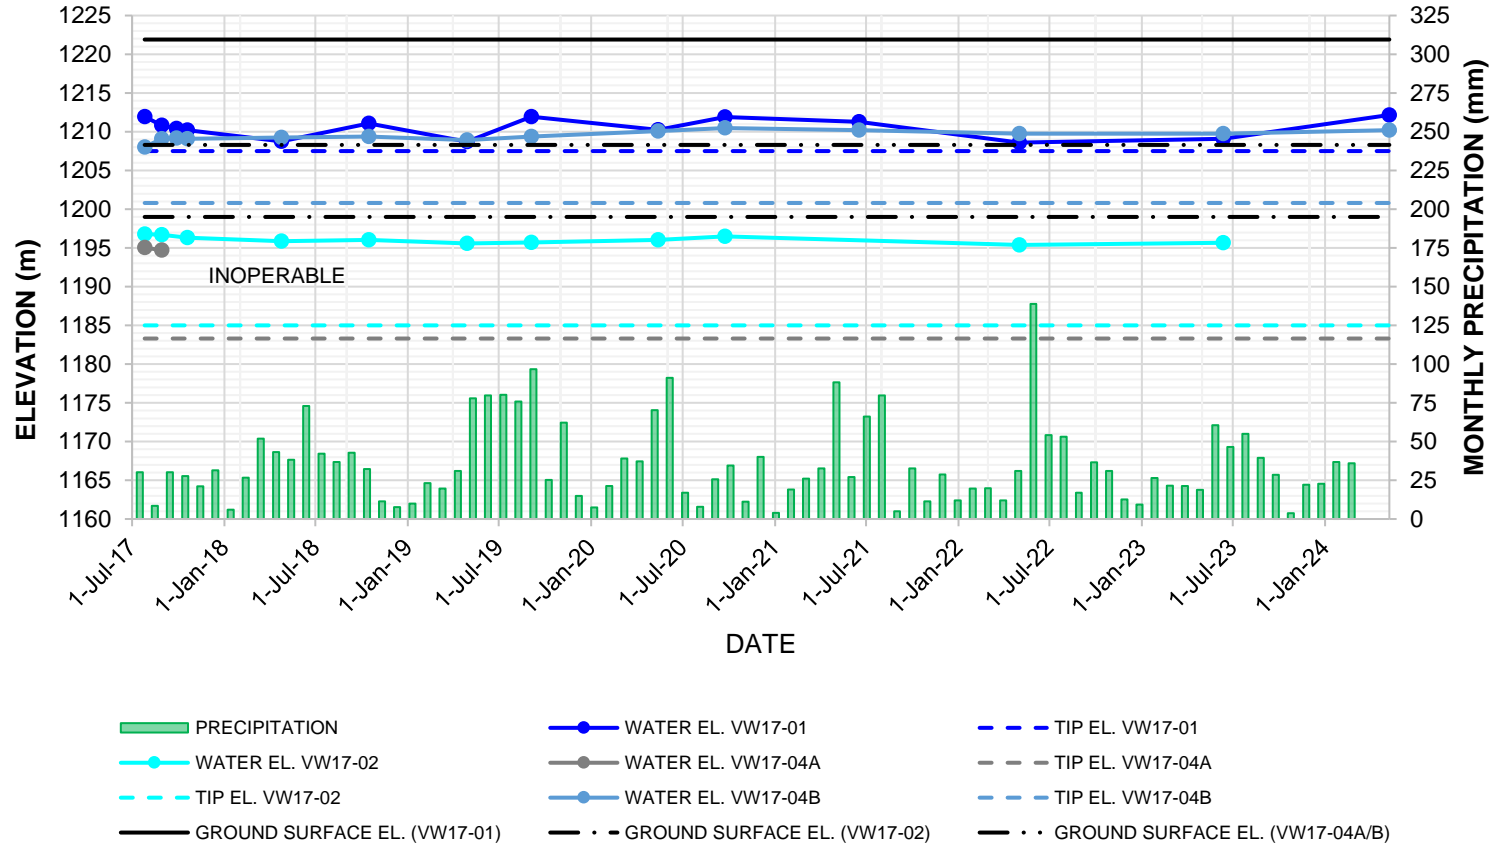
Piezometer Data
S075 - Pekisko Creek Slides
Hwy 540:02, km 5.72

VW17-04B was installed 7.5 m below ground surface (approximately El. 1201 m) in the clay till. Relatively small and steady water level increases were recorded in VW17-04B since installation to September 23, 2020 (total increase of 2.5 m). The water level has since decreased by 0.2 m between September 2020 and May 2024. The water level recorded in VW17-04B is above-ground, indicating artesian groundwater conditions at this instrument.

Since installation, water levels recorded in VW17-01 (installed in the clay till) have fluctuated between 9.7 m and 13.3 m below ground surface. Before the reading frequency of the instrument was decreased from twice to once per year in 2020, water levels recorded in this instrument appeared to fluctuate seasonally, with the spring readings being lower than fall readings. The May 2024 reading increased 3.1 m since June 2023, which could be attributed to the increased

precipitation in spring 2024. At the time of writing this report, rainfall data was only available up to the end of March 2024.

Water levels recorded in VW17-02 (installed in the bedrock) have been relatively steady since installation between an approximate depth of 2.2 m and 3.6 m below ground surface. In May 2024 the VWP wires could not be located, after a subsequent site visit the wires were still unable to be located. It is assumed that the wires have fallen to the base of the head box but could not be retrieved. Equipment should be brought to site for the next readings to attempt to locate and retrieve the VWP wire.

KCB will bring equipment to site during the next site visit to try and retrieve the VWP wire that could not be located within the head box.
