SITE NUMBER AND NAME: <b>S020 Highwood House Rock Cut</b>		HIGHWAY & KM: 541:02, 0.817	PREVIOUS INSPECTION DATE: May 6, 2019	INSPECTION DATE: <b>July 7, 2020</b>
LEGAL DESCRIPTION: 04-33-016-05 W5M	NAD 83 COORDINATES: UTM Northing Easting 11 5584038 667795		RISK ASSESSMENT: PF: 14 CF: 3 TOTAL: 42	
AVERAGE ANNUAL DAILY TRAFFIC (AADT): 280 (west), 290 (east), (Ref. No. 59130)			CONTRACTOR MAINTENANCE AREA (CMA): 27

<b>NOTES:</b> 1. HORIZONTAL DATUM: NAD83 2. GRID ZONE: UTM Zone 11N 3. IMAGE SOURCE: Bing Maps 2020, Microsoft Corporation. Source date September 2013	CLIENT 	PROJECT SOUTHERN REGION GEOHAZARD RISK MANAGEMENT PROGRAM
		TITLE Site Plan S020 - Highwood House Rockfall Hazard Hwy 541:02, km 0.817
	SCALE 1:1,250	PROJECT No. A05115A03
		FIG No. 1

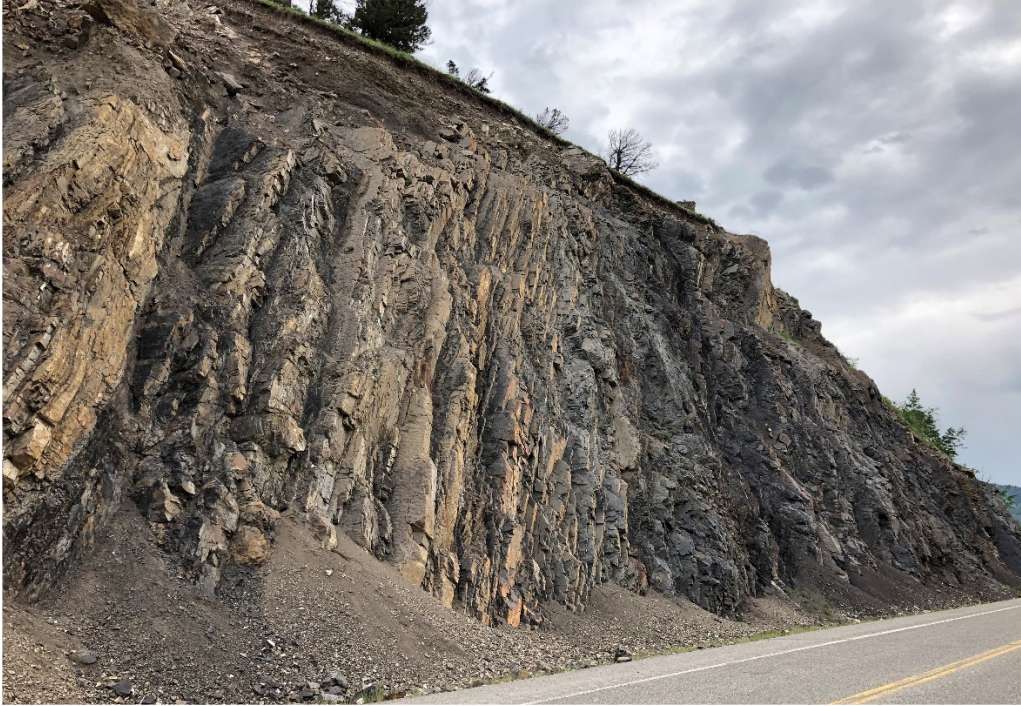
**Photo 1** Rock slope has a maximum height of approximately 20 m, with continuous joints in an adverse orientation. Photo was taken facing northeast on July 7, 2020.

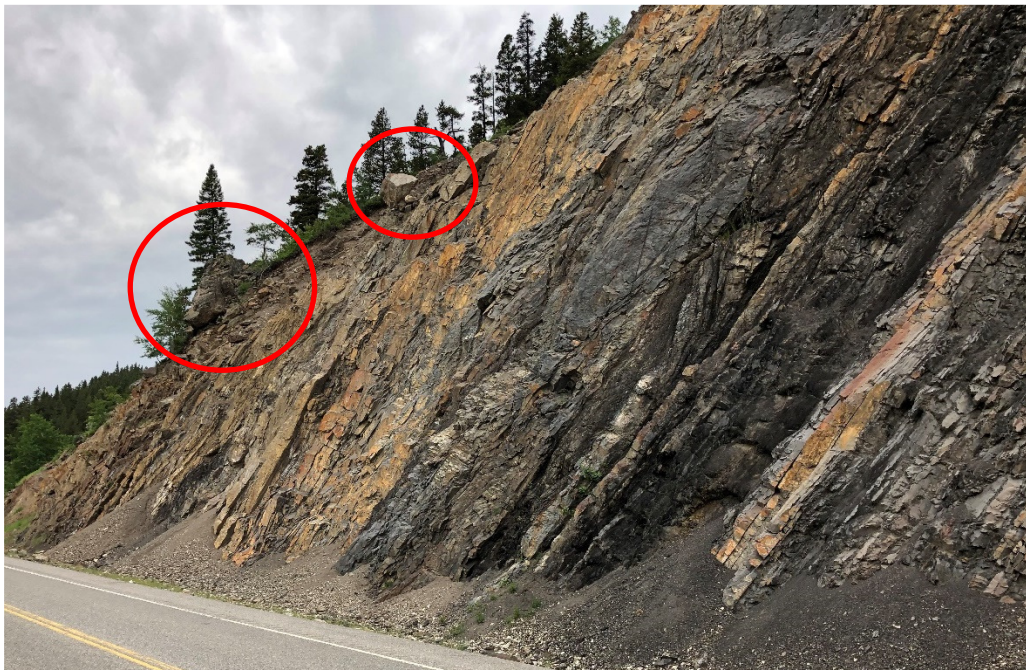
**Photo 2** Loose blocks and boulders up to 0.5 m x 0.5 m x 0.5 m present along the length of the rock slope. Note large boulder at crest of slope. Photo was taken facing west on July 7, 2020.

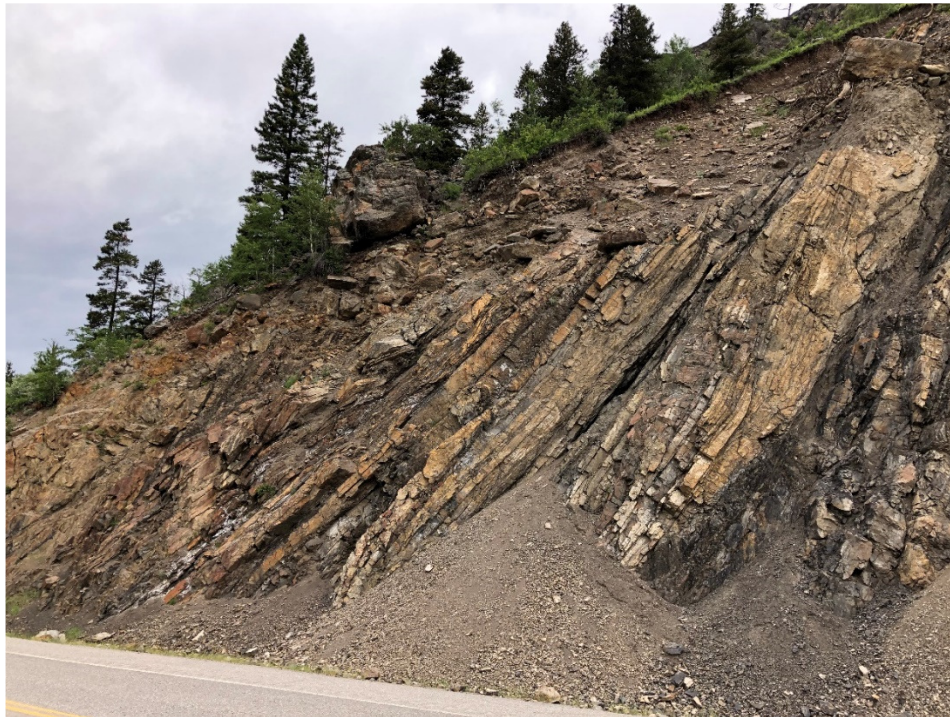
**Photo 3** Active rockfall - debris fans and large rocks in ditch. The ditch should be regularly cleaned of debris. Photo taken facing northwest on July 7, 2020.

- Clean rockfall ditch; and
- Carry out drone survey including photogrammetric survey and 3D surface model of slope to assess failure modes and volumes. A proposal to complete a photogrammetry survey and rock slope assessment was submitted to AT by KCB in 2019.

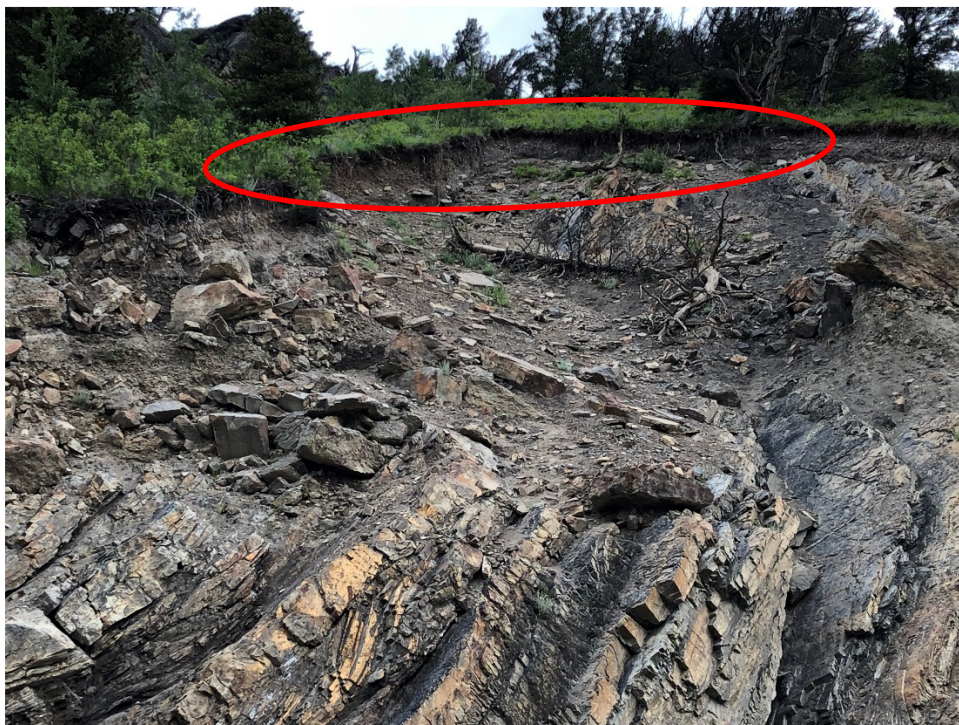
There appeared to be a minor increase in extent of soil erosion at brow of hill, and surface runoff down the slope is leading to erosion and washout of material, which is being deposited in fans at the base of the slope.

**Photo 4** Erosion of soil at brow of slope, leading to rockfalls and debris fans in the ditch.
