SITE NUMBER AND NAME: S020 Highwood House Rockfall Hazard		HIGHWAY & KM: 541:02, 0.817	PREVIOUS INSPECTION DATE: July 7, 2020	INSPECTION DATE: July 9, 2021
LEGAL DESCRIPTION: 04-33-016-05 W5M	NAD 83 COORDINATES: UTM Northing Easting 11 5584038 667795		RISK ASSESSMENT: PF: 14 CF: 5 TOTAL: 70	
AVERAGE ANNUAL DAILY TRAFFIC (AADT): 280 (west), 290 (east), (Ref. No. 59130)			CONTRACTOR MAINTENANCE AREA (CMA): 27

PROJECT		
SOUTHERN REGION GEOHAZARD RISK MANAGEMENT PROGRAM		
TITLE		
Site Plan S020 - Highwood House Rockfall Hazard Hwy 541.05; km 0.817		
SCALE 1:1,500	PROJECT No. A05116A03	FIG No. 1

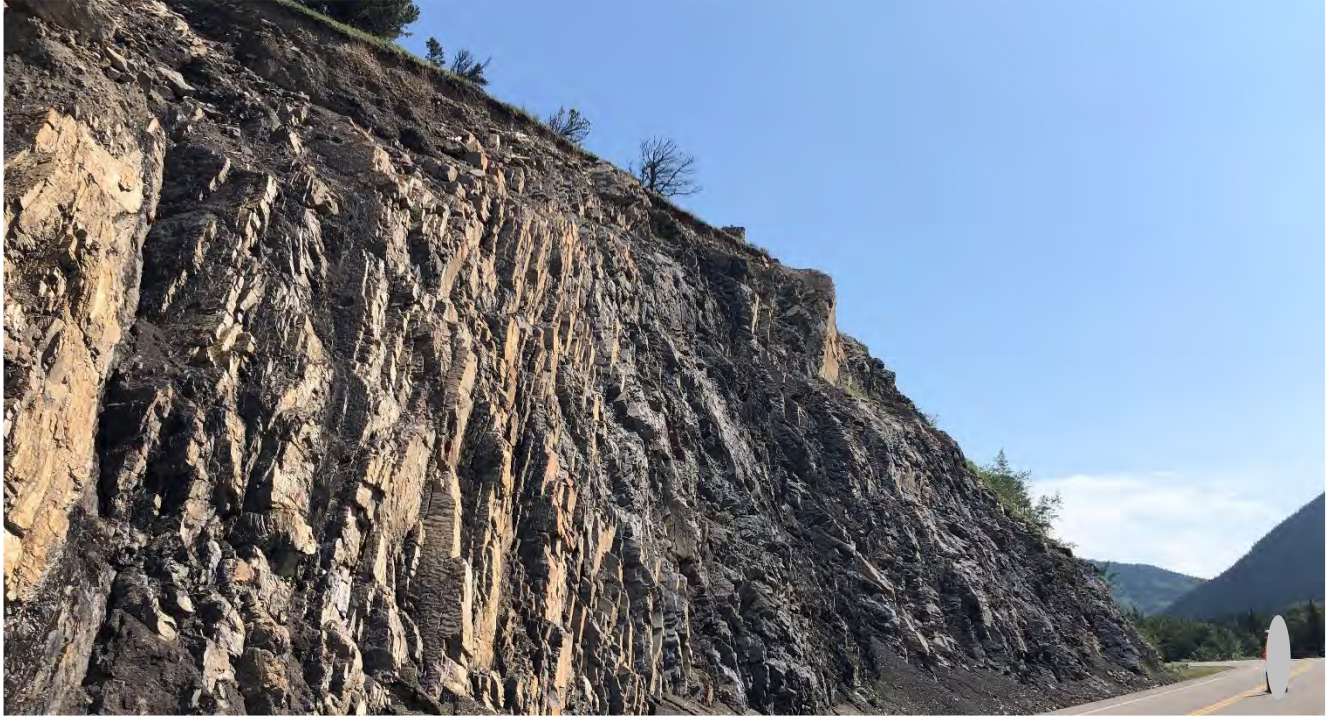
Photo 1 Rock slope has a maximum height of approximately 20 m, with continuous joints in an adverse orientation. Photo was taken facing northeast on July 9, 2021.

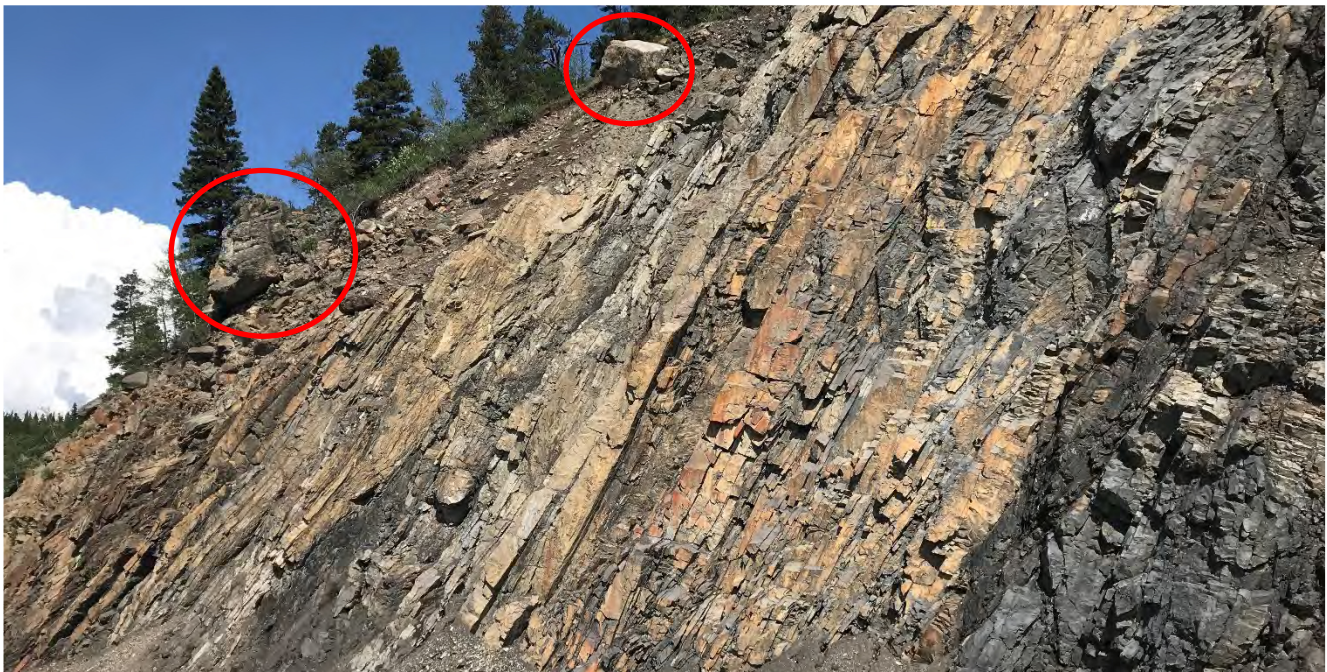
Loose blocks and boulders up to 0.5 m x 0.5 m x 0.5 m present along the top of the rock slope. Some blocks of rock are within the soil at the brow of slope and are being eroded out and will eventually fall. One large boulder at the brow of western end of the slope, and one smaller boulder midslope are both perched at the crest of the exposed bedrock.

Photo 2 Loose blocks and boulders up to 0.5 m x 0.5 m x 0.5 m present along the length of the rock slope. Note large boulder at crest of slope. Photo was taken facing west on July 8, 2021.

- Rock face scaling, including check scaling of loose blocks (for safety), clearance of trees and loose debris from the brow of the slope, and removal of the large potentially unstable rock blocks on the upper portion of the rock slope (possibly requiring drilling and blasting);
- Place rock slope mesh in critical areas to protect road users, leaving gaps for sheep passage; and
- Increase the ditch depth/width and evaluate the addition of HTCB or possible barrier wall at the toe of the rock slope (between rock slope and highway).
- Jersey barriers could be installed as an alternative to HTCB or rockfall barrier.

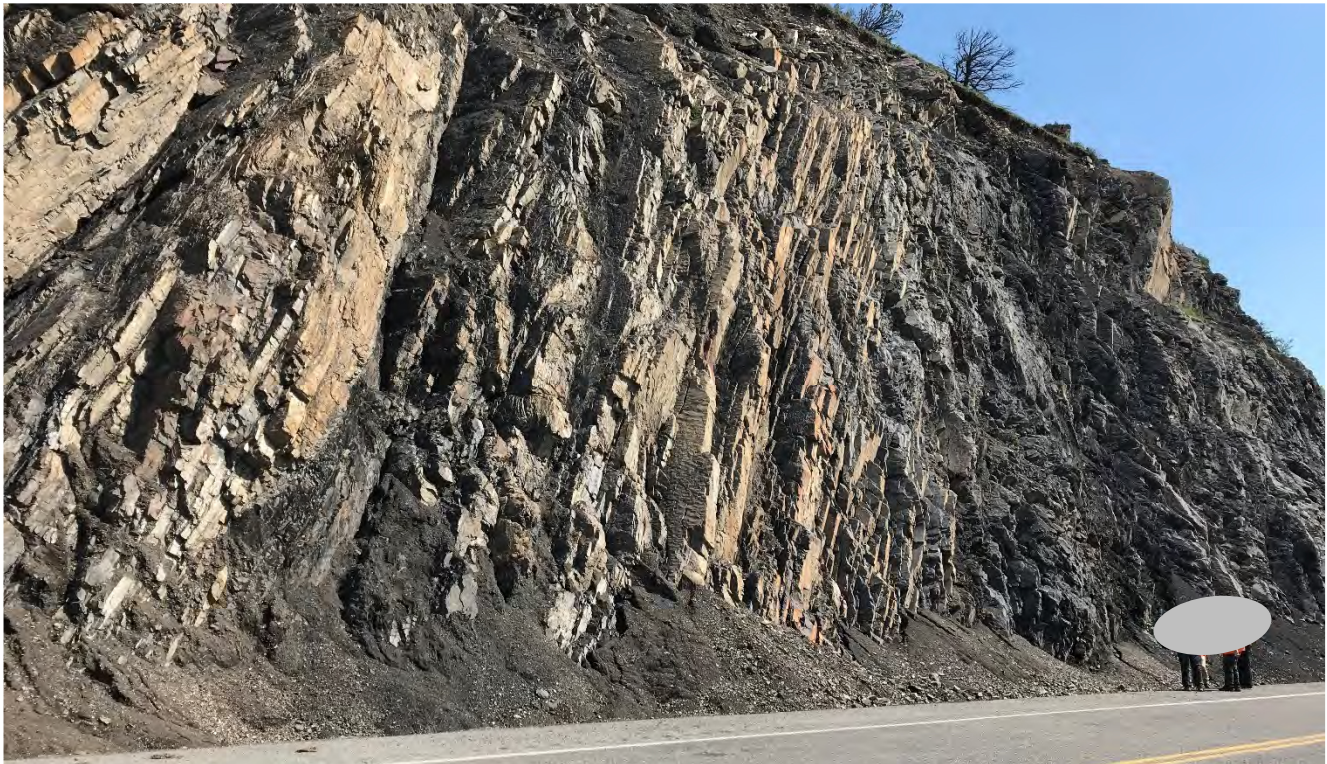
COMMENTS
Overall, no significant changes to the site when compared to 2020. Ongoing rockfalls at the site, the majority of which are retained in the ditch, but some rocks are falling onto and across the highway.
Small amount of rockfall debris observed in the ditch during the 2021 inspection as ditch had recently been cleaned out. MCI reports that ditch needs cleaning out at least once per year. The MCI noted that during 2021, ten tabular blocks of approximately 0.3 m x 0.3 m, and a boulder (approximately 1 m x 1 m x 1 m) had fallen into the ditch.

Photo 3 Active rockfall - debris fans and large rocks in ditch. The ditch should be regularly cleaned of debris. Photo taken facing northeast on July 8, 2021.

- Continue to monitor site and clean out ditch regularly to maintain storage capacity for future rockfalls;
- Carry out drone survey including photogrammetric survey and 3D surface model of slope to assess failure modes and volumes. A proposal to complete a photogrammetry survey and rock slope assessment was submitted to AT by KCB in 2019.

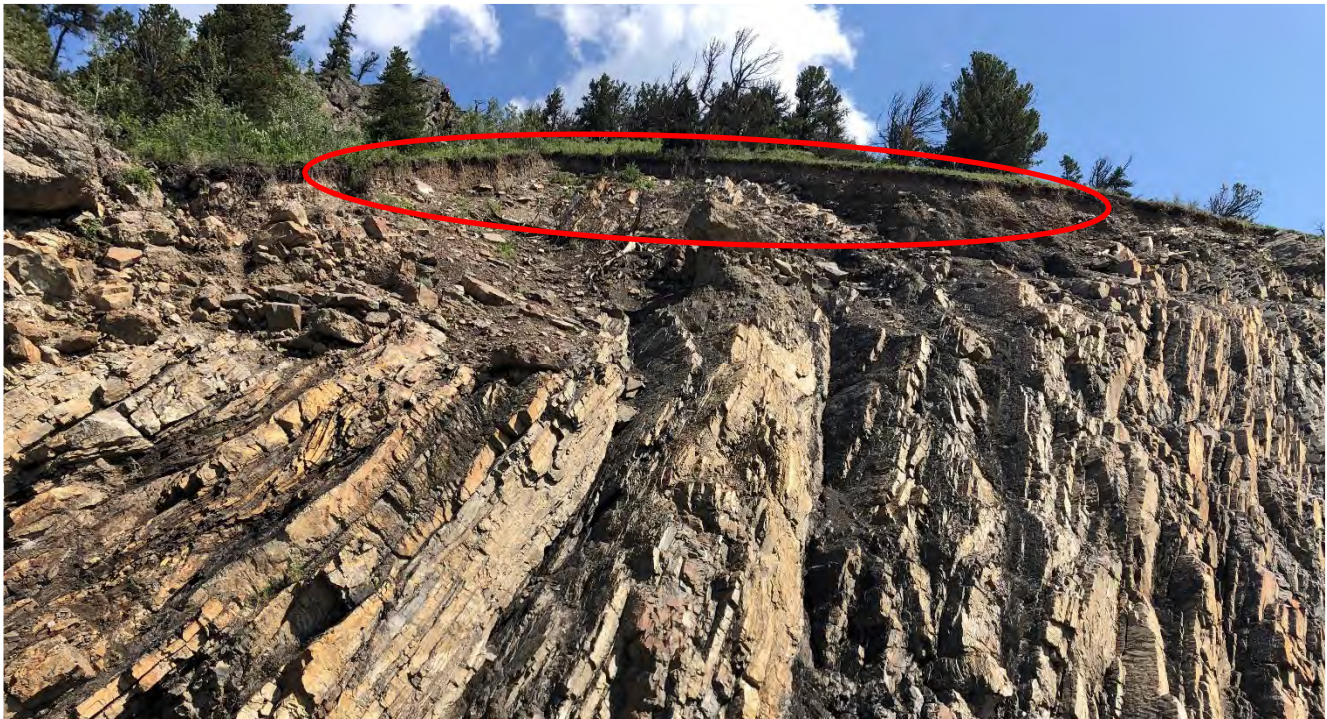
No significant change in extent of soil erosion at brow of hill since 2020. Surface runoff down the slope is leading to erosion and washout of material, which is being deposited in fans at the base of the slope.

Photo 4 Erosion of soil at brow of slope leading to rockfalls and debris fans in the ditch.
