S13 – SHEEP RIVER SITE

Alberta Transportation
Southern Region Geohazard Assessment
Annual Assessment Report
June 2004

PROJECT: SOUTHERN REGION GEOHAZARD ASSESSMENT

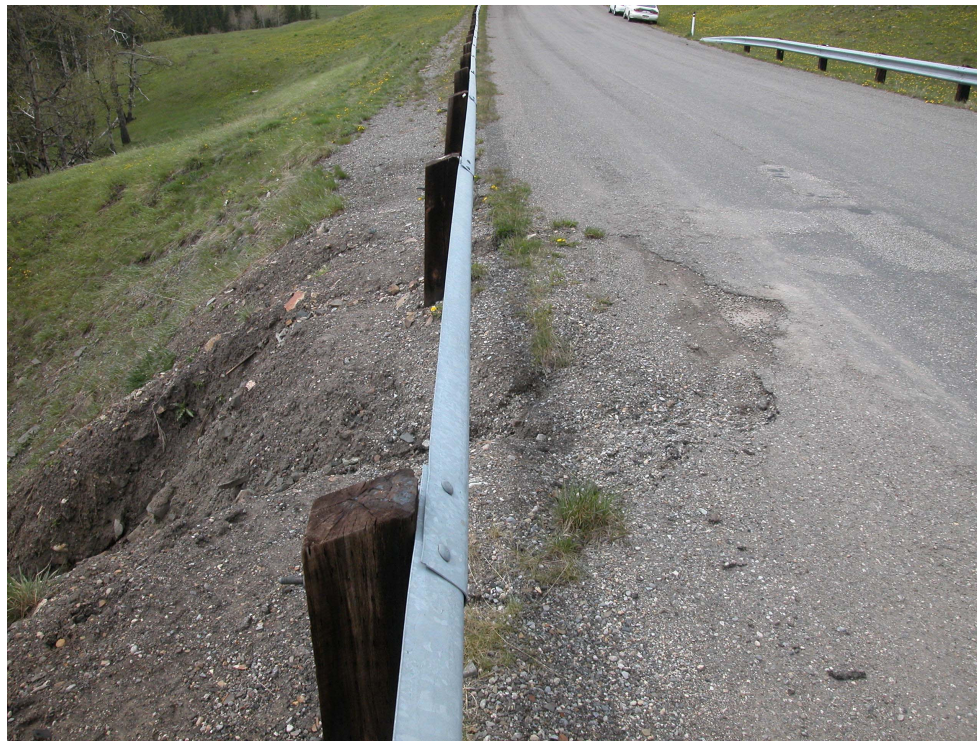
- No repair measures have been made to the erosion into the south edge of the road since the 2003 assessment. The previously-noted gully and surface erosion in the fill embankment slope face downslope (south) of the road has been continuing. The gully erosion has retrogressed slightly further (in the order of 0.5 m or less) into the eastbound lane of the road. Photos S13-1 to S13-4 illustrate the site conditions.
- There was a pile of rockfall debris from a rock cut to the east of this site stockpiled on the area downslope (south) of the guardrail on the east side of the creek, as shown in Photo S13-3. AMEC understands that this has been done in previous years prior to disposing of the debris by bulldozing it into the gully downstream of the road.

The rate of gully erosion into the eastbound lane was not estimated during the 2003 assessment because no previous assessments had been performed at this site and therefore there was no basis for comparison with previous years. Based on the visual observations from the 2004 assessment, the rate of gully erosion into the road surface is relatively slow and is

roughly estimated to have been less than 5 cm since the July 2003 assessment. Portions of the guardrail have been undermined but the guardrail itself has not been deflected to date. As noted in the 2003 assessment, the road surface is relatively wide at this location and it appears that the portion of the eastbound lane that has been lost to erosion to date is not within the traffic path. However any vehicles that pass close to the south guardrail are at risk of hitting the eroded and slightly undermined area. It is possible that the erosion into the southbound lane could be left unrepaired for several years without significant risk to the eastbound lane, however it would be preferable to repair the current damage, restore the full support to the guardrail posts and prevent it from happening again.

Photo S13-1 (upper left) – May 2004 – gully erosion retrogressing into the south edge of the road surface. There has been a slight retrogression (estimated less than 5 cm) of the erosion further back into the road since the July 2003 inspection. Compare with Photo S13-2.

- Backfill and asphalt patch the eroded/undermined area on the south edge of the road.
- Construct a small berm of asphalt along the south edge of the road.
- Leave two gaps in the asphalt berm to allow runoff to leave the road surface.
- Flumes (half culverts) or even whole culverts should be installed at the gaps in the asphalt berm to carry the runoff down to the toe of the embankment slope, so that runoff does not flow on the steep slope face at all. It will be very important to have a good contact between the inlet of the flume/culvert and the gap in the asphalt berm, or else the runoff will simply be concentrated onto the slope face immediately around the inlet.

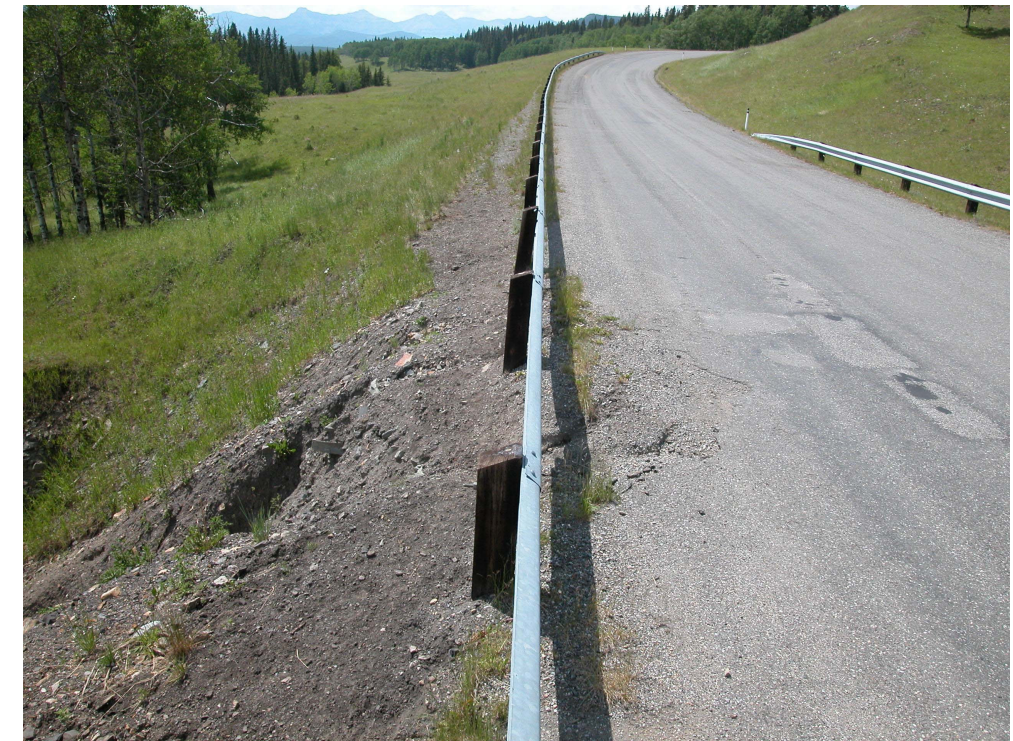
Photo S13-2 (upper right) – July 2003 – same area as shown in Photo S13-1, as seen during the July 2003 inspection.

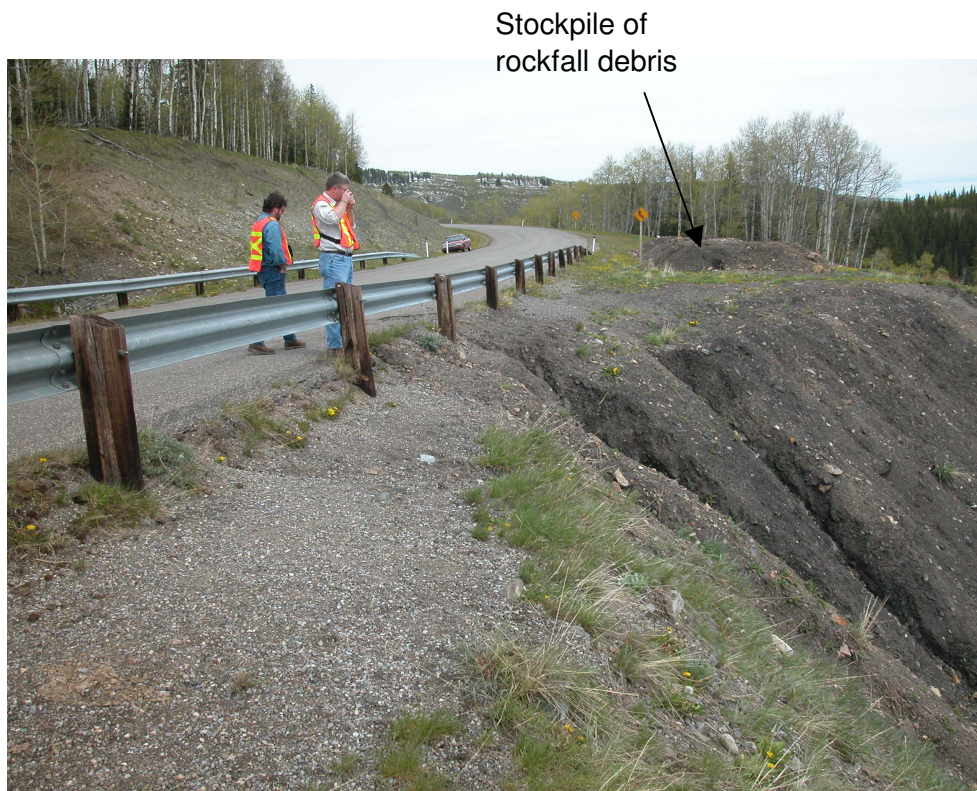
Stockpile of rockfall debris

Photo S13-3 (lower left) – May 2004 – facing east across the site, showing the relative position of the gully erosion in the fill embankment slope face and the guardrail/road surface. Note the pile of rockfall debris that has been hauled from a site to the east and stockpiled here for later disposal into the gully downstream of the road.

The occasional bulldozing/end-dumping of rockfall debris into the gully should be stopped. Aside from any environmental regulatory issues related to this practice, there is the potential that large rocks in the debris could strike and damage the exposed portion of the culvert at the base of the fill embankment.

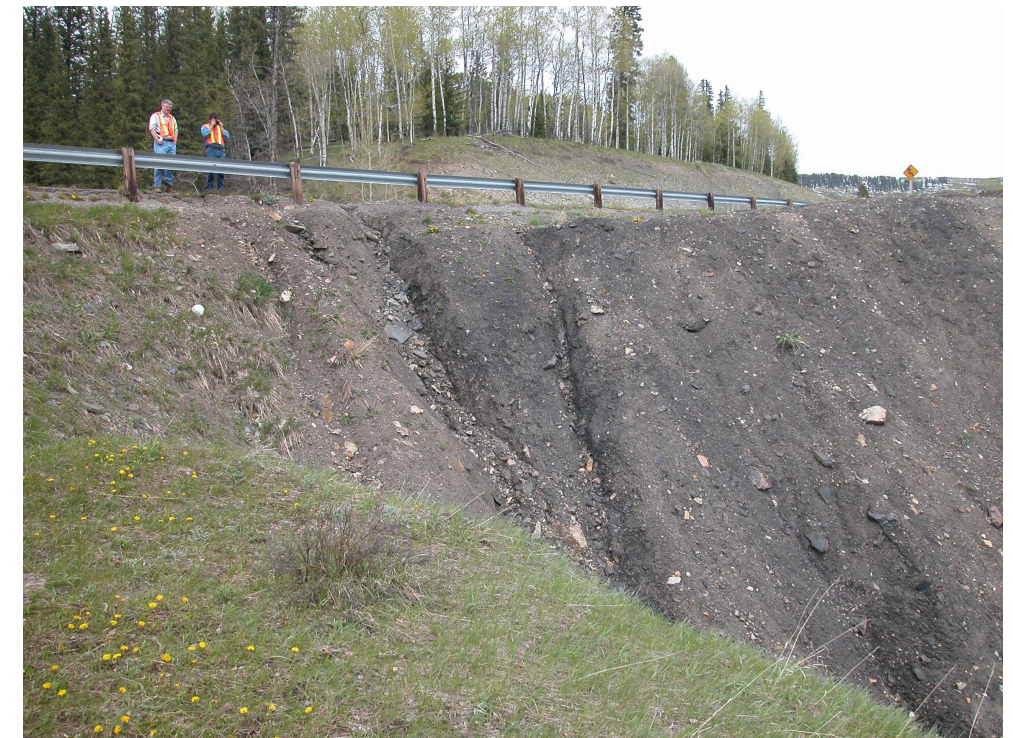
The surface erosion of the fill embankment slope face below the road is continuing but does not appear to have worsened significantly since the 2003 assessment. The retrogression of one of the erosion gullies into the eastbound lane of the road is still evident but does not appear to have advanced significantly since the 2003 assessment.

Photo S13-4 (lower right) – May 2004 – facing upslope/northeast towards the road. Note the gully erosion visible in the fill embankment slope face below the guardrail.

The gullying on the fill slope below the road should be mitigated by improved control of the runoff from the road surface. AMEC recommends the following to achieve this (see Figure 2-S13 in Appendix S13 for a schematic illustration):
