### SOUTHERN REGION GRMP SITE INSPECTION FORM

SITE NUMBER AND NAME:		HIGHWAY & KM:		PREVIOUS		INSPECTION DATE:	
S056-II West Gorge Creek, west of		Sheep River Road		INSPECTION DATE:		May 6, 2019	
Turner Valley				N/A		May 0, 2010	
LEGAL DESCRIPTION:	NAD 83 COORDINATES:			RISK ASSESSMENT:			
01-32-019-05 W5M	UTM Northing Easting			PF: 9 CF: 3 TOTAL: 27			
01-02-010-00 0000		613067	666206	11.5			
MONTHLY AVERAGE DAILY	CONTRACTOR MAINTENANCE AREA (CMA):						
360 (west), 300 (east). (Ref. N	27

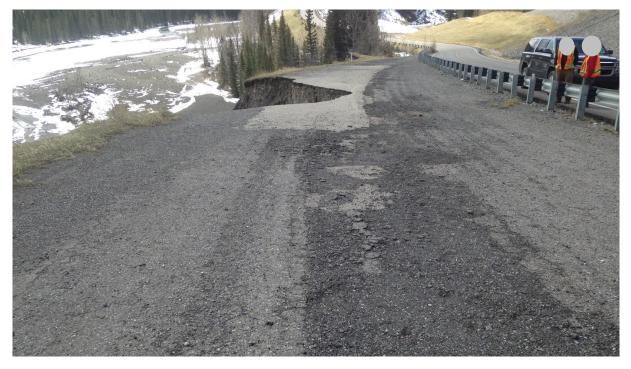
## Photo 1 Realigned highway on the right-hand side of the picture due to slope instability impacting the old road. Photo was taken facing southwest on May 6, 2019.

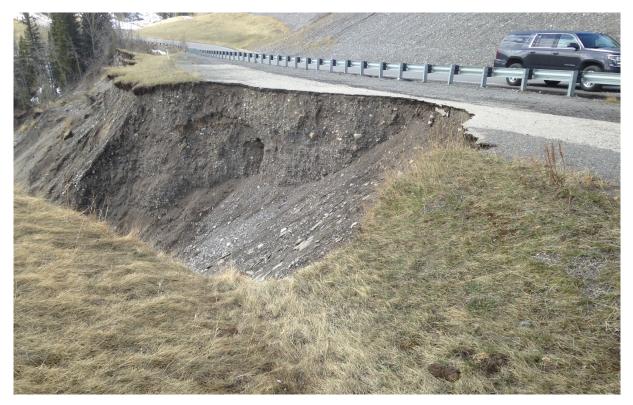
Photo 2 Ongoing slope retrogression. Photo was taken facing west on May 6, 2019.

- Annual inspections for the site to monitor retrogression of the slide; and
- Hydroseeding of the cut slope north of the highway to minimize runoff erosion.

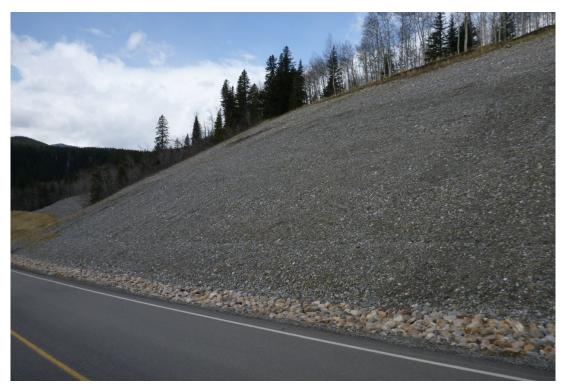
Cut slope to the north of the highway is poorly vegetated and should be seeded to reduce surface water runoff erosion. A proposal has been submitted to AT for evaluation of hydroseed mixes to promote vegetation.

# Photo 3 Unvegetated cut slope from highway realignment. Photo was taken facing west on May 6, 2019.

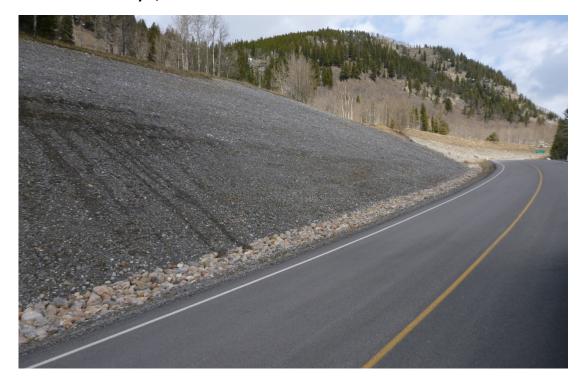
Photo 4 Unvegetated cut slope from highway realignment. Photo was taken facing east on May 6, 2019.
