SITE NUMBER AND NAME: S056-IV West Gorge Creek, west of Turner Valley		HIGHWAY & KM: Sheep River Road	PREVIOUS INSPECTION DATE: N/A	INSPECTION DATE: May 6, 2019
LEGAL DESCRIPTION: 12-36-019-05 W5M	NAD 83 COORDINATES: UTM Northing Easting 11 5614130 671333		RISK ASSESSMENT: PF: 3 CF: 2 TOTAL: 6 (Erosion) PF: 2 CF: 1 TOTAL: 2 (Rockfall)	
MONTHLY AVERAGE DAILY TRAFFIC (MADT): June 2017 360 (west), 300 (east). (Ref. No. 55460220)			CONTRACTOR MAINTENANCE AREA (CMA): 27

NOTES: 1. HORIZONTAL DATUM: NAD83 2. GRID ZONE: UTM Zone 11N 3. IMAGE SOURCE: Bing Maps 2019, Microsoft Corporation.	CLIENT 	PROJECT SOUTHERN REGION GEOHAZARD RISK MANAGEMENT PROGRAM
		TITLE Site Plan West Gorge Creek Site IV Sheep River Road
SCALE 1:1,000	PROJECT No. A05115A03	FIG No. 1

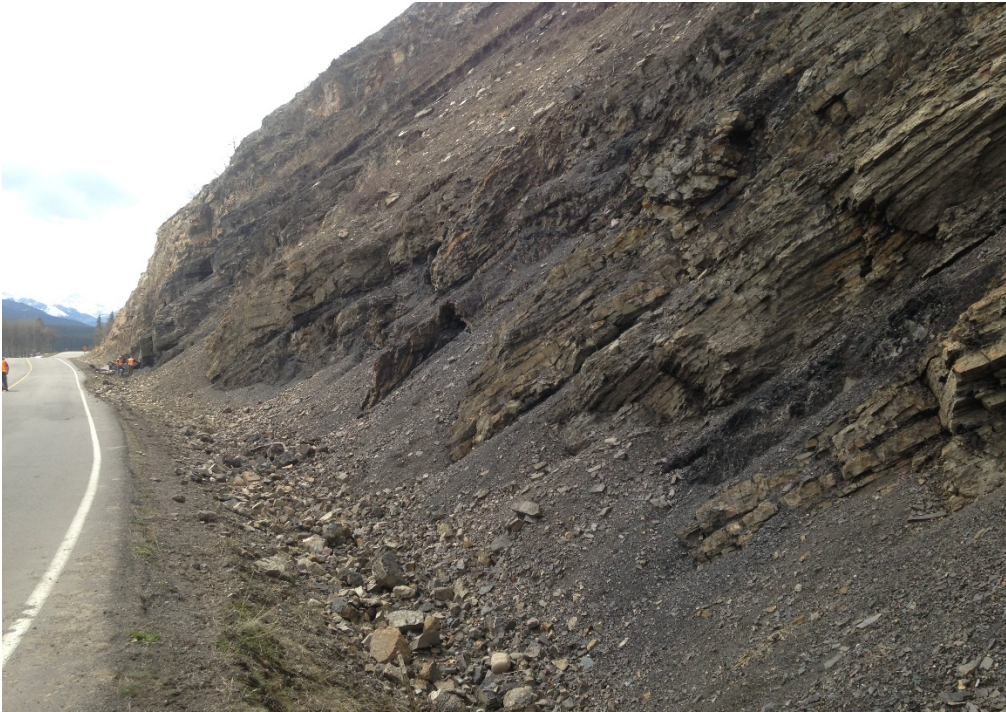
Photo 1 Rock slope north of highway. Photo was taken facing west on May 6, 2019.

- Rock slope analysis to evaluate rockfall potential and routes;
- Scaling of portions of the rock slope where the rock slope is directly adjacent to the road to create a rock fall ditch; and
- Installation of rockfall fence partway up the rock slope to catch rocks with the potential to bounce onto the roadway.

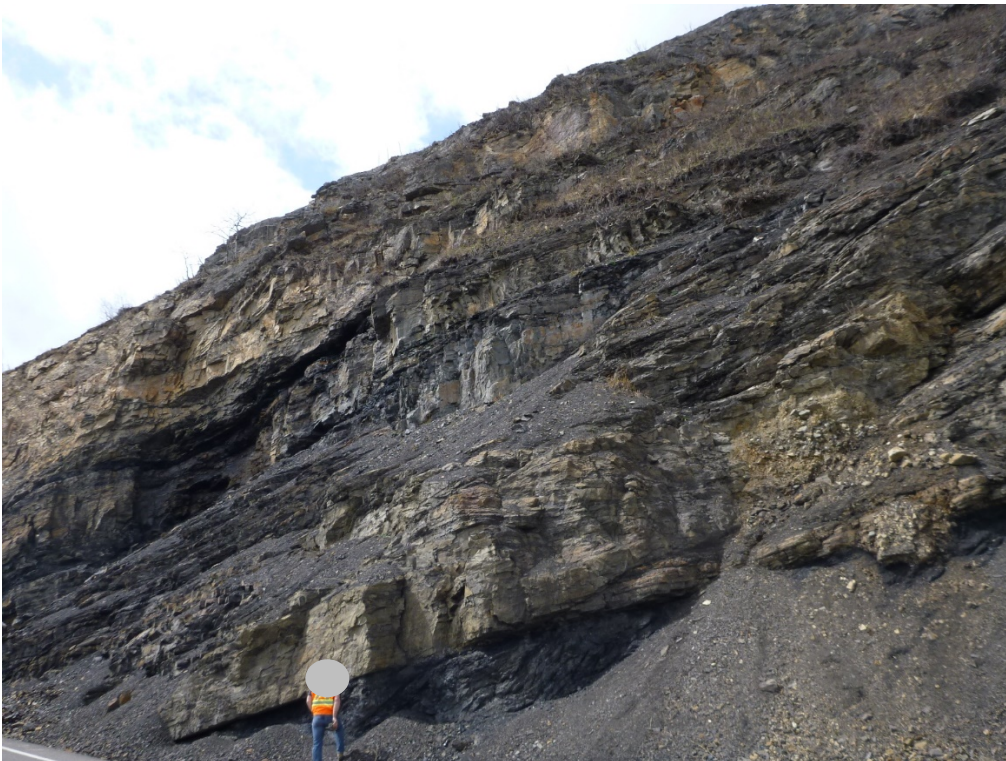
Photo 2 Rock slope north of highway. Photo was taken facing northwest on May 6, 2019.

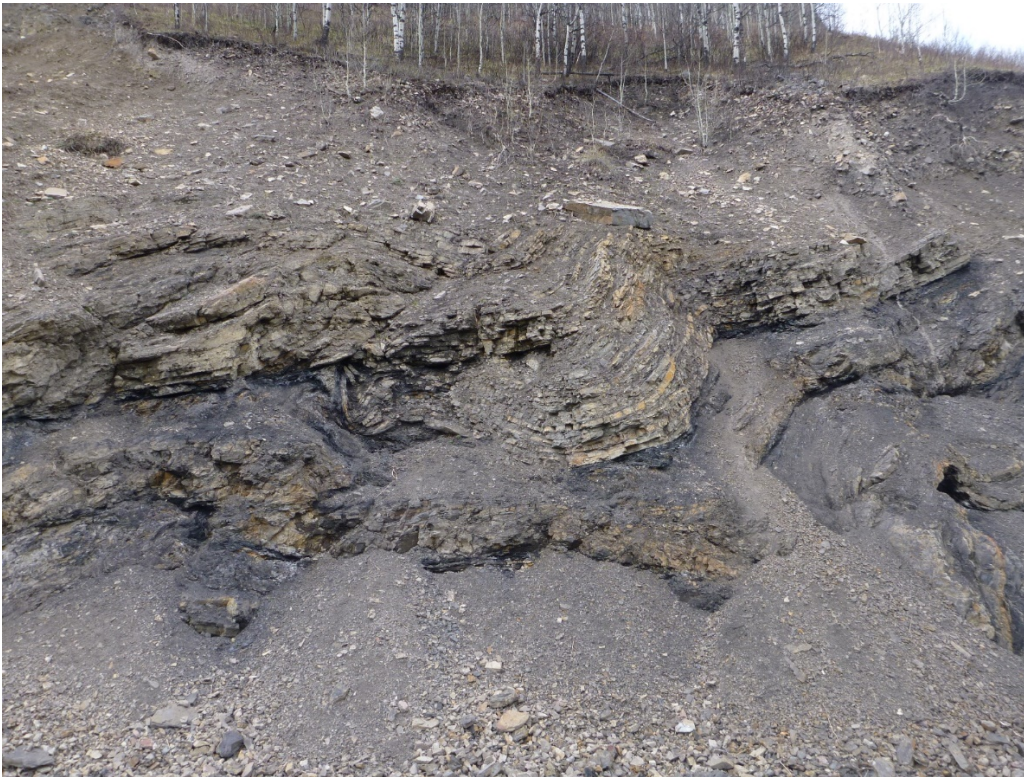
Photo 3 **Rock slope north of highway. Photo taken facing north on May 6, 2019.**

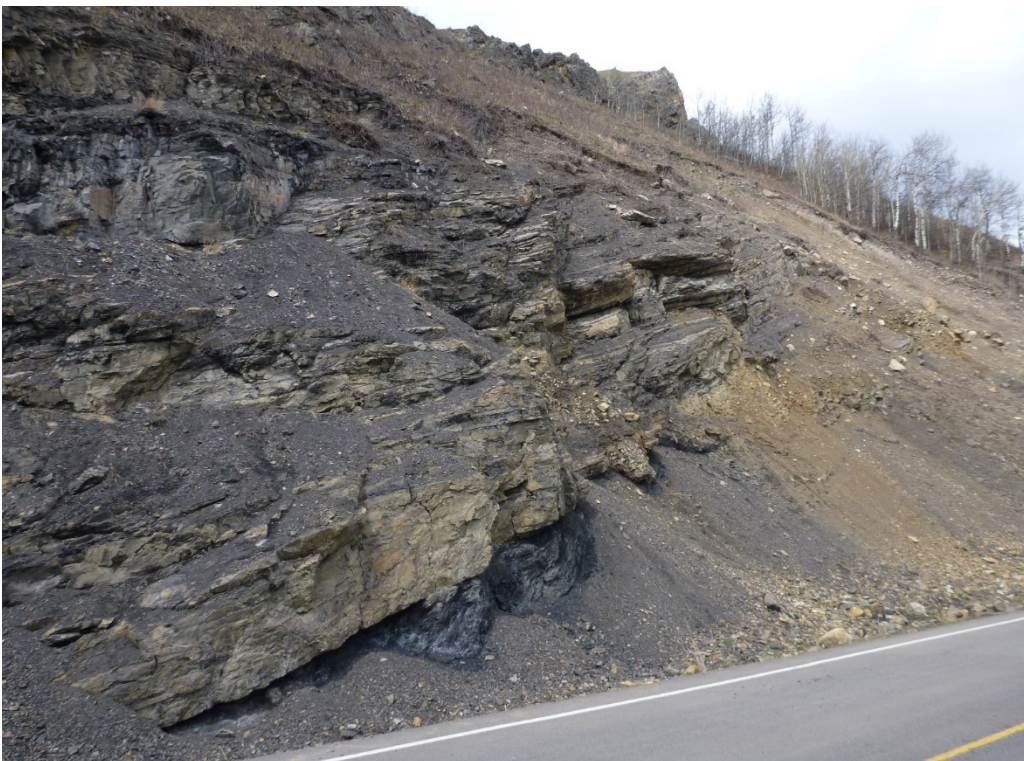
Photo 4 **Rock slope north of highway. Photo taken facing northeast on May 6, 2019.**

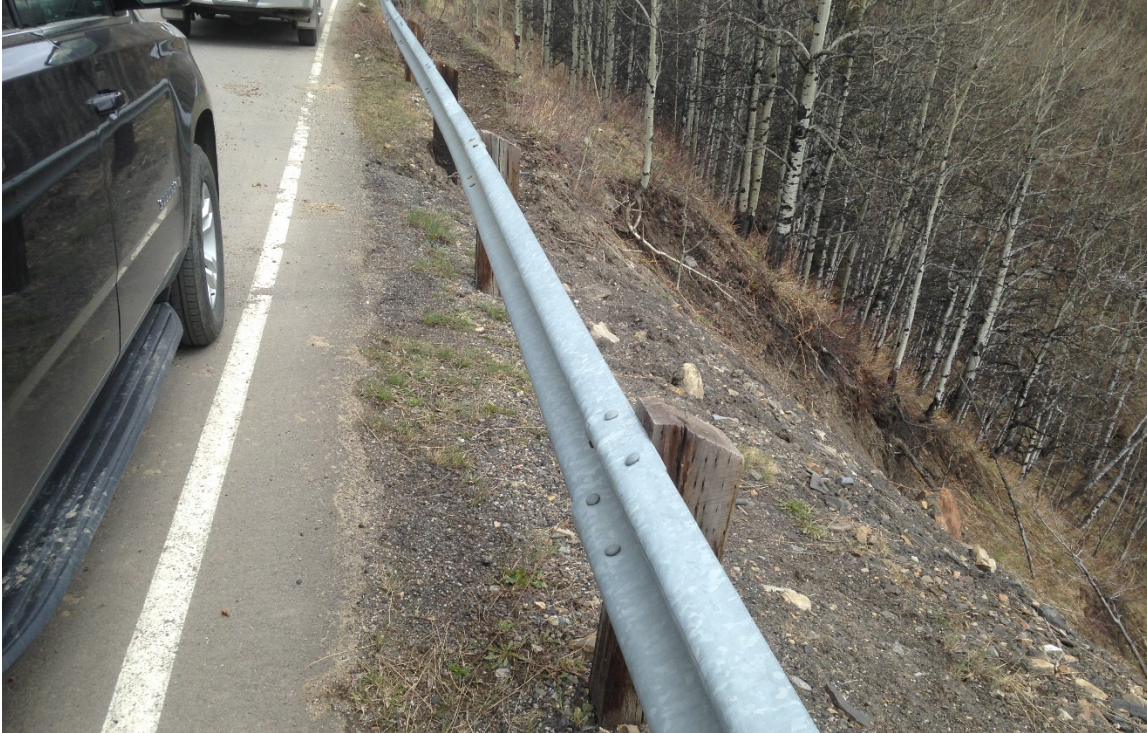
ITEM	CONDITION EXISTS		DESCRIPTION AND LOCATION	NOTICABLE CHANGE FROM LAST INSPECTION	
	YES	NO		YES	NO
Pavement Distress	X		Damage to pavement observed due to rockfalls.		
Slope Movement		X			
Erosion	X		Surface water runoff leading to slope erosion on southern side of highway.		
Seepage		X	None observed.		
Culvert Distress		X			
COMMENTS					
First visit to the site. Site will be monitored moving forward.					
Rock slope on north side of highway consists of folded and fractured sandstone and conglomerate with claystone layers. The toe ditch is shallow and rocks are falling onto the highway. A culvert under the road is present at the east end and is plugged with a rock.					
Surface runoff is eroding the slope south of the highway and erosion has reached the pavement edge.

Photo 5 Slope erosion south of highway. Photo was taken facing east on May 6, 2019.

- Clean out the toe ditch and unplug the culvert beneath the road to minimize runoff erosion into the existing erosion site.
