SITE NUMBER AND NAME: S056-I West Gorge Creek, West of Turner Valley		HIGHWAY & KM: Sheep River Road	PREVIOUS INSPECTION DATE: June 8, 2020	INSPECTION DATE: July 5, 2021
LEGAL DESCRIPTION: 15-29-019-05 W5M	NAD 83 COORDINATES: UTM Northing Easting 11 5612799 665797		RISK ASSESSMENT: PF: 13 CF: 10 TOTAL: 130	
MONTHLY AVERAGE DAILY TRAFFIC (MADT): May 2020 390 (west), 382 (east). (Ref. No. 55460220)			CONTRACTOR MAINTENANCE AREA (CMA): 27

NOTES: 1. HORIZONTAL DATUM: NAD83 2. GRID ZONE: UTM Zone 11N 3. IMAGE SOURCE: Bing Maps 2020, Microsoft Corporation.	CLIENT 	PROJECT SOUTHERN REGION GEOHAZARD RISK MANAGEMENT PROGRAM
		TITLE Site Plan S056-I West Gorge Creek Site I Sheep River Road
SCALE 1:1,000	PROJECT No. A05116A03	FIG No. 1

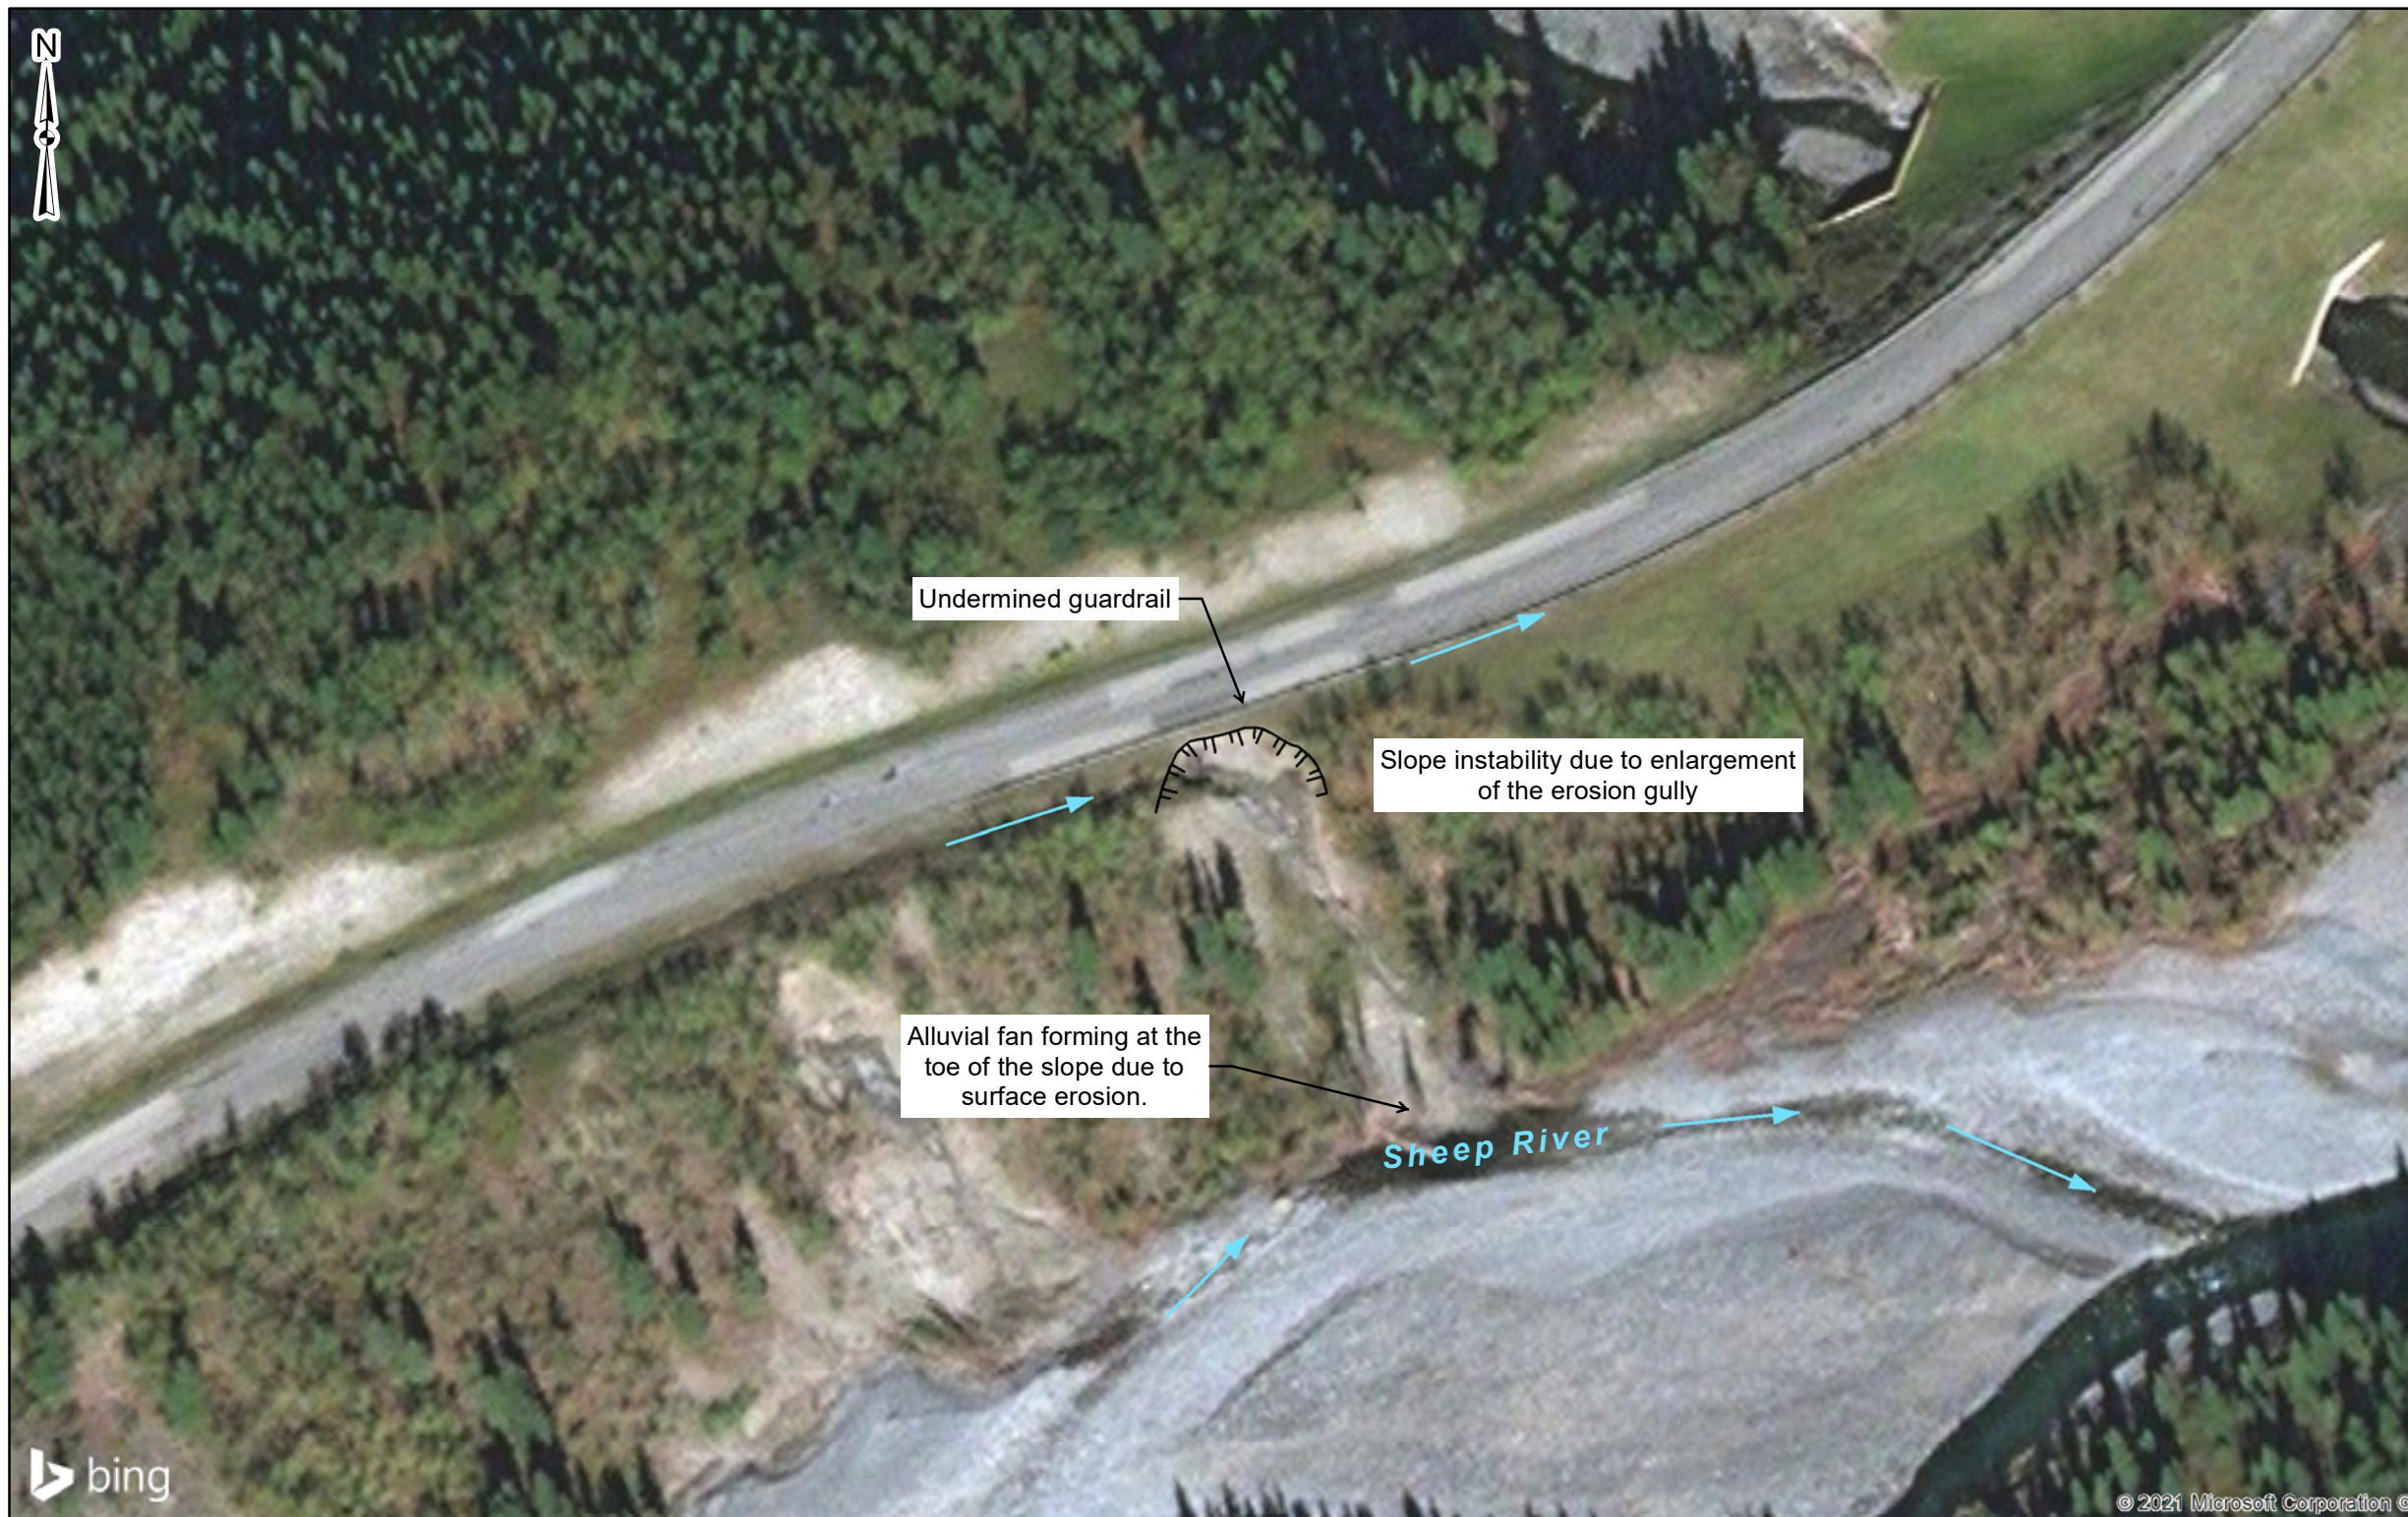
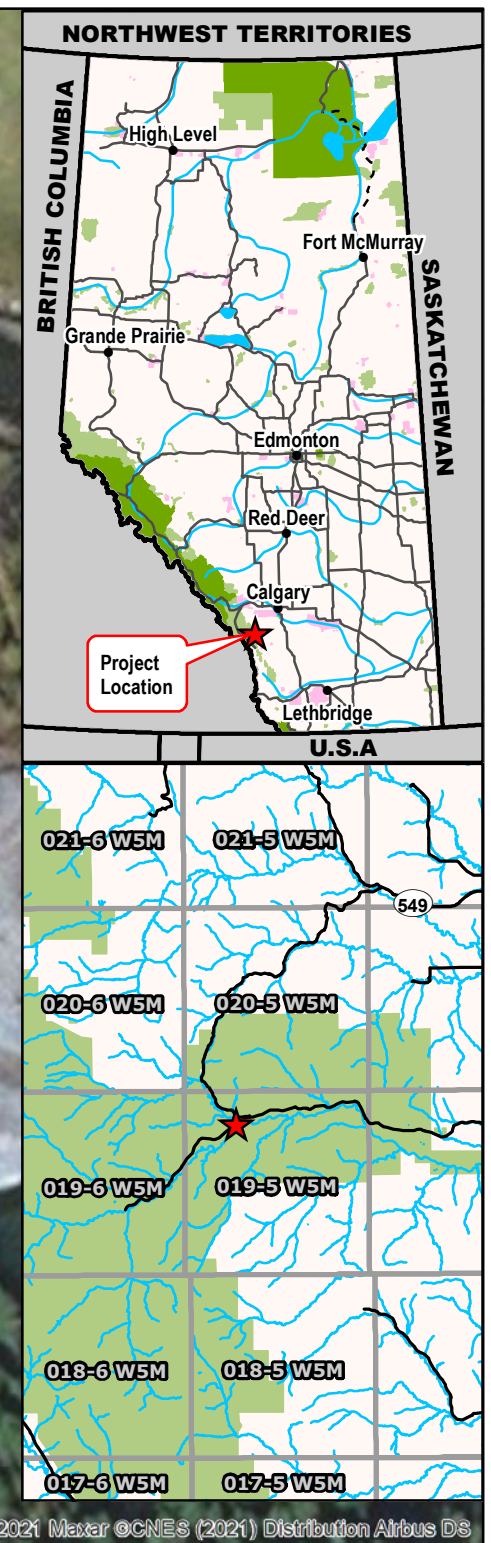
Undermined guardrail

Slope instability due to enlargement of the erosion gully

Alluvial fan forming at the toe of the slope due to surface erosion.

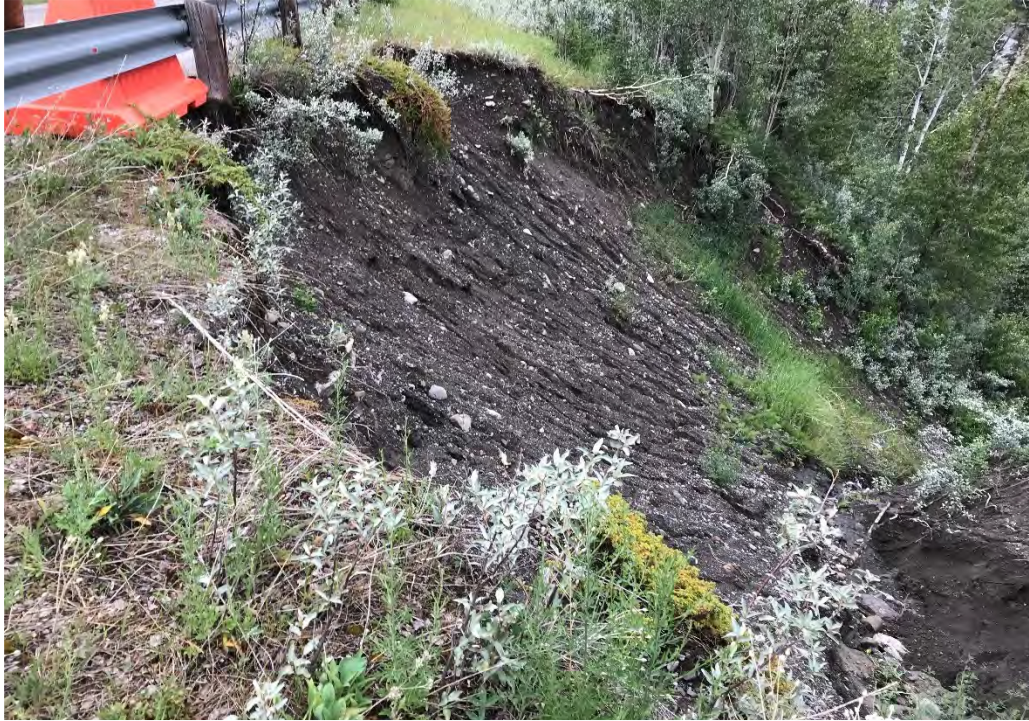
Photo 1 Head scarp on south side of Sheep River Road. Photo taken facing east on July 5, 2021.

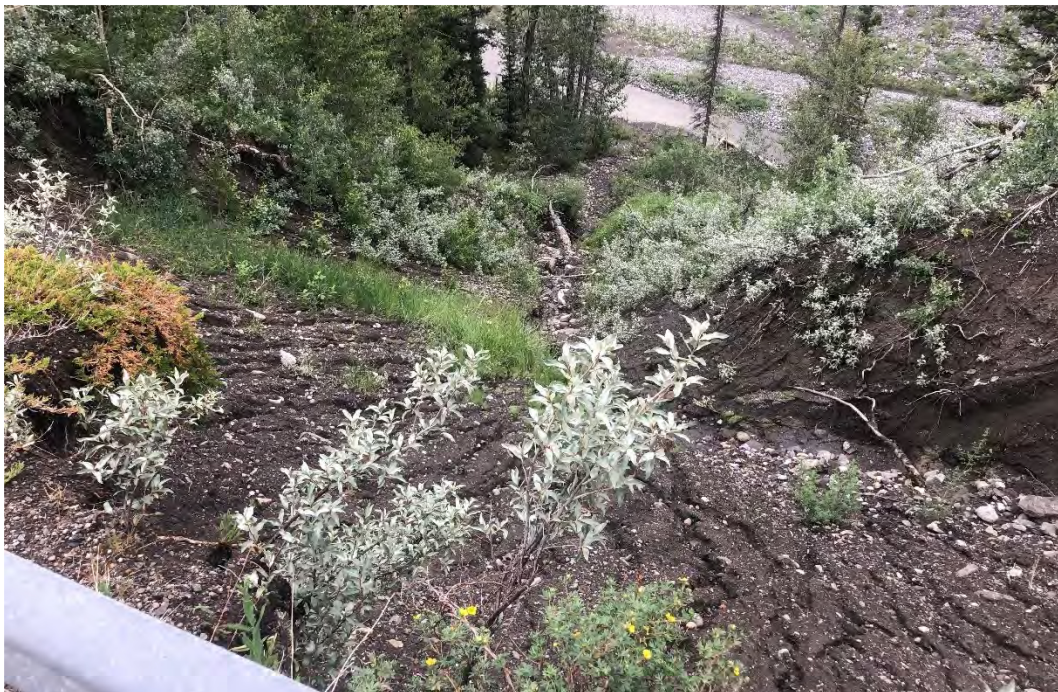
Slope erosion is depositing an alluvial fan in the Sheep River.

Photo 2 View from highway down the erosion gully. An alluvial fan is forming in the Sheep River due to erosion. Photo taken facing southeast on July 5, 2021.

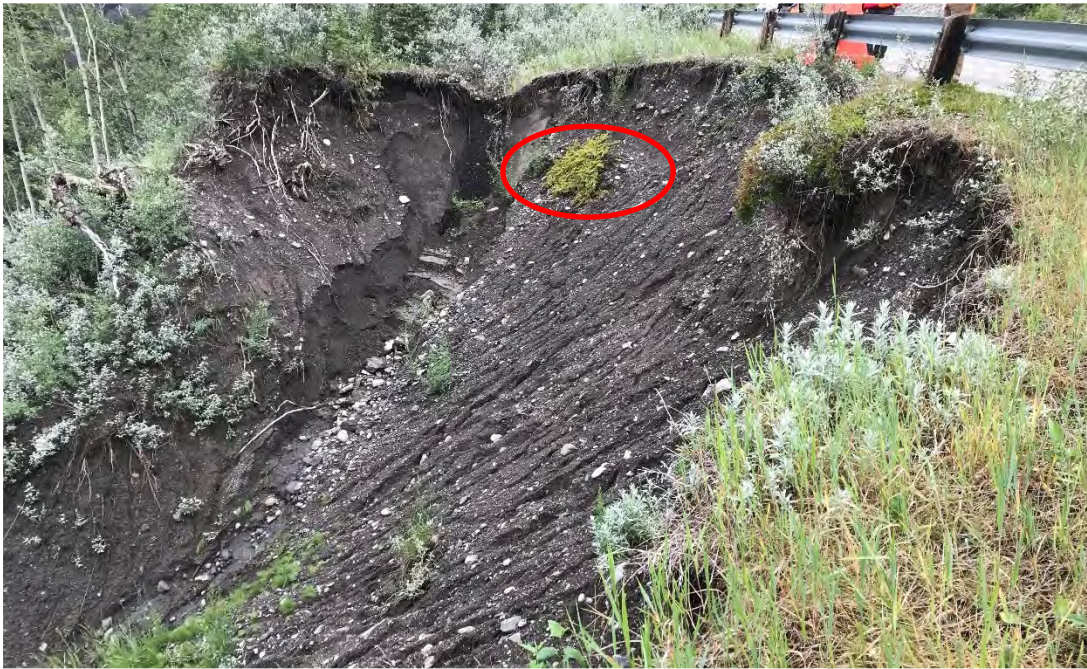
Photo 3 Ditch draining into failure area from the west. A bush has fallen into the erosion feature since 2020 (red circle). Photo taken facing west on July 5, 2021.

- Diversion of the south ditch to the north side of the highway with a cross culvert;
- Relocation of the highway north, possibly including steepening of the north slope, and improvements to surface water drainage; or
- Repair of the erosion gully using a geogrid reinforced embankment, a timber crib wall, a lock block retaining wall, or a gabion basket wall. A stable foundation will be needed to provide a working surface for construction.

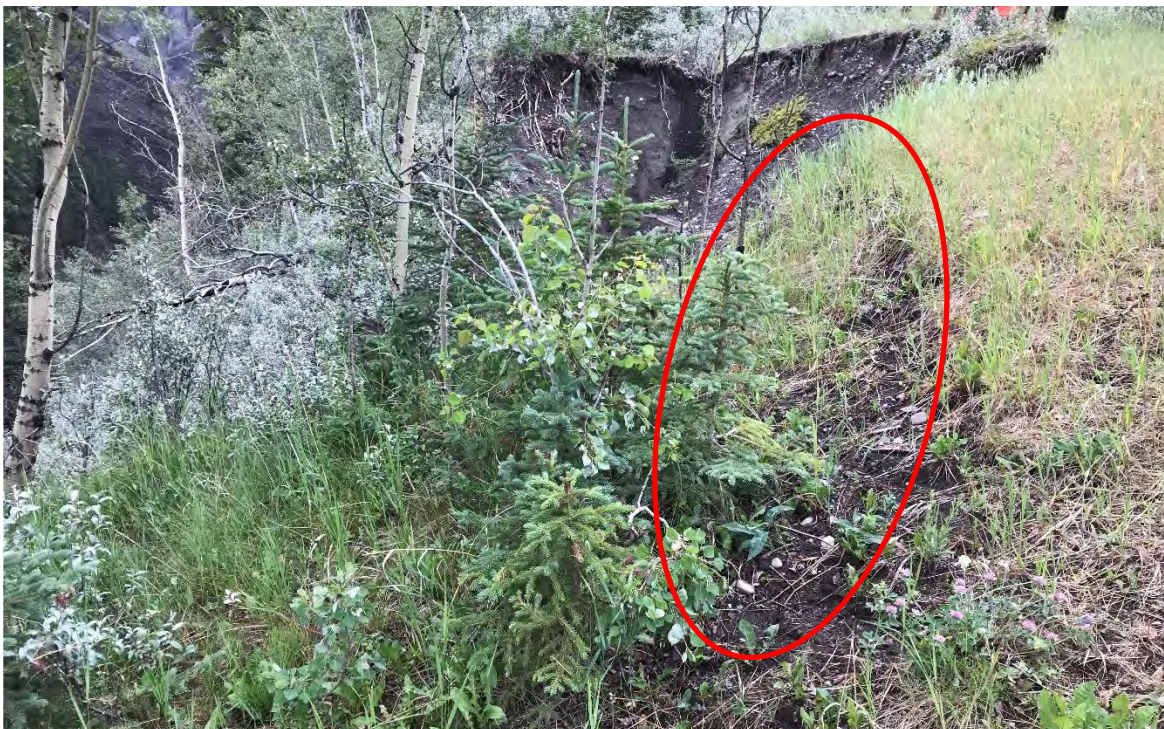
Tension cracking and slumping was observed on the left (east) flank of the slope failure in 2020. The ground surface had dropped by up to 0.15 m and is expected to eventually slide into the erosion feature, enlarging the disturbed area. There is one fallen sapling but overall, there was no significant change observed in this area when compared to 2020 observations.

Photo 4 Slumping of the bank on the left flank due to ongoing erosion. Photo taken facing northwest on July 5, 2021.
