SITE NUMBER AND NAME: <b>S056-IV West Gorge Creek, West of Turner Valley</b>		HIGHWAY & KM: Sheep River Road	PREVIOUS INSPECTION DATE: May 6, 2019	INSPECTION DATE: <b>July 5, 2021</b>
LEGAL DESCRIPTION: 12-36-019-05 W5M	NAD 83 COORDINATES: UTM Northing Easting 11 5614130 671333		RISK ASSESSMENT: PF: 13 CF: 3 TOTAL: 39 (Rockfall)	
MONTHLY AVERAGE DAILY TRAFFIC (MADT): June 2017 360 (west), 300 (east). (Ref. No. 55460220)			CONTRACTOR MAINTENANCE AREA (CMA): 27

SUMMARY OF SITE INSTRUMENTATION:  None  LAST READING DATE: N/A	INSPECTED BY: Chris Gräpel (KCB) Chris Morgan (KCB) Alex Frotten (AT) Roger Skirrow (AT)
PRIMARY SITE ISSUE: Rock slope adjacent to the highway with ongoing sloughing. Rocks from the slope are falling onto the road.	
APPROXIMATE DIMENSIONS: Rock face north of highway is approximately 120 m long. On the south side of the highway, surface runoff erosion has undermined the safety barrier in one location.	
DATE OF ANY REMEDIAL ACTION: N/A

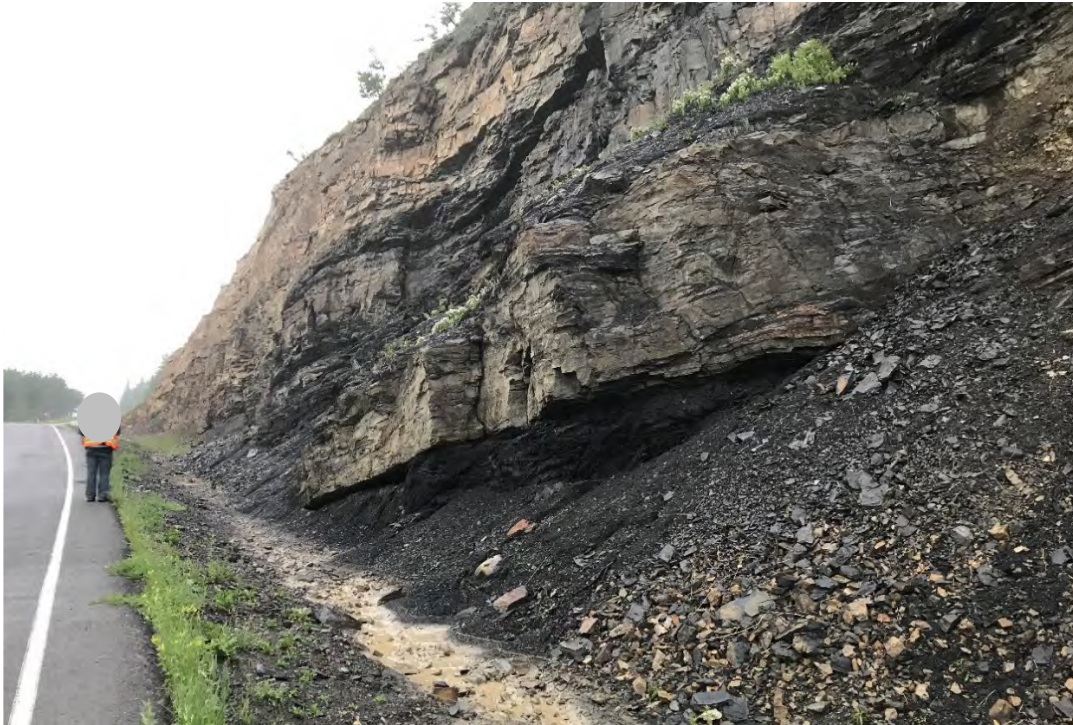
**Photo 1** Rock slope north of highway. Photo was taken facing west on July 5, 2021.

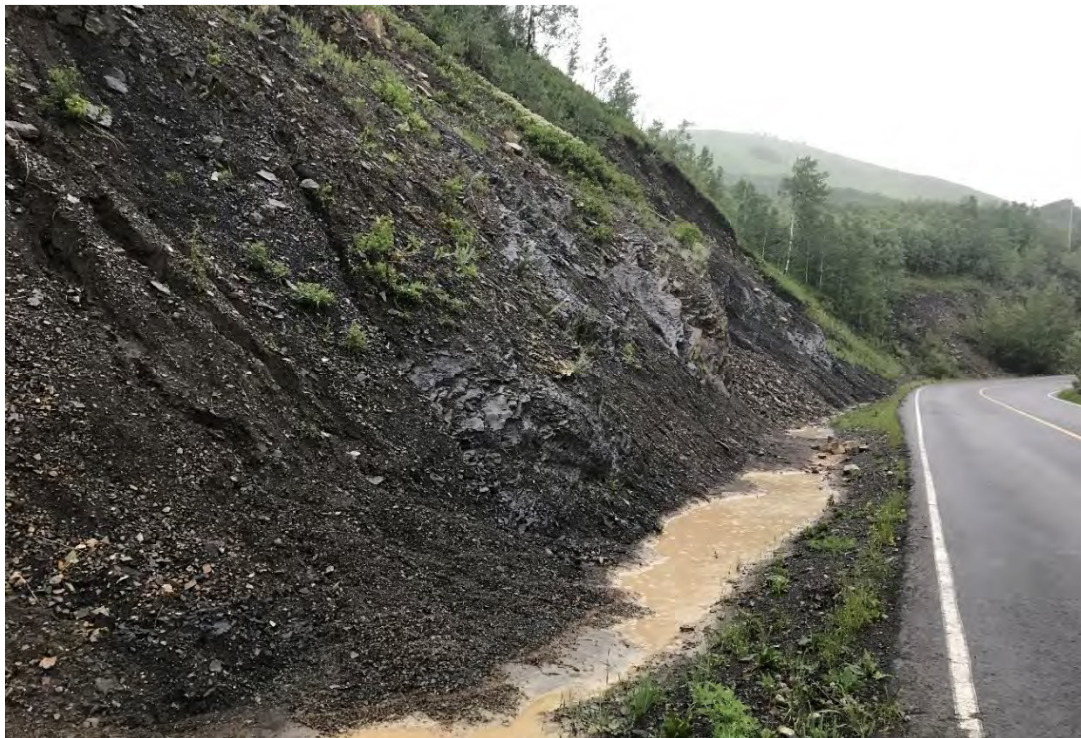
**Photo 2** Rock slope north of highway. Rock fall ditch appeared to have been cleaned out recently. Photo was taken facing east on July 5, 2021.

- Clean out the toe ditch regularly to maintain storage capacity for future rockfalls; and
- Unplug the culvert beneath the road to minimize runoff erosion at the existing erosion site.

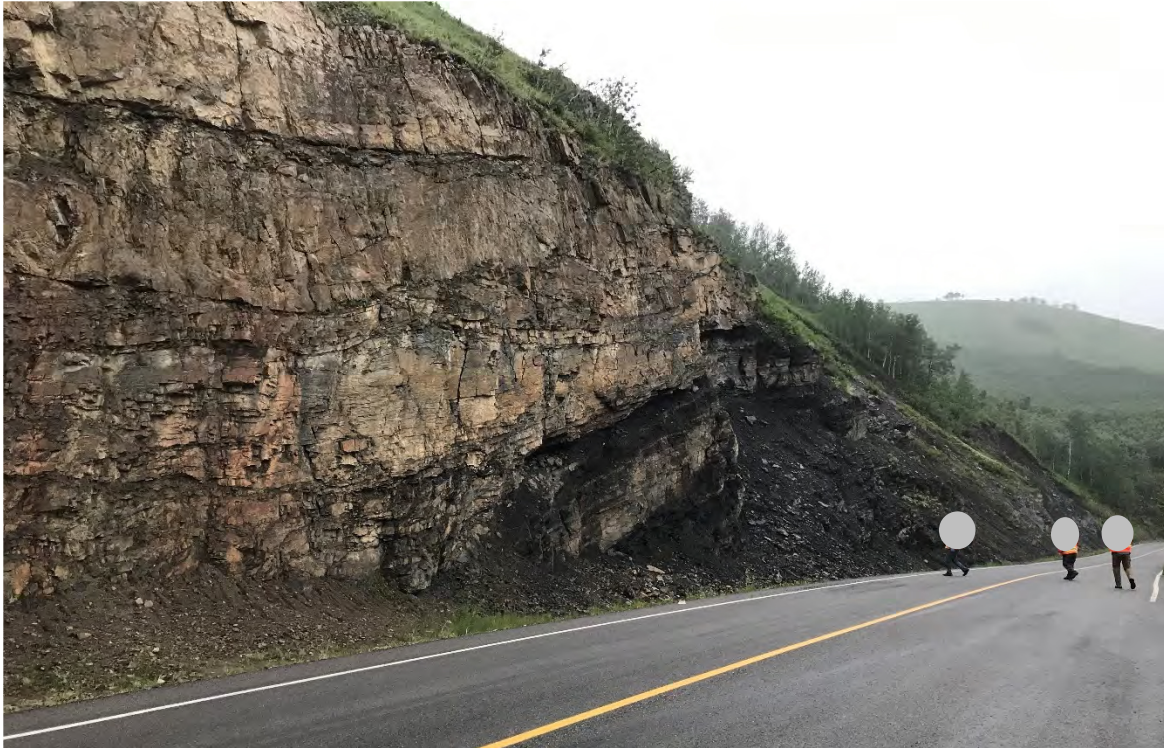
<b>COMMENTS</b>
The rock slope on the north side of the highway consists of folded and fractured sandstone and conglomerate with claystone layers. The toe ditch is shallow and rocks are falling onto the highway. Rock blocks up to 0.7 m x 0.4 m x 0.5 m are present in the ditch.
During the 2021 inspection, it appeared that the toe ditch below the rock slope had recently been cleaned out. The excavated material had been stockpiled near a pull-out to the west of the site.
The MCI reported that rock falls appeared to be increasing in frequency and that the ditch was being cleaned out regularly.
A culvert under the road is present at the east end and is plugged with a rock.
Surface runoff from the highway is eroding the slope on the south side of the highway. Erosion has undermined the safety barrier and reached the pavement edge at one location, but no pavement distress was visible in 2021.

**Photo 3** Rock slope north of highway. Photo taken facing northeast on July 5, 2021.

- Rock slope analysis to evaluate rockfall potential and routes;
- Scaling of portions of the rock slope where the rock slope is directly adjacent to the road to create a rock fall ditch; and
- Installation of rockfall fence partway up the rock slope to catch rocks with the potential to bounce onto the roadway.

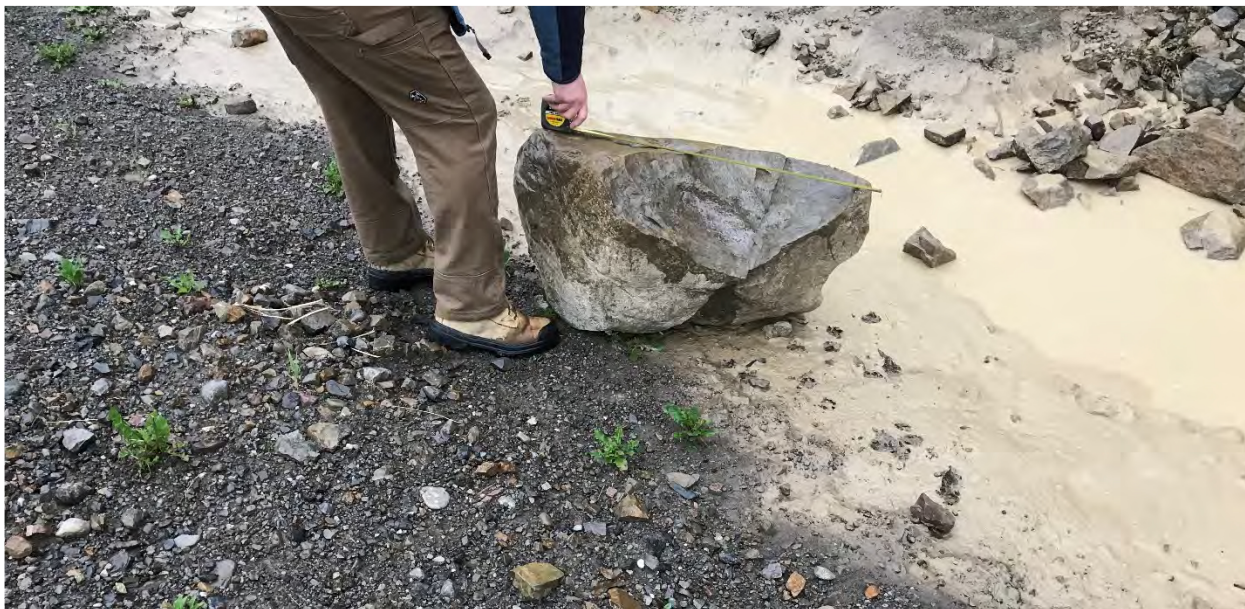
**Photo 4** Rock block in the ditch on the north side of the highway. Photo taken on July 5, 2021.

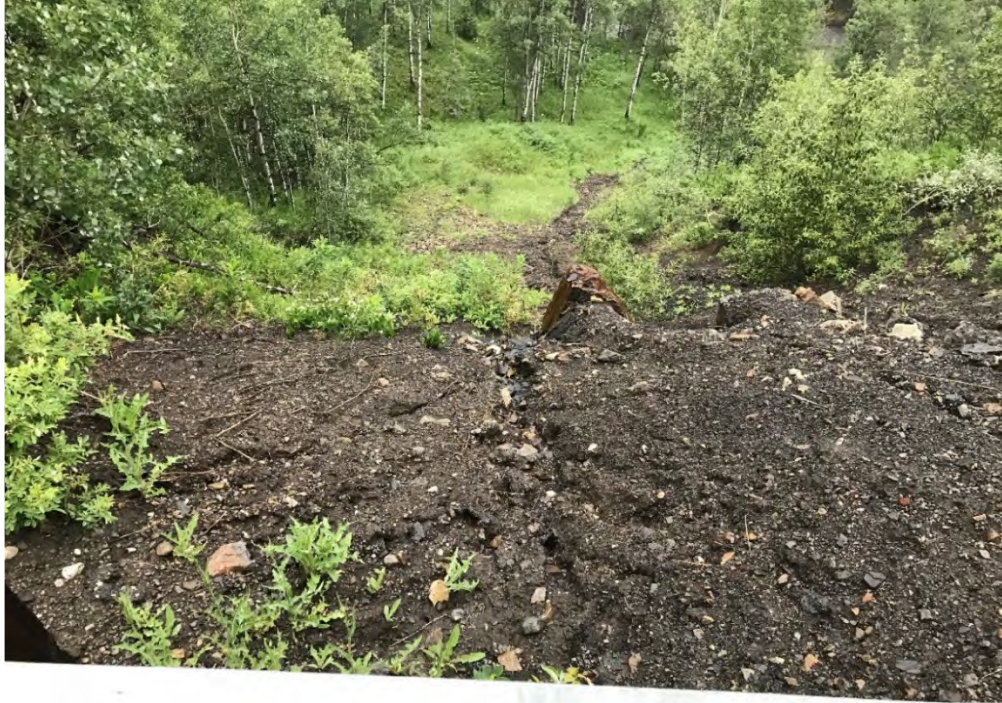
**Photo 5** Surface runoff erosion on the south side of highway has undermined the safety barrier and reached the pavement edge. There was no evidence of pavement crack during the 2021 inspection. Photo taken facing south on July 5, 2021.

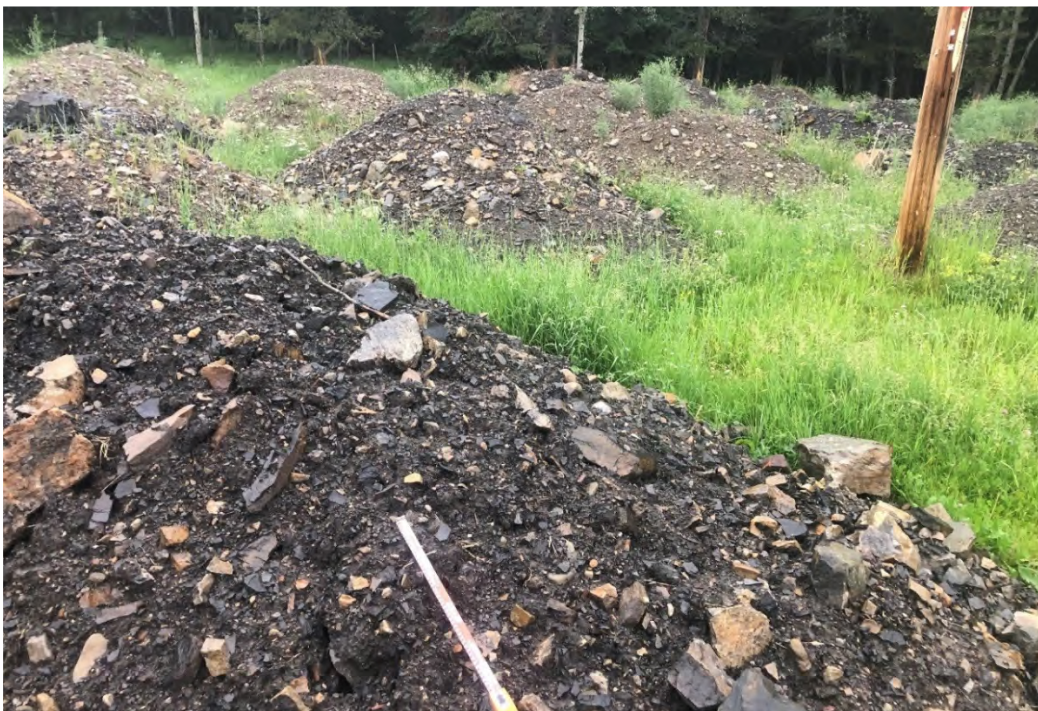
**Photo 6** Rock fall debris from ditch cleanup has been stockpiled in an area to the west of the site. Photo taken on July 5, 2021.
