SITE NUMBER AND NAME: <b>S056-I West Gorge Creek Steep Slope Slides</b>		HIGHWAY & KM: 25002:02 7.693	PREVIOUS INSPECTION DATE: July 5, 2021	INSPECTION DATE: <b>May 16, 2022</b>
LEGAL DESCRIPTION: 15-29-019-05 W5M	NAD 83 COORDINATES: UTM Northing Easting 11 5612799 665797		RISK ASSESSMENT: PF: 12 CF: 10 TOTAL: 120	
MONTHLY AVERAGE DAILY TRAFFIC (MADT): May 2020 390 (west) & 382 (east) (Reference No. 55460220)			CONTRACTOR MAINTENANCE AREA (CMA): 27

PROJECT SOUTHERN REGION GEOHAZARD RISK MANAGEMENT PROGRAM		
TITLE Site Plan S056-1 - West of Gorge Creek Steep Slope Slides Hwy 25002:02, km 7.693		
SCALE 1:1,500	PROJECT No. A05116A03	FIG No. 1

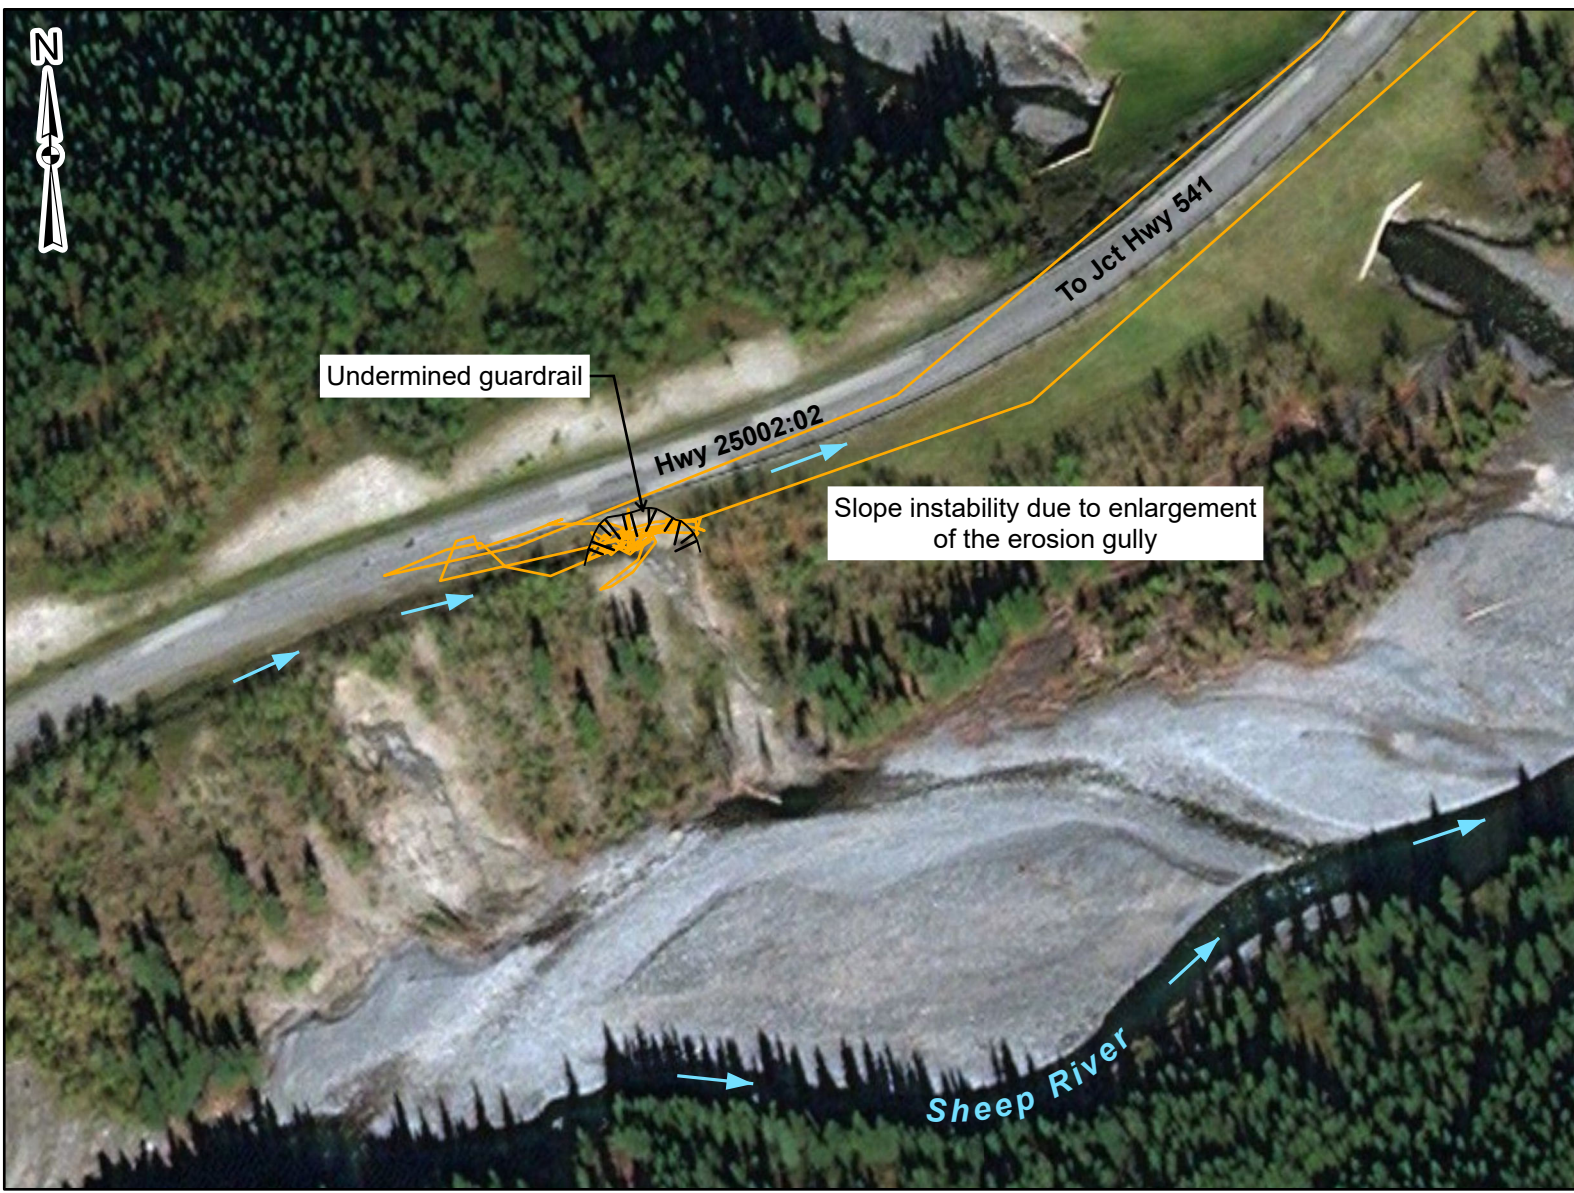
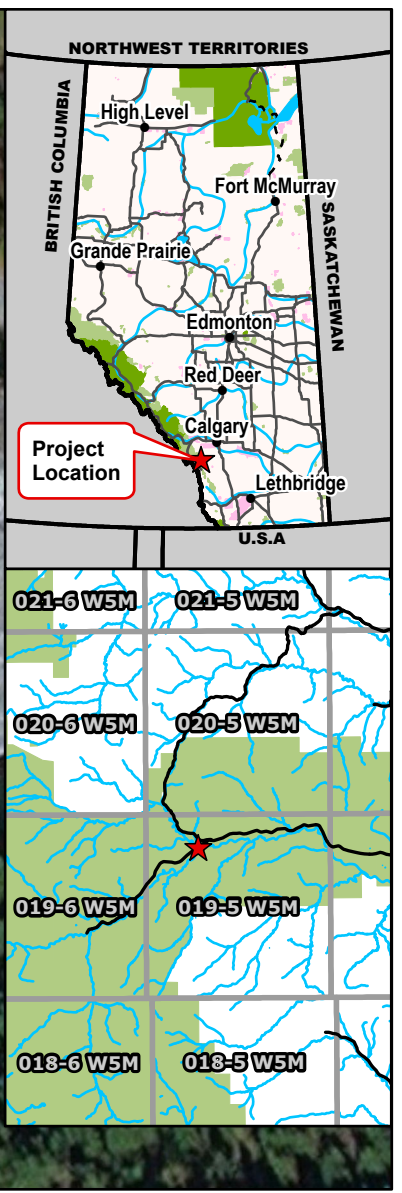
Undermined guardrail

Slope instability due to enlargement of the erosion gully

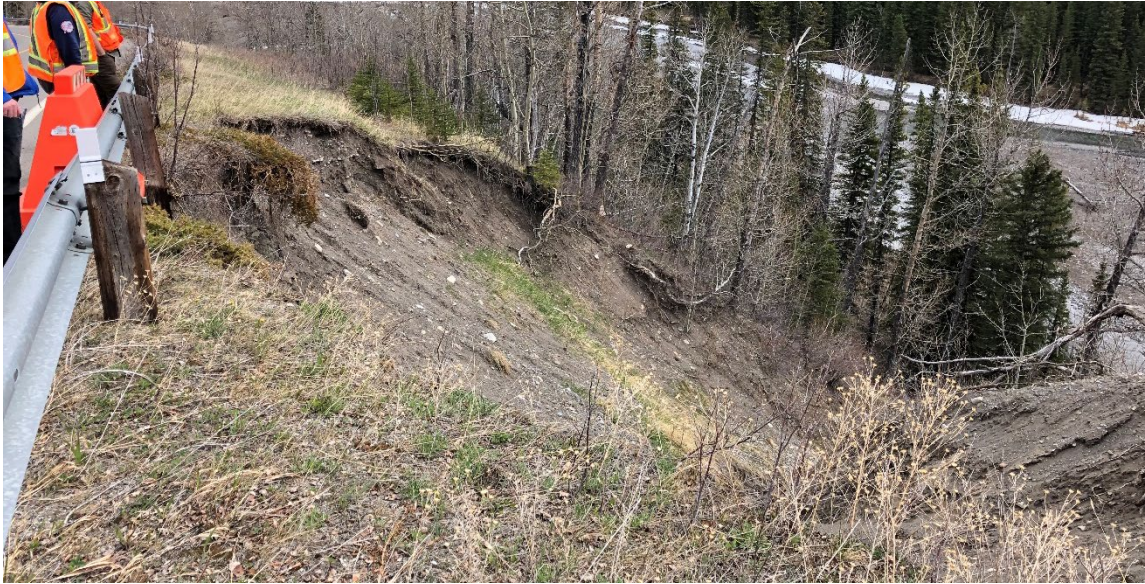
<b>COMMENTS</b>
Steep slope at approximately 2H:1V, with no vegetative cover in the slide area. The highway ditch on the right (west) flank of the slide is draining directly onto the slide area. The slope failure will continue to encroach on the highway surface and guard rail with continued erosion due to the ditch discharge.
A seepage zone was observed during the 2021 inspection, approximately halfway down the slope at a bedrock outcrop. The seepage zone appeared dry during the 2022 inspection.
Between the 2021 and 2022 inspection, the slope failure has continued to expand to the west (upslope) and vegetation is falling into the erosion feature. In addition to expanding westwards, the overall slope of the erosion feature is flattening in the upper section as the feature deepens and ongoing erosion continues to remove sediment. Erosion has exposed a sedimentary rock ledge on the west side.
The back scarp has retrogressed to within 0.5 m of the highway and the guardrail continues to be undermined. A plastic jersey barrier has been placed north of the guard rail to protect road users (Photo 1). No deflection of the

**Photo 1** Failure area located on the downslope side of Sheep River Road. Photo taken May 16, 2022, facing east.

<p><u>Maintenance/Repair/Monitoring Recommendations:</u></p> <ul style="list-style-type: none"> <li>• The surface water flow into the slide area from the south (eastbound) ditch should be diverted away from the slide area. A cross culvert could divert flow beneath the highway into the north (westbound) ditch.</li> <li>• The slope could be stabilized using either geogrid reinforced granular fill with a timber crib wall, a lock block retaining wall, or a gabion basket wall constructed at the toe of the slide zone on stable ground. A geotechnical investigation and laboratory testing program should be completed to assess subsurface conditions to support design and construction work.</li> <li>• If slope stabilization is not feasible, the highway could potentially be realigned further north, which would require steepening of the north slope. Drainage improvement would also be required to divert surface water runoff from the slide area.</li> </ul>

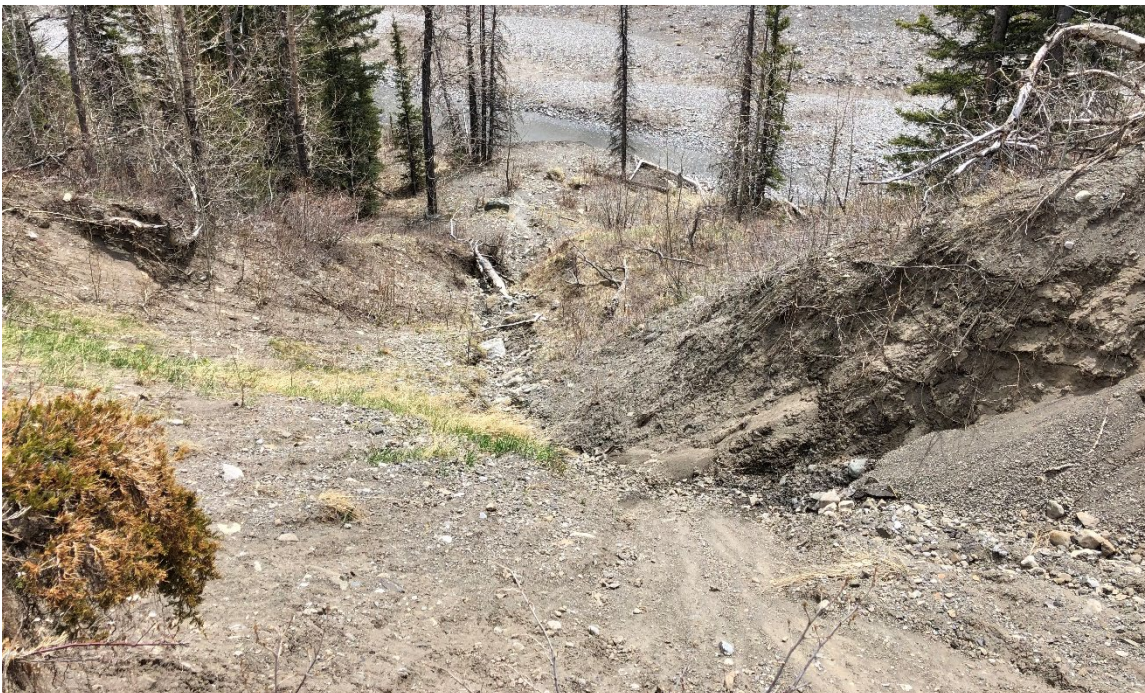
<p>barrier was noted.</p>
<p>Slope erosion appears to be depositing an alluvial fan in the Sheep River (Photo 2).</p>
<p>There is a wooden stake and a rock painted orange present upstream of the right flank used to estimate the gully retrogression. At the time of the 2022 inspection, the wooden stake was 1.7 m from the edge of the right flank (Photo 3).</p>
<p>During the 2020 inspection, tension cracking and slumping was first observed on the left (east) flank of the slope failure (Photo 4). Between the 2021 and 2022 inspections, the ground surface appears to have dropped approximately 0.30 m (0.45 m since 2020) and a tree had fallen down the slope. The area is expected to eventually fail into the erosion feature downslope, enlarging the disturbed area.</p>
<p>During the 2022 inspection, a potential bank swallow nest was observed in the back slope.</p>
<p>The ongoing toe erosion from the river and surface water runoff from the highway ditch are causing the erosion feature to enlarge and will eventually lead to undermining of the pavement, surface cracking, and a dip that will require extensive repairs, including a possible shift of the road to the north.</p>

**Photo 2** View from highway of the erosion gully, facing downslope. An alluvial fan is forming in the Sheep River due to ongoing erosion. Photo taken May 16, 2022, facing southeast.

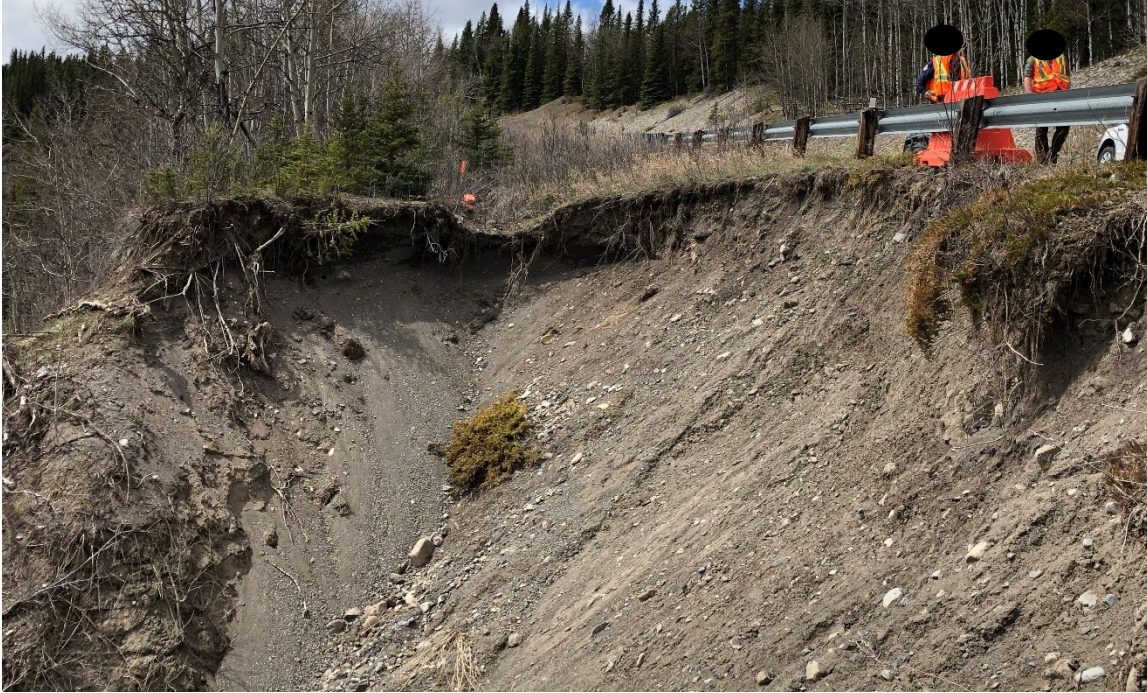
**Photo 3** The south (eastbound) ditch is diverting flows into failure area. A painted wooden stake is approximately 1.7 m from the edge of the right (west) flank. Photo taken May 16, 2022, facing west.

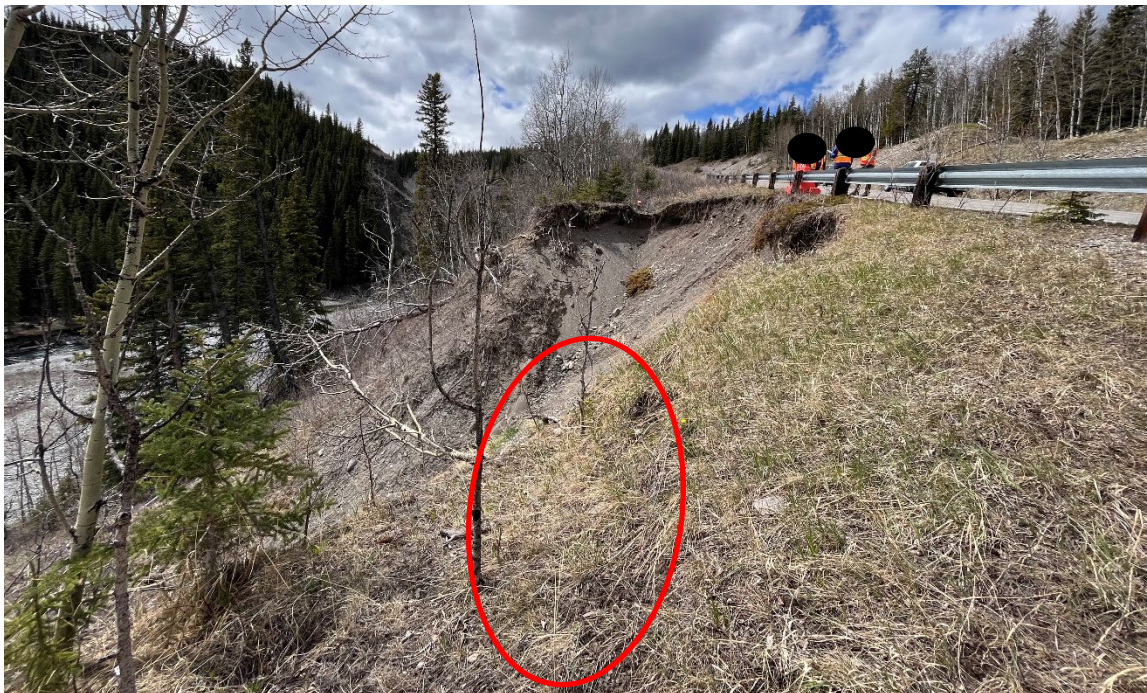
**Photo 4** Slumping of the bank on the left (east) flank due to ongoing erosion (indicated by red circle). Photo taken May 16, 2022, facing southwest.
