SITE NUMBER AND NAME: S056-I West Gorge Creek Steep Slope Slides		HIGHWAY & KM: 25002:02 7.693	PREVIOUS INSPECTION DATE: May 16, 2022	INSPECTION DATE: May 28, 2024
LEGAL DESCRIPTION: 15-29-019-05 W5M	NAD 83 COORDINATES: UTM Northing Easting 11 5612799 665797		RISK ASSESSMENT: PF: 12 CF: 10 TOTAL: 120	
MONTHLY AVERAGE DAILY TRAFFIC (MADT): May 2024 242 (west) & 232 (east) (Reference No. 55460220)			CONTRACTOR MAINTENANCE AREA (CMA): 27

PROJECT		
SOUTHERN REGION GEOHAZARD RISK MANAGEMENT PROGRAM		
TITLE		
Site Plan		
S056-1 - West of Gorge Creek Steep Slope Slides Hwy 25002:02, km 7.693		
SCALE	PROJECT No.	FIG No.
1:1,500	A05116A03	1

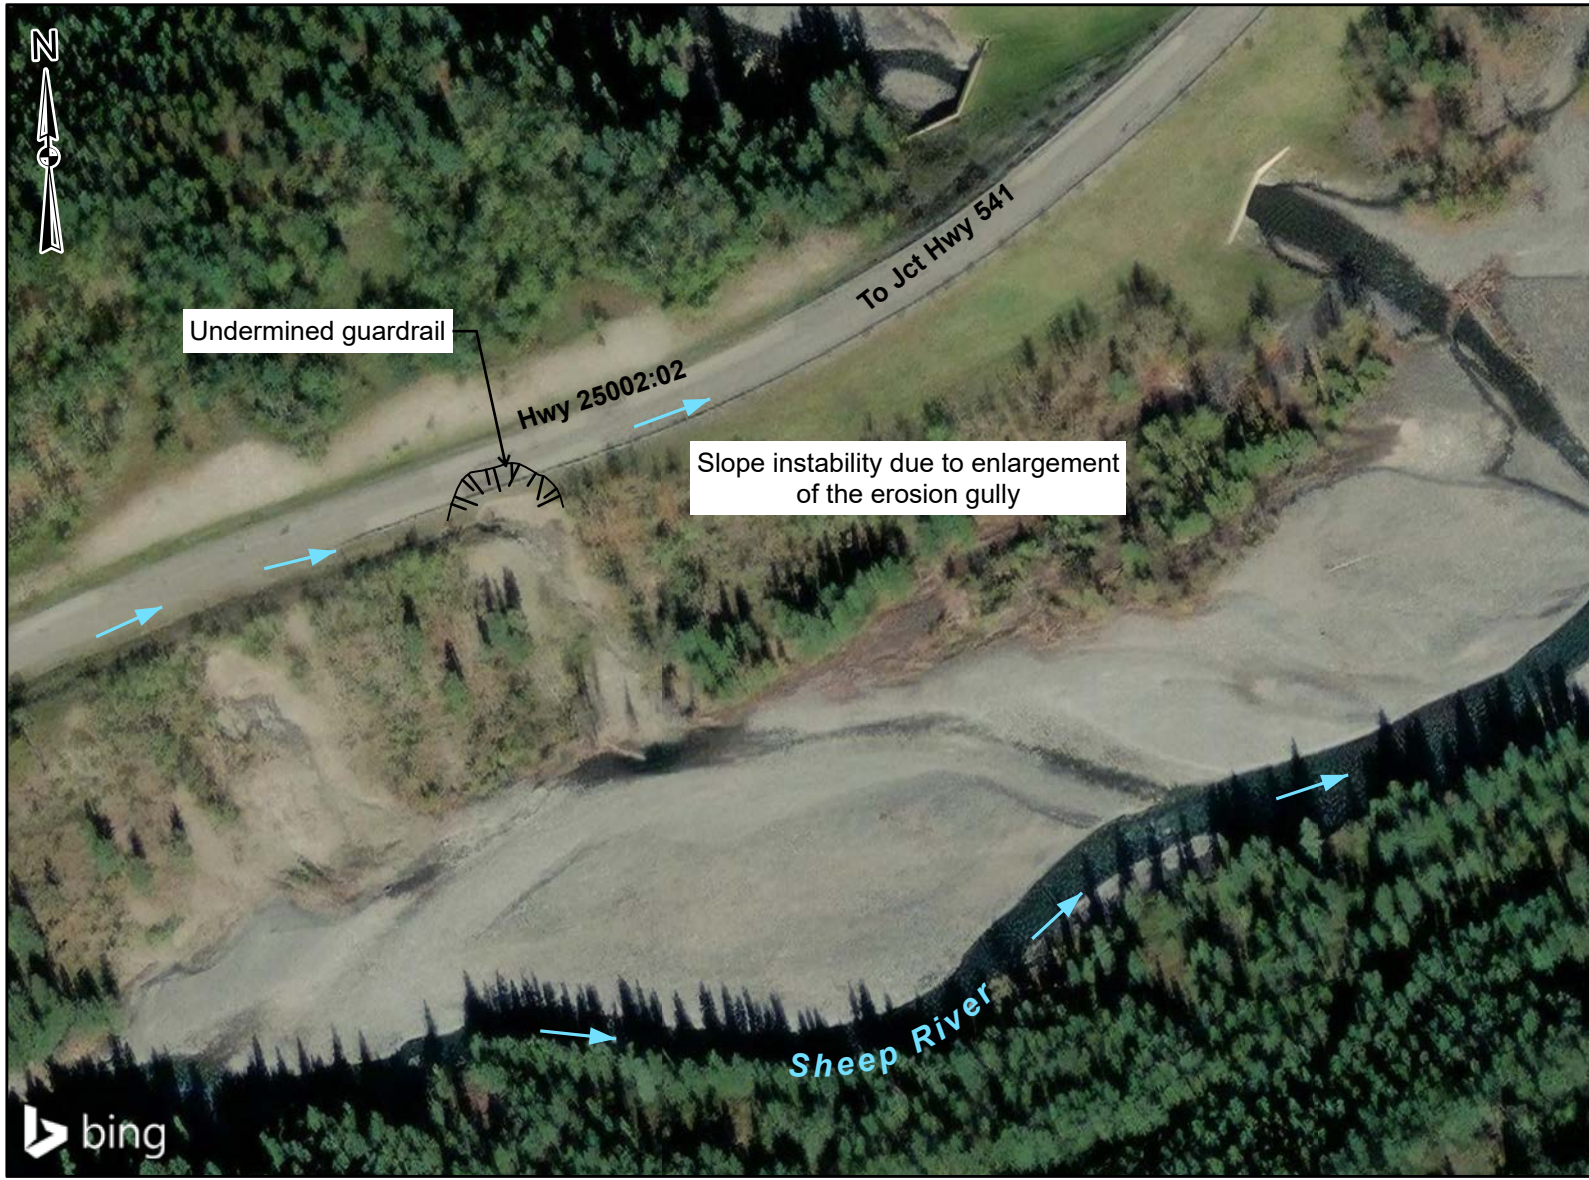
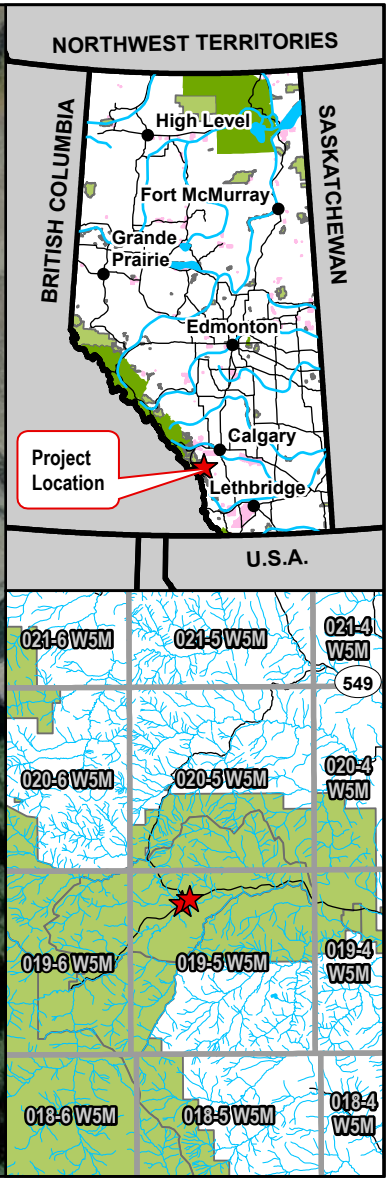
PRIMARY SITE ISSUE: Slope failure on the south side of the highway due to surface runoff erosion and groundwater. The highway is located at the crest of a steep valley slope above Sheep Creek River. The southern ditch has been undermined and is draining directly into the slide zone. Head scarp has reached the south edge of the highway.

APPROXIMATE DIMENSIONS: Head scarp is approximately 15 m wide at the crest of a 40 m to 50 m high slope above Sheep River. Approximately 1/3 of the way down the slope, the failure area narrows to a 3 m to 5 m wide erosion gully.

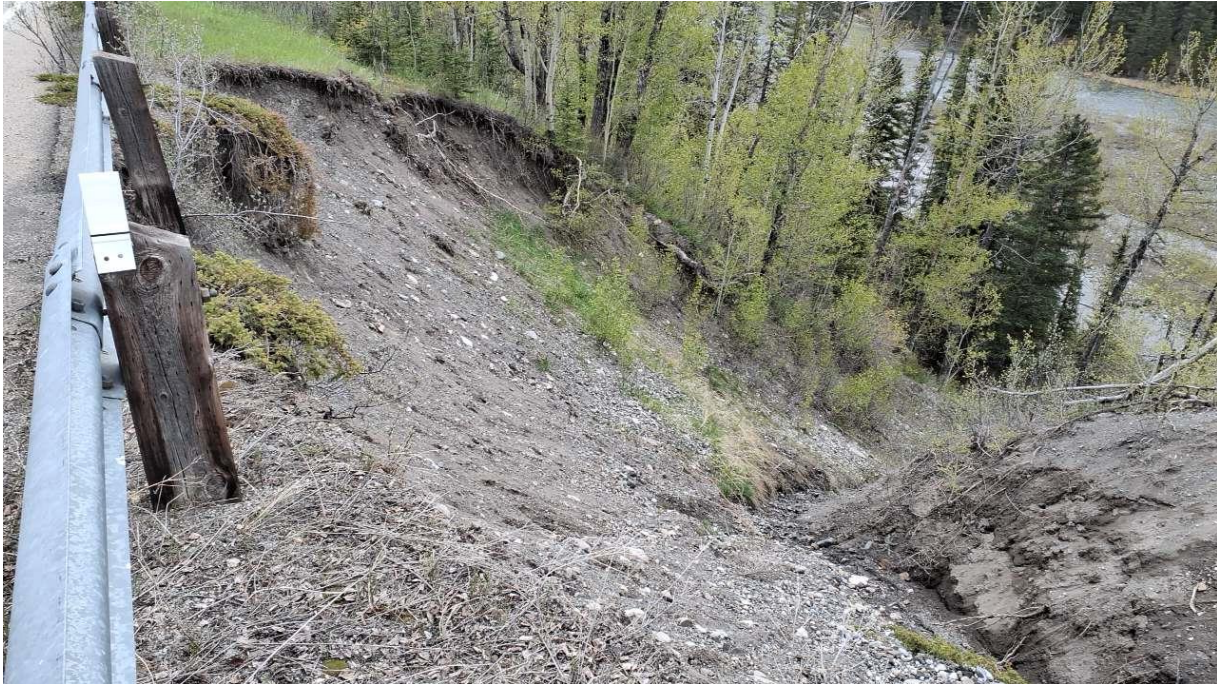
Photo 1 Failure area located on the downslope side of Sheep River Road. Photo taken May 28, 2024, facing east.

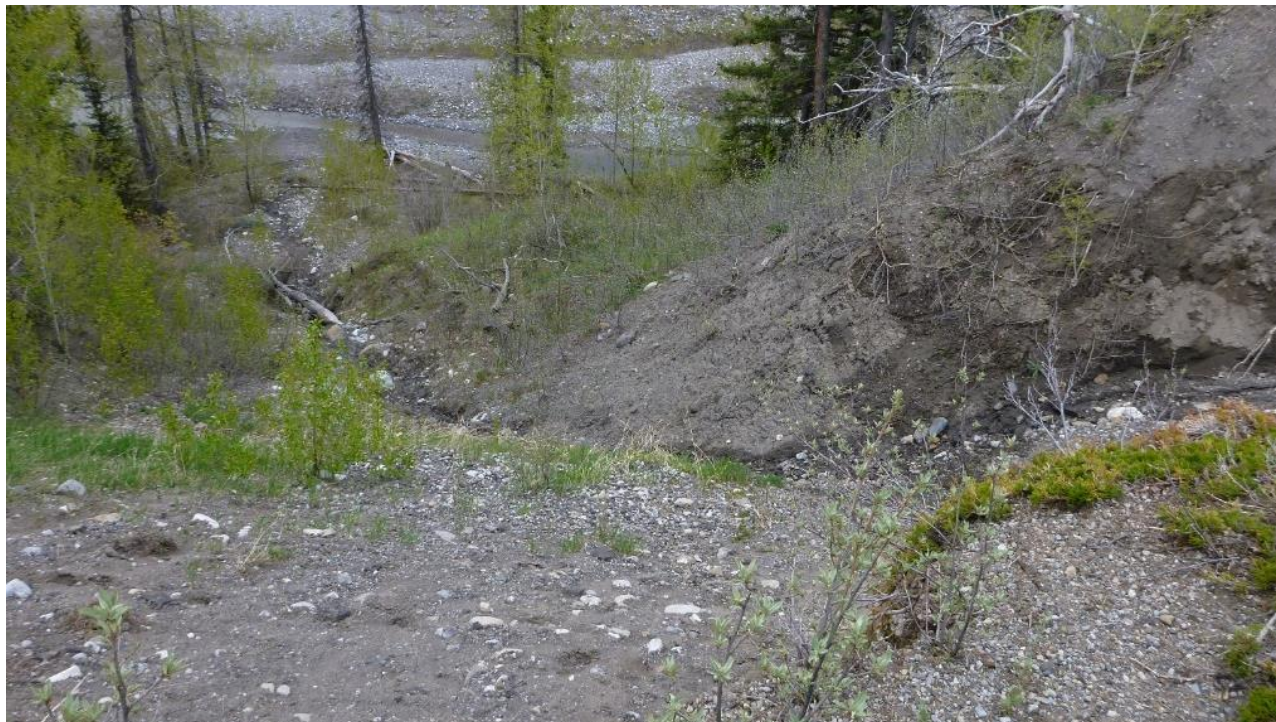
Photo 2 View from highway of the erosion gully, facing downslope. An alluvial fan is forming in the Sheep River due to ongoing erosion. Photo taken May 28, 2024, facing south.

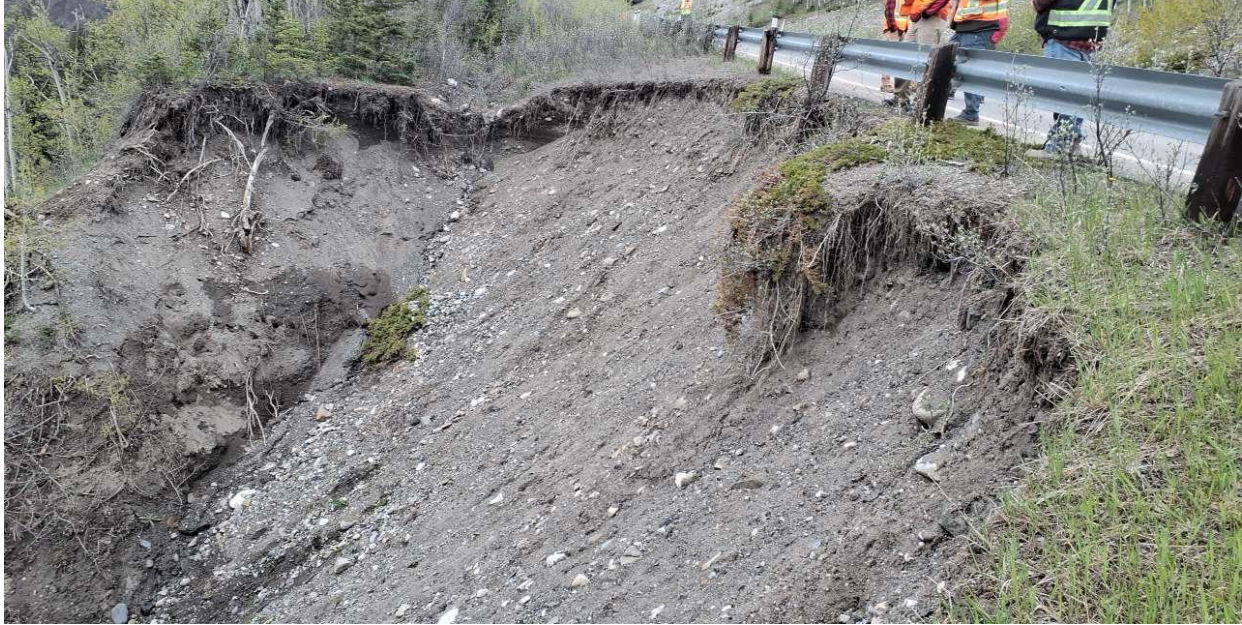
Steep slope at approximately 2H:1V, with no vegetative cover in the slide area. The highway ditch on the right (west) flank of the slide is draining directly onto the slide area. The slope failure will continue to encroach on the highway surface and guard rail with continued erosion due to the ditch discharge.

Photo 3 The south (eastbound) ditch is diverting flows into failure area. A painted wooden stake is approximately 1.7 m from the edge of the right (west) flank. Photo taken May 28, 2024, facing west.

<p>Maintenance/Repair/Monitoring Recommendations:</p> <ul style="list-style-type: none"> • The surface water flow into the slide area from the south (eastbound) ditch should be diverted away from the slide area. A cross culvert could divert flow beneath the highway into the north (westbound) ditch. • The slope could be stabilized using either geogrid reinforced granular fill with a timber crib wall, a lock block retaining wall, or a gabion basket wall constructed at the toe of the slide zone on stable ground. A repair design is in progress and this site is tentatively scheduled for construction in 2025.
<p>This report is an instrument of service of Klohn Crippen Berger (KCB). The report has been prepared for the exclusive use of Alberta Transportation and Economic Corridors (Client) for the specific application to the Southern Region Geohazard Risk Management Program (Contract No. CON0022161) and it may not be relied upon by any other party without KCB's written consent.</p> <p>KCB has prepared this report in a manner consistent with the level of care, skill and diligence ordinarily provided by members of the same profession for projects of a similar nature at the time and place the services were rendered. KCB makes no warranty, express or implied.</p> <p>Use of or reliance upon this instrument of service by the Client is subject to the following conditions:</p> <ol style="list-style-type: none"> (i) The report is to be read in full, with sections or parts of the report relied upon in the context of the whole report. (ii) The observations, findings and conclusions in this report are based on observed factual data and conditions that existed at the time of the work and should not be relied upon to precisely represent conditions at any other time. (iii) The report is based on information provided to KCB by the Client or by other parties on behalf of the client (Client-supplied information). KCB has not verified the correctness or accuracy of such information and makes no representations regarding its correctness or accuracy. KCB shall not be responsible to the Client for the consequences of any error or omission contained in Client-supplied information. (iv) KCB should be consulted regarding the interpretation or application of the findings and recommendations in the report. (v) This report is electronically signed and sealed and its electronic form is considered the original. A printed version of the original can be relied upon as a true copy when supplied by the author or when printed from its original electronic file.

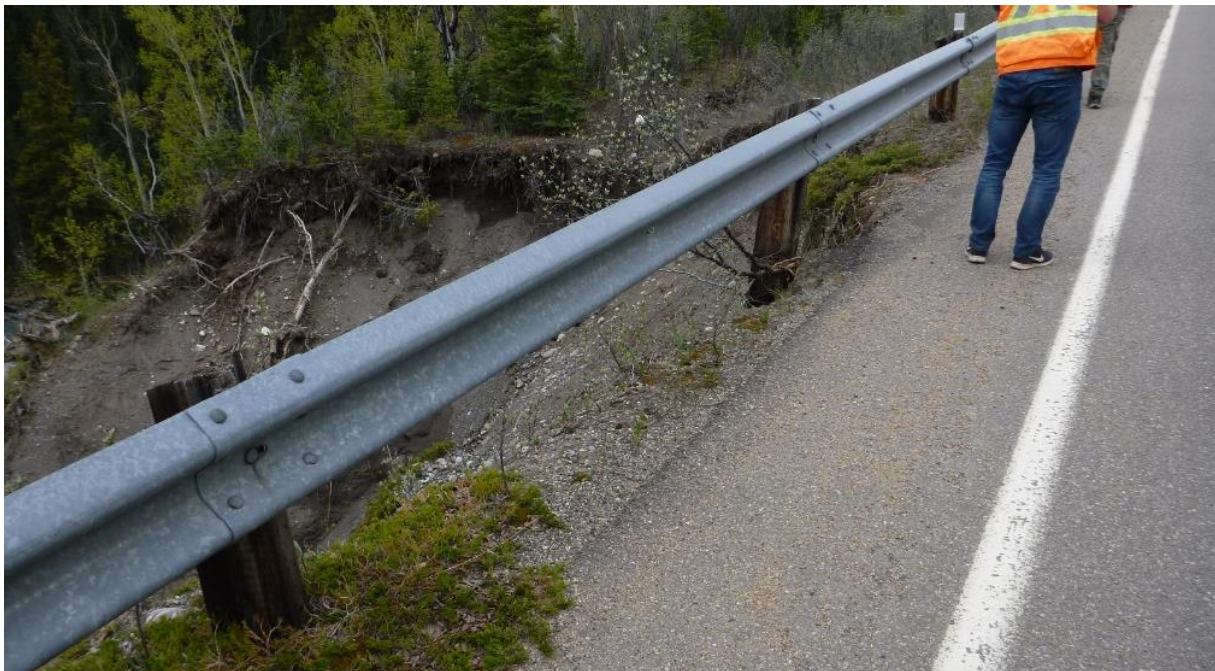
The back scarp has retrogressed to the south edge of highway and the guardrail continues to be undermined. No

deflection of the guardrail was noted.
Slope erosion appears to be depositing an alluvial fan in the Sheep River.
There is a wooden stake and a rock painted orange present upstream of the right flank used to estimate the gully retrogression. At the time of the 2023 inspection, the wooden stake was 1.7 m from the edge of the right flank (Photo 1), which is the same measurement as in 2022.
During the 2020 inspection, tension cracking and slumping was first observed on the left (east) flank of the slope failure. Between the 2021 and 2022 inspections, the ground surface appears to have dropped approximately 0.30 m and a tree had fallen down the slope. There was minimal change noted in this area during the 2024 inspection. The area is expected to eventually fail into the erosion feature downslope, enlarging the disturbed area.
The ongoing toe erosion from the river and surface water runoff from the highway ditch are causing the erosion feature to enlarge and will eventually lead to further undermining of the pavement, surface cracking, and a dip that will require extensive repairs.

Photo 4 Failure of slope close to the shoulder of the eastbound lane, undermining guardrail post. Photo taken May 28, 2024, facing southwest.
