SITE NUMBER AND NAME: S056-IV West Gorge Creek, West of Turner Valley		HIGHWAY & KM: Sheep River Road	PREVIOUS INSPECTION DATE: May 6, 2019	INSPECTION DATE: May 28, 2024
LEGAL DESCRIPTION: 12-36-019-05 W5M	NAD 83 COORDINATES: UTM Northing Easting 11 5614130 671333		RISK ASSESSMENT: PF: 13 CF: 6 TOTAL: 78 (Rockfall)	
MONTHLY AVERAGE DAILY TRAFFIC (MADT): May 2024 242 (west) & 232 (east) (Reference No. 55460220)			CONTRACTOR MAINTENANCE AREA (CMA): 27

SUMMARY OF SITE INSTRUMENTATION: None LAST READING DATE: N/A	INSPECTED BY: Chris Gräpel (KCB) Peter Roy (KCB) Renato Macciotta (U of A) Alex Frotten (TEC) Kristen Tappenden (TEC) Maury Siddons (TEC)
PRIMARY SITE ISSUE: Rock slope adjacent to the highway with ongoing sloughing. Rocks from the slope are falling onto the road.	
APPROXIMATE DIMENSIONS: Rock face north of highway is approximately 120 m long, ranging from 20 m to 40 m in height. On the south side of the highway, surface runoff erosion has undermined the safety barrier in one location.	
DATE OF ANY REMEDIAL ACTION: N/A

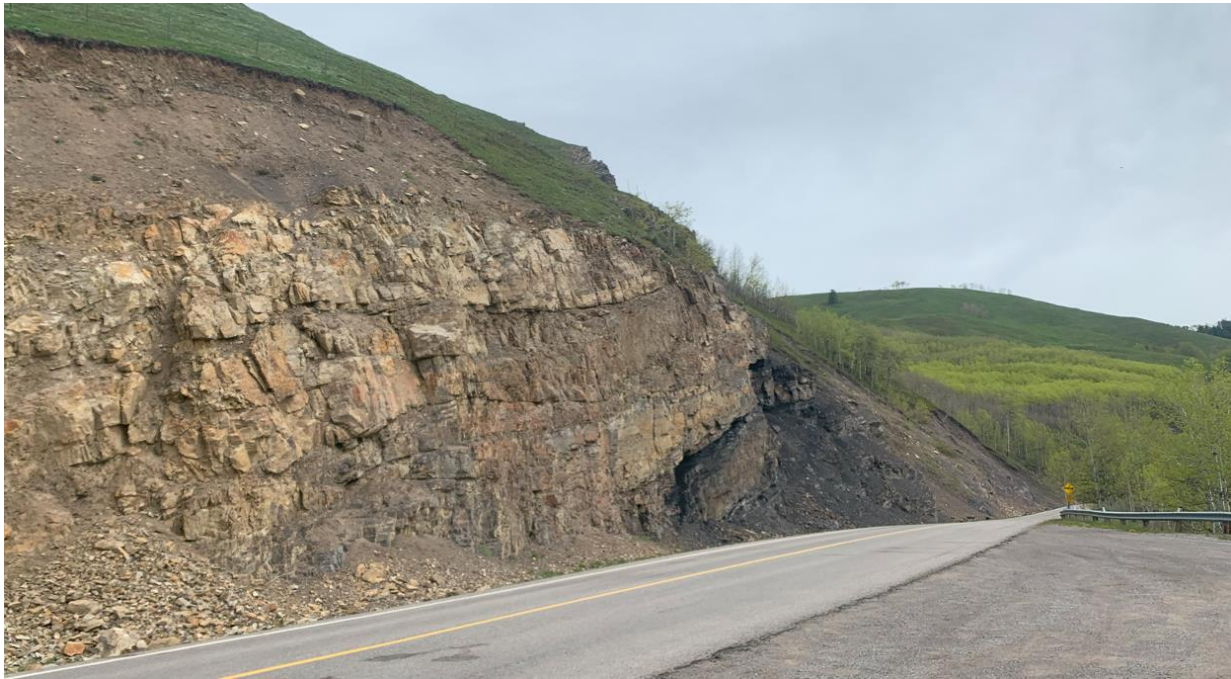
COMMENTS
The rock slope on the north side of the highway consists of folded and fractured sandstone and conglomerate with claystone and coal layers. The toe ditch is shallow and rocks are falling onto the highway. Rock blocks up to 1 m x 0.5 m x 0.5 m are present in the ditch.
Erosion at the brow of the slope is causing debris to fall into the ditch and onto the highway.
The MCI reported that rock falls appeared to be increasing in frequency and that the ditch was being cleaned out annually.
A culvert under the road is present at the east end and is plugged with a rock.
Surface runoff from the highway is eroding the slope on the south side of the highway. Erosion has undermined the safety barrier and reached the pavement edge at one location, but no pavement distress was visible in 2024.

Photo 1 Rock slope north of highway. Photo was taken facing northeast on May 28, 2024.

- Unplug the culvert beneath the road to minimize runoff erosion at the existing erosion site.
- Installation of rockfall fence partway up the rock slope to catch rocks with the potential to bounce onto the highway.

- Install jersey barriers at the at the edge of the pavement to help prevent rock fall particles from reaching the highway.
- This site was included in the K-Country Rockfall Hazard Assessment completed by KCB in 2023. A draft report was submitted on September 18, 2023. One of the recommendations in the report included that the risk rating should be re-assessed during the next Section B inspection based on the results of the rockfall hazard assessment. The risk rating was re-assessed as part of the 2024 Section B inspection based on the results of the rockfall hazard assessment.

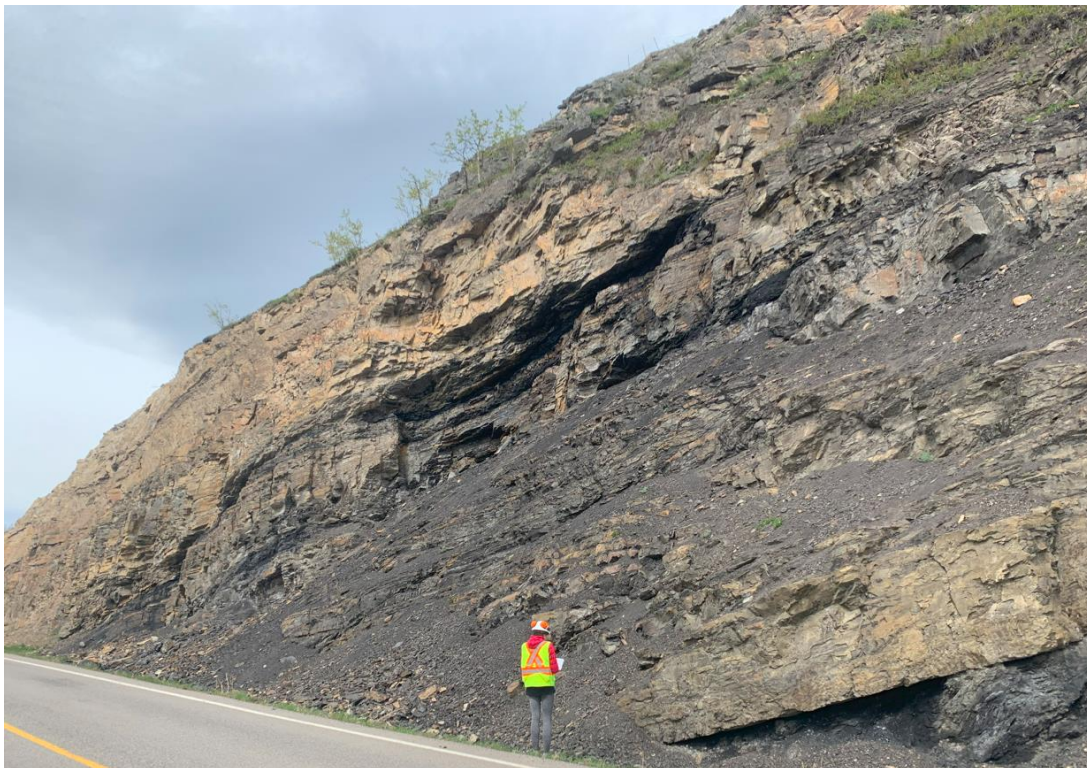
Photo 2 Rock slope north of highway. Coal seams creating rock overhang on slope. Photo was taken facing northwest on May 28, 2024.

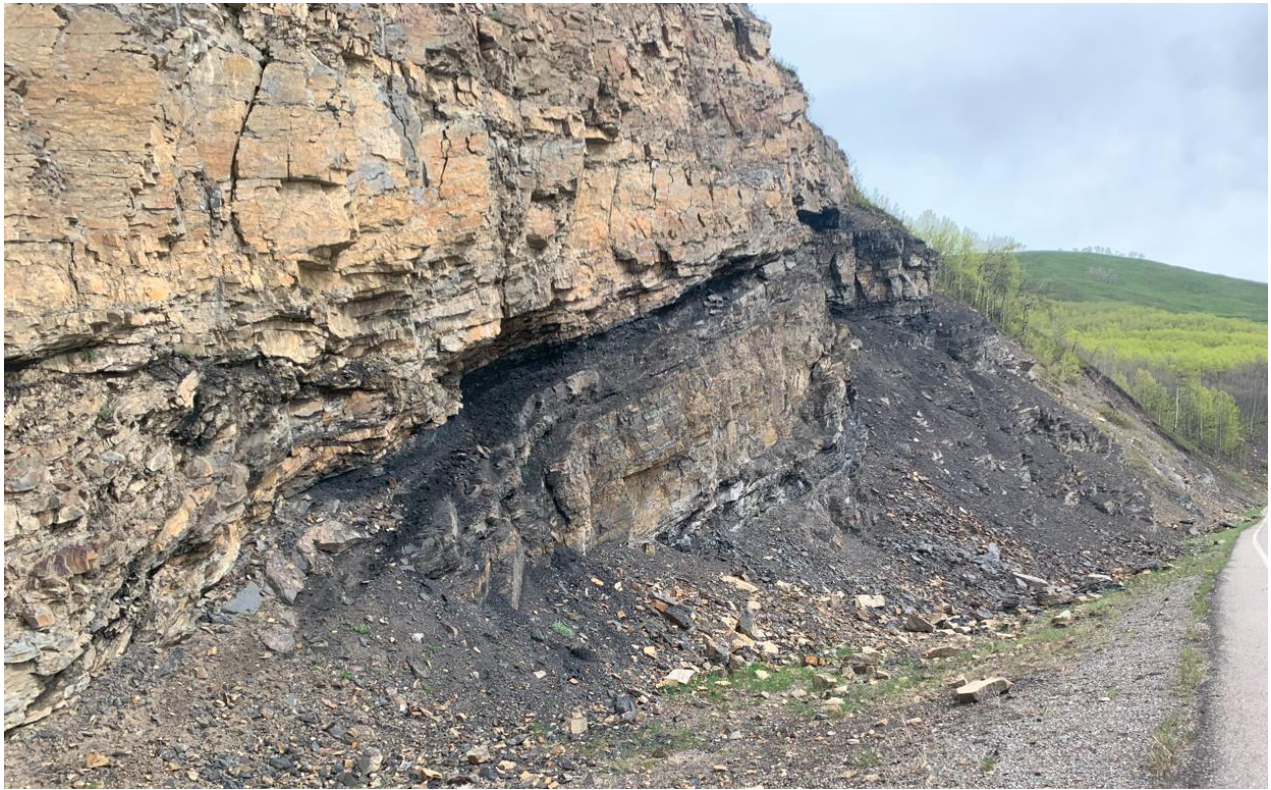
Photo 3 Rock slope north of highway. Photo taken facing northeast on May 28, 2024.

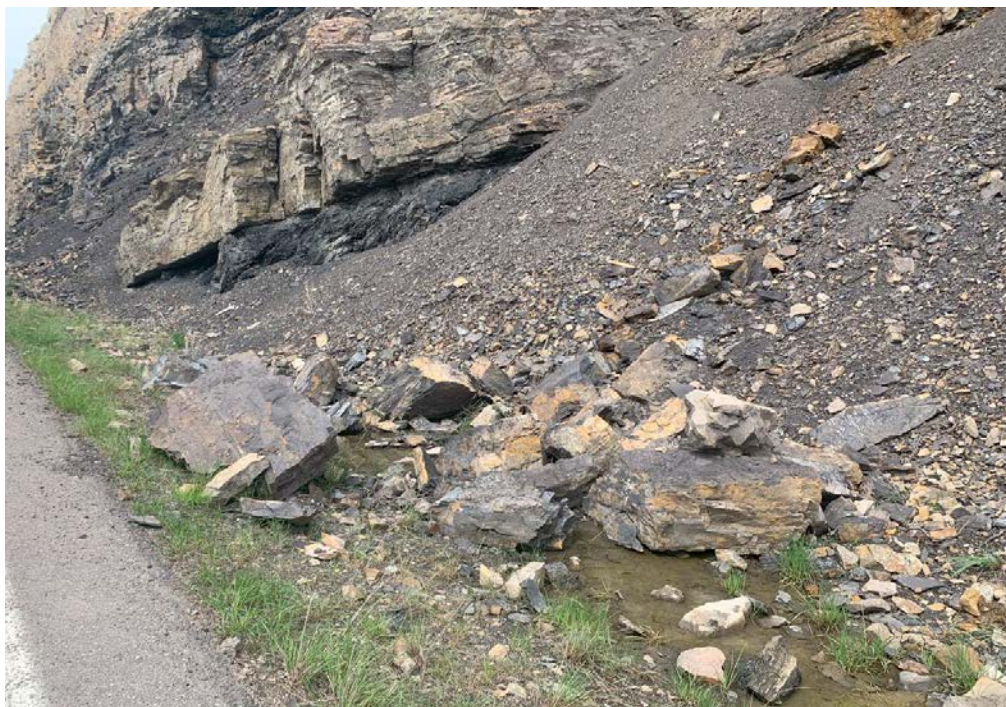
Photo 4 Rock blocks in the ditch on the north side of the highway. Photo taken on May 28, 2024.

- The site should be regularly inspected by TEC's MCI and annually as part of the Southern Region GRMP Section B inspections.
- Clean out the toe ditch regularly to maintain storage capacity for future rockfalls; and

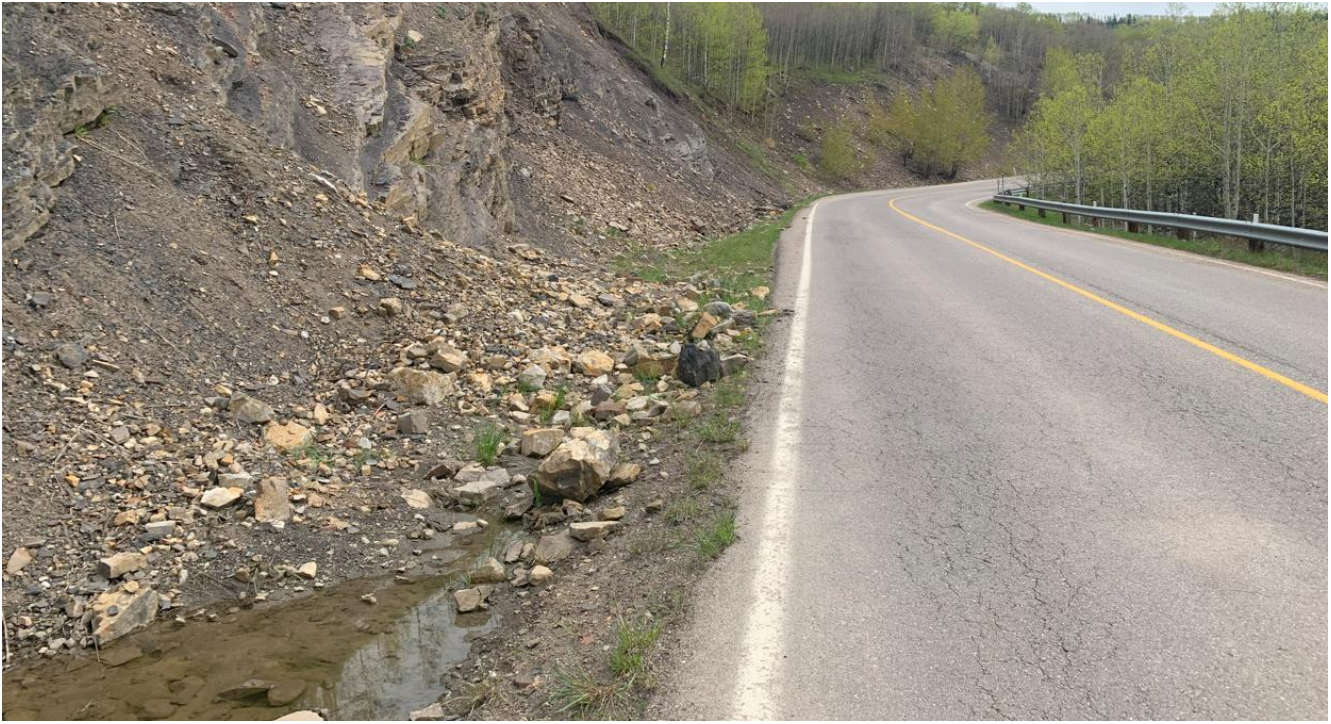
Photo 5 Rock blocks in the ditch on the north side of the highway. Photo taken facing east on May 28, 2024.

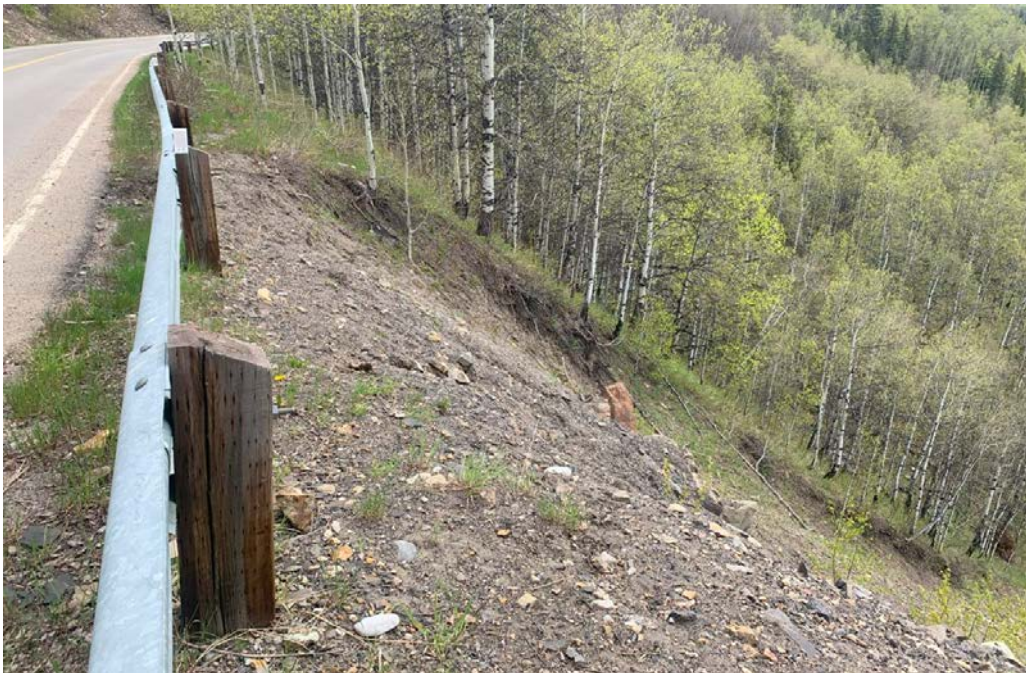
Photo 6 Surface runoff erosion on the south side of highway has undermined the guardrail and reached the pavement edge. There was no evidence of pavement crack during the 2024 inspection. Photo taken facing east on May 28, 2024.
