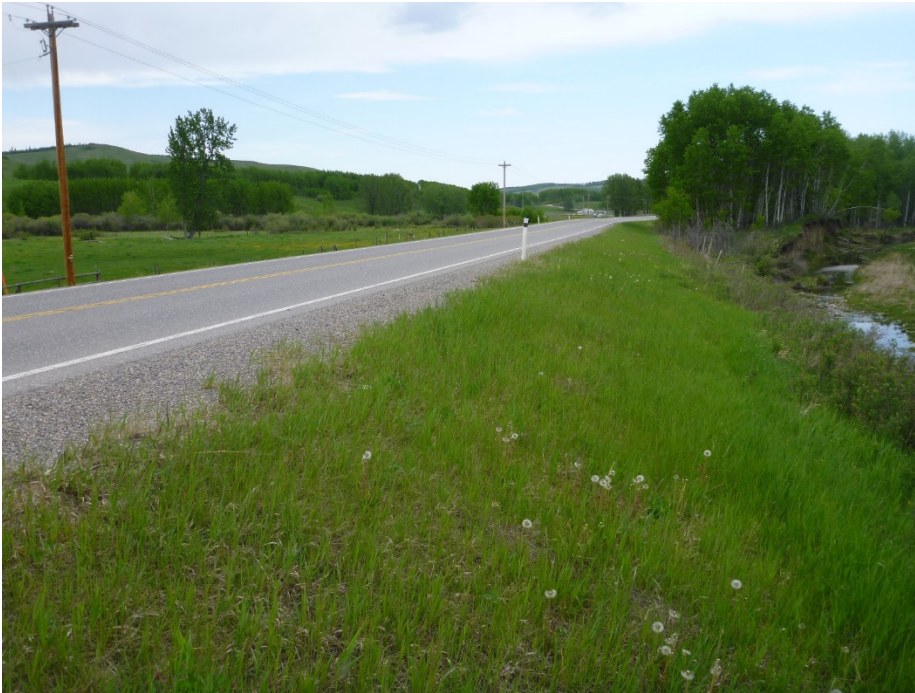
Photo 1 Highway and bank above cut bank on secondary channel S45-I. Photo was taken facing west on May 29, 2017.

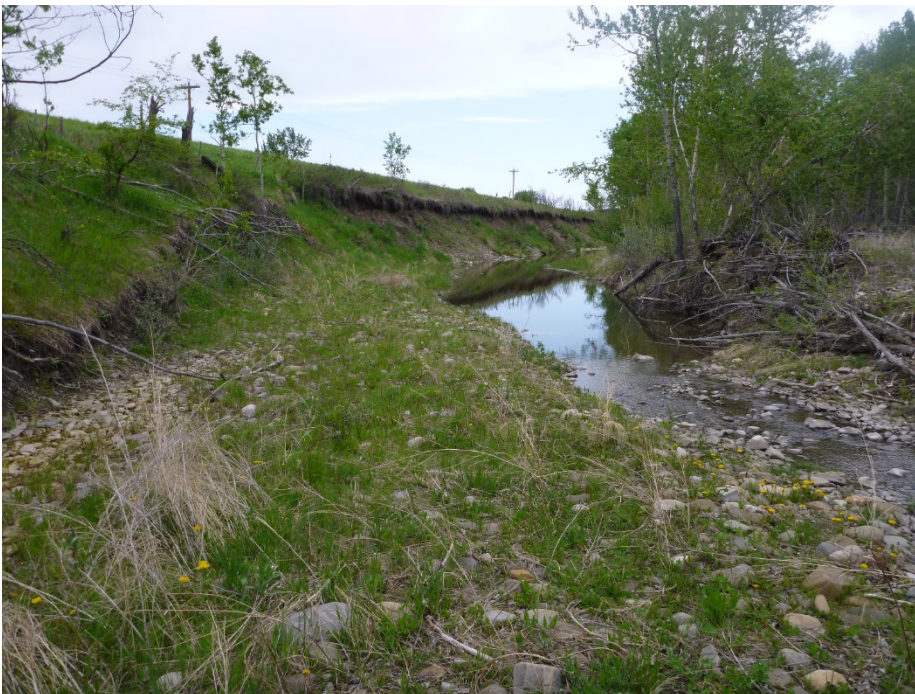
Photo 2 Downstream of eroded slope. No change in creek erosion towards road embankment in approximately 4 years. Photo was taken facing northeast May 29, 2017.

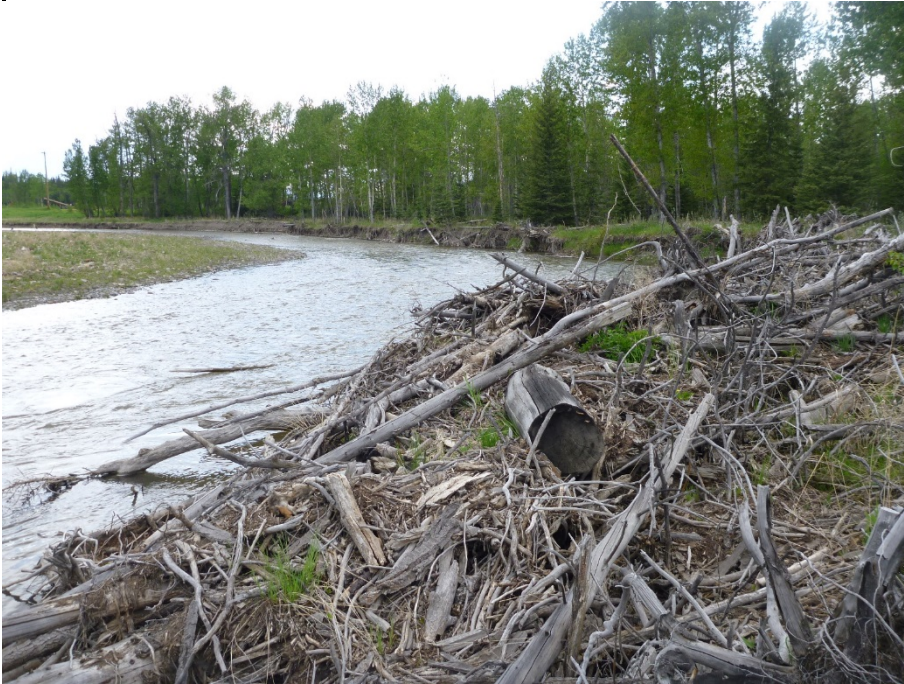
Photo 3 **Tree debris blocking river from entering creek. No change in tree debris from 2016 inspection. Some additional plant growth. Photo was taken facing southwest on May 29, 2017.**
