SITE NUMBER AND NAME: S045-I West Fisher Creek		HIGHWAY & KM: 549:02, 10.704	PREVIOUS INSPECTION DATE: June 8, 2020	INSPECTION DATE: July 5, 2021
LEGAL DESCRIPTION: 16-08-021-03 W5M	NAD 83 COORDINATES: UTM Northing Easting 11 5626463 683084		RISK ASSESMENT: PF: 10 CF: 10 TOTAL: 100	
AVERAGE ANNUAL DAILY TRAFFIC (AADT): 760 (east), (Ref. No. 65170)			CONTRACTOR MAINTENANCE AREA (CMA): 27

PRIMARY SITE ISSUE: Active slope erosion due to seasonal high flows and flood flows at meander bend in Fisher Creek. Seepage and surface runoff erosion threatens to undermine road. Crest of the erosion feature is approximately 1.2 m from edge of pavement (was 2.7 m during 2016 inspection, 2.0 m during the 2017 and 2018 inspections, 1.9 m during 2019 inspection, and 1.4 m during the 2020 inspection).

PROJECT		
SOUTHERN REGION GEOHAZARD RISK MANAGEMENT PROGRAM		
TITLE		
Site Plan S045-1 - West Fisher Creek Hwy 549:02; km 10.704		
SCALE	PROJECT No.	FIG No.
1:1,000	A05116A03	1

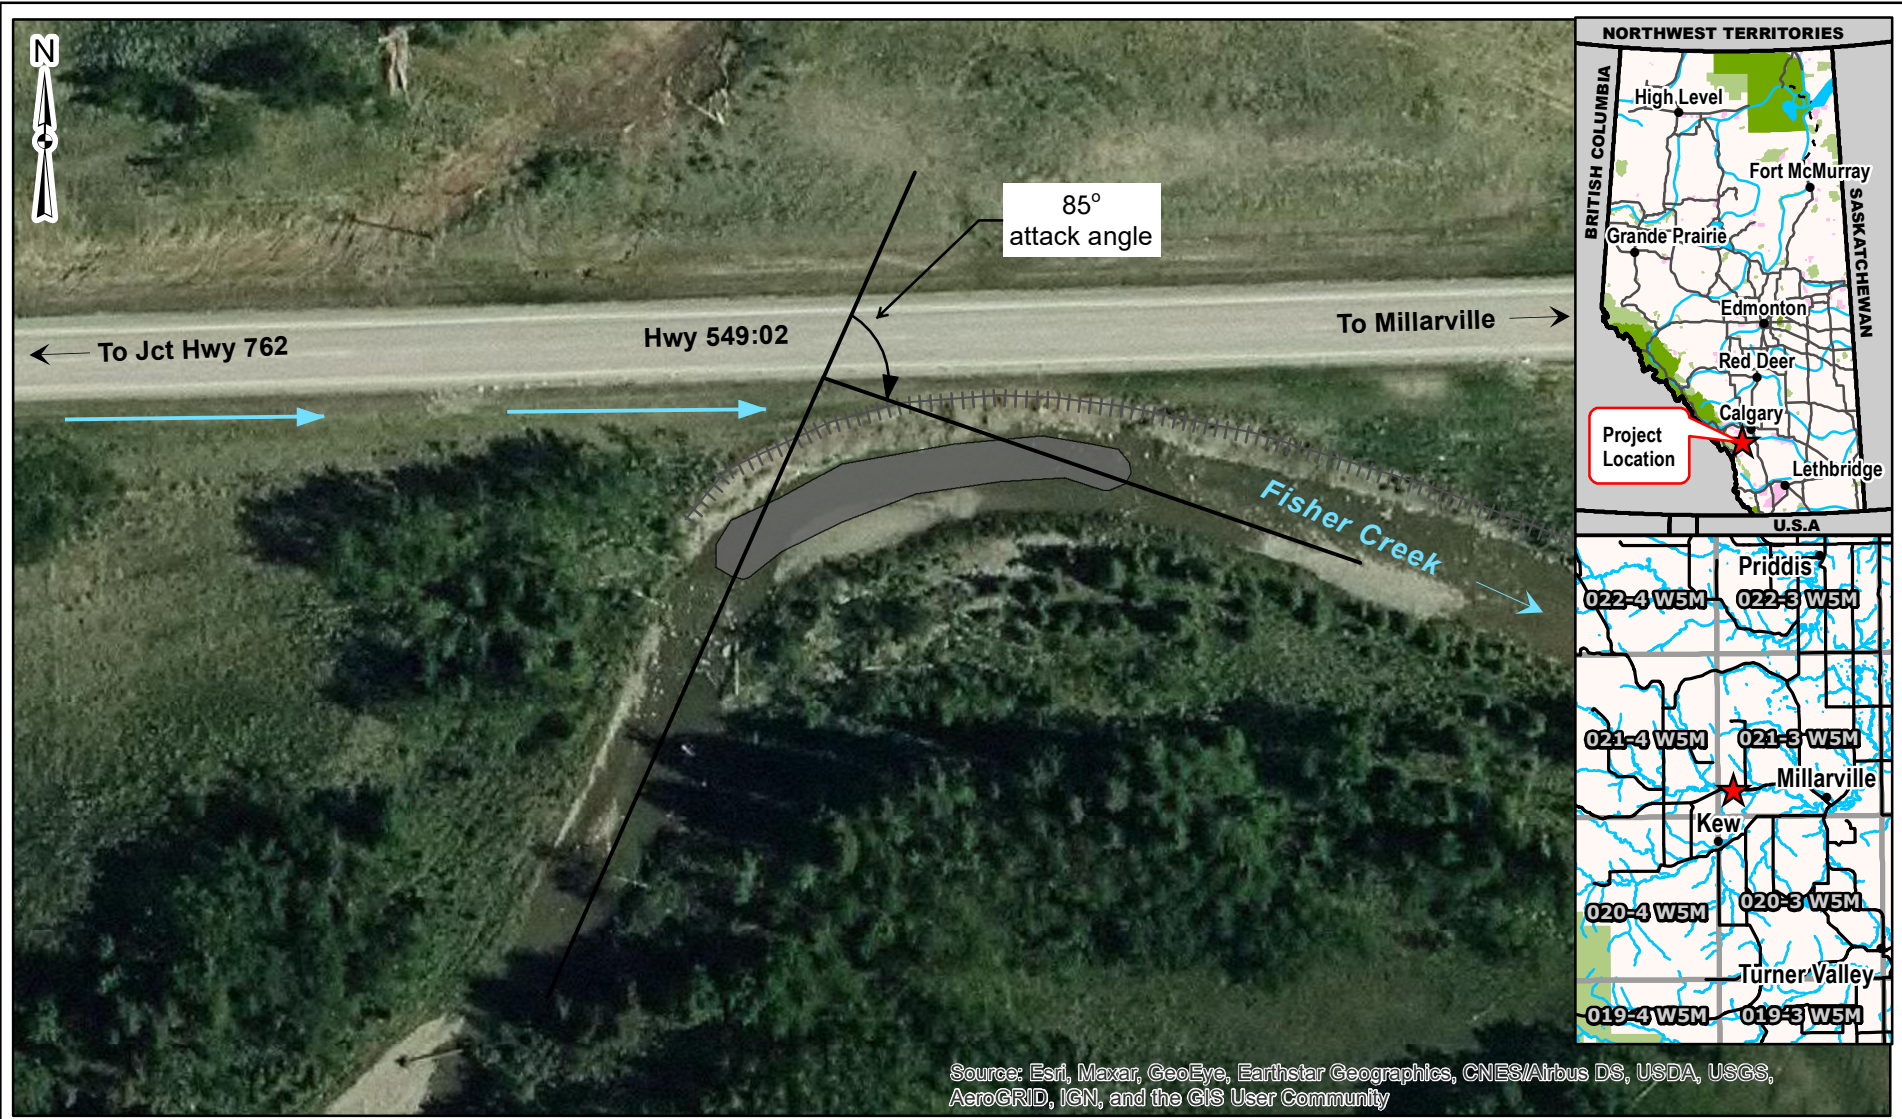
This bank has a high attack angle (85°), gravel bed, scour hole formed, and erodible material in the bank slope. Due to gravel/cobble beds, significant changes to the bed and channel only occur during high energy runoff events.

- Short-Term
 - Monitor location during and after high flows and significant antecedent rain or snow melt.
 - Divert surface water flow away from site.
- Long-Term
 - Progress design solution using slope reconstruction with traditional riprap armouring and geogrid reinforcement gravel. The design solution has been finalized and KCB are completing a tender document for S045-I. Construction is currently scheduled for 2023.

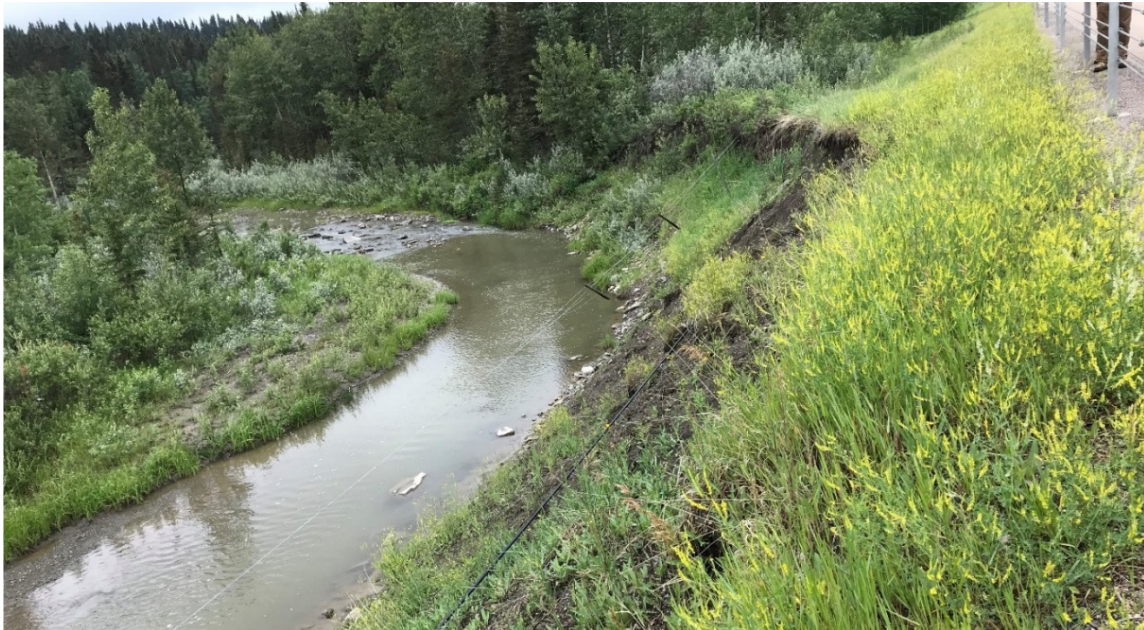
Erosion and sloughing of the slope are undermining the fence. Recently displaced blocks of grass and soil were observed. The equivalent of thirteen fence posts were hanging from the fence in 2020. In 2021, all the fence posts had fallen off and KCB were not able to confirm whether the erosion limits had extended laterally.

There are three black utility cables in the slope, exposed by erosion (two cables have snapped) and it is unclear if any are still active.

Photo 1 Active slope erosion from creek flow. The ditch has eroded and is draining onto the slope. Hanging fence and exposed utility cables in scarp. Photo was taken facing west on July 5, 2021.

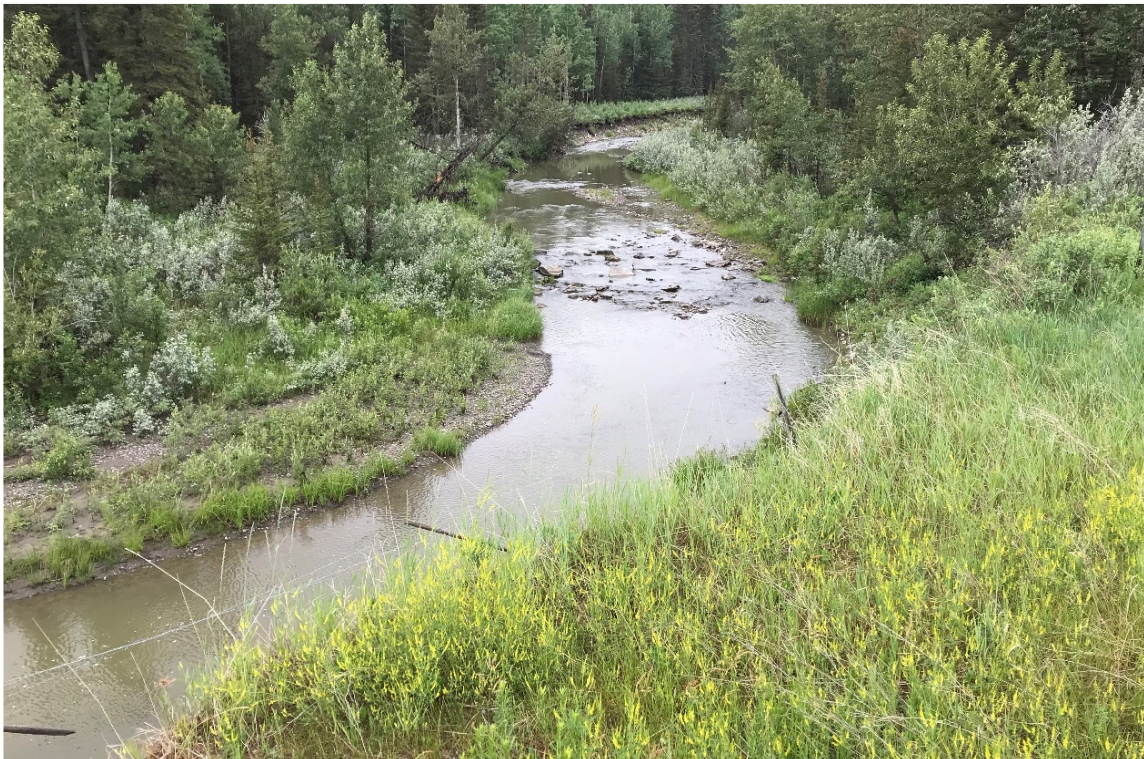
Photo 2 Upstream corner of slope erosion (west end). Photo was taken facing southwest on July 5, 2021.

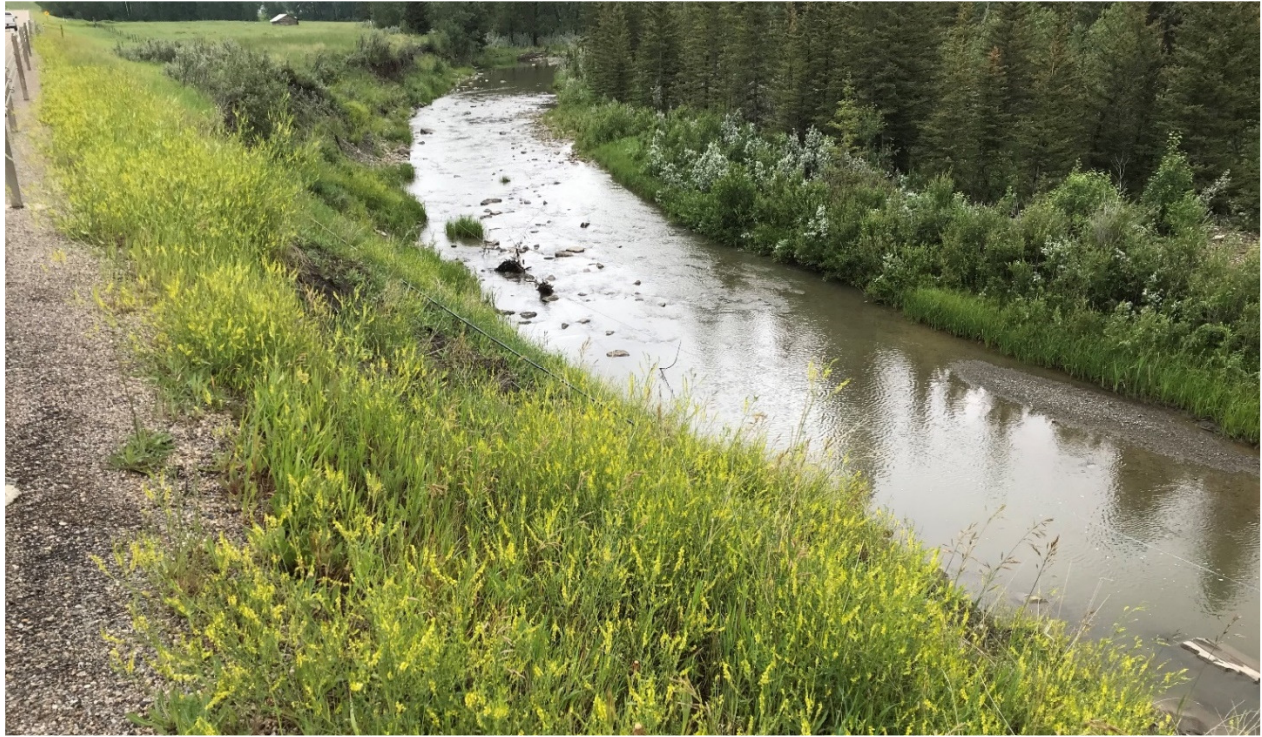
Photo 3 Displaced grass and soil due to surface runoff and ongoing bank erosion from Fisher Creek. Photo taken facing east on July 5, 2021.
