SITE NUMBER AND NAME: <b>S045-II Threepoint Creek</b>		HIGHWAY & KM: 549:02, 12.315	PREVIOUS INSPECTION DATE: May 6, 2019	INSPECTION DATE: <b>June 8, 2020</b>
LEGAL DESCRIPTION: 02-08-021-03 W5M	NAD 83 COORDINATES: UTM Northing Easting 11 5626611 684647		RISK ASSESSMENT: PF: 7 CF: 4 TOTAL: 28	
AVERAGE ANNUAL DAILY TRAFFIC (AADT): 760 (east), (Ref. No. 65170)			CONTRACTOR MAINTENANCE AREA (CMA): 27

NOTES: 1. HORIZONTAL DATUM: NAD83 2. GRID ZONE: UTM Zone 11N 3. IMAGE SOURCE: World Imagery from ESRI ArcGIS Online. Source date January 2015	CLIENT 	PROJECT SOUTHERN REGION GEOHAZARD RISK MANAGEMENT PROGRAM
		TITLE Site Plan S045-II - Threepoint Creek H549:02, km 12.315
SCALE 1:2,000	PROJECT No. A05115A03	FIG No. 1

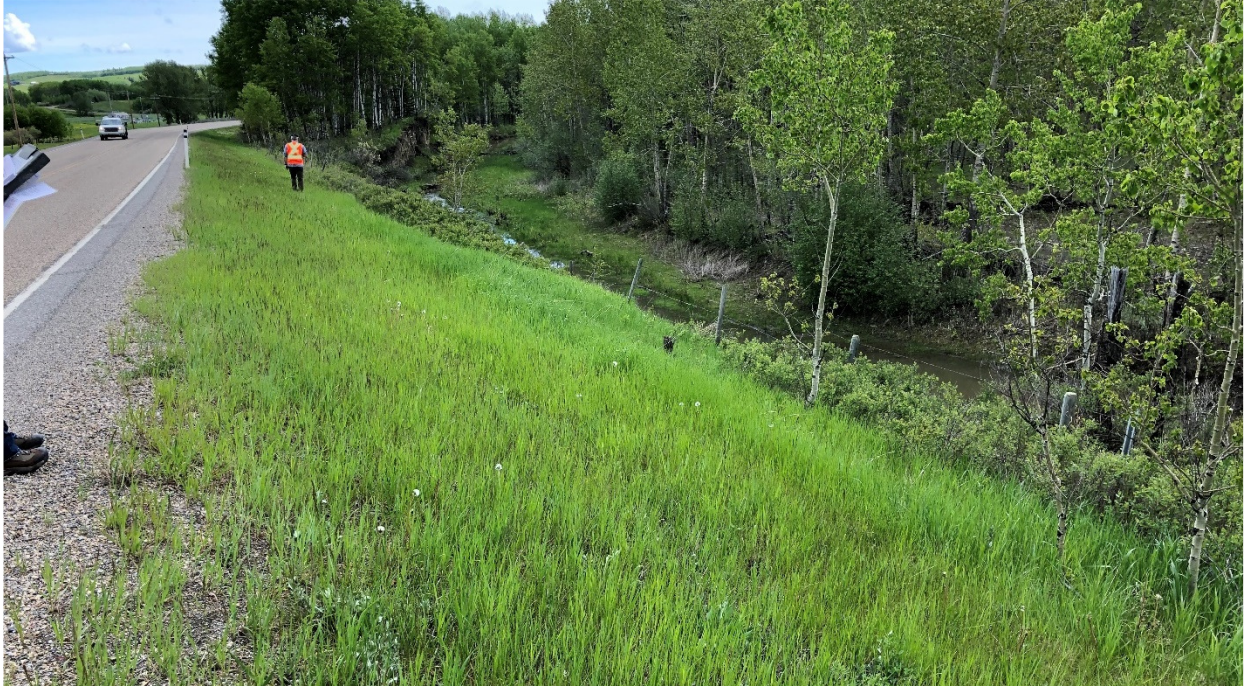
**Photo 1** Highway slope above area of toe erosion on secondary channel S045-II. Photo was taken facing northeast on June 8, 2020.

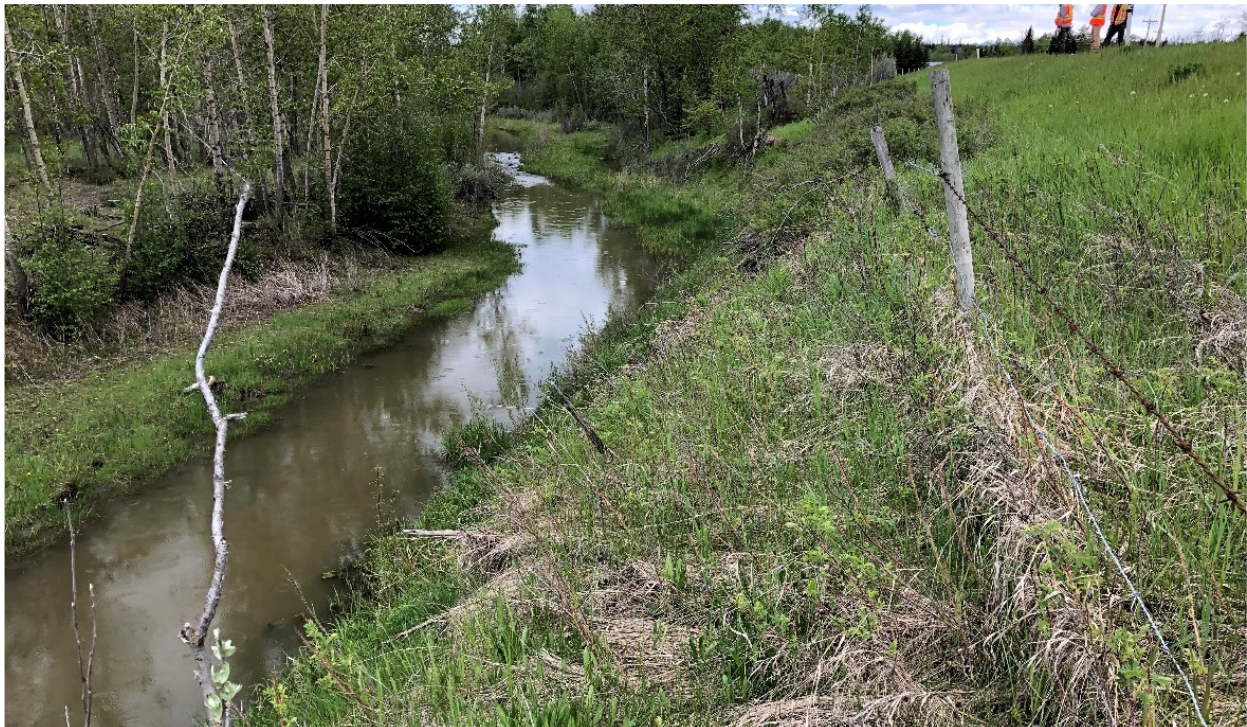
**Photo 2** Highway slope above area of toe erosion on secondary channel S045-II. Photo was taken facing southwest on June 8, 2020.

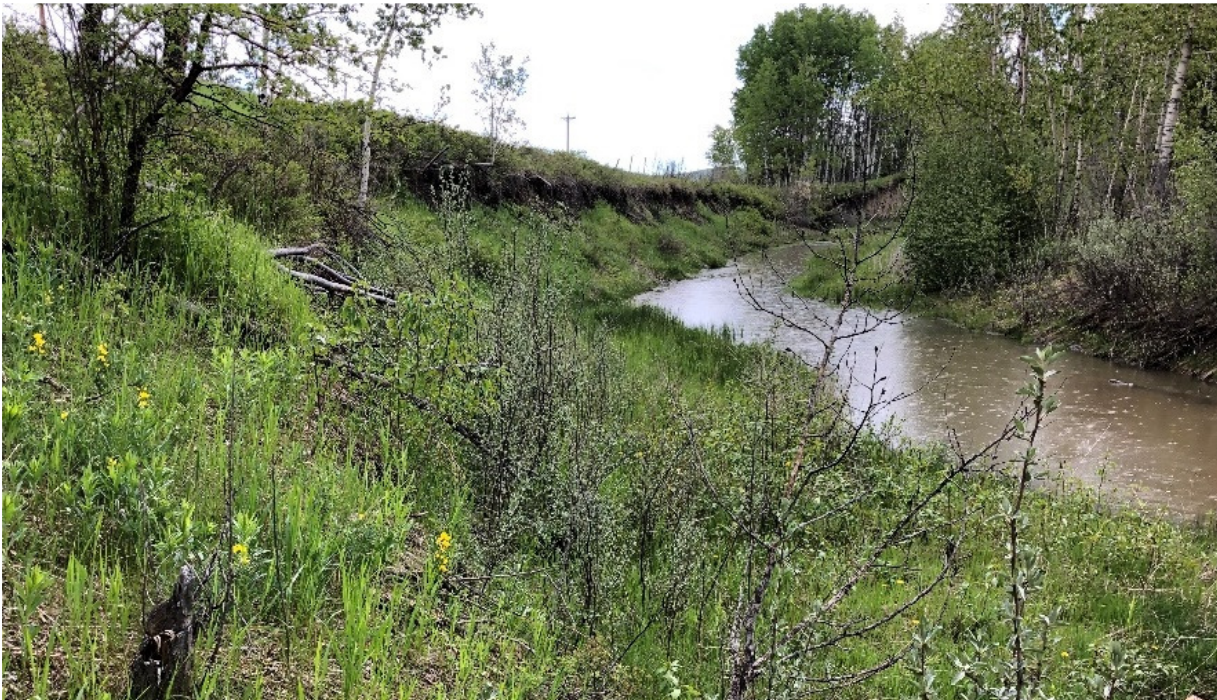
**Photo 3** Erosion scarp on outside of secondary channel. Photo was taken facing northeast on June 8, 2020.

Repair design is underway to protect the bank from further erosion, that will likely include bank reconstruction and riprap placement. In the short-term, HTCB should be installed to minimize potential for motorists going over the steep erosion scarp.

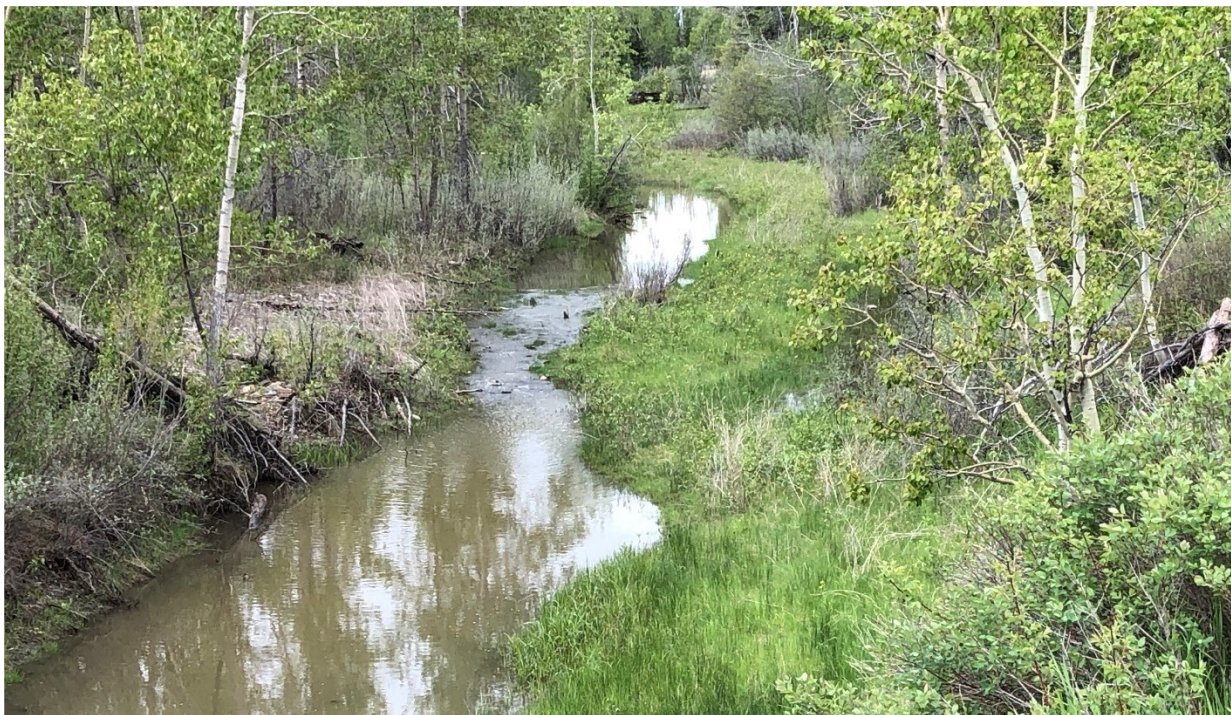
COMMENTS
The side channel adjacent to Site II was blocked by a wood debris dam deposited in June 2013. The debris dam restricts flow in the side channel, however the 2020 site visit observed an increased volume of channel flow when compared to 2019, suggesting that the debris dam is starting to decay and break down.
2020 observations also noted that the creek has started outflanking the debris dam on the upstream side.
No change in condition of the erosion scarp was observed in 2020. Increasing flow in the side channel may lead to reactivation of earth slope toe erosion.
The fence at the top of the eroded slope has been undermined and 5 posts have fallen over.
An oil pipeline is present, located between highway and the side channel and running parallel to the highway.
A tension crack appeared to be forming in the embankment side slope, approximately 1.8 m upslope of the existing bank erosion crest.

**Photo 4** View from erosion site along the side channel towards the wood debris dam. Photo was taken facing southwest on June 8, 2020.
