SITE NUMBER AND NAME: S045-II Threepoint Creek		HIGHWAY & KM: 549:02, 12.315	PREVIOUS INSPECTION DATE: June 8, 2020	INSPECTION DATE: July 5, 2021
LEGAL DESCRIPTION: 02-08-021-03 W5M	NAD 83 COORDINATES: UTM Northing Easting 11 5626611 684647		RISK ASSESSMENT: PF: 7 CF: 8 TOTAL: 56	
AVERAGE ANNUAL DAILY TRAFFIC (AADT): 760 (east), (Ref. No. 65170)			CONTRACTOR MAINTENANCE AREA (CMA): 27

PROJECT
 SOUTHERN REGION GEOHAZARD RISK MANAGEMENT PROGRAM

TITLE
 Site Plan
 S045-2 - Threepoint Creek
 Hwy 549:02; km 12.315

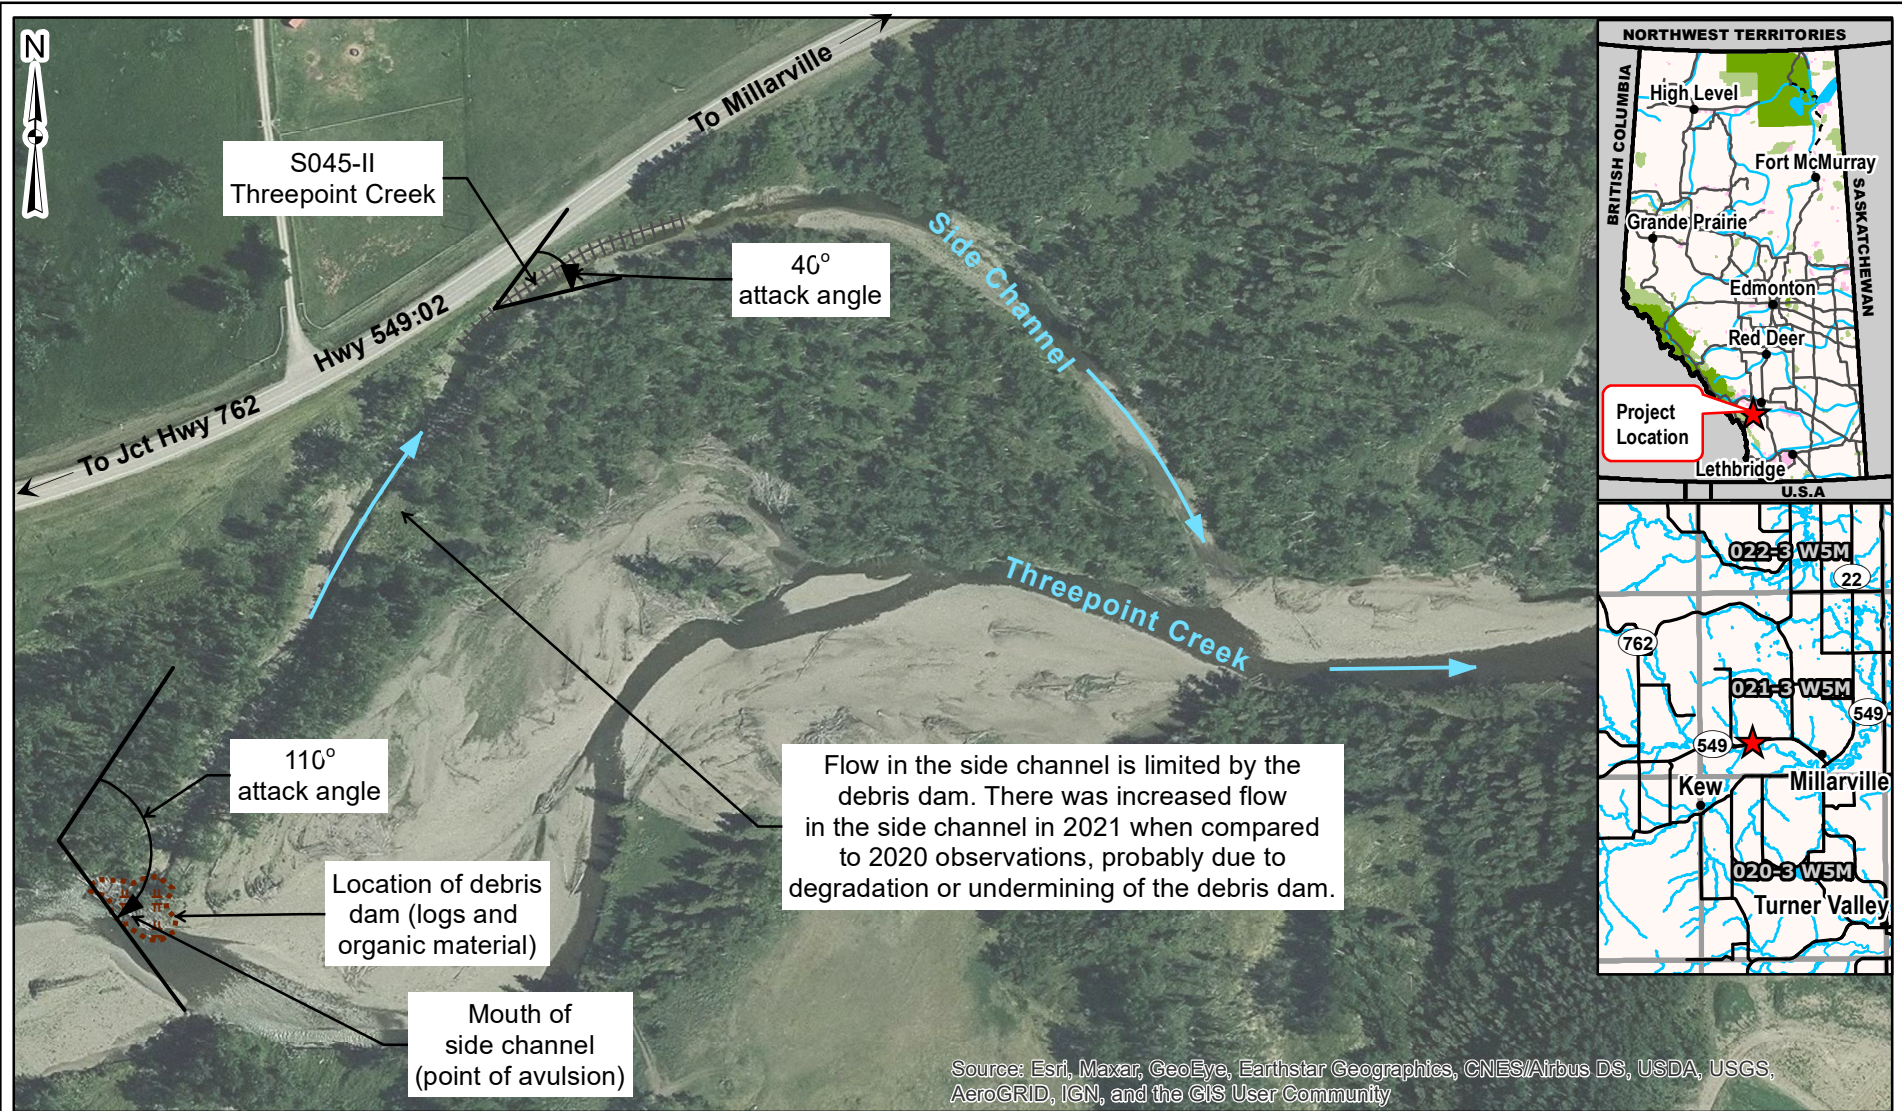
SCALE 1:3,000	PROJECT No. A05116A03	FIG No. 1
---------------	-----------------------	-----------

COMMENTS
The side channel adjacent to Site II became blocked by a wood debris dam deposited in June 2013, which restricts flow in the side channel. When compared to the 2019 inspection, increased channel flow was observed during the 2020 and 2021 site visits, suggesting that the debris dam is decaying and breaking down.
The 2020 observations noted that the creek has started outflanking the debris dam on the upstream side. KCB were unable to visit the debris dam in 2021 due to increased flow in the channel.
No change in condition of the erosion scarp observed in 2021. Increasing flow in the side channel may lead to reactivation of earth slope toe erosion.
The fence at the top of the eroded slope has been undermined and 5 posts have fallen over.
A pipeline is present, located between highway and the side channel and running parallel to the highway.
A tension crack appeared to be forming in the embankment side slope, approximately 1.8 m upslope of the existing bank erosion crest. No observable change from 2020 to 2021.

Preliminary design of repair options has been completed, including bank reconstruction and riprap placement. In the short-term, guardrail should be installed to minimize potential for motorists going over the steep erosion scarp as it is located within the clear zone.

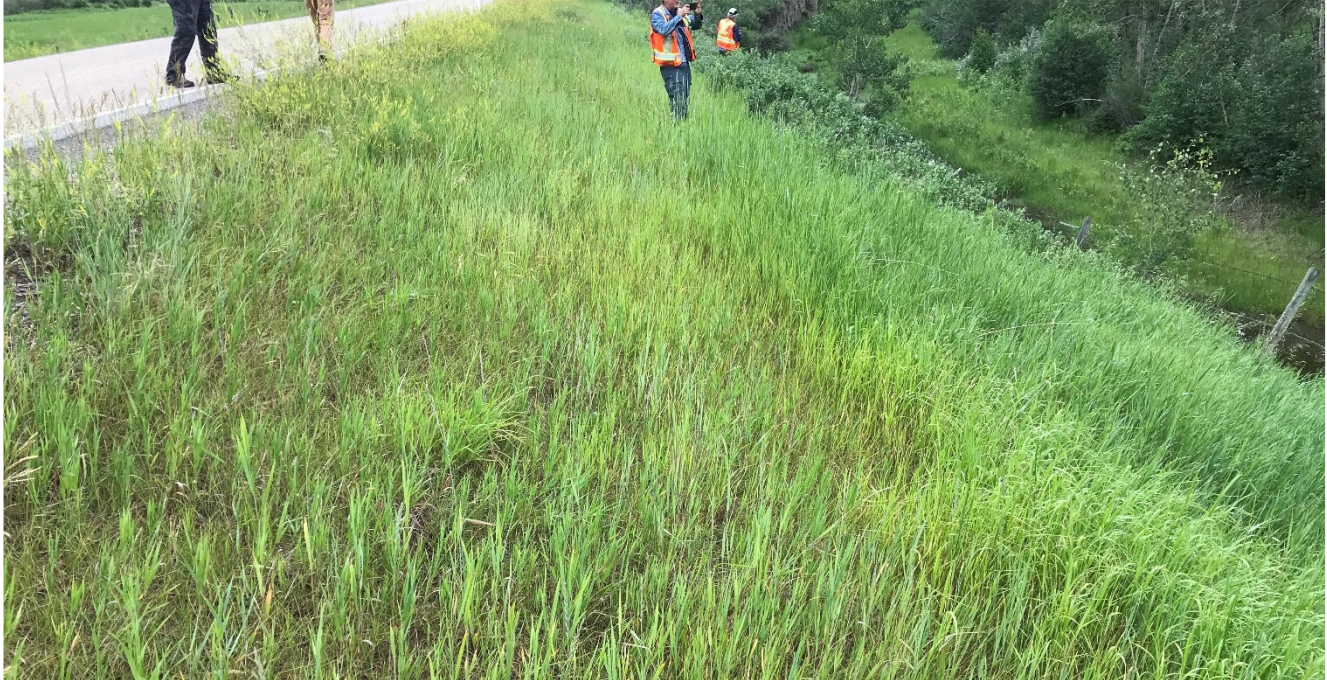
Photo 1 Highway slope above area of toe erosion on secondary channel S045-II. Photo was taken facing northeast on July 5, 2021.

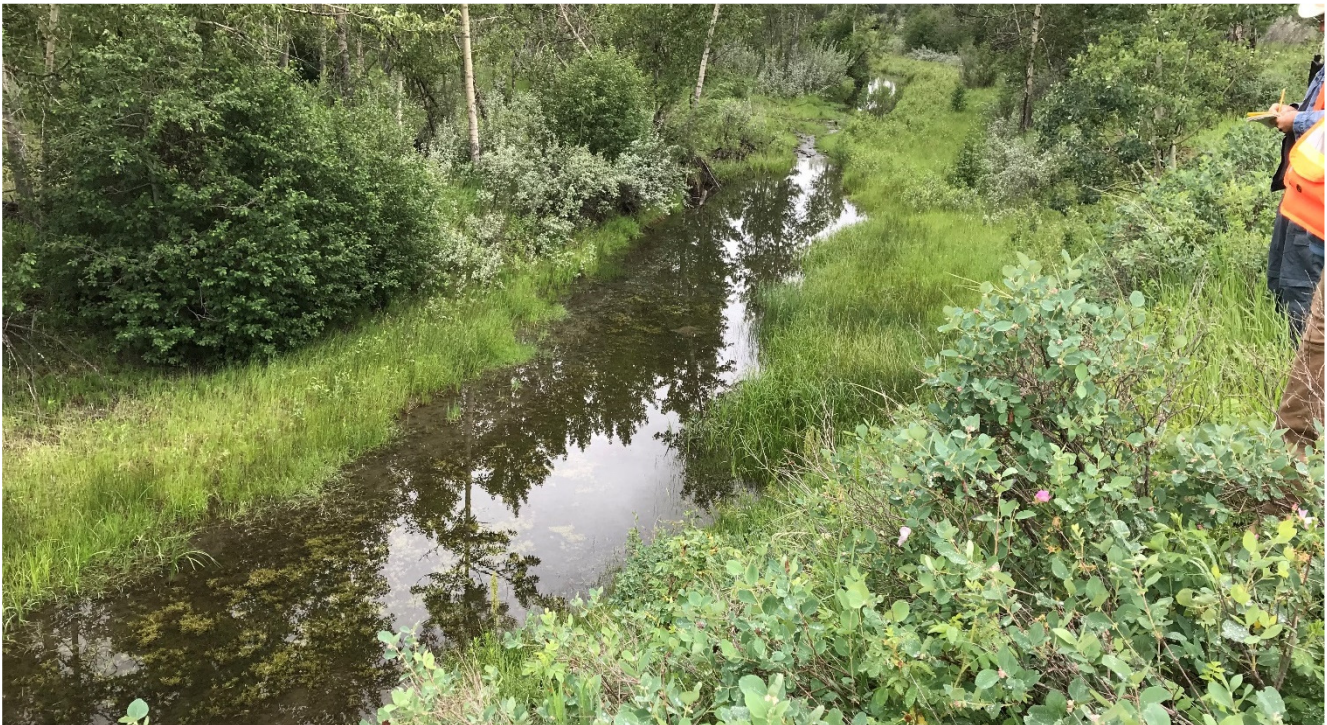
Photo 2 Increased flow observed in the side channel when compared to 2020 observations. Photo was taken facing southwest on July 5, 2021.

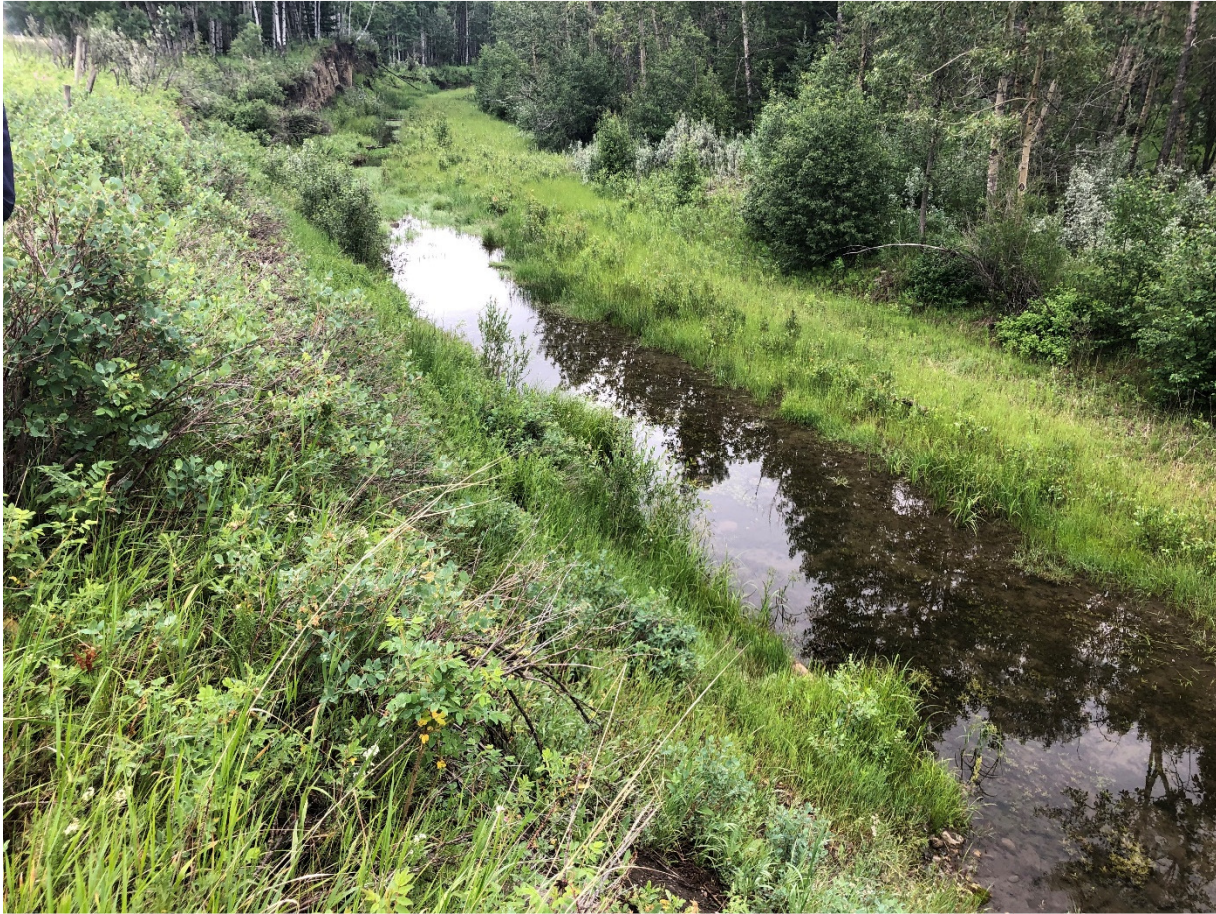
Photo 3 **Increased flow in the side channel potentially leading to an increase in bank erosion adjacent to the highway. Photo was taken facing east on July 5, 2021.**
