SITE NUMBER AND NAME: S050 Badger Culvert Slide		HIGHWAY & KM: 549:02, 4.831	PREVIOUS INSPECTION DATE: May 29, 2017	INSPECTION DATE: April 30, 2018
LEGAL DESCRIPTION: 05-03-021-04 W5M	NAD 83 COORDINATES: UTM Northing Easting 11 5625113 677537		RISK ASSESMENT: PF: 9 CF: 2 TOTAL: 18	
AVERAGE ANNUAL DAILY TRAFFIC (AADT): 220 (west), 900 (east), (Ref. No 65170)			CONTRACTOR MAINTENANCE AREA (CMA): 27

NOTES: 1. HORIZONTAL DATUM: NAD83 2. GRID ZONE: UTM Zone 11N 3. IMAGE SOURCE: Google Earth. Image dated August 22, 2015	CLIENT 	PROJECT SOUTHERN REGION GEOHAZARD RISK MANAGEMENT PROGRAM
		TITLE Site Plan S050 - Badger Creek Embankment Slope Slide Hwy 549:02-1
SCALE 1:800	PROJECT No. A05115A03	FIG No. 1

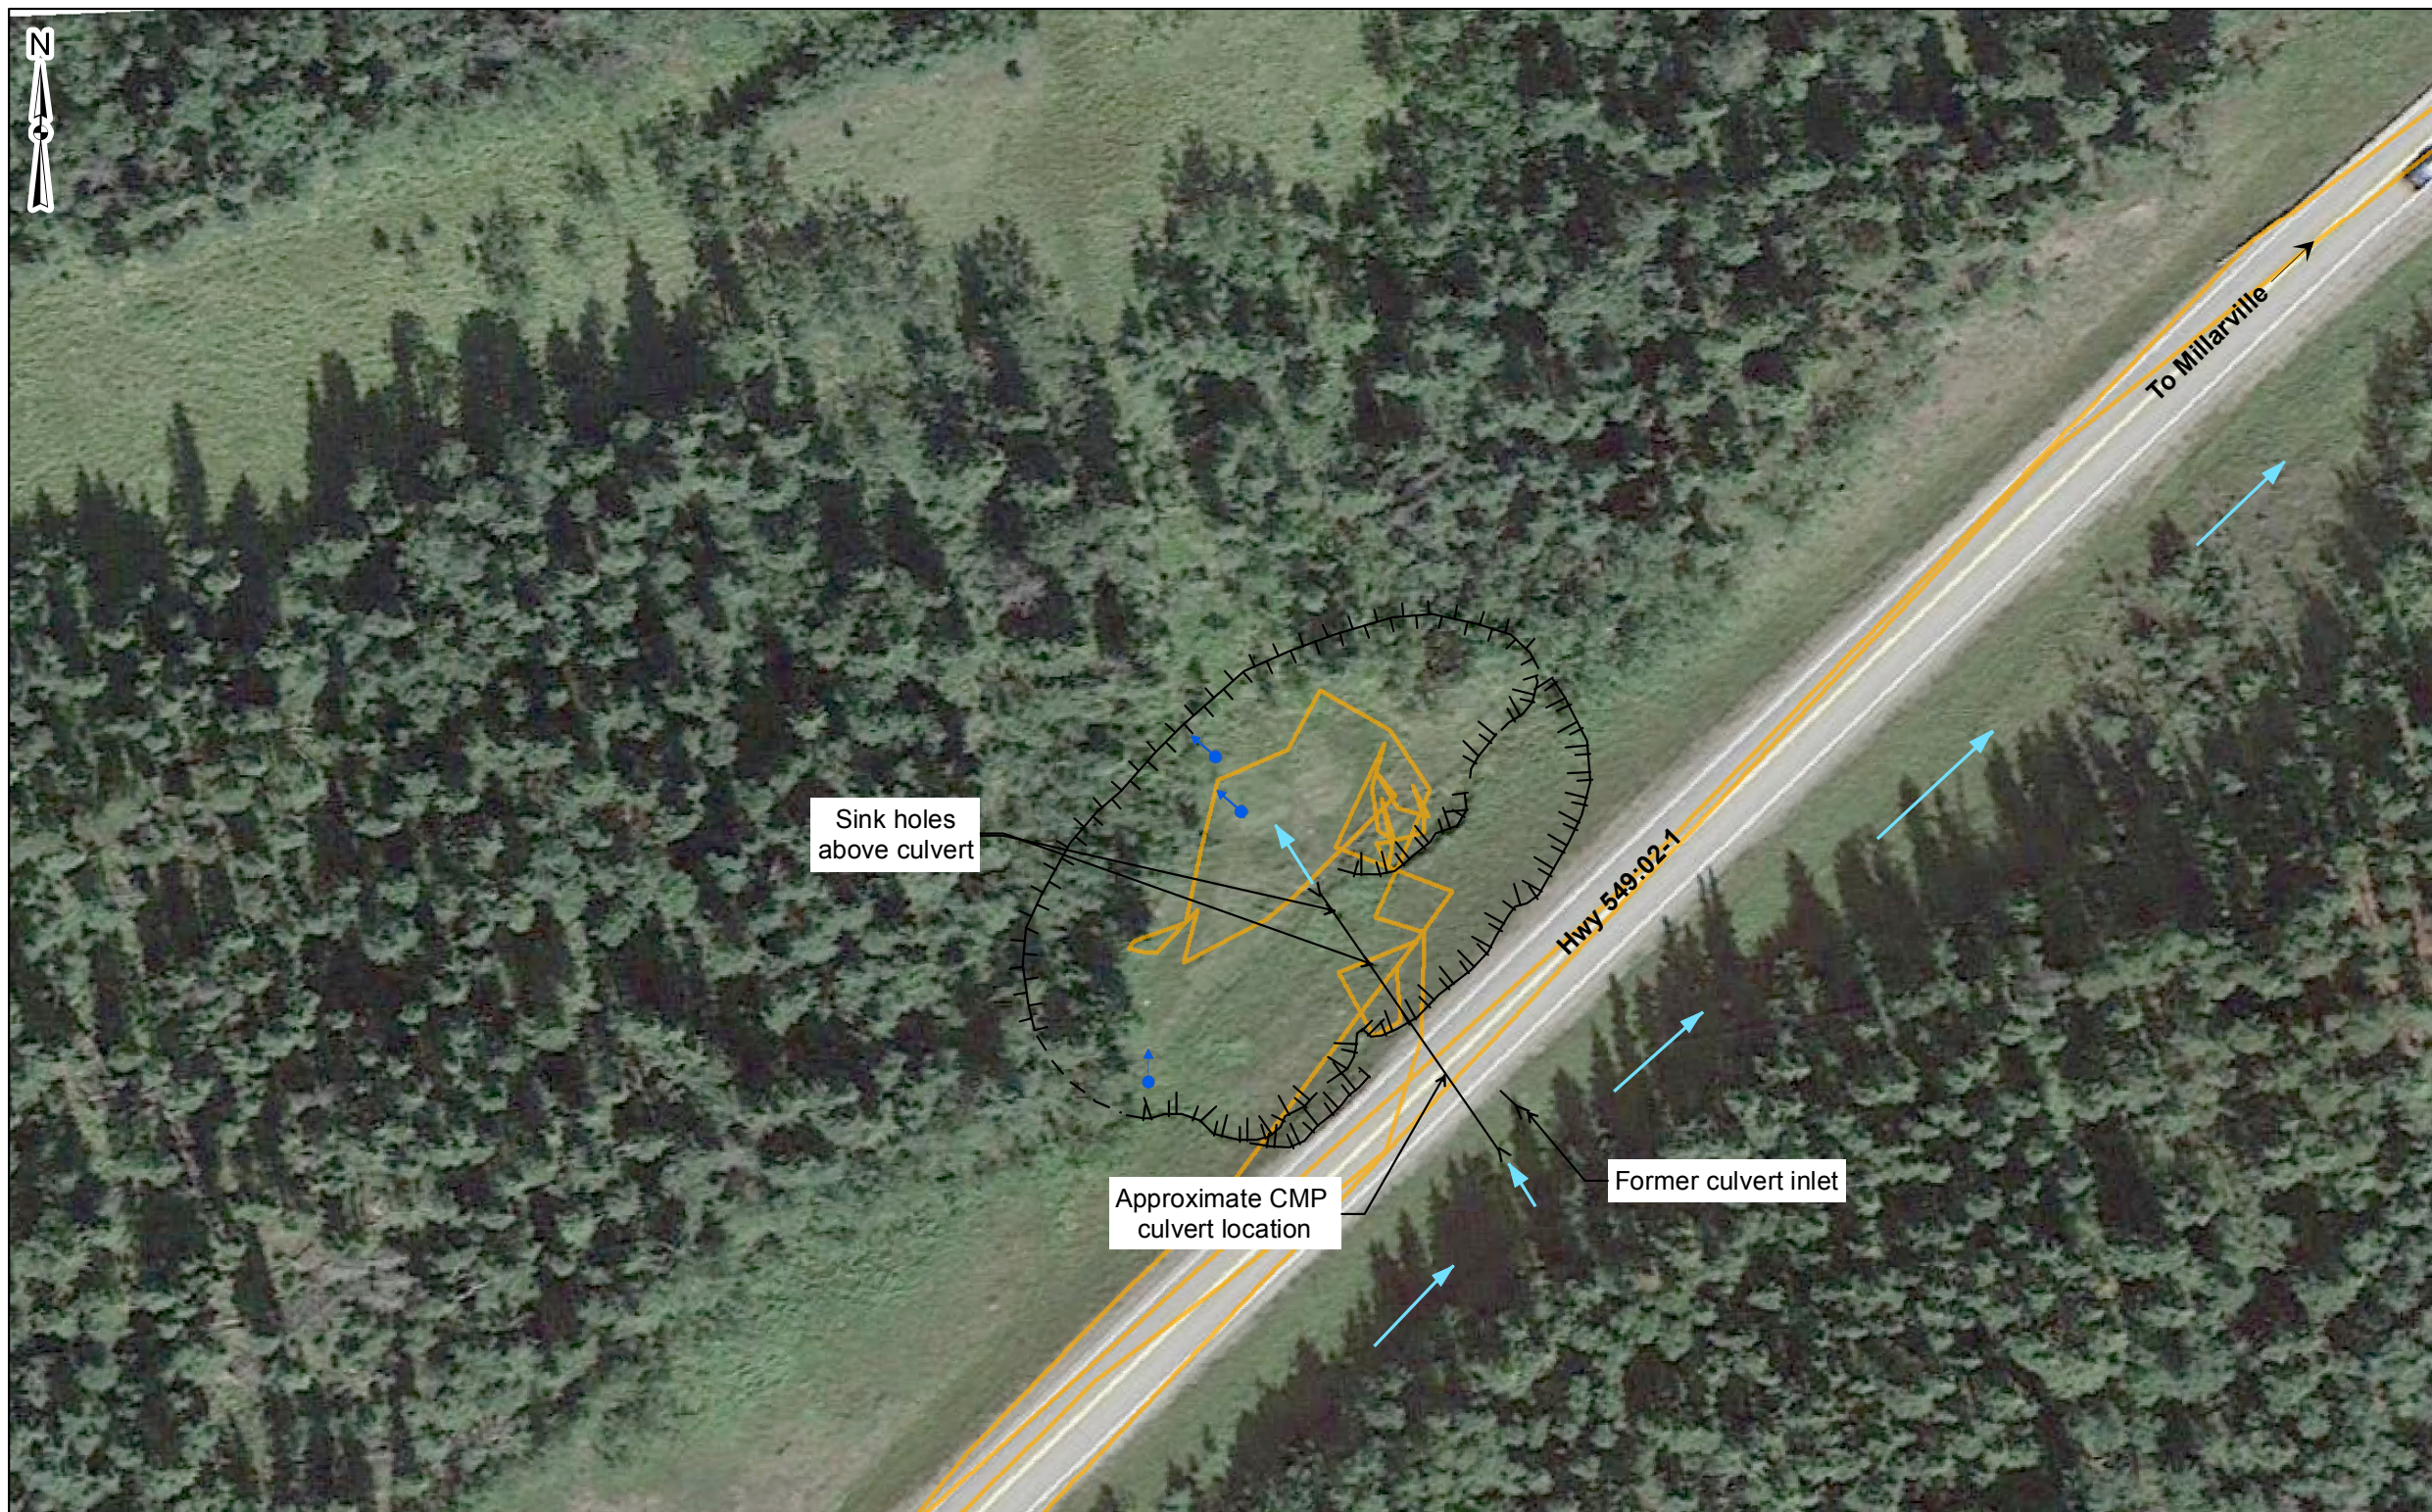
PRIMARY SITE ISSUE: Landslide below highway, on north embankment slope. Slide extended 0.5 m into north shoulder of highway. Corroded culvert beneath highway likely allowing water to drain into the embankment. Smaller slide located on the east toe, 3 m inside the fence line, not impacting the highway.

APPROXIMATE DIMENSIONS: Approximately 10 m of the highway shoulder impacted by the slide. Larger slide approximately 30 m wide at the middle. Smaller slide approximately 10 m wide, head scarp up to 1.5 m high.

At the center of the large slide, the extent of the movement is indicated by a toe bulge approximately 20 m beyond the toe of the embankment. The slide toe being this far from the toe of the embankment suggests the failure is either deep-seated rotational or translational, sliding along a shallow sub horizontal surface.

Several springs are apparent beyond the toe of the embankment, which suggests high water table and possibly artesian groundwater.

A drilling program consisting of 2 to 3 boreholes should be undertaken to assess the ground conditions in the slide area. Possible remediation could include a shear key at the base of the slope with improved drainage through the embankment.

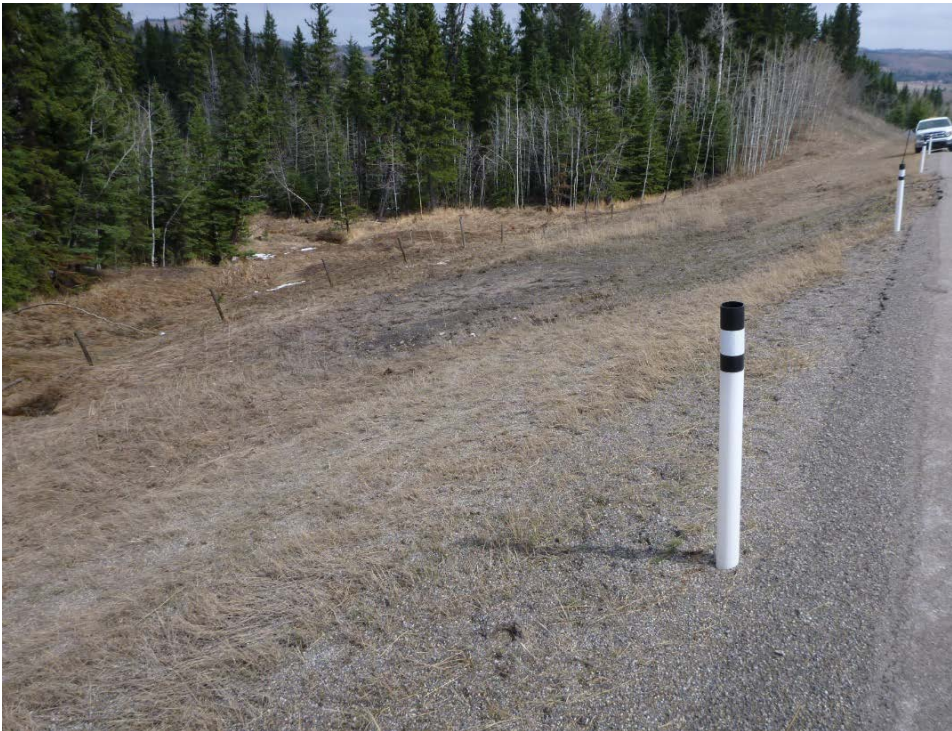
Photo 1 North side of highway. Photo taken facing east on April 30, 2018.

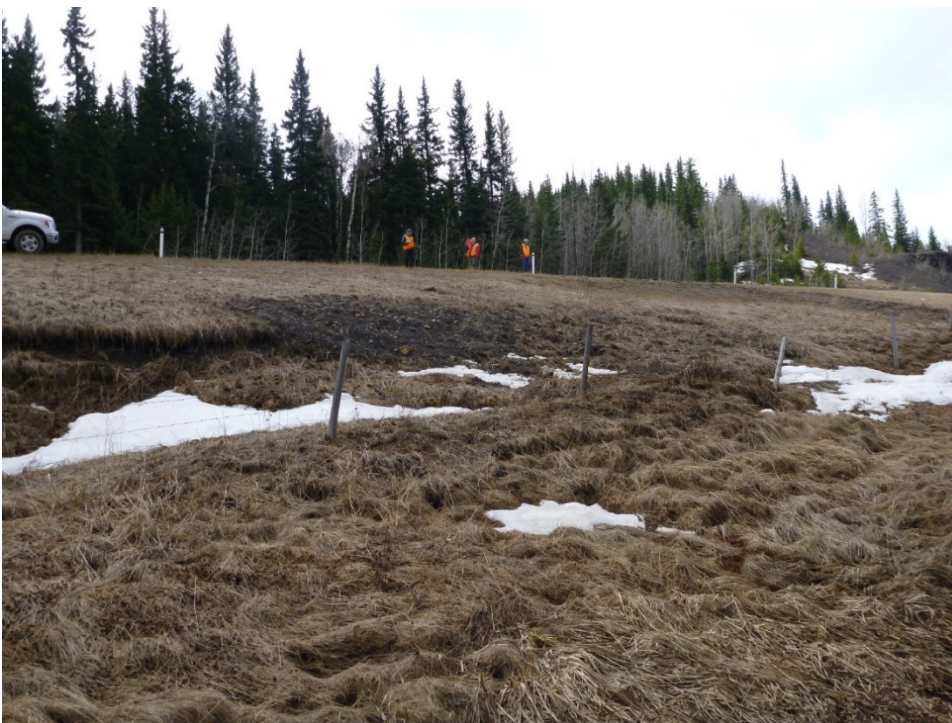
Photo 2 Slide area viewed from toe area. Photo taken facing southwest on April 30, 2018.

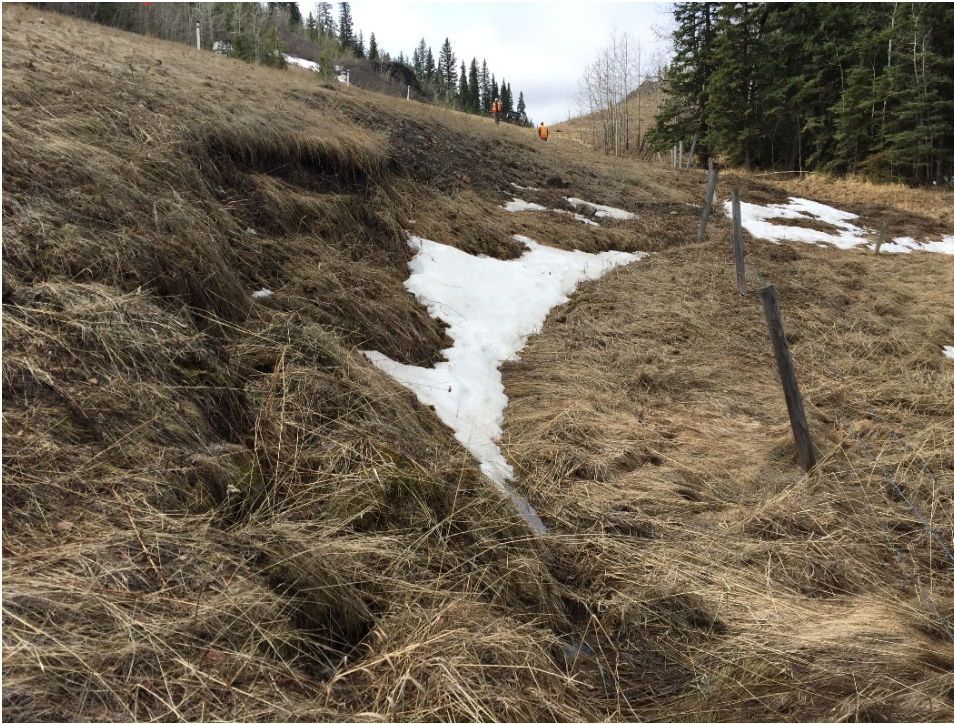
The right (east) head scarp appears to have dropped about 0.5 m since the 2017 inspection

Photo 3 East (right) flank of slide area where movement has occurred since 2017. Photo taken facing west on April 30, 2018.

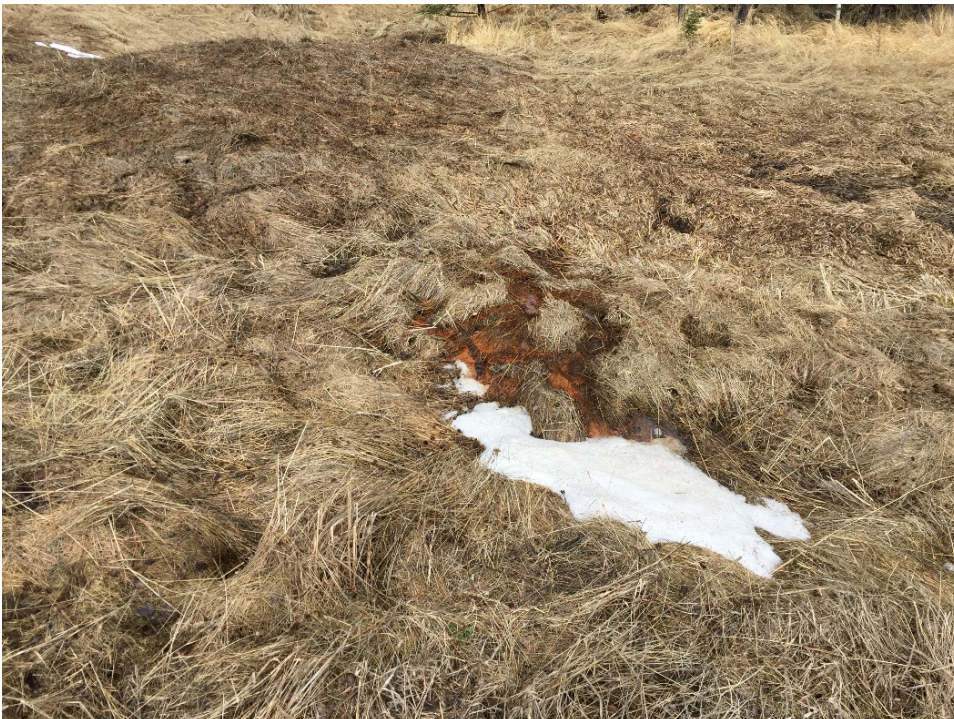
Photo 4 Rust staining from seepage through plugged culvert at the toe of the slide. Photo taken on April 30, 2018.
