SITE NUMBER AND NAME: S050 Quirk Creek Slide		HIGHWAY & KM: 549:02, 4.869	PREVIOUS INSPECTION DATE: April 30, 2018	INSPECTION DATE: July 5, 2021
LEGAL DESCRIPTION: 05-03-021-04 W5M	NAD 83 COORDINATES: UTM Northing Easting 11 5625113 677537		RISK ASSESMENT: PF: 8 CF: 2 TOTAL: 16	
AVERAGE ANNUAL DAILY TRAFFIC (AADT): 200 (west), 770 (east), (Ref. No 65170)			CONTRACTOR MAINTENANCE AREA (CMA): 27

NOTES: 1. HORIZONTAL DATUM: NAD83 2. GRID ZONE: UTM Zone 11N 3. IMAGE SOURCE: Google Earth. Image dated August 22, 2015	CLIENT 	PROJECT SOUTHERN REGION GEOHAZARD RISK MANAGEMENT PROGRAM
		TITLE Site Plan S050 - Quirk Creek Slide Hwy 549:02-1
SCALE 1:800	PROJECT No. A05116A03	FIG No. 1

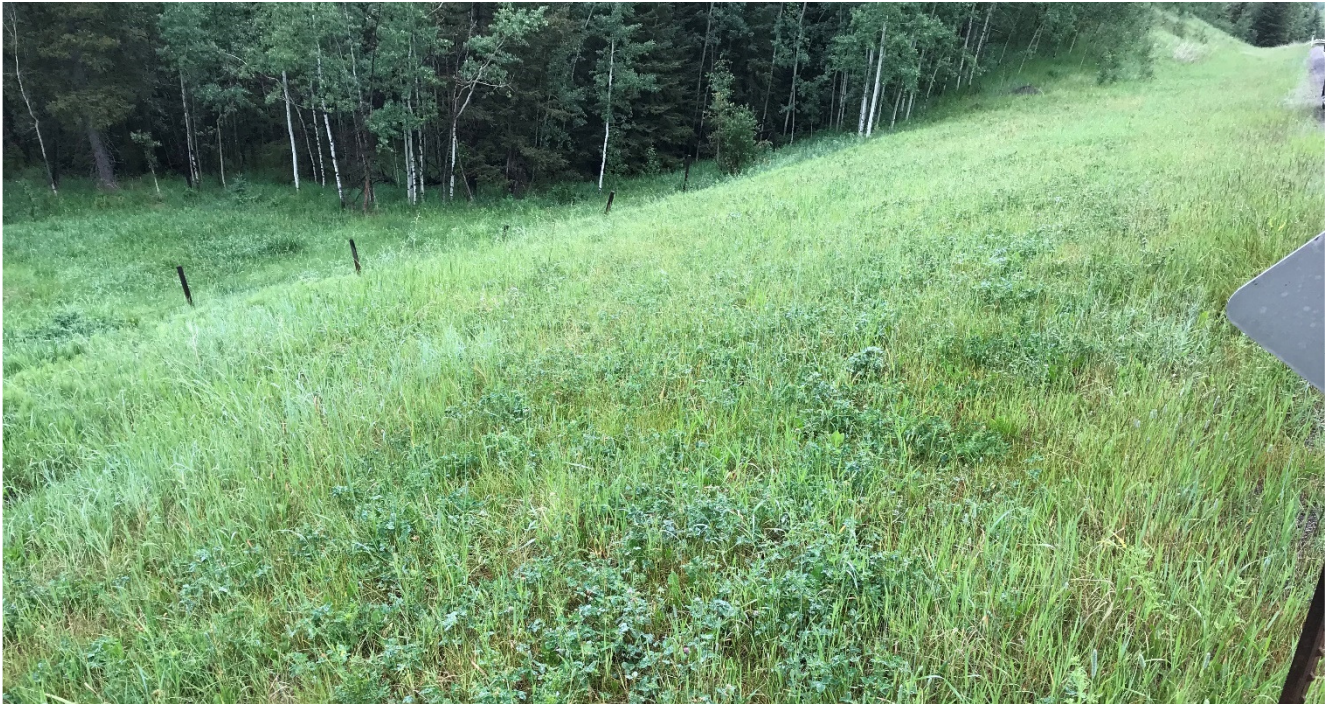
Photo 1 North side of highway. Photo taken facing north on July 5, 2021.

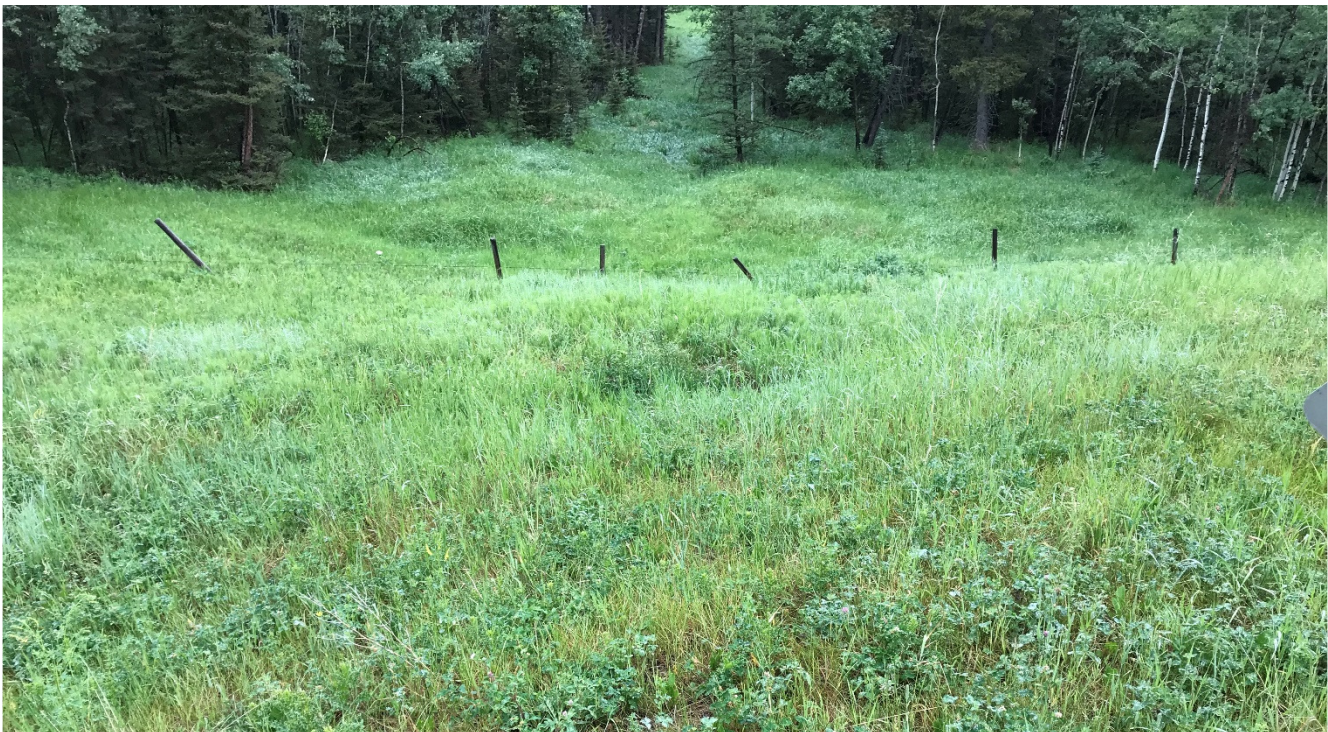
Photo 2 Slide area viewed from highway. Photo taken facing northwest on July 5, 2021.

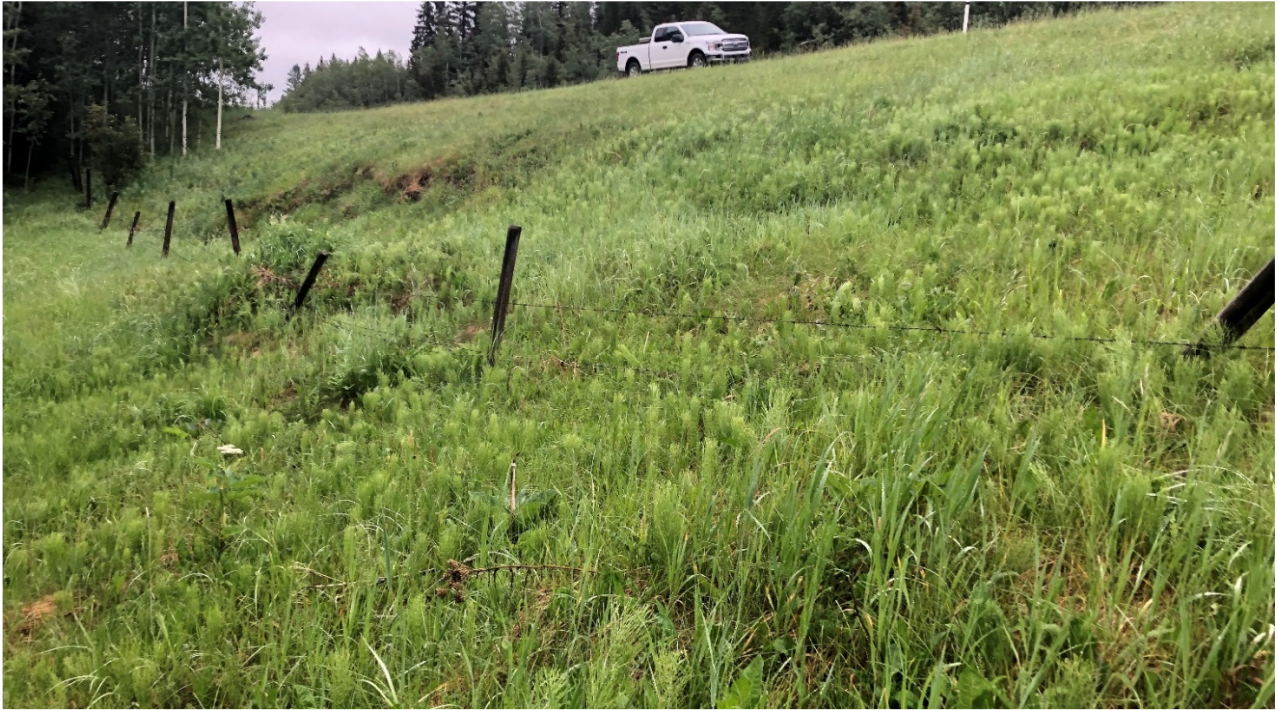
Photo 3 Slide area viewed from toe. Photo taken facing east on July 5, 2021.

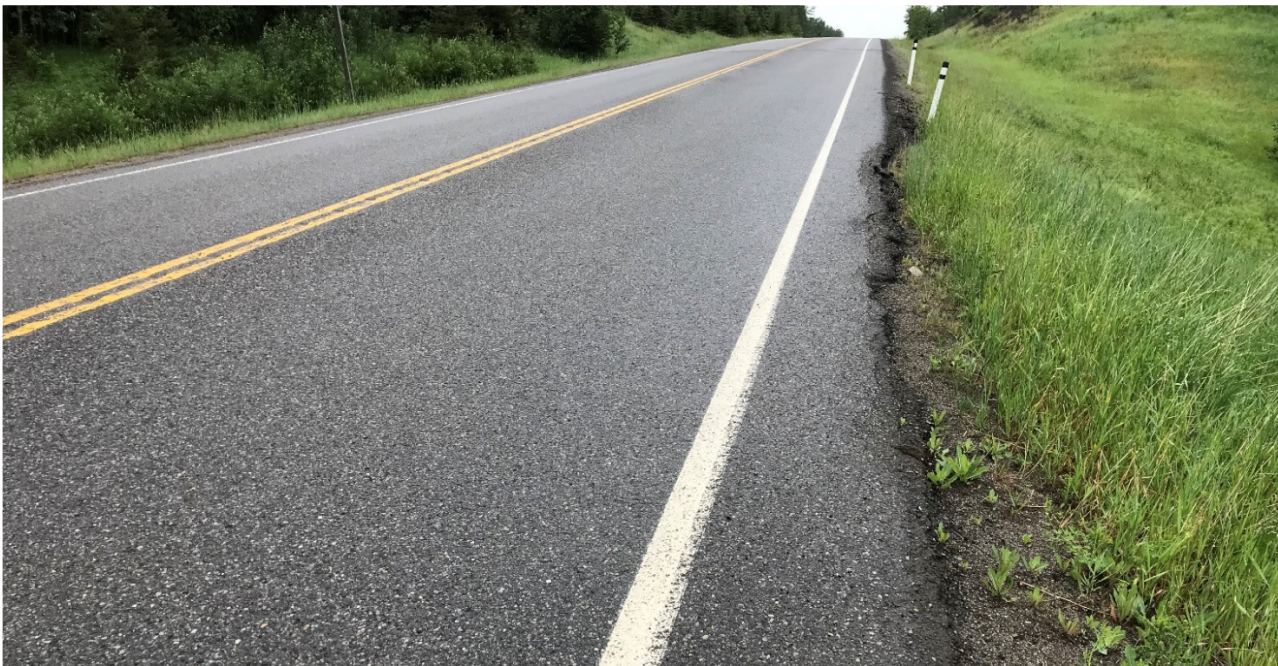
Photo 4 No pavement cracking observed on the highway. Photo taken facing southwest on July 5, 2021.
