SITE NUMBER AND NAME: S041 East Coulee Slide		HIGHWAY & KM: 564:10, 32.353	PREVIOUS INSPECTION DATE: June 10, 2020	INSPECTION DATE: June 24, 2021
LEGAL DESCRIPTION: 04-21-27-18 W4M	NAD 83 COORDINATES: UTM Northing Easting 12 5686022 396402		RISK ASSESSMENT: PF: 9 CF: 5 TOTAL: 45	
AVERAGE ANNUAL DAILY TRAFFIC (AADT): 130 (south), (Reference No. 113210)			CONTRACT MAINTENANCE AREA (CMA): 521

PROJECT SOUTHERN REGION GEOHAZARD RISK MANAGEMENT PROGRAM		
TITLE Site Plan S041 - East Coulee Slide Hwy 564:10 km, 32.353		
SCALE 1:1,500	PROJECT No. A05116A03	FIG No. 1

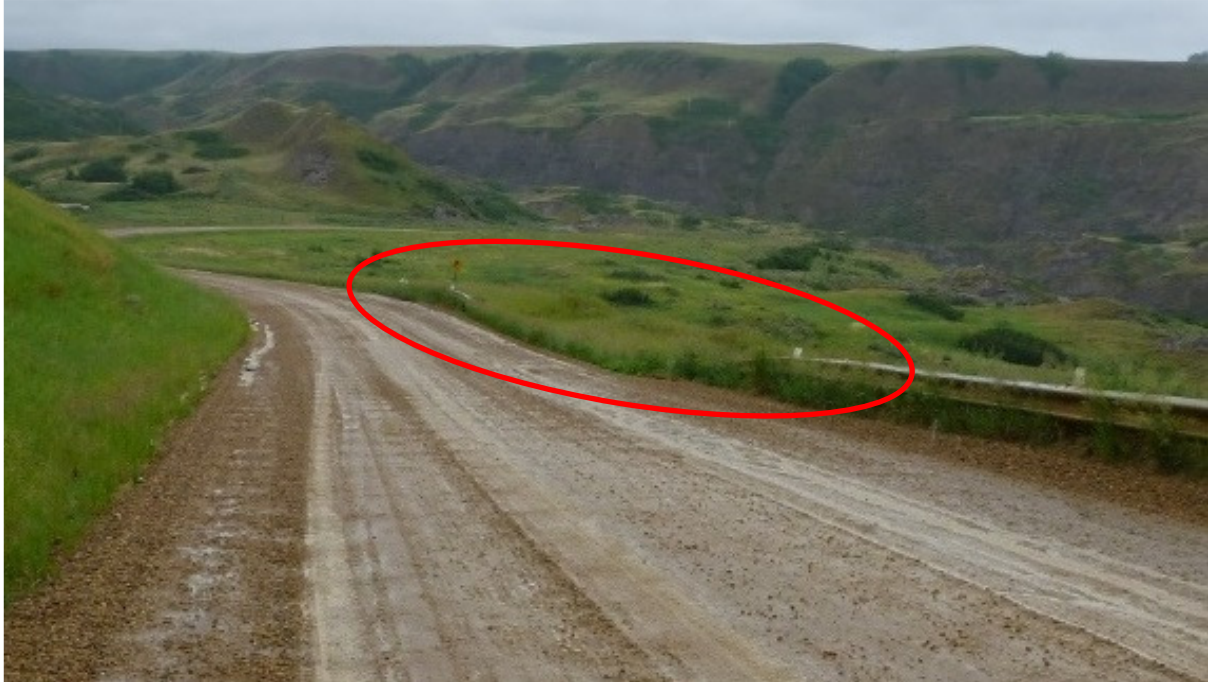
The guardrail appears to have subsided further since the 2020 inspection as the slope below the crest of the highway continues to fail. The top of the guardrail is now below the crest of the road. Note: the severity of guardrail subsidence may be accentuated by additional gravel placement on roadway.

Photo 1 Guardrail has subsided below the surface of the road (red circle). Photo taken facing southwest on June 24, 2021.

- Raising the elevation of the roadway to create a proper ditch on the south side of the highway (would require limited and carefully executed cutting into the existing backslope to create additional width for a ditch) and protect the ditch from being infilled.
- Raise subsided guardrail on north side of highway to prevent motorists from driving over the edge of the slope.

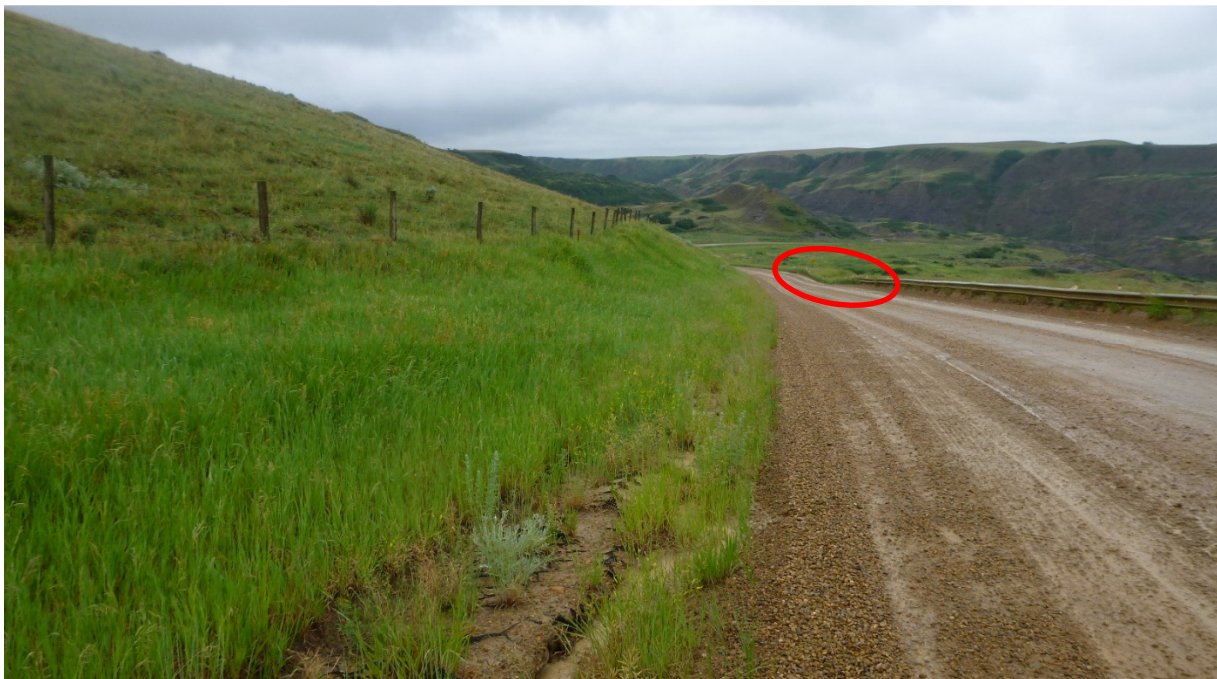
Drainage at the site is poor. A shallow ditch exists on the south side of the highway but is periodically filled with gravel during grading. The old geocell in the ditch has also been damaged and buried during grading operations. Where the highway is subsided, surface water from the ditch flows across the highway onto the slide area. Slope movements are likely exacerbated by infiltration of this surface water flow into cracks at the crest of the slide. Erosion is occurring at the culvert outlet northeast of the soil nail reinforced slope.

Photo 2 Shallow ditch on south side of highway has insufficient capacity to carry surface flows without discharging water across the road onto the slide mass. Photo taken facing southwest on June 24, 2021.

- Installing drainage (e.g., a ditch or culvert) to redirect water away from the slide area using a slope drain with energy dissipater to convey water over the slope and prevent further erosion or saturation of the slide area. A pile wall could be installed to stabilize the road, however the traffic volume may not justify a pile-wall.

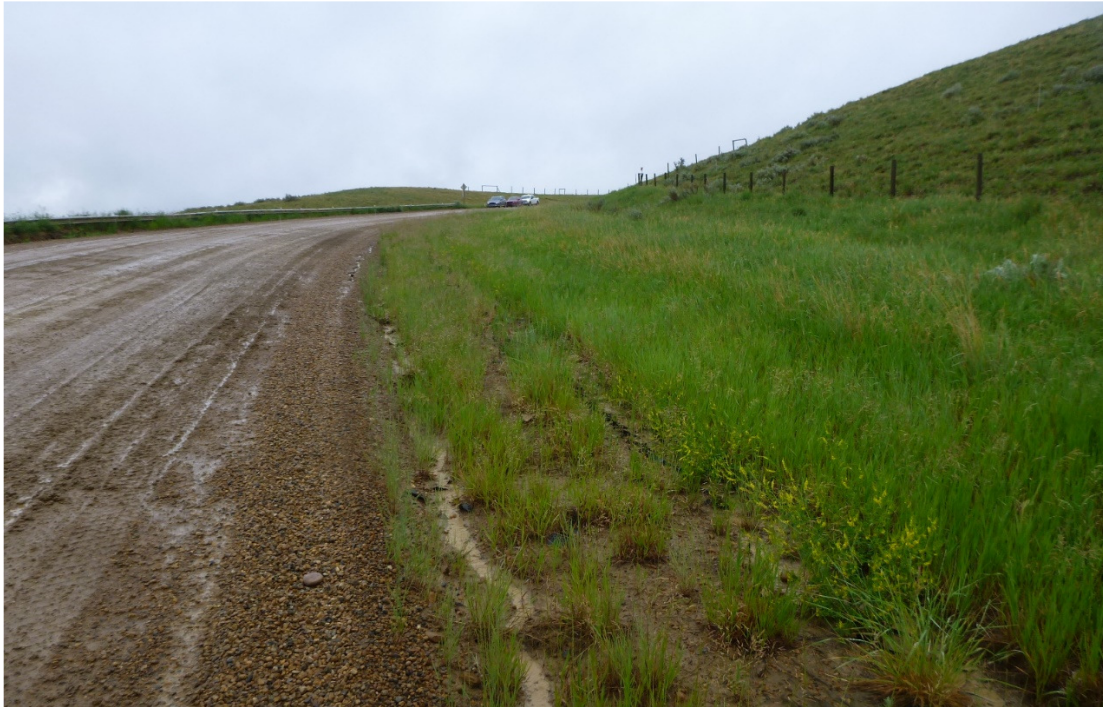
Photo 3 Shallow ditch on south side of highway has insufficient capacity to carry surface flows without discharging water across the road onto the slide mass. Photo taken facing northeast on June 24, 2021.

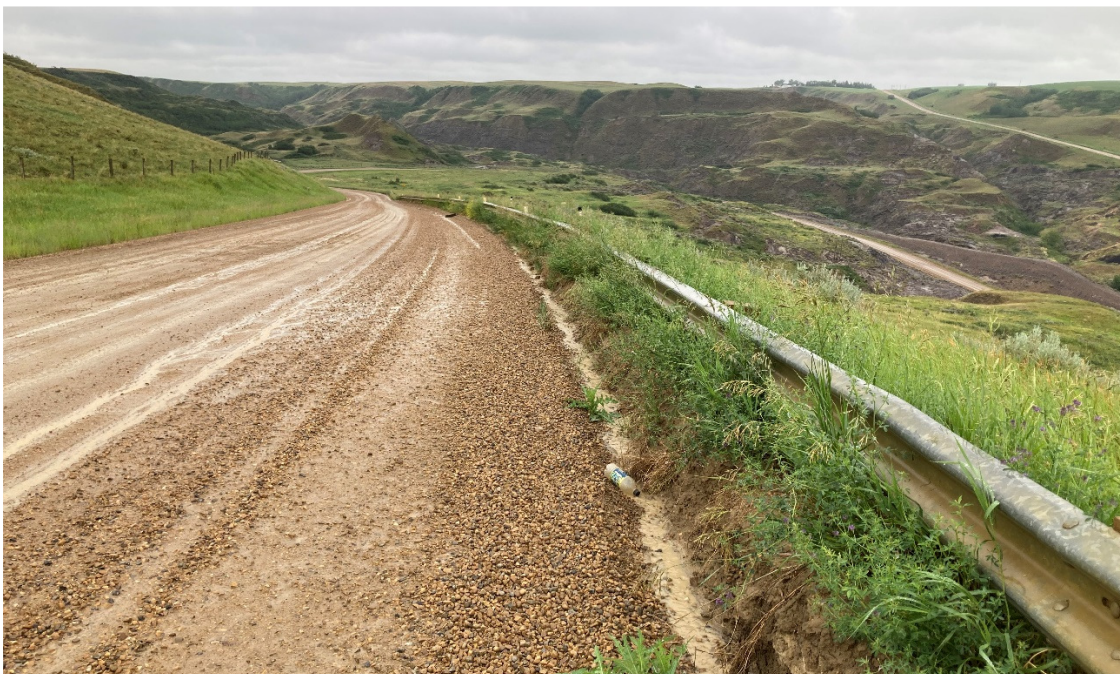
Photo 4 Surface runoff discharges northwards across the road onto the slide mass due to insufficient capacity in ditch on south side of highway. Photo taken facing southwest on June 24, 2021.
