SITE NUMBER AND NAME: S041 East Coulee Slide		HIGHWAY & KM: 564:10, 32.353	PREVIOUS INSPECTION DATE: June 24, 2021	INSPECTION DATE: May 31, 2022
LEGAL DESCRIPTION: 04-21-27-18 W4M	NAD 83 COORDINATES: UTM Northing Easting 12 5686022 396402		RISK ASSESSMENT: PF: 8 CF: 5 TOTAL: 40	
AVERAGE ANNUAL DAILY TRAFFIC (AADT): 60 (south) (Reference No. 113210)			CONTRACT MAINTENANCE AREA (CMA): 521

PRIMARY SITE ISSUE: A natural slope failure on the west side (southbound lane) of Hwy 564 that was triggered by highway widening (i.e., cut and fill placement) in 1979.

PROJECT SOUTHERN REGION GEOHAZARD RISK MANAGEMENT PROGRAM		
TITLE Site Plan S041 - East Coulee Slide Hwy 564:10, km 32.353		
SCALE 1:1,500	PROJECT No. A05116A03	FIG No. 1

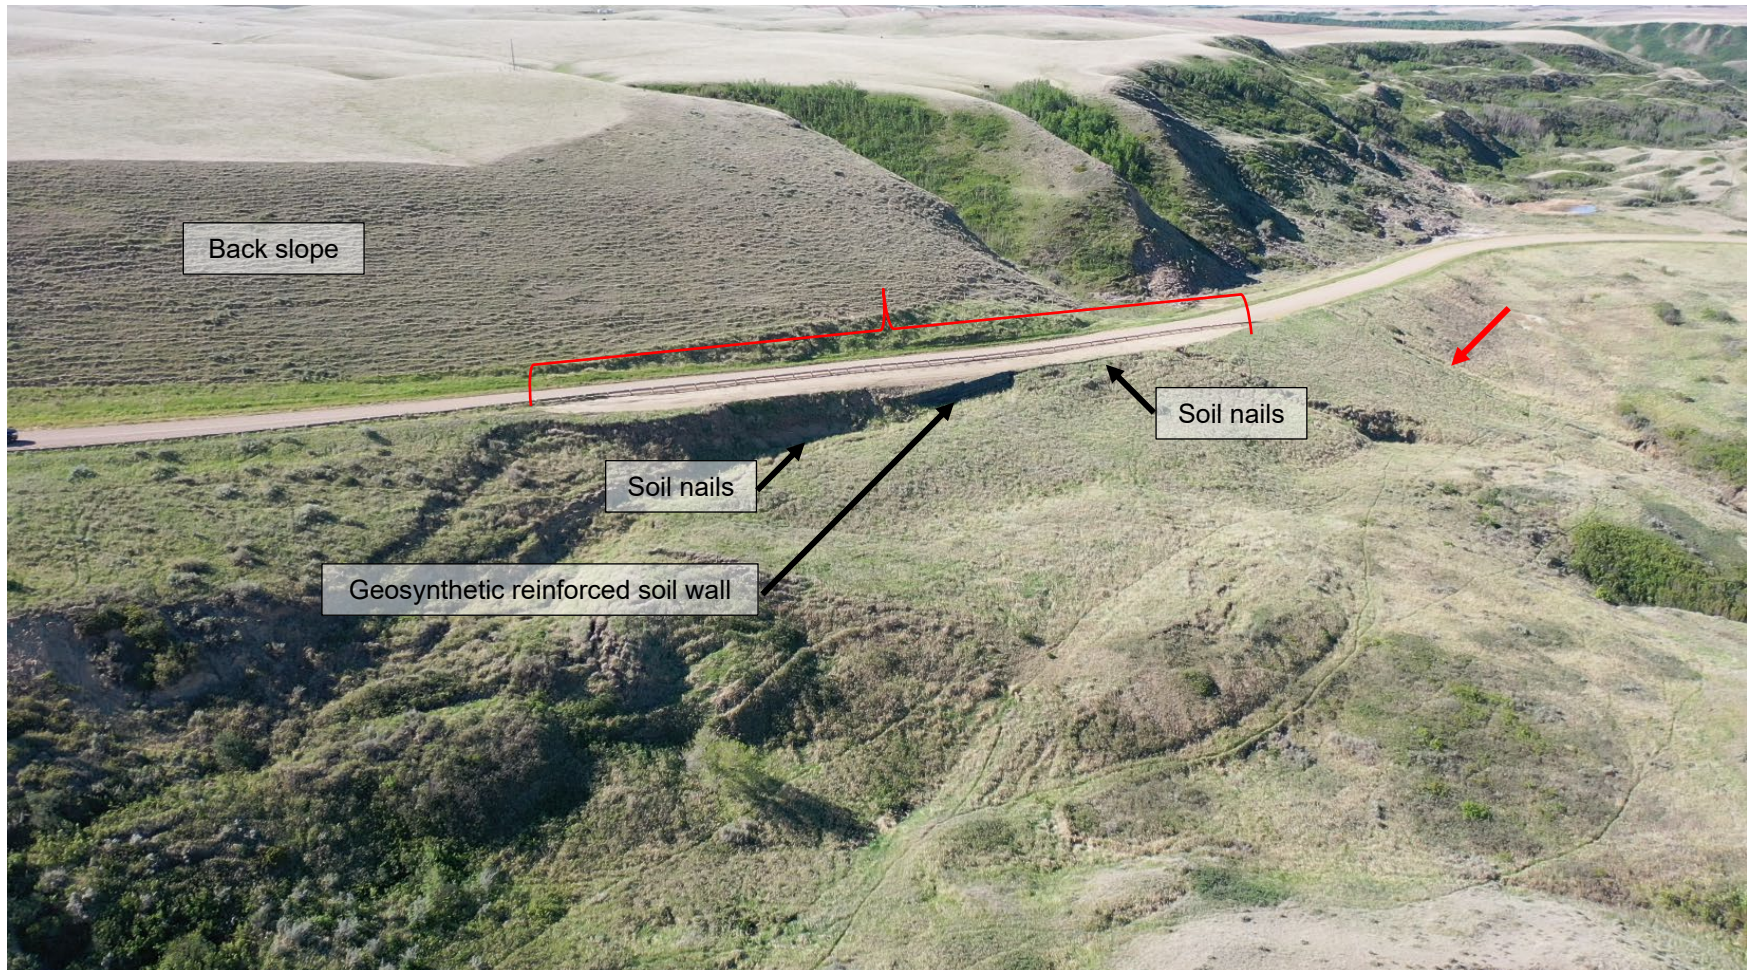
During the 2021 work, the back slope was not impacted, and the toe remains in the same location as during previous inspections (Photo 1 through 3).

Photo 1 Aerial photo of the S041 East Coulee Slide site indicated the approximate locations of the CSP slope drain (indicated by red arrow), length of highway and guardrail shifted south in November 2021 (indicated by red bracket), and location of previous repairs. Photo taken May 31, 2022, facing south.

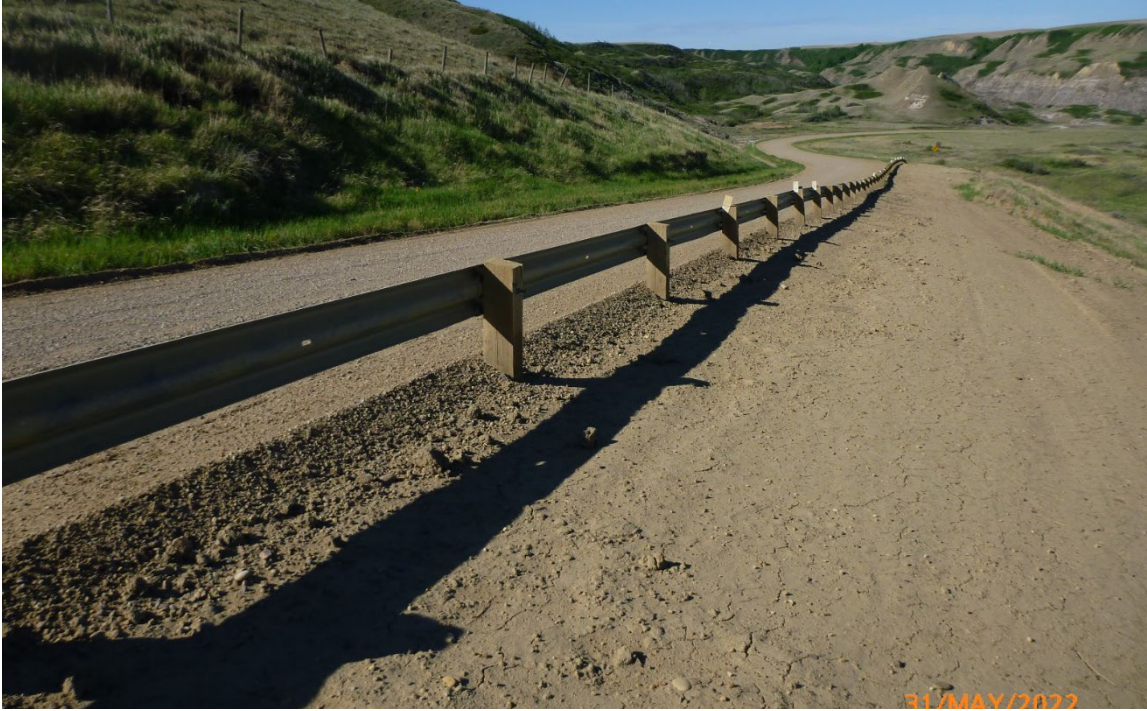
In 2021, the guardrail was raised and shifted south up to approximately 3 m as part of realigning the highway/road narrowing (Photo 1). The highway surface was shifted/realigned south into the south (eastbound) ditch and a "Road Narrows – 35 km/hr" sign was installed in beside the south (westbound) lane at the east end of the site (i.e., near the top of the hill) (Photo 3).

Photo 2 The guardrail and highway has been shifted approximately 3 m south towards the back slope, narrowing the highway and south (eastbound) ditch. Photo taken May 31, 2022, facing southwest.

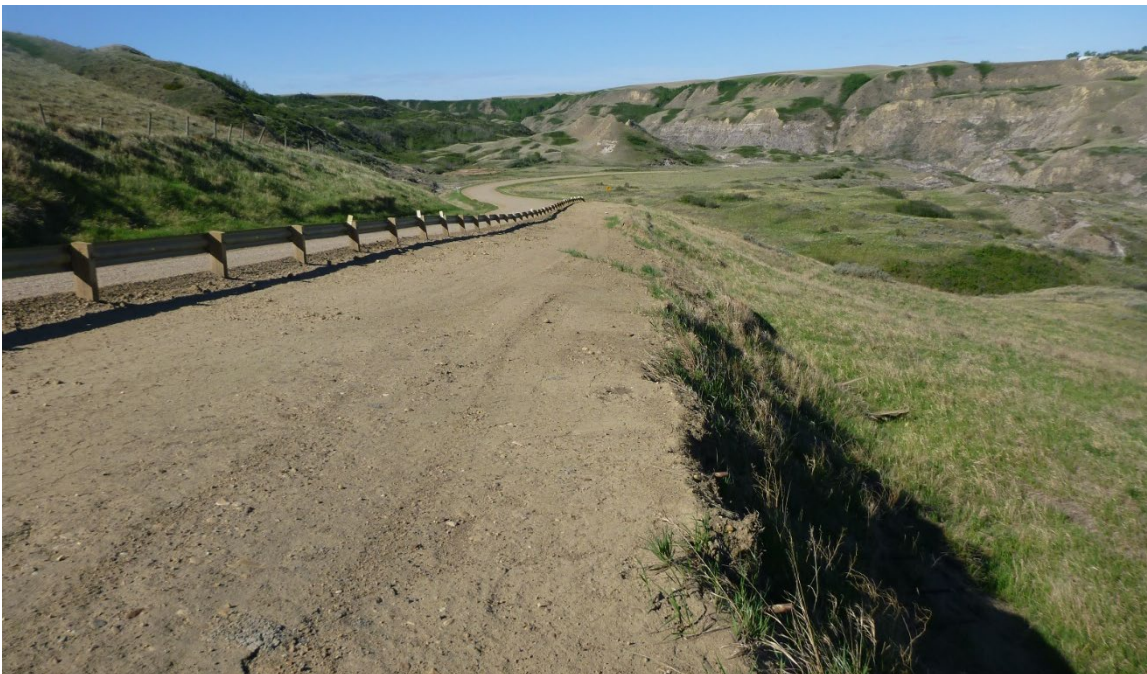
The area downslope of the guardrail was graded during the 2021 work, but no vegetation has begun to grow (Photo 3).

Photo 3 North side of the guardrail has been graded but does not have any vegetation cover. Photo taken May 31, 2022, facing southwest.

- The site was repaired in 2021. The site should continue to be monitored and inspected once per contract cycle as part of the Southern Region GRMP Section B inspections.
- The site should be inspected by AT’s MCI and if vegetation does not begin to grow downslope of the guardrail, the area should be seeded with a seed mix suitable for the Alberta Badlands.

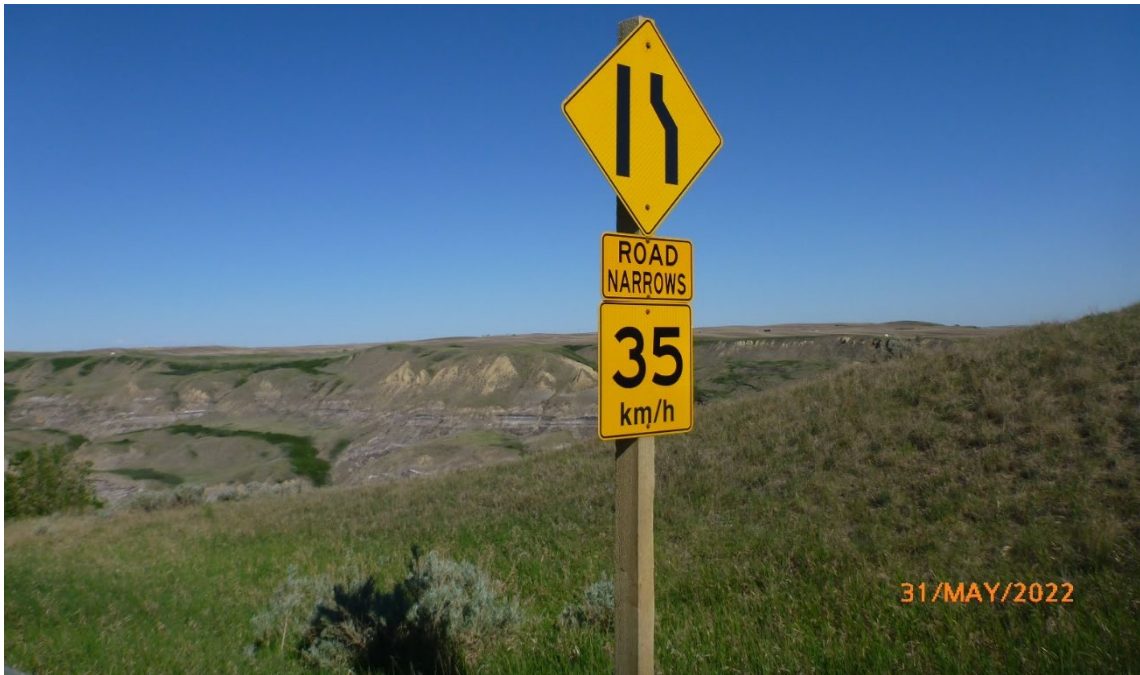
Photo 4 A “Road Narrows – 35 km/hr” sign was installed near the top of the hill east of the site. Photo taken May 31, 2022, facing north.

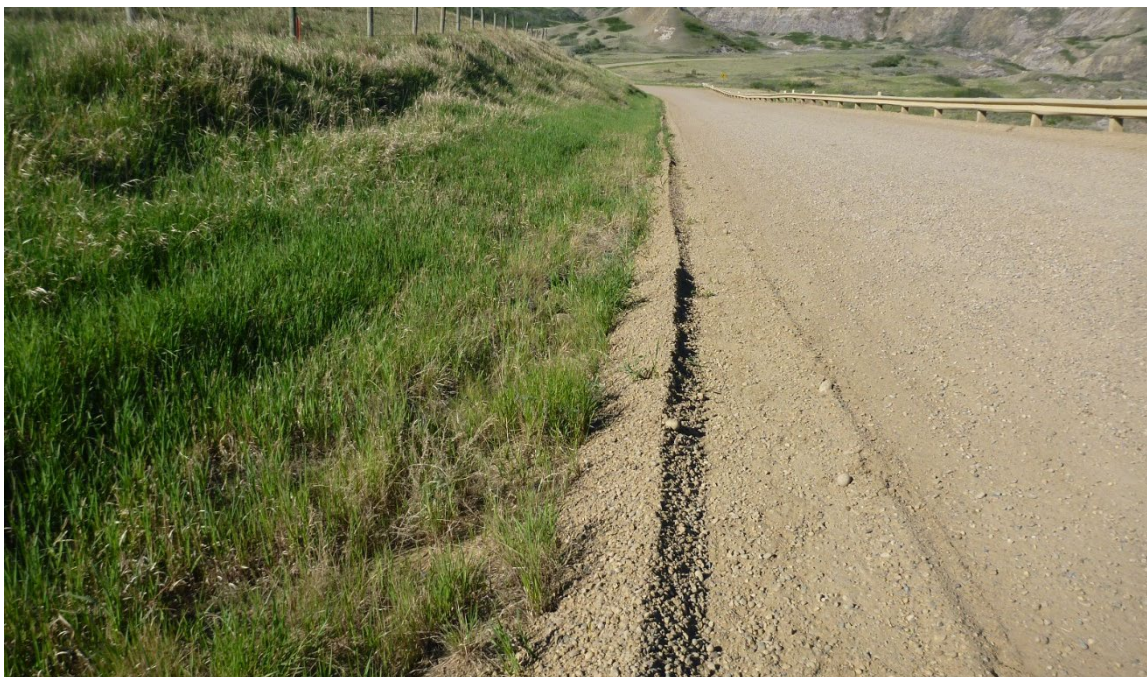
Drainage at the site is poor. A shallow ditch exists on the south side of the highway but is periodically filled with gravel during grading. The old geocell in the ditch has also been damaged and buried during grading operations.

During the 2021 realignment work, the south (eastbound) ditch was narrowed considerably (from a wide flat ditch to a “v-ditch”) (Photo 4) and the highway was graded towards the downslope direction. To reduce the likelihood/degree of surface water runoff from the highway infiltrating into the slide zone, a gravel “berm” was built below the guardrail (Photo 2).

Photo 5 The south (eastbound) ditch was narrowed during the highway realignment and is now a v-ditch. Photo taken May 31, 2022, facing southwest.
