SITE NUMBER AND NAME: <b>S041 East Coulee Slide</b>		HIGHWAY & KM: 564:10, 32.353	PREVIOUS INSPECTION DATE: May 31, 2022	INSPECTION DATE: <b>June 18, 2024</b>
LEGAL DESCRIPTION: 04-21-27-18 W4M	NAD 83 COORDINATES: UTM Northing Easting 12 5686022 396402		RISK ASSESSMENT: Slide: PF: 8 CF: 3 TOTAL: 24 Erosion: PF: 11 CF: 4 TOTAL: 44	
AVERAGE ANNUAL DAILY TRAFFIC (AADT): 60 (south) (Reference No. 113210)			CONTRACT MAINTENANCE AREA (CMA): 521

PROJECT SOUTHERN REGION GEOHAZARD RISK MANAGEMENT PROGRAM		
TITLE Site Plan S041 - East Coulee Slide Hwy 564:10, km 32.353		
SCALE 1:1,500	PROJECT No. A05116A03	FIG No. 1

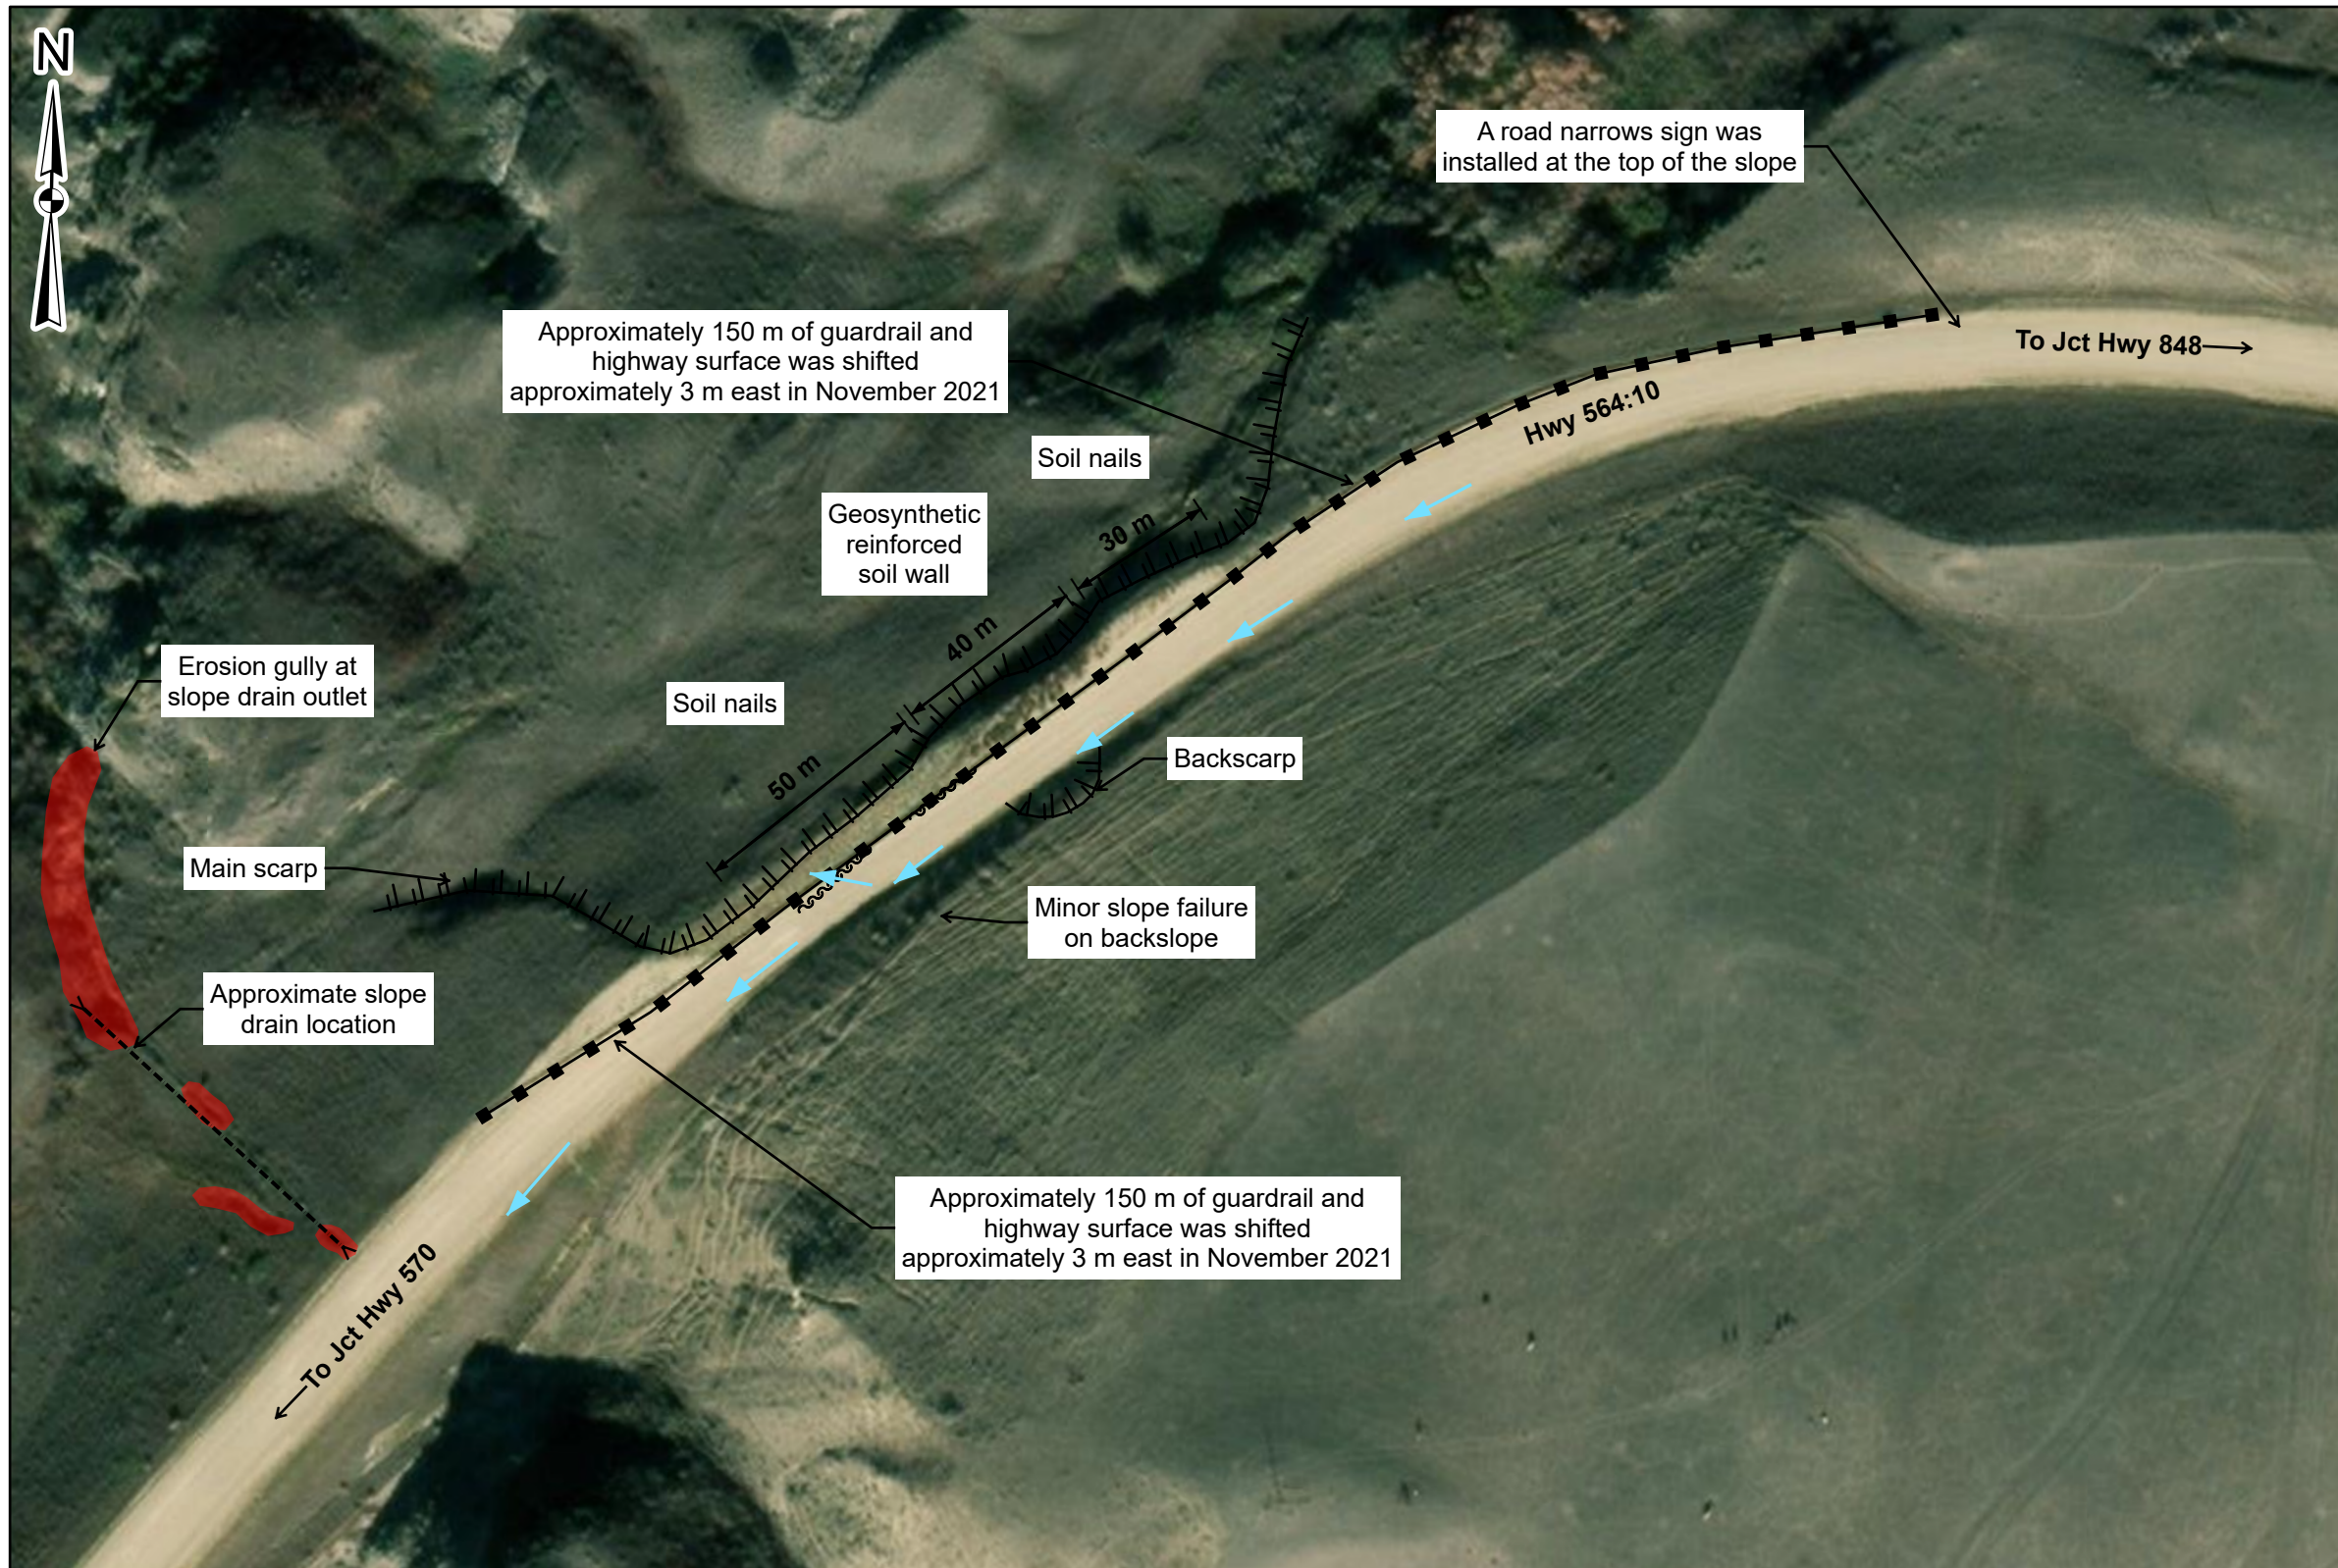
Approximately 150 m of guardrail and highway surface was shifted approximately 3 m east in November 2021

Minor slope failure on backslope

Erosion gully at slope drain outlet

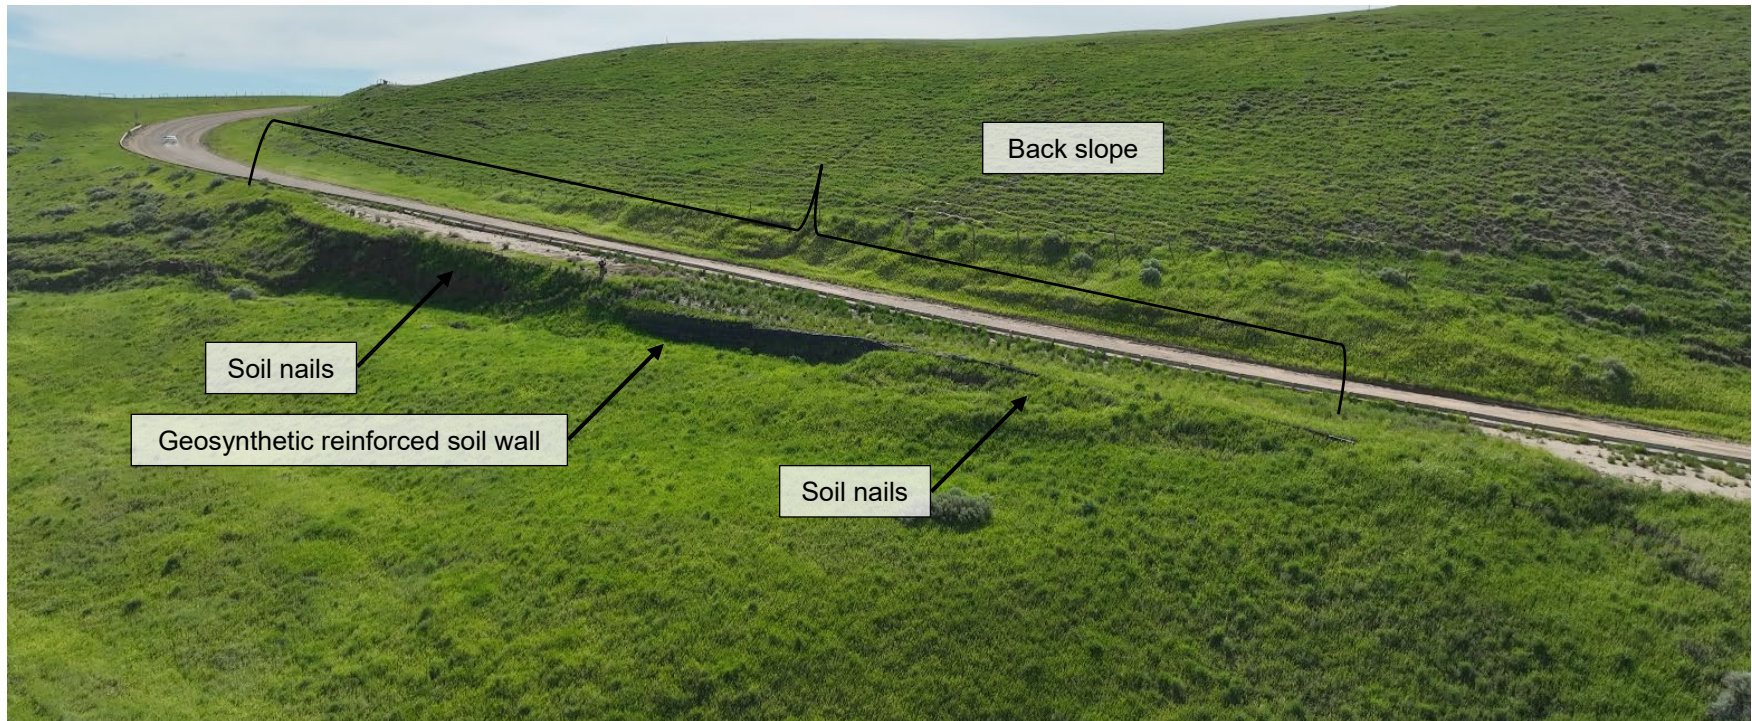
**Photo 1** Aerial photo of the S041 East Coulee Slide site indicating the length of highway where there has been previous repairs (soil nails and geosynthetic reinforced soil wall). The westbound lane was shifted upslope in 2021. Photo taken June 18, 2024, facing southeast.

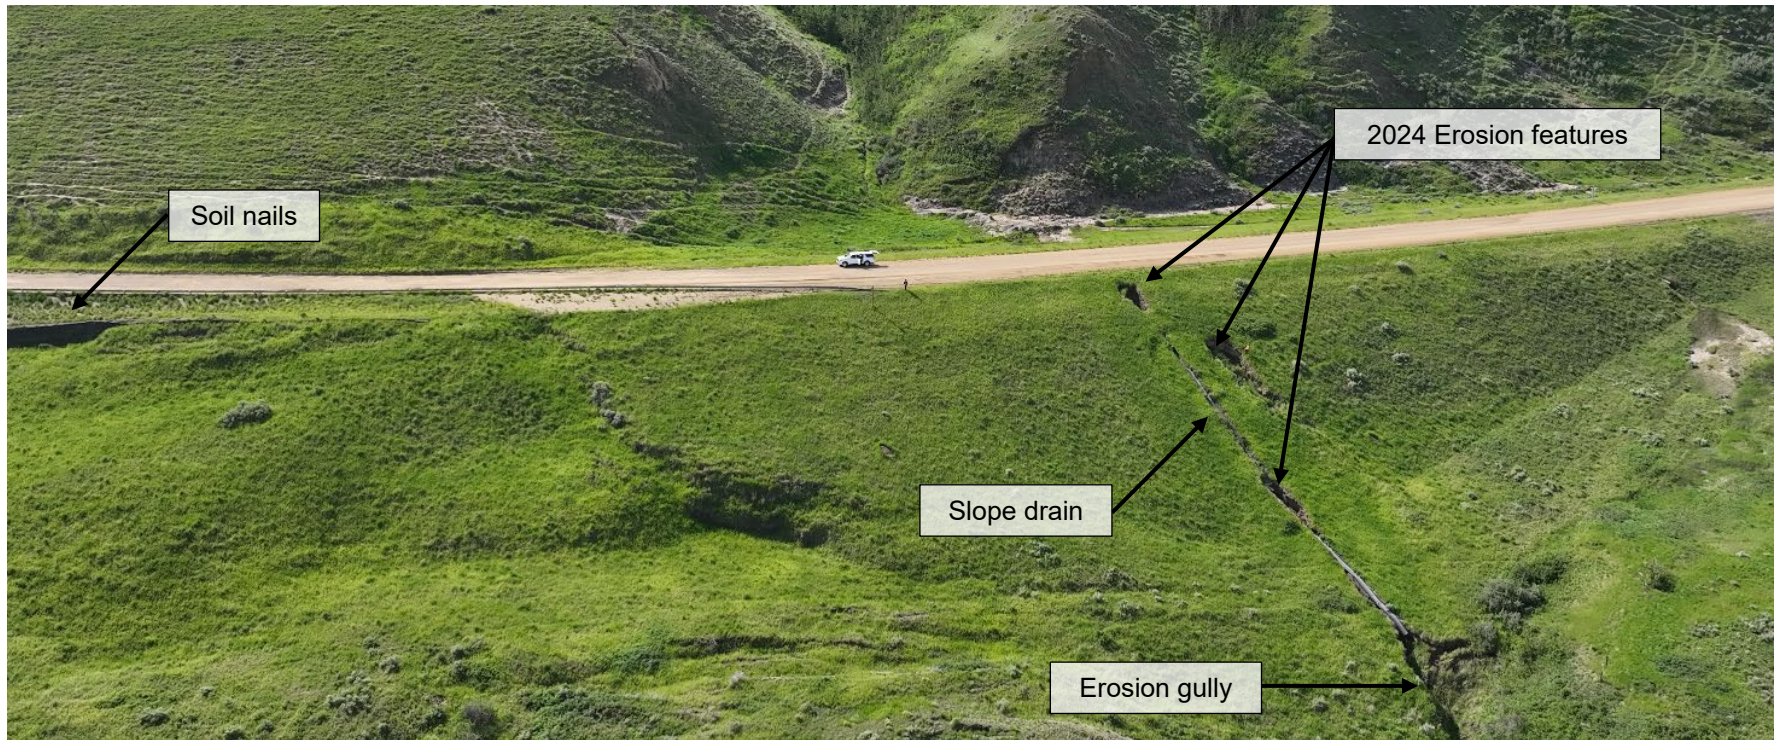
- Along the half pipe CSP slope drain (downslope of the CSP culvert) there is evidence of ongoing erosion, likely from surface water flow from the highway embankment and leakage from the slope drain (Photo 2).

- At the slope drain outlet, there is a large erosion gully (Photo 2). The erosion gully was observed from a distance during the 2024 inspection and no field measurements were taken. The erosion gully is not yet impacting the highway embankment and is outside of TEC’s right-of-way.

**Photo 2** Aerial image of the west extent of the S041 East Coulee Slide site, indicating the west soil nail repair, slope drain west of the slide site, as well as new erosion features near/along the slope drain. Photo taken June 18, 2024, facing south.

- The slope drain should be replaced with a seamless HDPE slope drain and an energy dissipation structure built at the slope drain outlet.
  - KCB can prepare and issue a proposal for the hydrotechnical assessment and design of the replacement culvert, slope drain, and energy dissipation structure (including design figures, quantities, and c-estimate). KCB believes this repair should be completed by TEC’s HMC and can prepare a Request for Quotation (RFQ) to provide to the HMC.

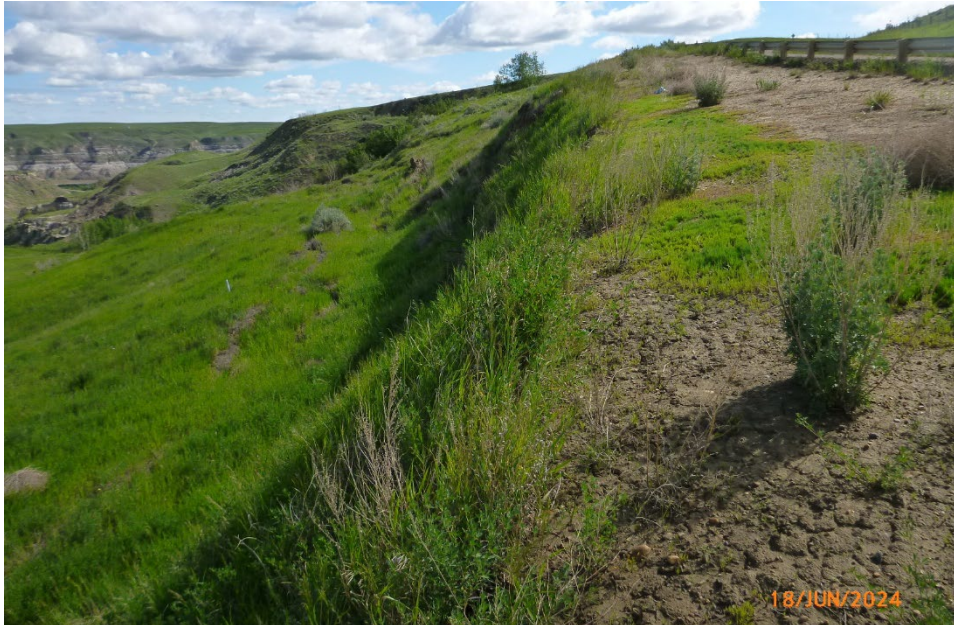
- The area downslope of the guardrail, above the previous slope repairs and along where the highway was shifted in 2021, is poorly vegetated (Photo 3).

**Photo 3** Crest along the eastern portion of the slide at the location of the previous soil nail repair. Slope is poorly vegetated downslope of the guardrail (upslope of the soil nails) after the highway was shifted in 2021. Photo taken June 18, 2024, facing east.

- The highway should be regularly graded by TEC’s HMC to direct flows towards the south (westbound) ditch and off the slide.
- The site should be regularly inspected by TEC’s MCI. The vegetation cover is poor downslope of the guardrail, where the highway was shifted in 2021. The area should be seeded with a seed mix suitable for the Alberta Badlands.

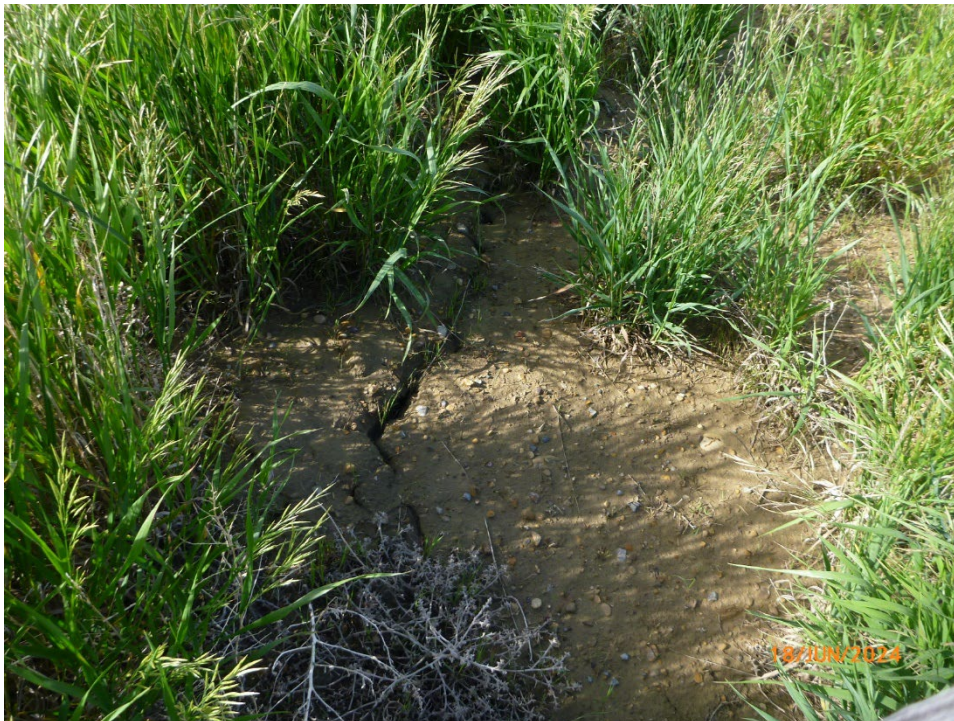
- During the inspection, ground cracks up to approximately 50 mm wide was observed upslope of the geosynthetic reinforced soil wall (Photo 4). The geosynthetic wall appears to have deflected between the 2022 and 2024 inspections (Photo 5).

**Photo 4** Ground crack up to approximately 50 mm wide located upslope of the geosynthetically reinforced soil wall. Photo taken June 18, 2024.

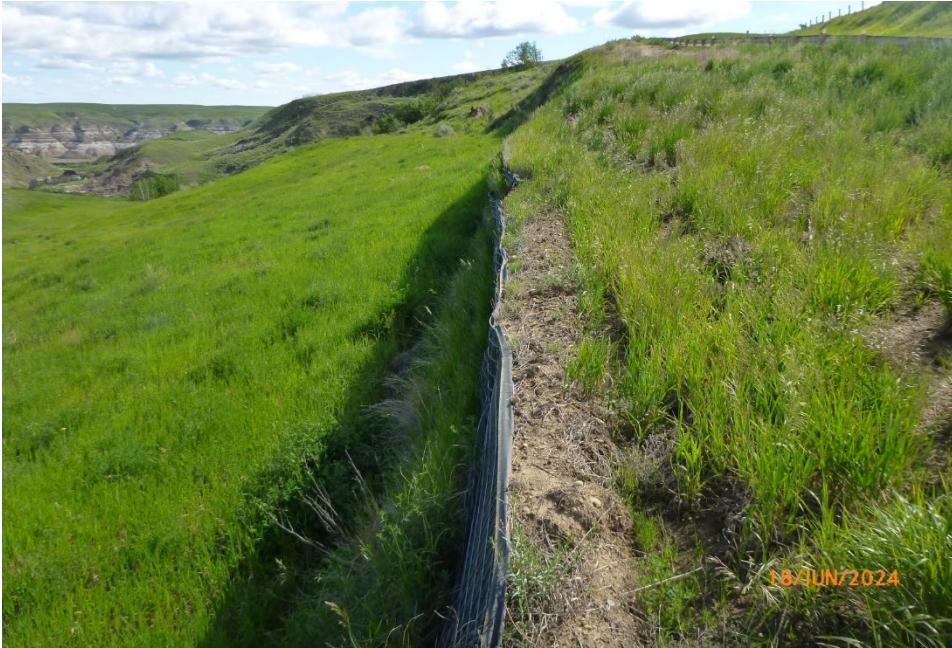
**Photo 5** The slope along the geosynthetically reinforced soil wall appears to have deflected between the 2022 and 2024 inspections. Photo taken June 18, 2024, facing east.

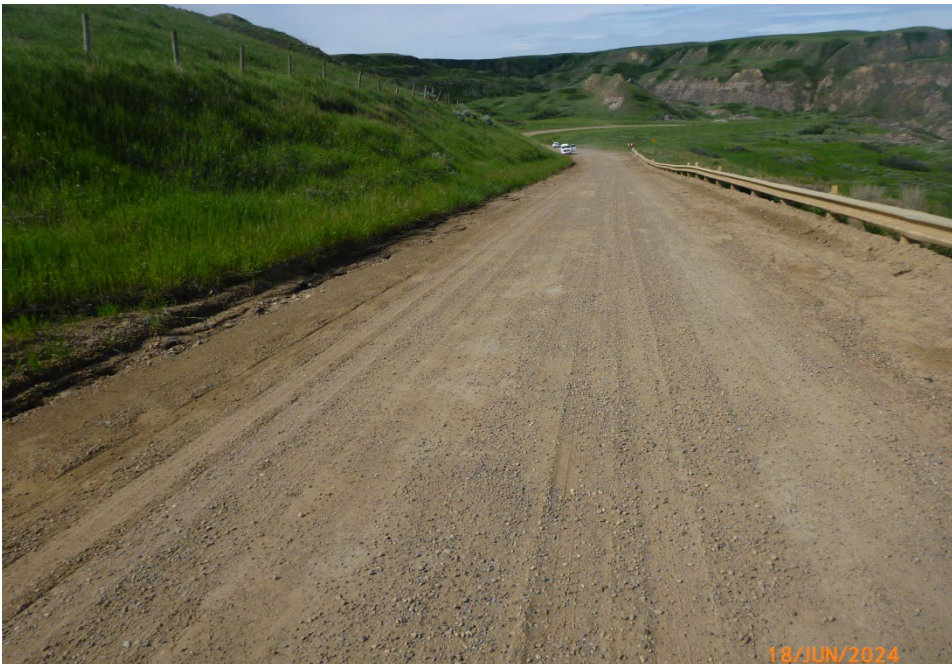
- Drainage at the site is poor. A shallow ditch exists on the south side of the highway but is periodically filled with gravel during grading. The old geocell in the ditch has also been damaged and buried during grading operations. There was minor erosion observed in the south (westbound) ditch during the inspection (Photo 6).

**Photo 6** The highway surface is in good condition. There is minor erosion along the south (eastbound) ditch. Photo taken June 18, 2024, facing west.

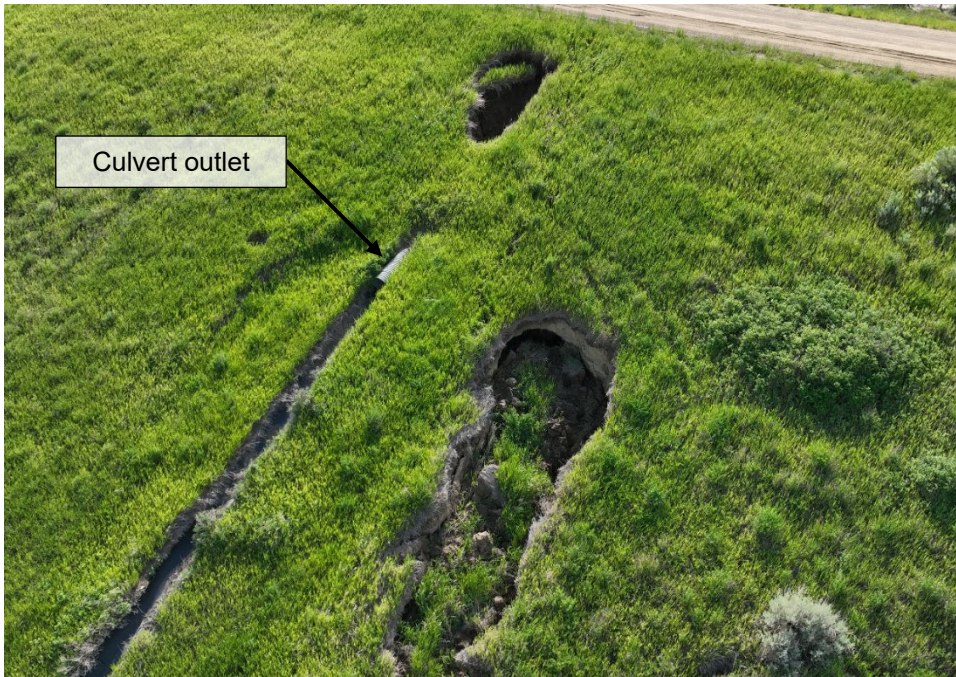
- A sinkhole above the CSP culvert underlying the highway developed between the 2022 and 2024 inspections (Photo 7). The sinkhole is approximately 4 m in diameter and up to 2 m to 3 m deep. At the base of the sinkhole, the CSP culvert has separated (Photo 8).

- Flow from surface runoff and from the CSP culvert has resulted in piping through the highway embankment, and a second sinkhole has formed approximately 10 m to 15 m northwest of the sinkhole above the CSP culvert (Photo 7). This sinkhole is approximately 3 m to 4 m wide, 2 m to 3 m deep, and 15 m to 20 m long.

**Photo 7** Sinkholes located above and west of the culvert underlying H564:10 and slope drain. The sinkhole to the west is significantly larger and more developed than during the 2022 inspection while the sinkhole above the culvert was first observed in 2024. Photo taken June 18, 2024, facing south.

- The separated culvert underlying the highway should be repaired. The hanging culvert should be removed, and a seamless HDPE pipe should sleeve the existing CSP culvert (the annulus between the new and existing culvert should be backfilled with grout). The new culvert should be backfilled with compacted non-dispersive material (e.g., well graded granular fill).

- During the repair work, the sinkhole west of the slope drain should be backfilled with compacted non-dispersive material (e.g., well graded granular fill).

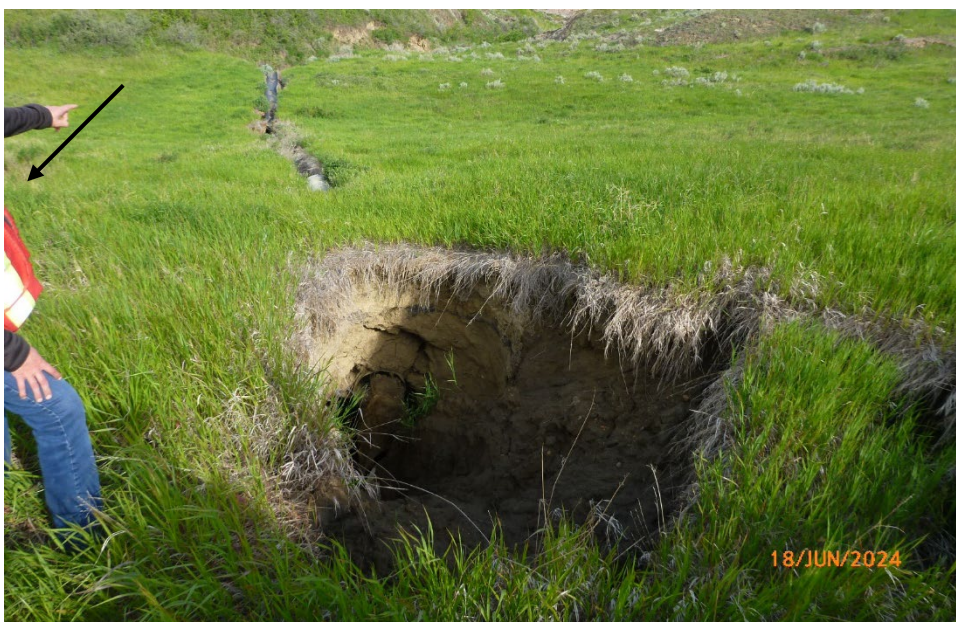
**Photo 8** Sinkhole above the culvert and upslope of the slope drain. Sinkhole is approximately 4 m in diameter and up to 2 m to 3 m deep. Lower sinkhole location indicated by black arrow. Photo taken June 18, 2024, facing north.
