Southern Region GRMP - Call – Out Report
Site S012; Hwy 742:02, km 4.319 Spray Lake Road

1 HWY 742:02, KM 4.319 CALL-OUT REPORT INTRODUCTION

PROJECT SOUTHERN REGION GEOHAZARD RISK MANAGEMENT PROGRAM		
TITLE April 19, 2017 Emergency Call-out S012 - Canmore Spray Lakes Road Hwy 742:02, km 4.319		
SCALE 1:1,000	PROJECT No. A05115A03	FIG No. 1

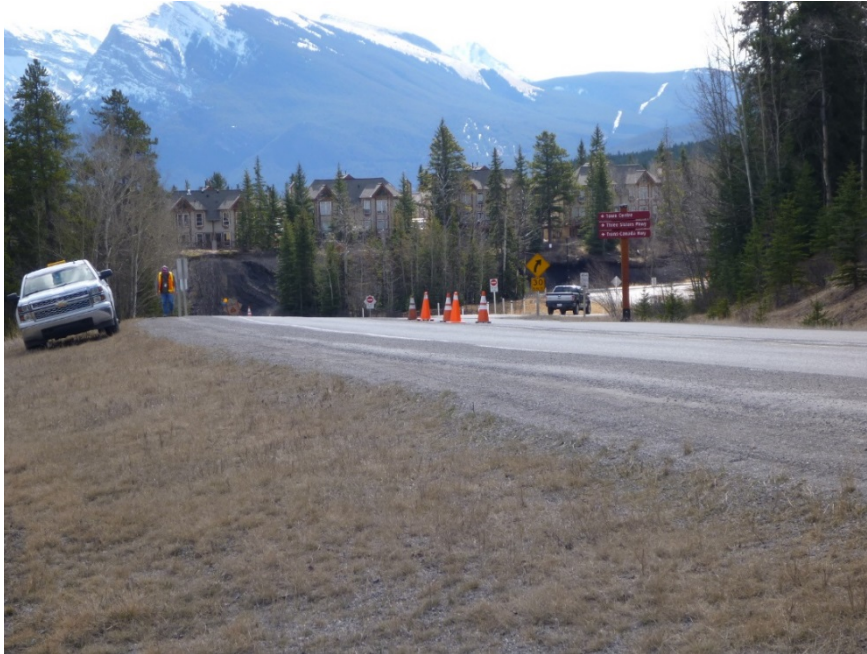
- A small pavement dip at the site appears to have increased in depth, based on the smoothness of vehicle ride across the site and visual inspection. The difference since last year is subtle. A view of the pavement dip is shown in Photo 1.

Photo 1 S012 site location with traffic cones in place. Photo taken west of S012 site, facing south east. Note dip at edge of road in westbound lane.

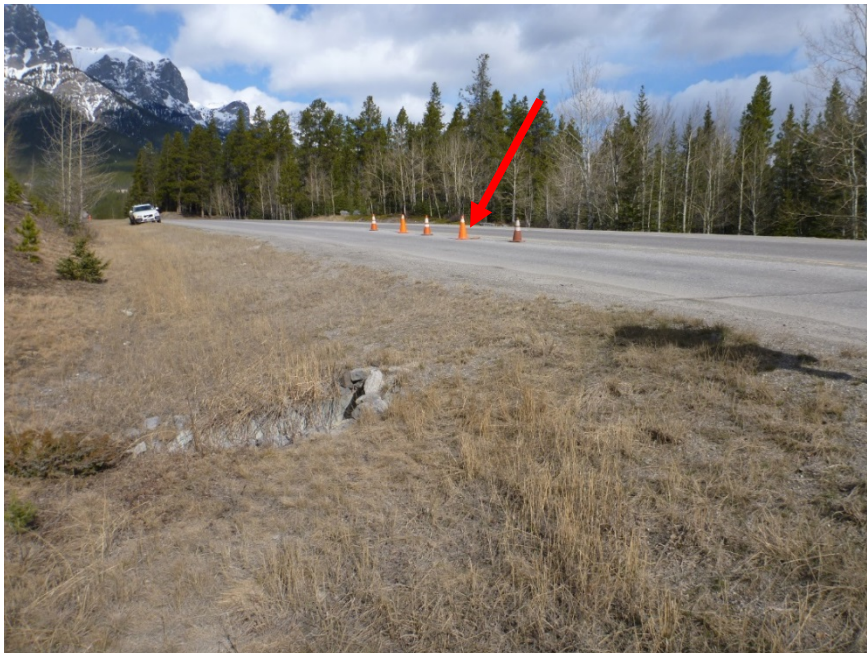
- The area of the sinkhole was delineated with traffic cones and an inverted cone was placed in the sinkhole as shown in Photos 2, 3 and 4.
- The edges of the hole are uniform and circular with a uniform diameter of approximately 250 mm as shown in Photo 5. The hole below the pavement was of uniform diameter and appeared to be an old borehole.

Photo 2 S012 sinkhole location (red arrow) with culvert to east of site in foreground. Photo taken facing northwest.

The MCI was advised to backfill the sinkhole as quickly as possible to minimize the potential for water to run into the void during rainfall events and further destabilize the coal-mine-void roof. KCB recommended that a foam backfill be used to fill the hole, with some manner of hole plug inserted a few meters down the borehole to hold the liquid foam in place until it expanded and cured. The asphalt could then be patched to seal the sinkhole and restore the smoothness of the pavement surface. At the end of the call-out visit the MCI advised KCB that the borehole would be backfilled with foam and patched with asphalt by Friday April 21, 2017. As a result, there was insufficient time to bring the downhole LiDAR camera subcontractor to site, even if our proposal dated March 6, 2017 was approved in-part or in-principle by AT.

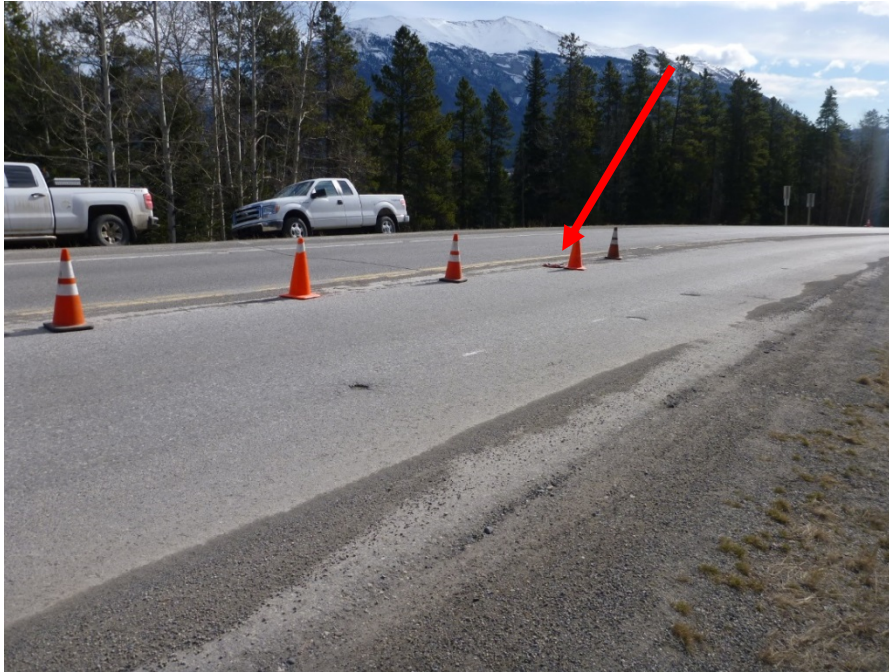
- Settlement of the remaining flush-mounted head boxes was observed. The MCI indicated that there have been no recent pavement overlays at the site. The settlement of the flush-mounted head boxes may indicate seepage of water from pavement surface into the coal-mine void. Seepage into the coal mine void could promote settlement of road surface and deformation of asphalt around boreholes.

Photo 3 S012 site with sinkhole location marked with a red arrow. Note boreholes drilled as part of historic investigations at this site. Photo taken facing northeast.

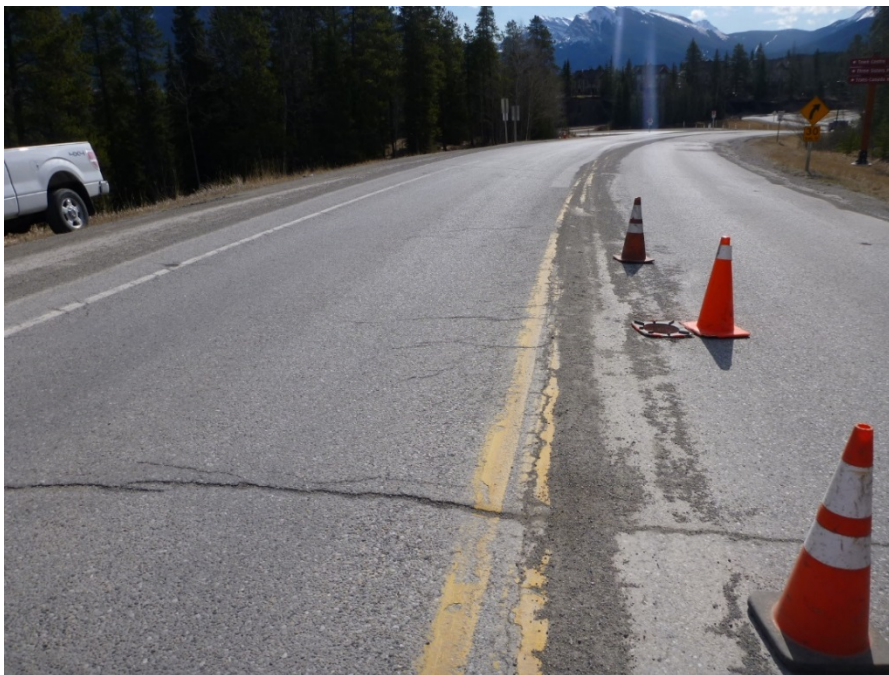
Photo 4 Inverted traffic cone marks location of sinkhole. Photo taken facing southeast.

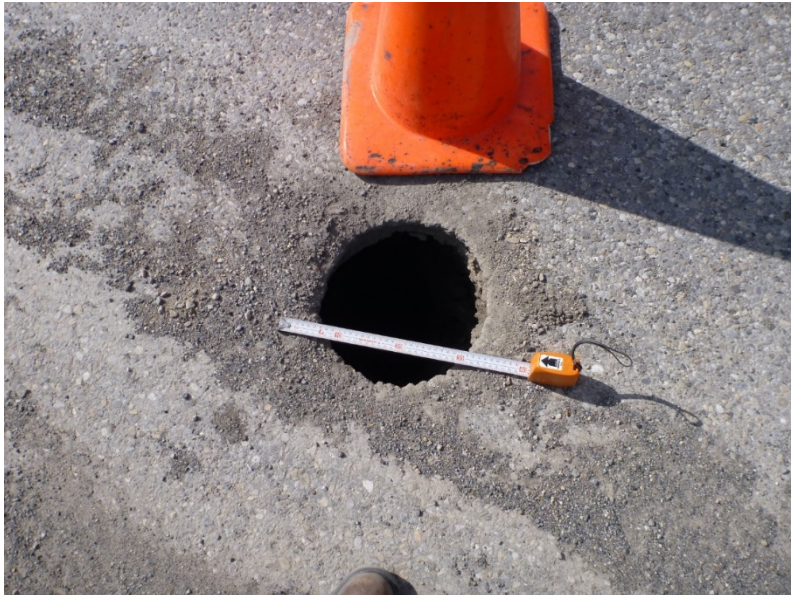
Photo 5 Sinkhole is uniform and appears to be a borehole location from previous investigations.

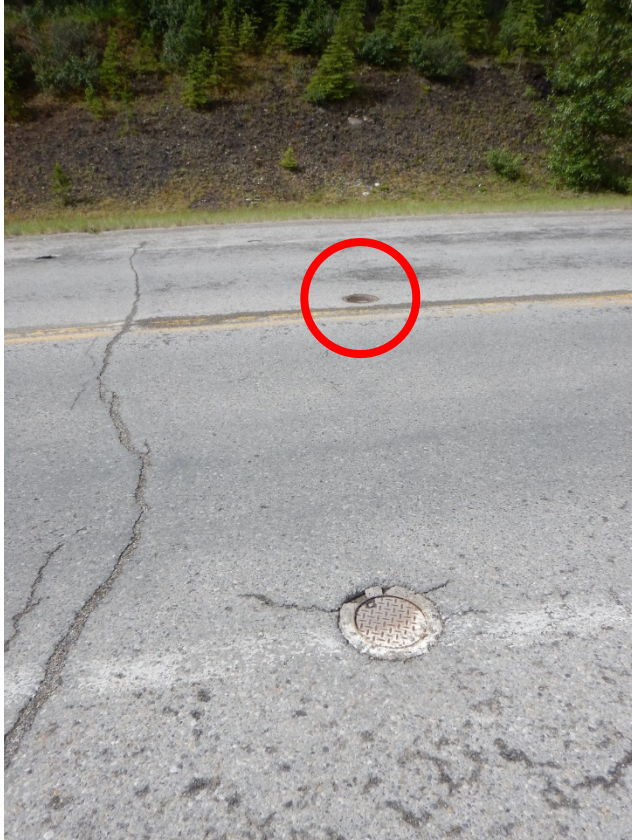
- A faint smell of rotten eggs was noted once during a period of no wind. This could indicate hydrogen sulphide gas escaping from the coal-mine void.
- The sinkhole reported by AT is a former location of a metal-capped borehole (flush-mounted headbox) located in the eastbound lane, close to centreline. A photo of the sinkhole site in June 2016 is included as Photo 6. The boreholes capped with a flush-mounted head box were used for downhole camera surveys in 2002. Footage captured during the 2002 downhole camera surveys shows that the boreholes were not cased. The remaining boreholes drilled during the 2002 investigation were capped with asphalt.

- It was KCB's opinion that it was surprising that the headbox and casing fell from surface into the void without hanging up within the borehole. It is unclear if the headbox fell into the borehole or was removed from ground surface.

Photo 6 Photo of sinkhole site taken during 2016 Section B inspection. Note that borehole at the location of the sinkhole had a removeable metal cap.

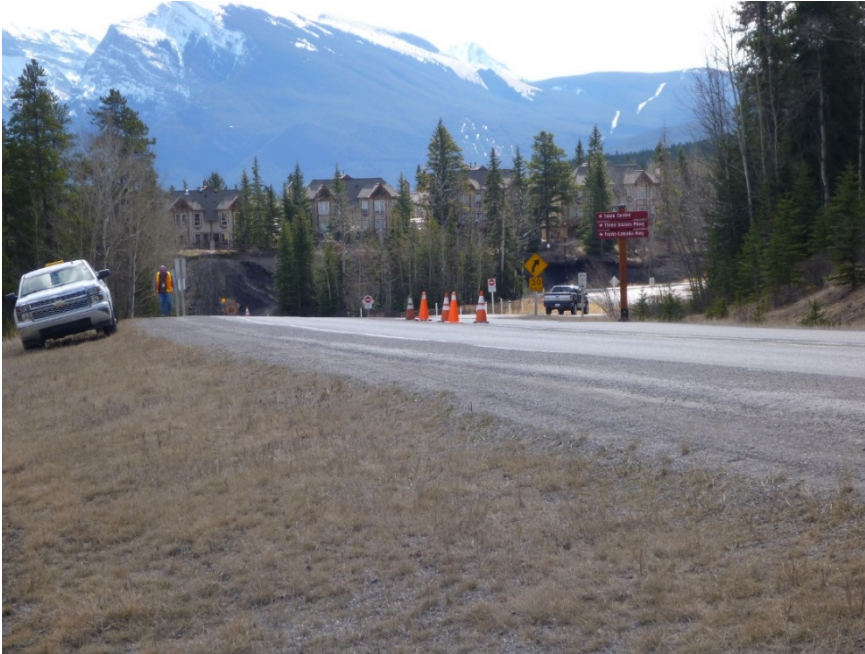
Photo 1 S012 site location with traffic cones in place. Photo taken west of S012 site, facing south east. Note dip at edge of road in westbound lane.

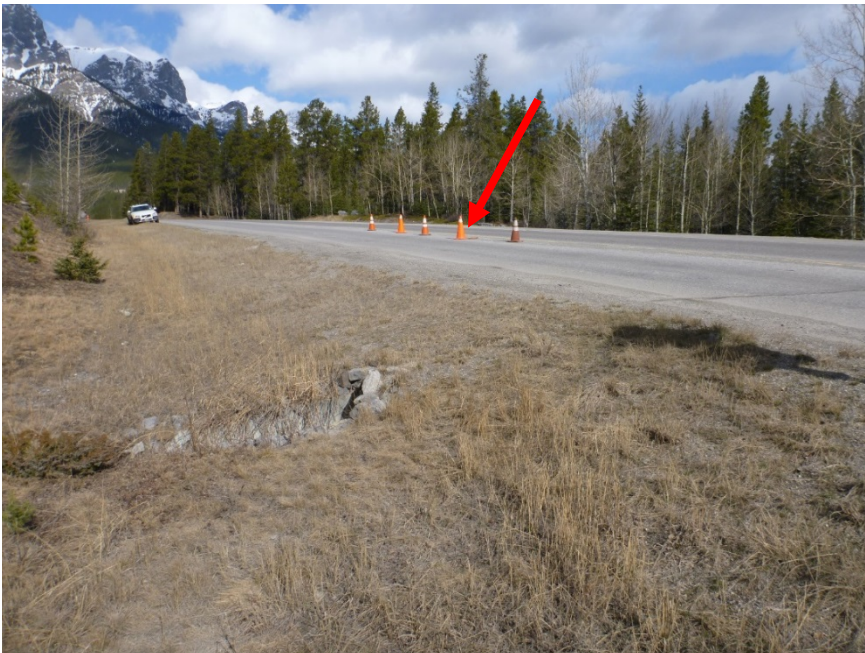
Photo 2 S012 sinkhole location (red arrow) with culvert to east of site in foreground. Photo taken facing northwest.

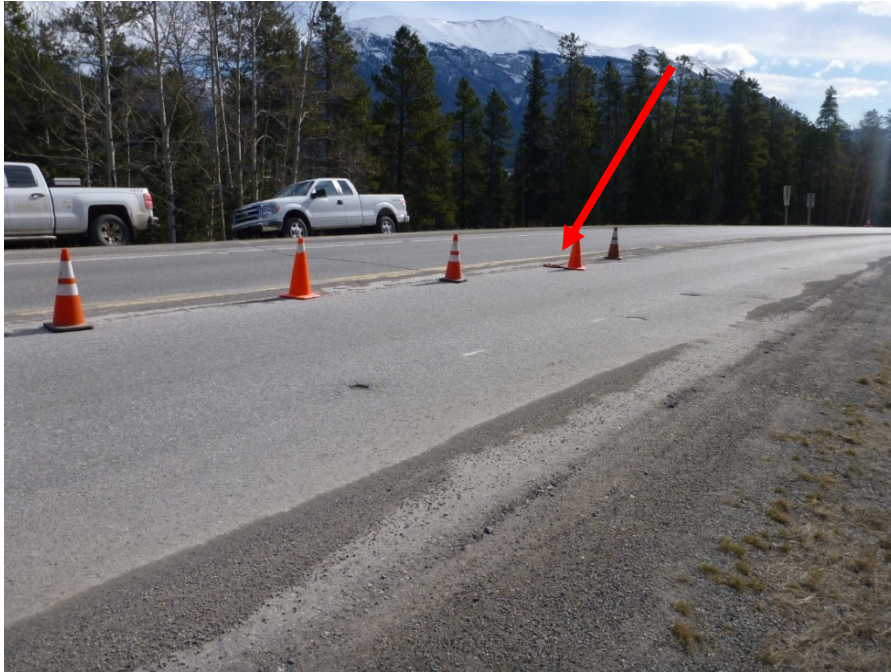
Photo 3 S012 site with sinkhole location marked with a red arrow. Note boreholes drilled as part of historic investigations at this site. Photo taken facing northeast.

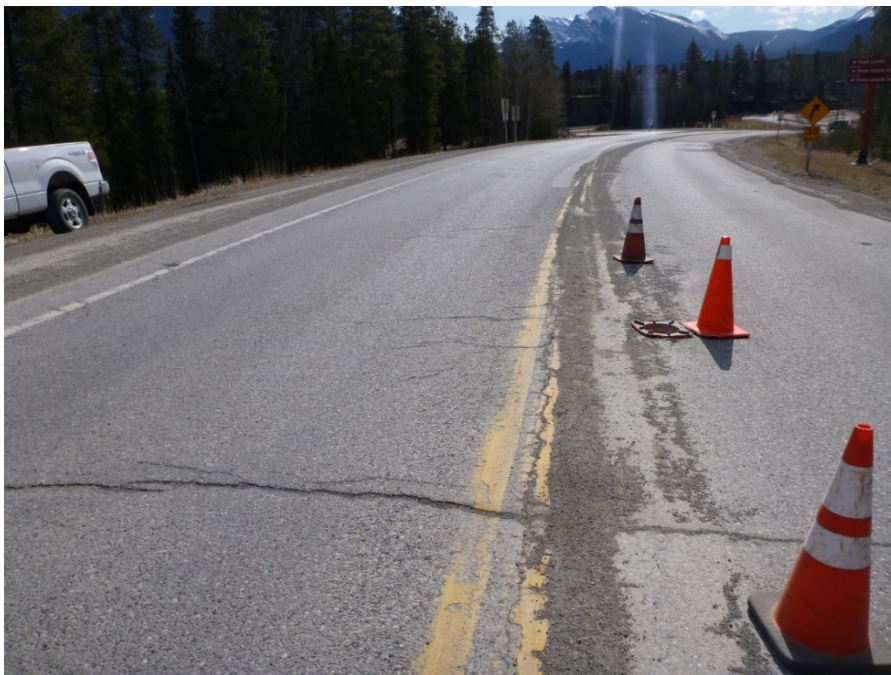
Photo 4 Inverted traffic cone marks location of sinkhole. Photo taken facing southeast.

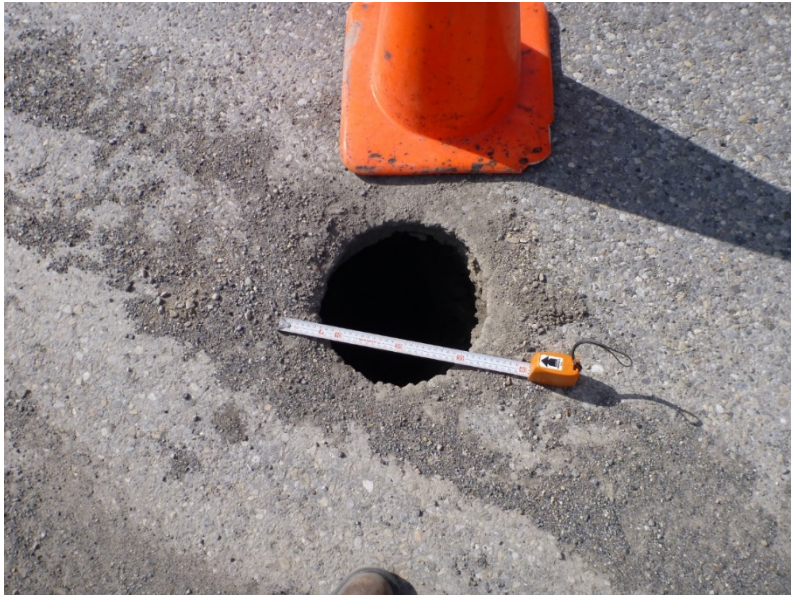
Photo 5 Sinkhole is uniform and appears to be a borehole location from previous investigations.

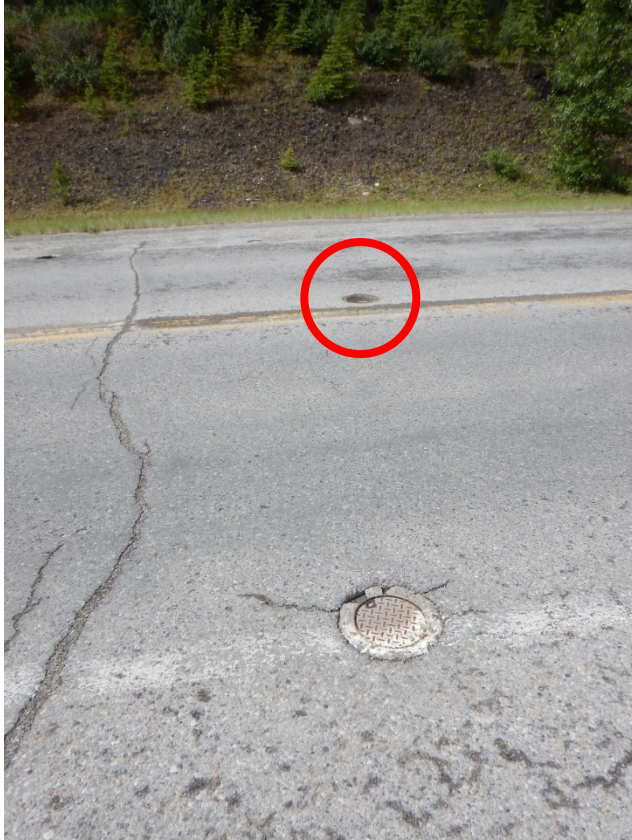
Photo 6 Photo of sinkhole site taken during 2016 Section B inspection. Note that borehole at the location of the sinkhole had a removeable metal cap.
