SITE NUMBER AND NAME: S012 Spray Lakes Road		HIGHWAY & KM: 742:02, 4.319	PREVIOUS INSPECTION DATE: May 1, 2018	INSPECTION DATE: May 7, 2019
LEGAL DESCRIPTION 11-29-024-10 W5M	NAD 83 COORDINATES: UTM Northing Easting 11 5659724 614296		RISK ASSESMENT: PF: 11 CF: 7 TOTAL: 77	
AVERAGE ANNUAL DAILY TRAFFIC (AADT): 1145 (north); 1141 (south), (Ref No. 67429980)			CONTRACTOR MAINTENANCE AREA (CMA): 28

PROJECT	SOUTHERN REGION GEOHAZARD RISK MANAGEMENT PROGRAM	
TITLE	Site Plan S012 - Canmore Spray Lakes Road Hwy 742:02, km 4.319	
SCALE	PROJECT No.	FIG No.
1:800	A05115A03	1

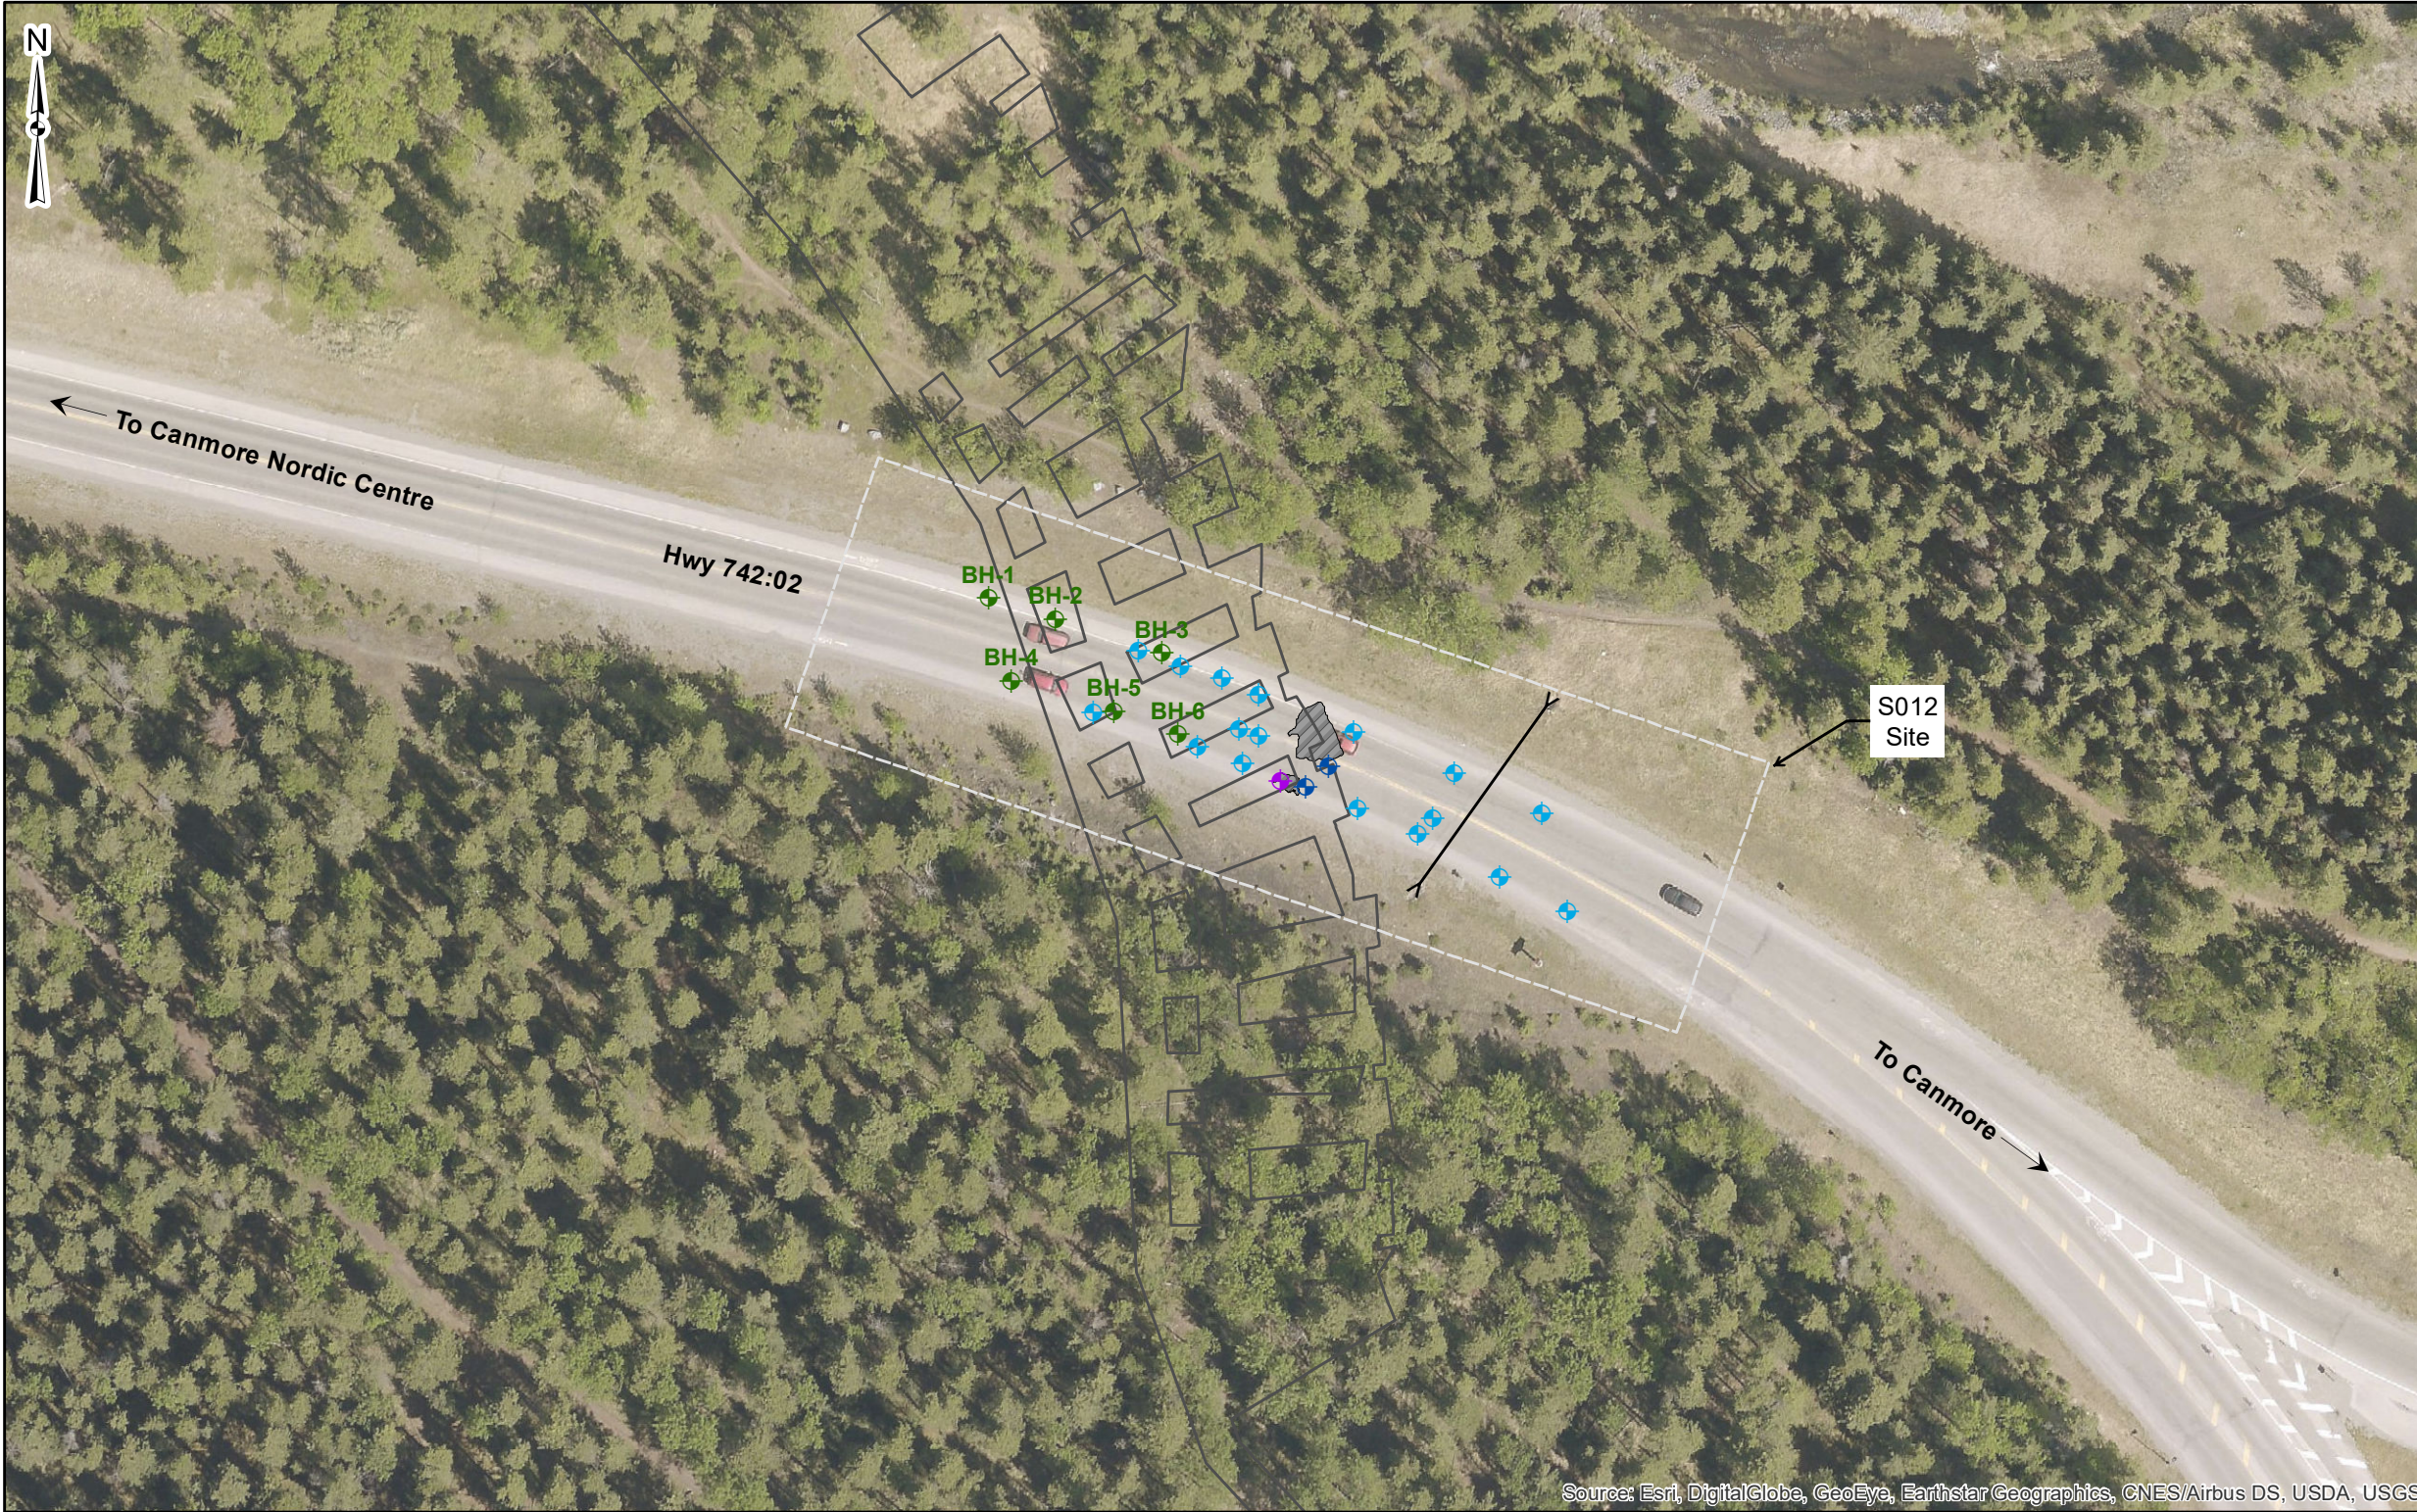
COMMENTS
No observable changes to the site when compared to 2018 inspection.
Pavement surface has some subtle depressions, indicating movement of subgrade. Bedrock is exposed to the south of the subject site. Subtle depression noted at outlet of culvert to east of site, may indicate infiltration of culvert discharge into an underlying void.
Settlement of flush mounted head boxes and void formation between head box and asphalt may indicate seepage of water from pavement surface into void via boreholes is promoting settlement of road surface and deformation of asphalt around boreholes.
The locations of the 2018 boreholes are shown on Figure 1. Repair works are proposed for 2019 construction.

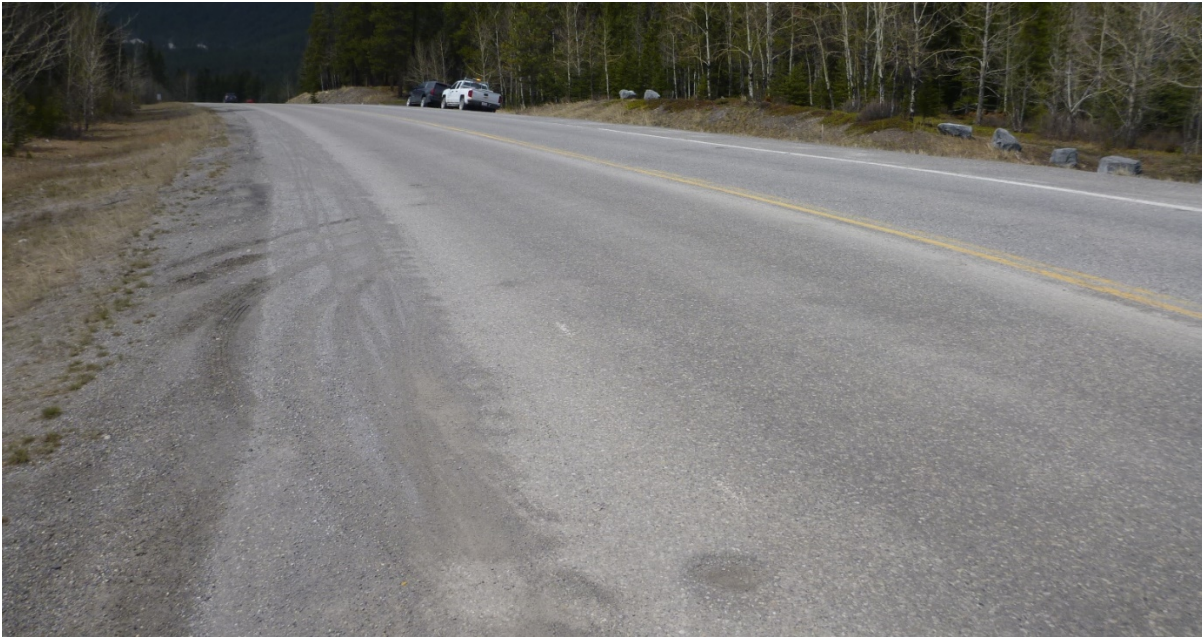
Photo 1 Patched boreholes in pavement. Photo was taken facing north on May 7, 2019.

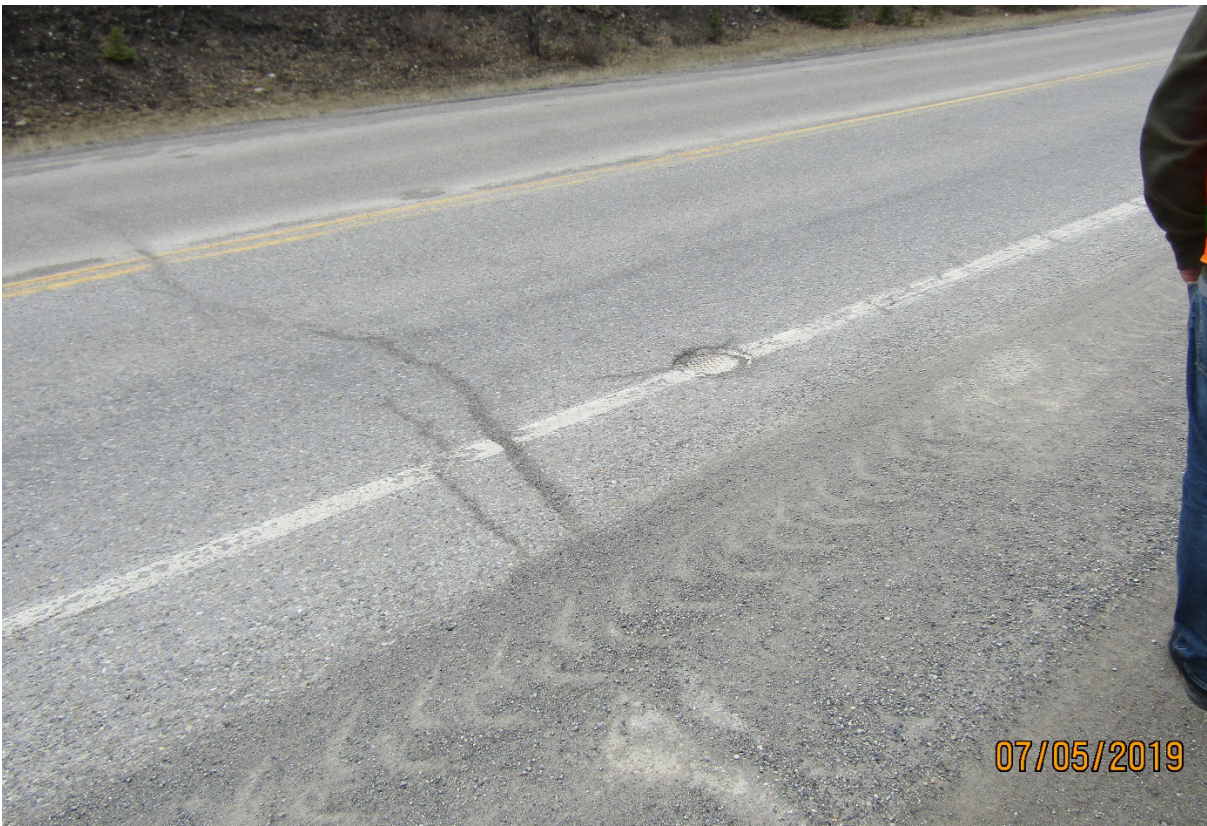
Photo 2 Pavement cracking and flush-mounted headbox for an old borehole. Photo taken facing west on May 7, 2019.
