SITE NUMBER AND NAME: <b>S012 Spray Lakes Road</b>		HIGHWAY & KM: 742:02, 4.319	PREVIOUS INSPECTION DATE: May 7, 2019	INSPECTION DATE: <b>July 6, 2020</b>
LEGAL DESCRIPTION 11-29-024-10 W5M	NAD 83 COORDINATES: UTM Northing Easting 11 5659724 614296		RISK ASSESSMENT: PF: 11 CF: 7 TOTAL: 77	
AVERAGE ANNUAL DAILY TRAFFIC (AADT): 1202 (north); 1202 (south), (Ref. No. 67429980)			CONTRACTOR MAINTENANCE AREA (CMA): 28

PROJECT	SOUTHERN REGION GEOHAZARD RISK MANAGEMENT PROGRAM	
TITLE	Site Plan S012 - Canmore Spray Lakes Road Hwy 742:02, km 4.319	
SCALE	PROJECT No.	FIG No.
1:800	A05115A03	1

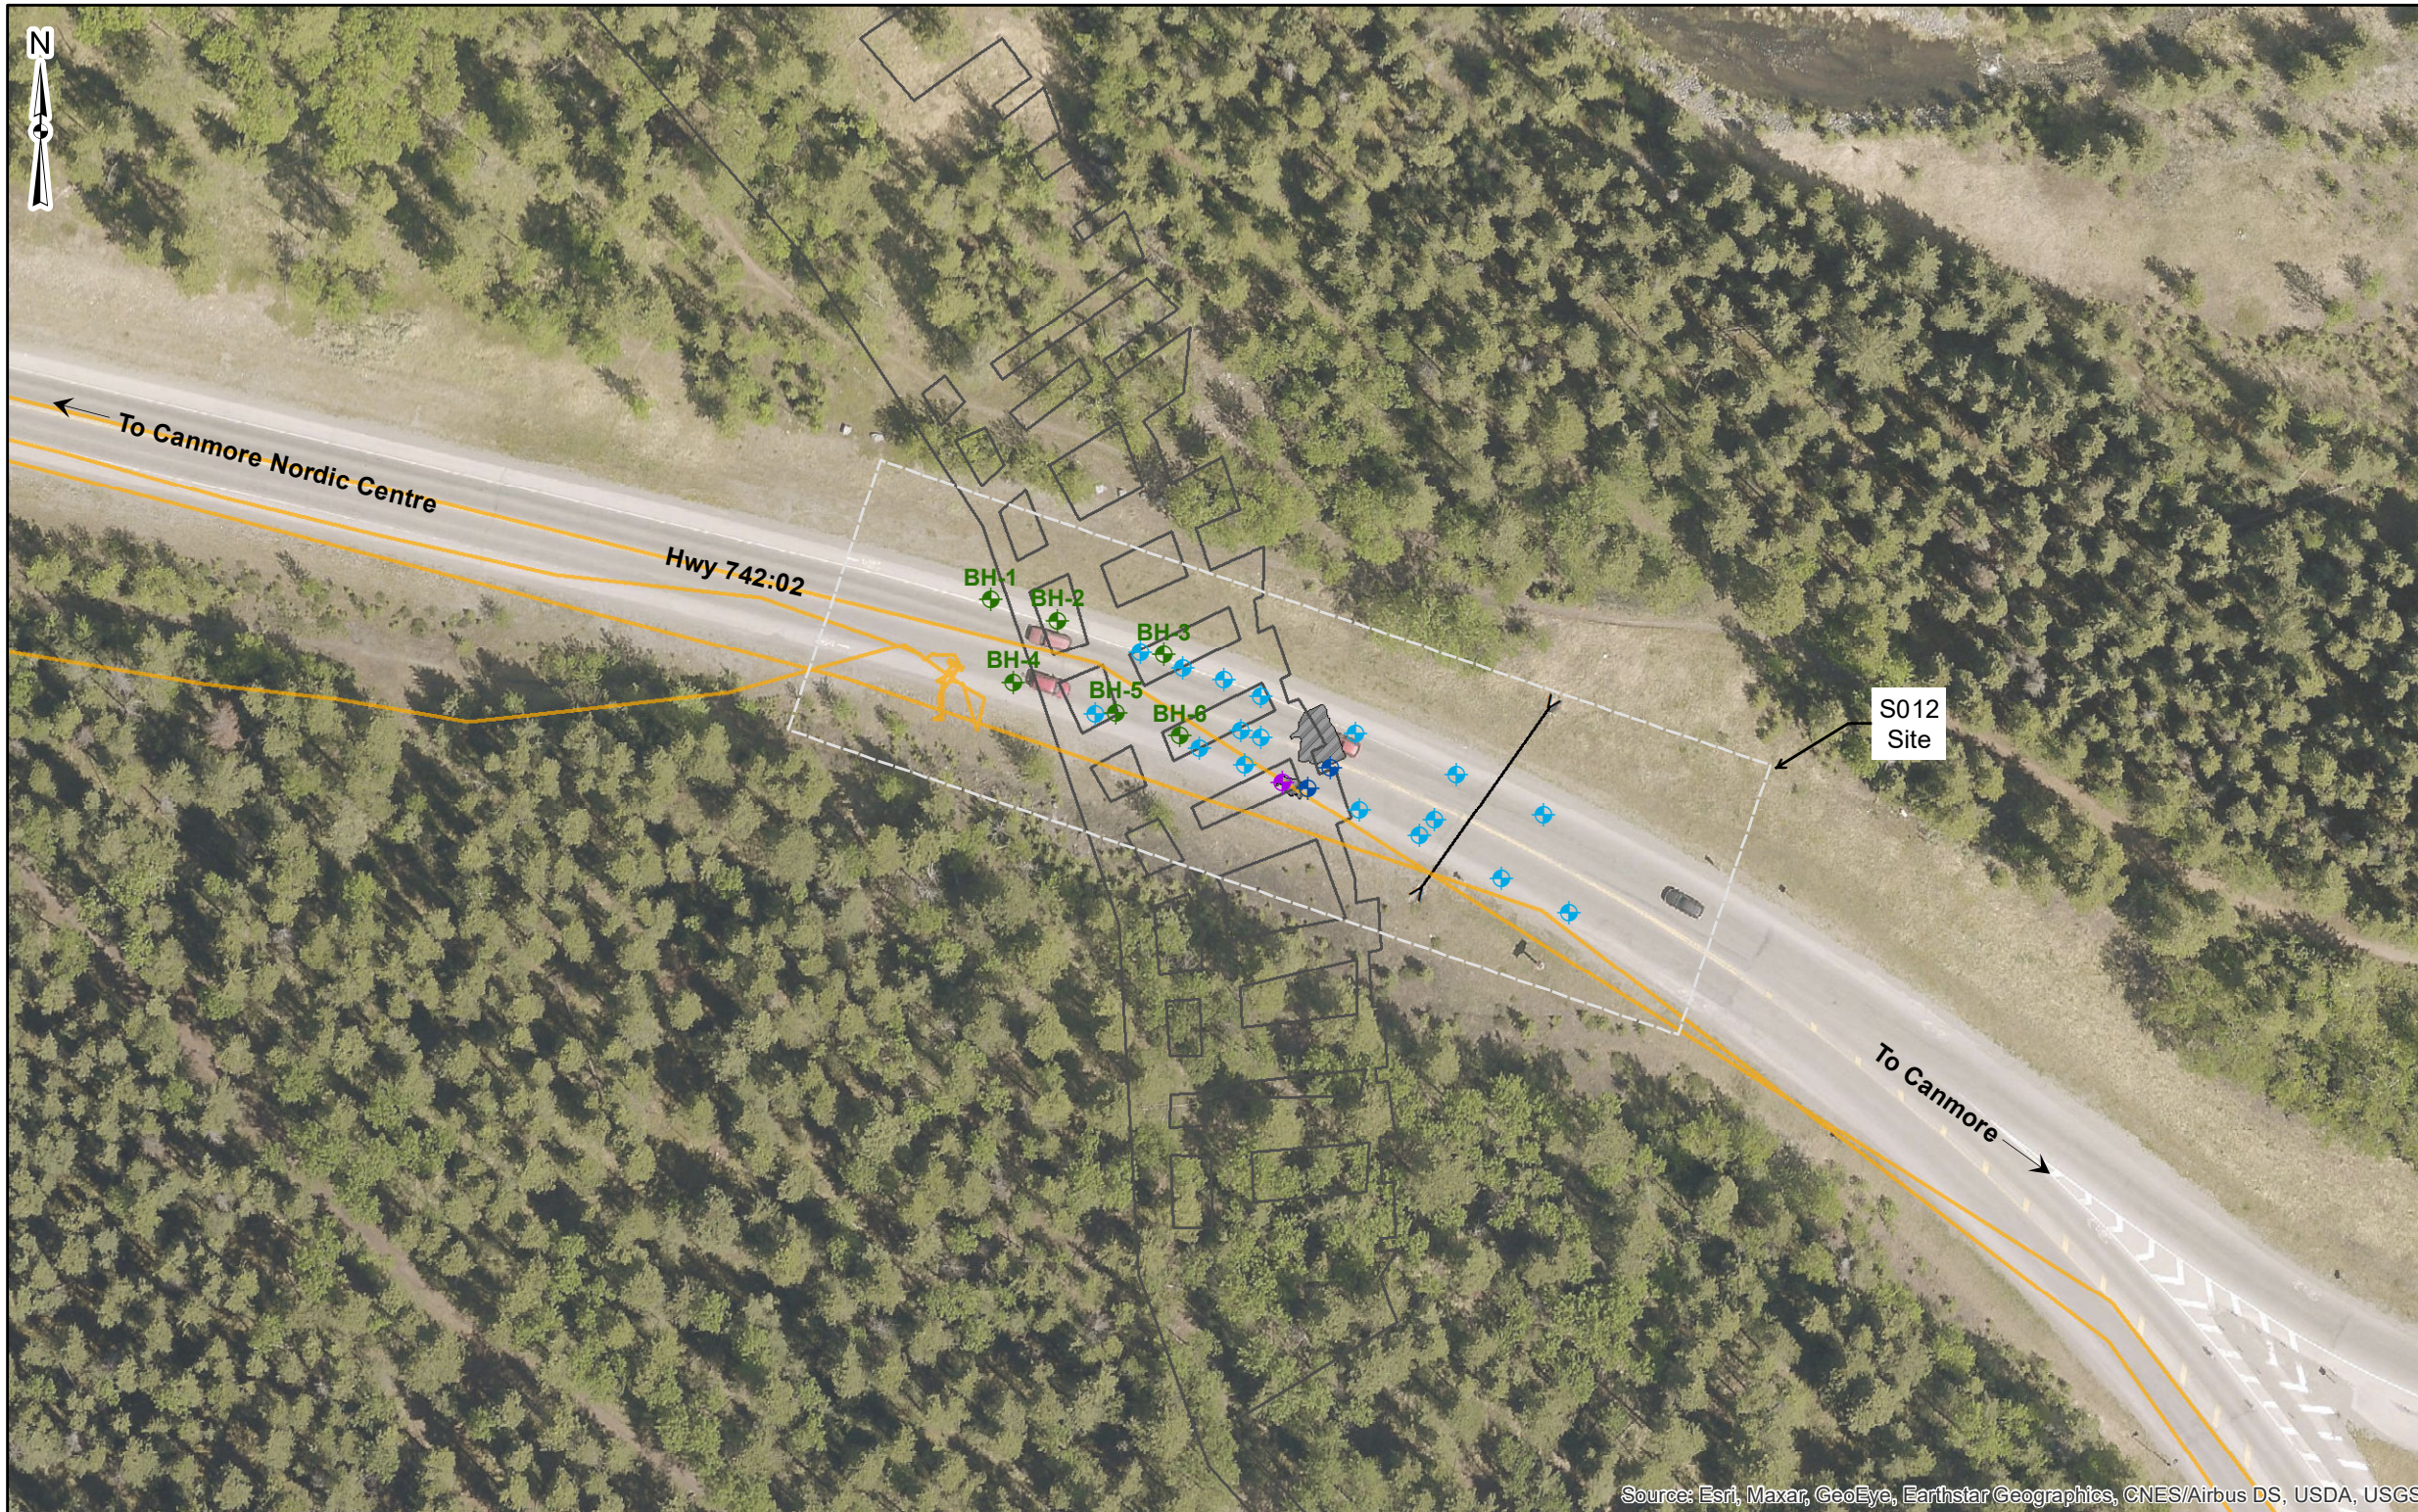
<b>COMMENTS</b>
No observable changes to the site when compared to 2019 inspection.
Pavement surface has some subtle depressions, indicating movement of subgrade. Bedrock is exposed to the south of the subject site. Subtle depression noted at outlet of culvert to east of site, may indicate infiltration of culvert discharge into an underlying void.
Settlement of flush mounted head boxes and void formation between the head box and asphalt may indicate that seepage from the pavement surface into the void via boreholes is promoting settlement of the road surface and asphalt deformation.
The locations of the 2018 boreholes are shown on Figure 1. Repair scheduled for 2020 construction.

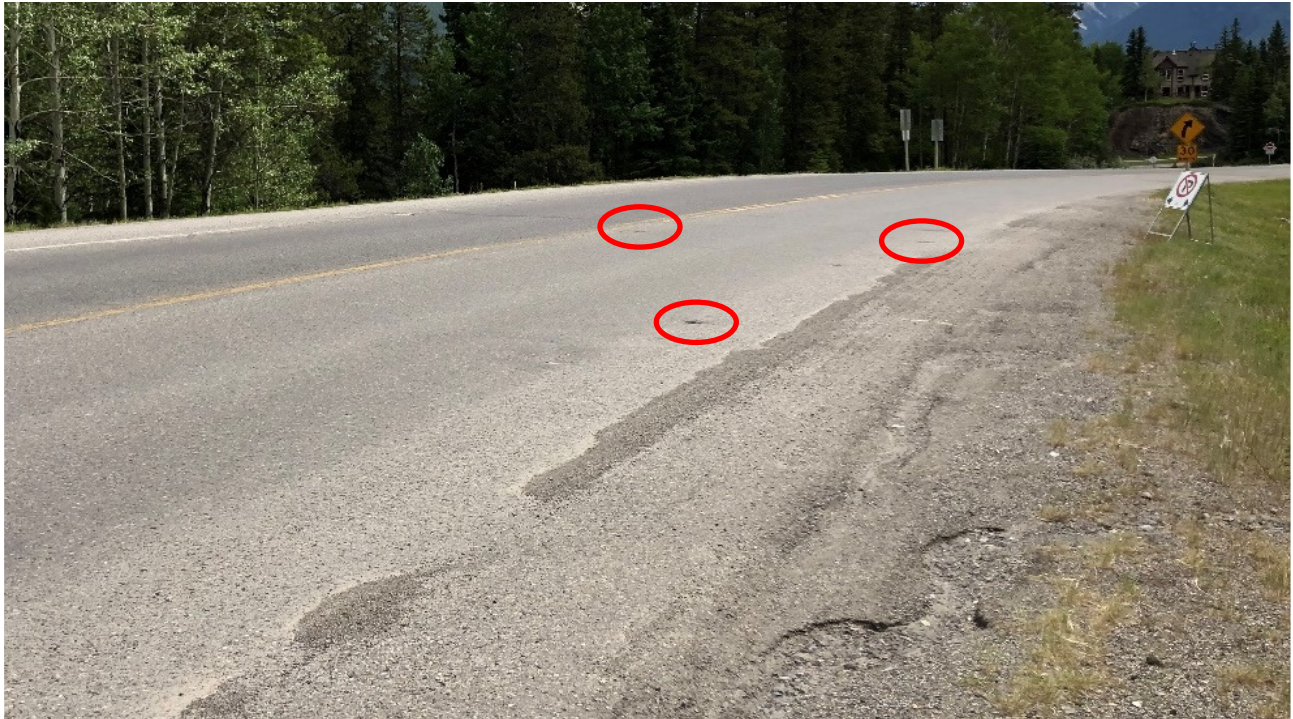
**Photo 1** Patched boreholes in pavement. Photo was taken facing northeast on July 6, 2020.

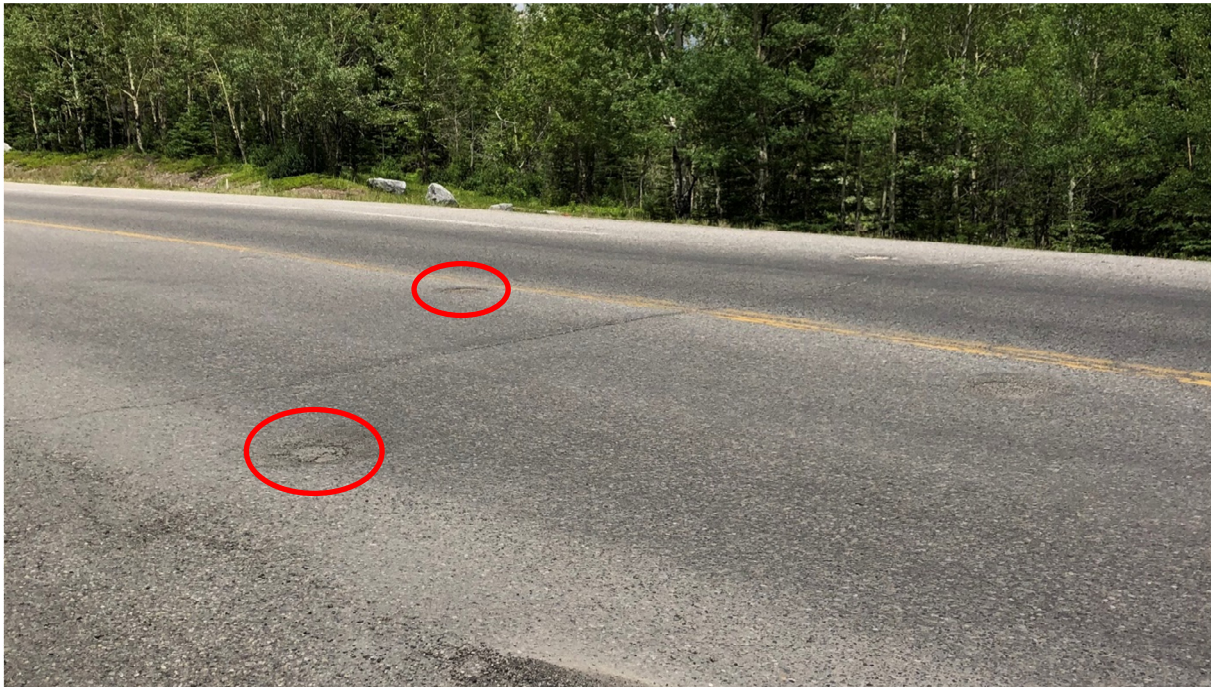
**Photo 2** Pavement cracking and flush-mounted headbox for old boreholes. Photo taken facing west on July 6, 2020.
