November 29, 2024

**CON0022161 Southern Region GRMP Instrumentation Monitoring
Site S012; H742:02, km 4.319 Spray Lakes Road
Section C – 2024 Fall Readings**

TITLE
Site Plan
S012 - Spray Lakes Road
Hwy 742:02, km 4.319

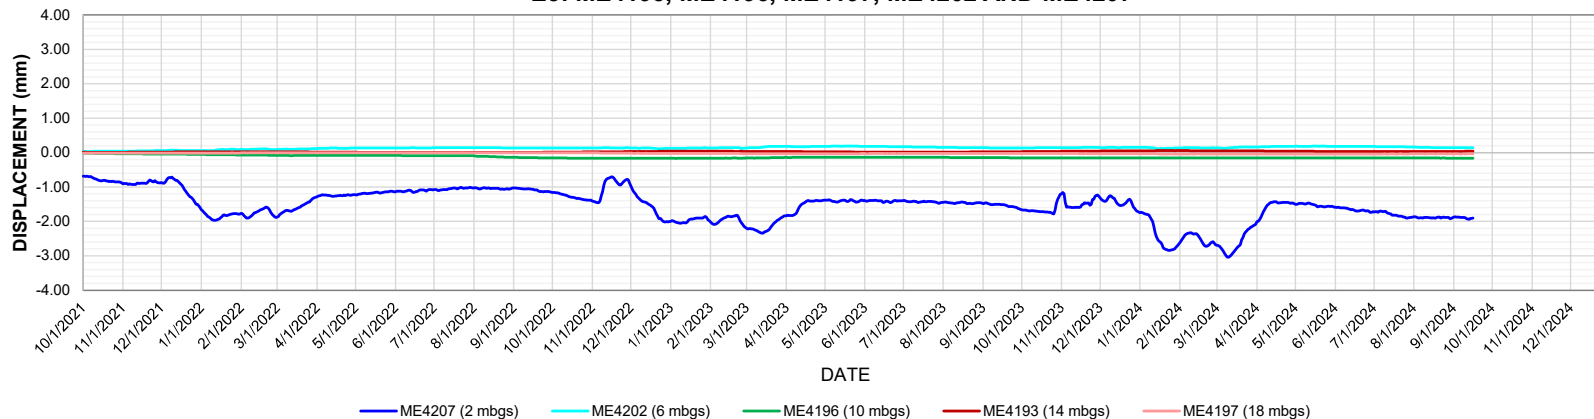
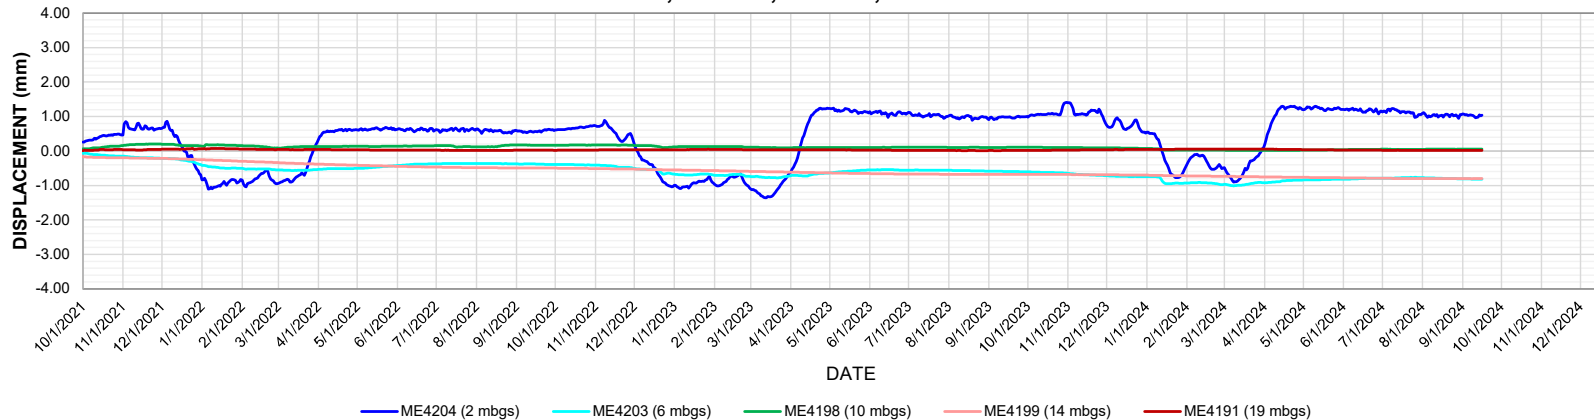
SCALE AS SHOWN PROJECT No. A05116A03 FIG No. I-II

- The maximum positive (i.e. lengthening) net displacement (difference between current reading and initial reading) in the extensometers is 0.78 mm, recorded in E4 ME4204 (2 mbgs). Only 3 other extensometers recorded net positive displacement, which are E3 ME4202 (6 mbgs), E4 ME4191 (18 mbgs), and E5 ME4212 (8 mbgs). All other extensometers have recorded negative (i.e., shortening) net displacement since the initial readings with a maximum of -1.23 mm, recorded in E3 ME4207 (2 mbgs).
- E5 ME4208 (4 mbgs) and E6 ME4211 (4 mbgs) have recorded irregular temperature readings since April 29, 2022 and June 28, 2022, respectively, and are inoperable. E5 and E6 are both located at the west extent of the repair site in the westbound and eastbound lanes, respectively.

The shallow extensometers (2 mbgs to 4 mbgs) have recorded the most linear displacement fluctuations. Most of the extensometers with anchors installed below 4 mbgs have recorded little to no displacement or displacement fluctuations since installation. The change in displacement (lengthening and contracting) recorded in the shallow extensometers appears to be due to seasonal temperature changes.

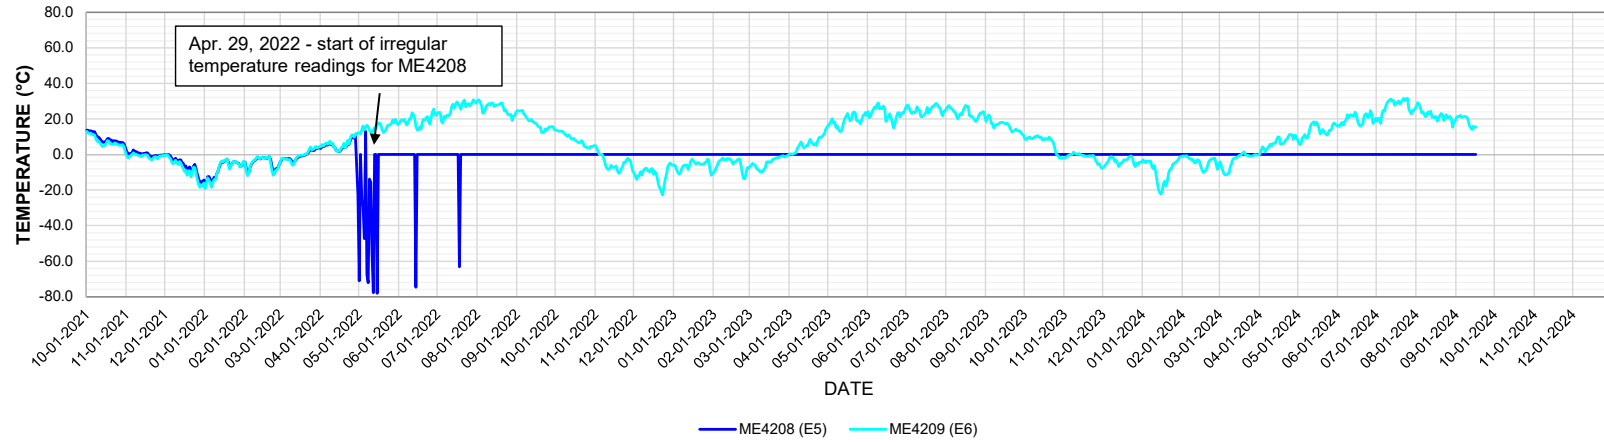
TEMPERATURE DATA FOR ME4208 (E5) (4 mbgs) AND ME4209 (E6) (4 mbgs)

³ ME4208 and ME4211 have recorded irregular temperature readings since April 29, 2022 and June 28, 2022, respectively, and are currently inoperable.

The connection between the cable leads for E5 ME4208 and E6 ME4211 and the RST data loggers were inspected and reconnected during the 2023 and 2024 instrument readings to check if a poor connection was attributing to the irregular data being recorded for those two instruments. After completing this, the instruments were still recording irregular data. KCB will continue to trouble shoot why these instruments are recording irregular data.
