July 10, 2024

**CON0022161 Southern Region GRMP Instrumentation Monitoring  
Site S012; H742:02, km 4.319 Spray Lakes Road  
Section C – 2024 Spring Readings**

**KLOHN CRIPPEN BERGER LTD.**

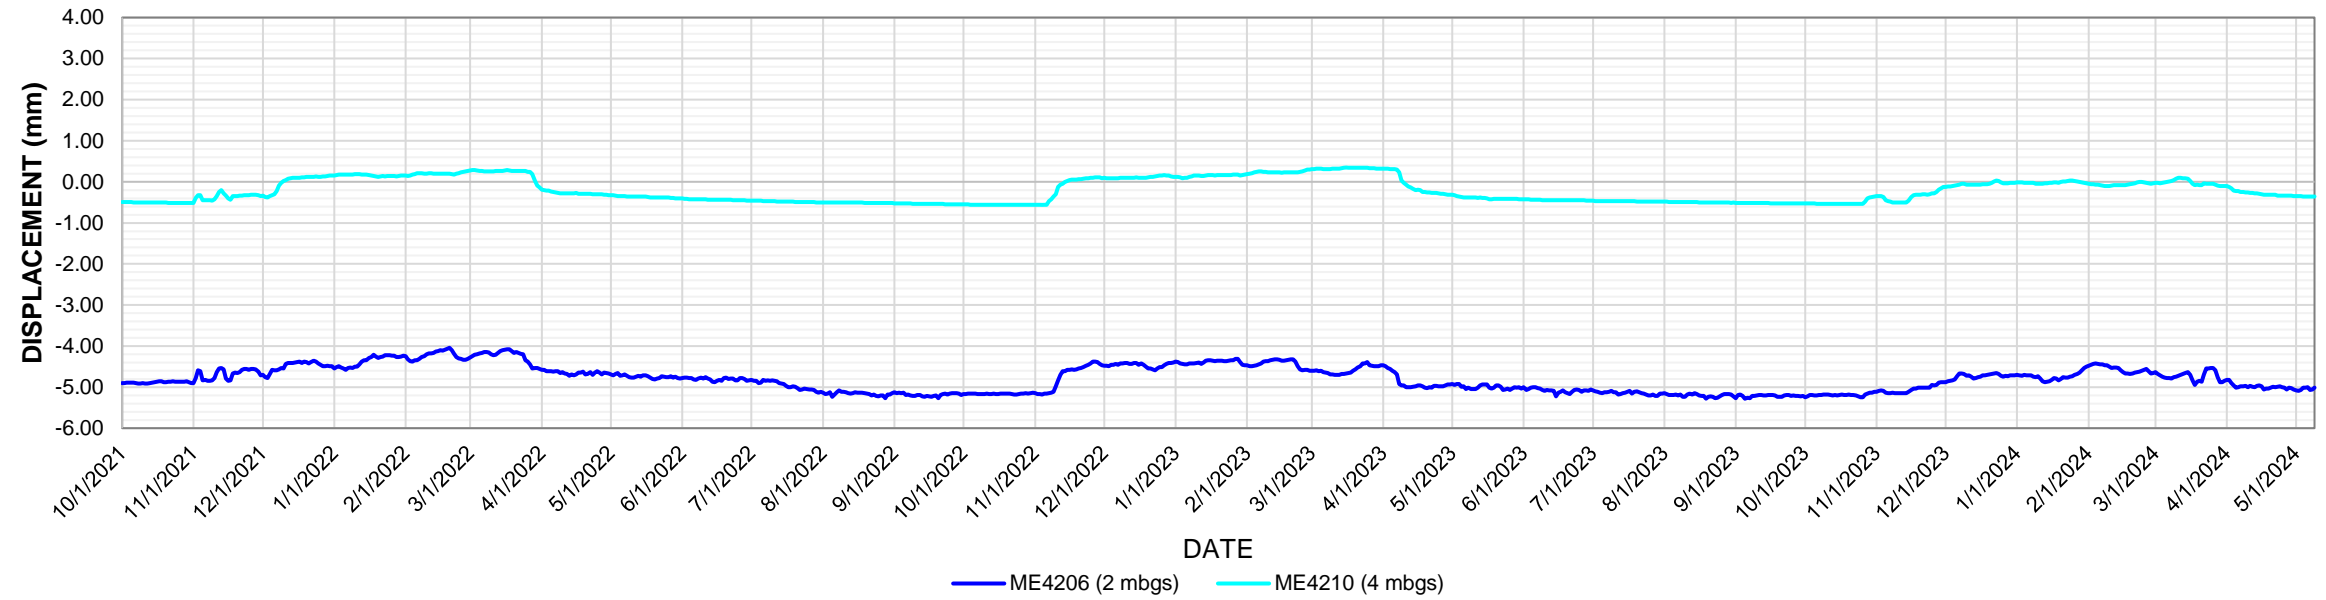
**E1: ME4206 AND ME4210**

- Negative displacement (i.e., shortening) has been recorded in E1 ME4206 (2 mbgs), E3 ME4207 (2 mbgs), E4 ME4204 (2 mbgs), and E4ME4203 (6mbgs) of 5.3 mm, 3.0 mm, 1.4 mm, and 1.0 mm respectively, since installation and the first reading recorded by the data loggers. Positive displacement (r.e., lengthening) has been recorded in E6 ME4209 (4 mbgs) of 1.1 mm. The remaining extensometers recorded little to no change in displacement (i.e., less than 1 mm) between installation and first data logger readings.
- E5 ME4208 (4 mbgs) and E6 ME4211 (4 mbgs) have recorded irregular temperature readings since April 29, 2022 and June 28, 2022, respectively, and are inoperable. E5 and E6 are both located at the west extent of the repair site in the westbound and eastbound lanes, respectively.

The shallow extensometers (2 mbgs – 4 mbgs) have recorded the most linear displacement. Most of the extensometers with anchors installed below 4 mbgs have recorded little to no displacement since installation. The change in displacement (lengthening and contracting) recorded in the shallow extensometers appears to be due to seasonal temperature changes.

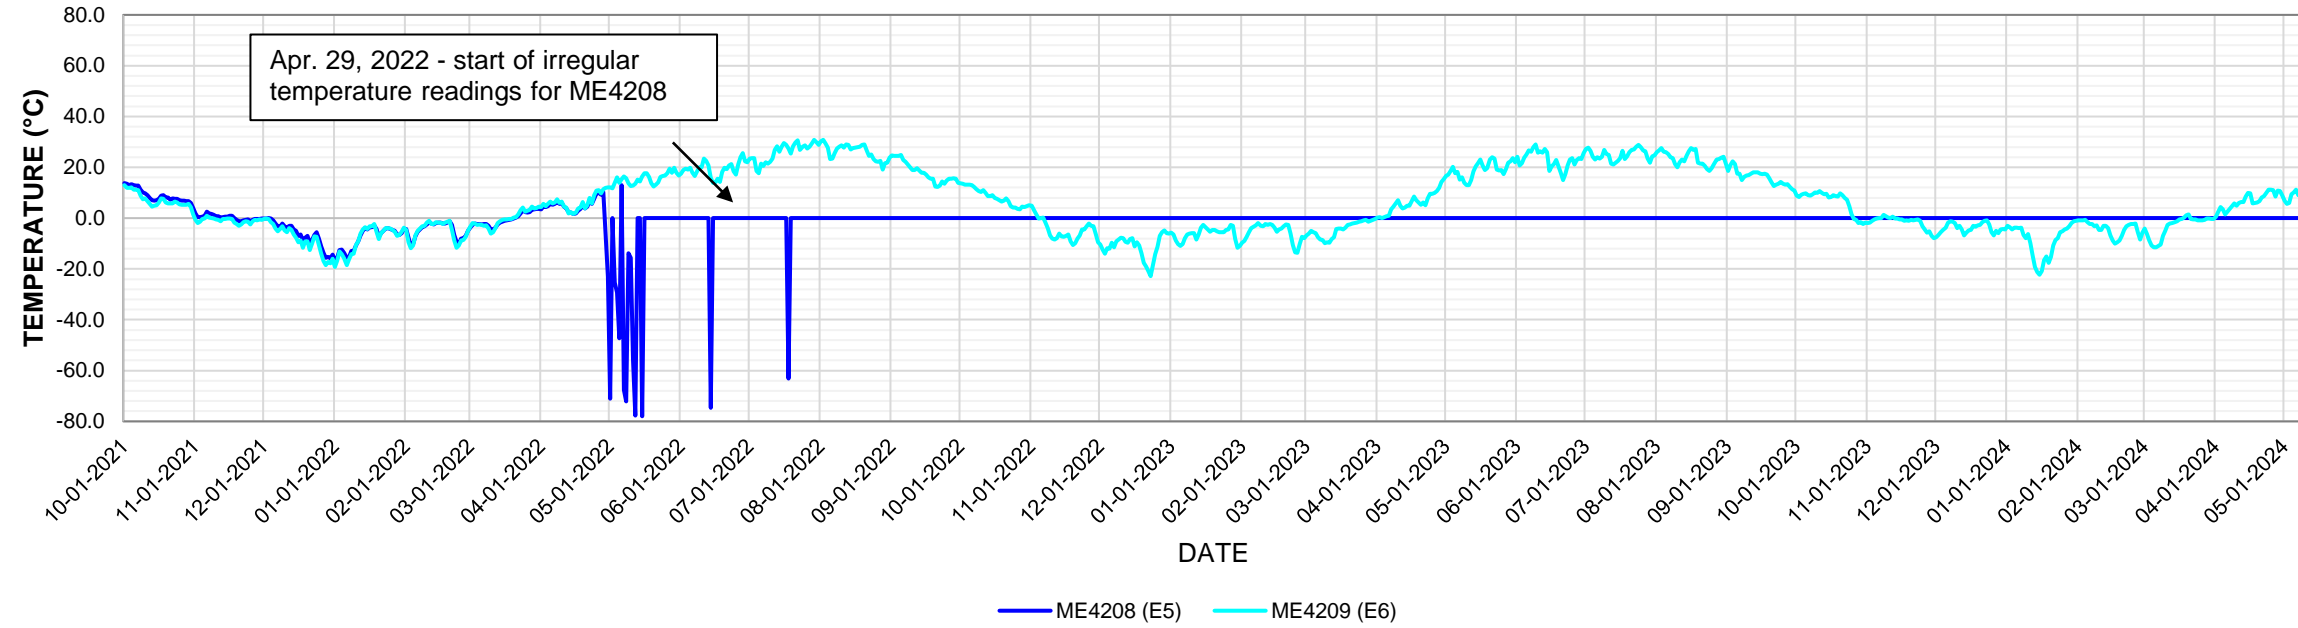
**TEMPERATURE DATA FOR ME4208 (E5) (4 mbgs) AND ME4209 (E6) (4 mbgs)**

<sup>3</sup> ME4208 and ME4211 have recorded irregular temperature readings since April 29, 2022 and June 28, 2022, respectively, and are currently inoperable.

The connection between the cable leads for E5 ME4208 and E6 ME4211 and the RST data loggers were inspected and reconnected during the 2023 and spring 2024 instrument readings to check if a poor connection was attributing to the irregular data being recorded for those two instruments. After completing this, the instruments were still recording irregular data. KCB will continue to trouble shoot why these instruments are recording irregular data.
