SITE NUMBER AND NAME: S042-I Spray Lakes Rockfall Barrier		HIGHWAY & KM: 25291:02, 30.434	PREVIOUS INSPECTION DATE: May 17, 2022	INSPECTION DATE: May 8, 2023
LEGAL DESCRIPTION: SW-25-024-11 M5	NAD 83 COORDINATES: UTM Northing Easting 11 5658604 611006		RISK ASSESSMENT: Small rockfall: PF: 13 CF: 4 TOTAL: 52 Large rockfall: PF: 7 CF: 7 TOTAL: 49	
AVERAGE ANNUAL DAILY TRAFFIC (AADT): 1670 (west) & 2160 (east) (Reference No. 70000698)			CONTRACTOR MAINTENANCE AREA (CMA): 28

PROJECT SOUTHERN REGION GEOHAZARD RISK MANAGEMENT PROGRAM		
TITLE Site Plan S042 - Spray Lakes Rockfall Barrier Hwy 25291:02, km 30.434		
SCALE 1:8,000	PROJECT No. A05116A03	FIG No. 1

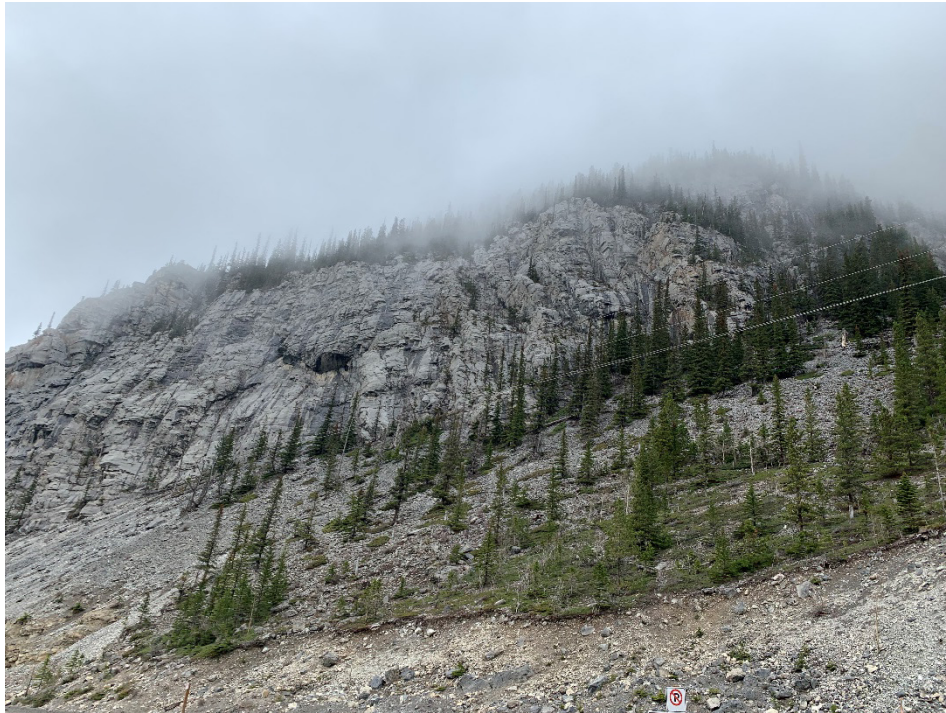
Photo 1 Source area for rockfall, north of the highway. Photo taken May 8, 2023, facing northeast.

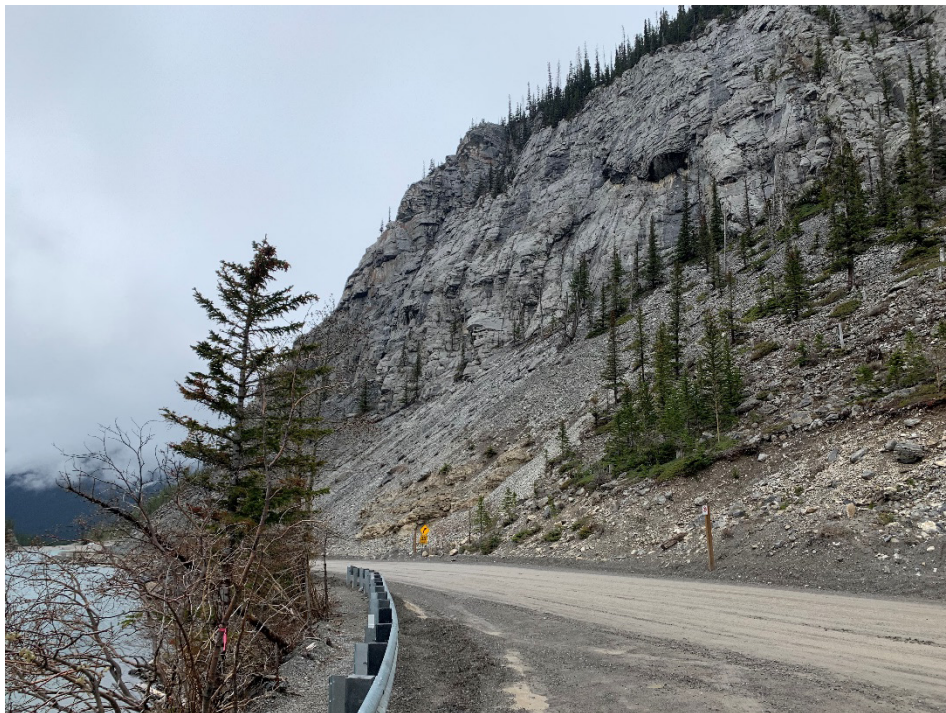
Photo 2 Rock slope north of the highway. Photo taken May 9, 2023, facing west.
