**SOUTHERN REGION GRMP
SITE INSPECTION FORM**

SITE NUMBER AND NAME: S042-I Spray Lakes Rockfall Barrier		HIGHWAY & KM: 25291:02, 30.434	PREVIOUS INSPECTION DATE: May 8, 2023	INSPECTION DATE: May 27, 2024
LEGAL DESCRIPTION: SW-25-024-11 M5	NAD 83 COORDINATES: UTM Northing Easting 11 5658604 611006		RISK ASSESMENT: Small rockfall: PF: 13 CF: 4 TOTAL: 52 Large rockfall: PF: 7 CF: 7 TOTAL: 49	
AVERAGE ANNUAL DAILY TRAFFIC (AADT): 980 (west) & 1840 (east) (Reference No. 70000698)			CONTRACTOR MAINTENANCE AREA (CMA): 28

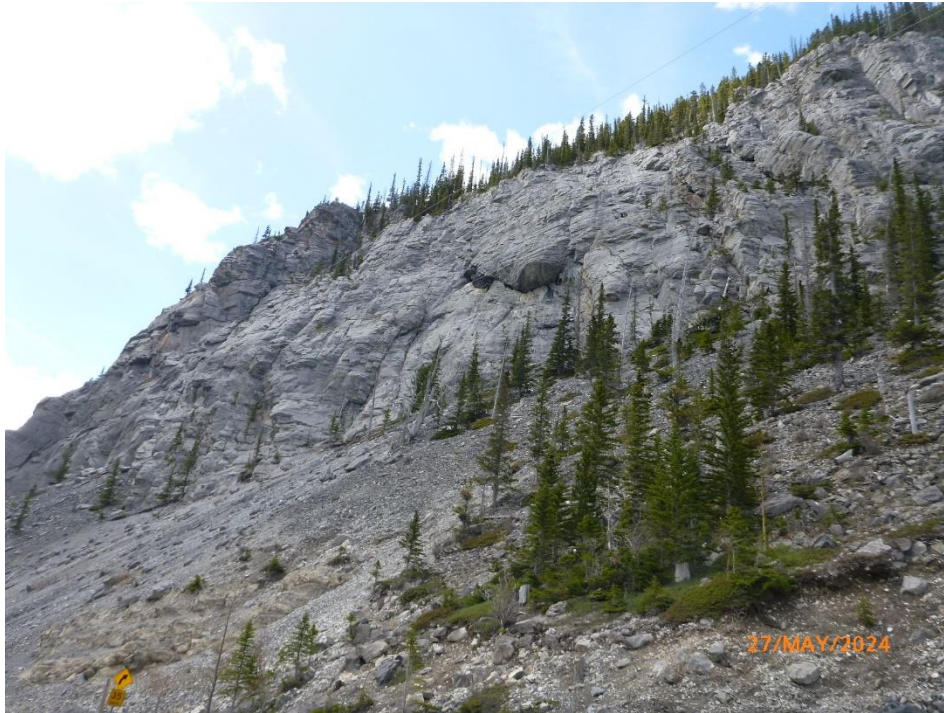
Photo 1 Source area for rockfall, north of the highway. Photo taken May 27, 2024, facing northwest.

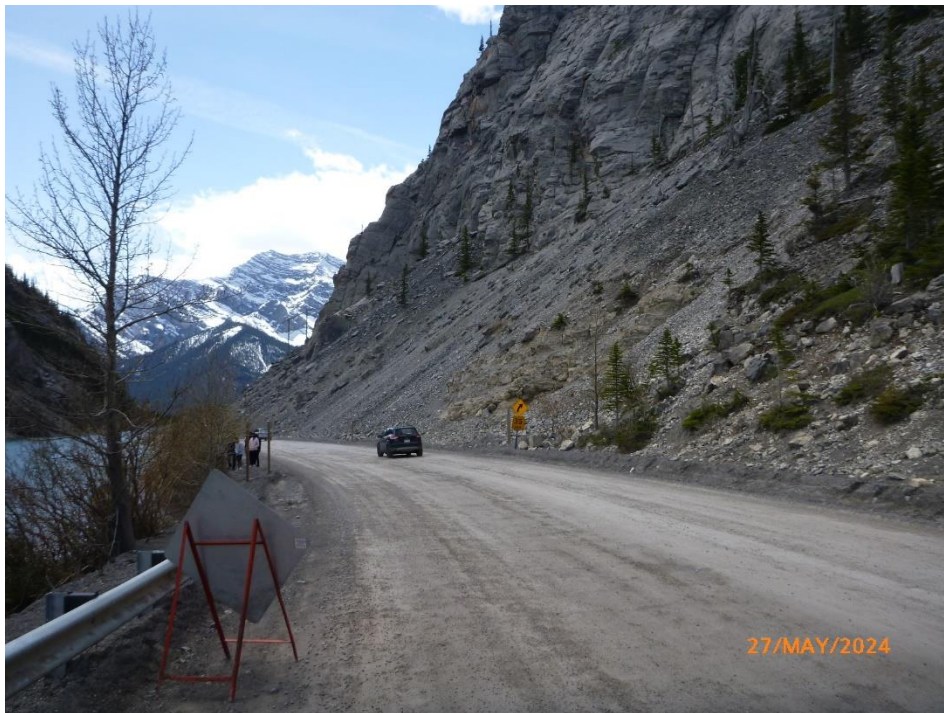
Photo 2 Rock slope north of the highway. Photo taken May 27, 2024, facing west.
