December 19, 2011
CG25352.300

**Re: Southern Region Geohazard Assessment
Fall 2011 Instrumentation Monitoring Results
Site S22: Highway 762:02, "S" Curve**

SECTION D
Southern Region Geohazard Assignment
Site S22 – “S” Curve
Fall 2011 Site Plan & Slope Cross-Section

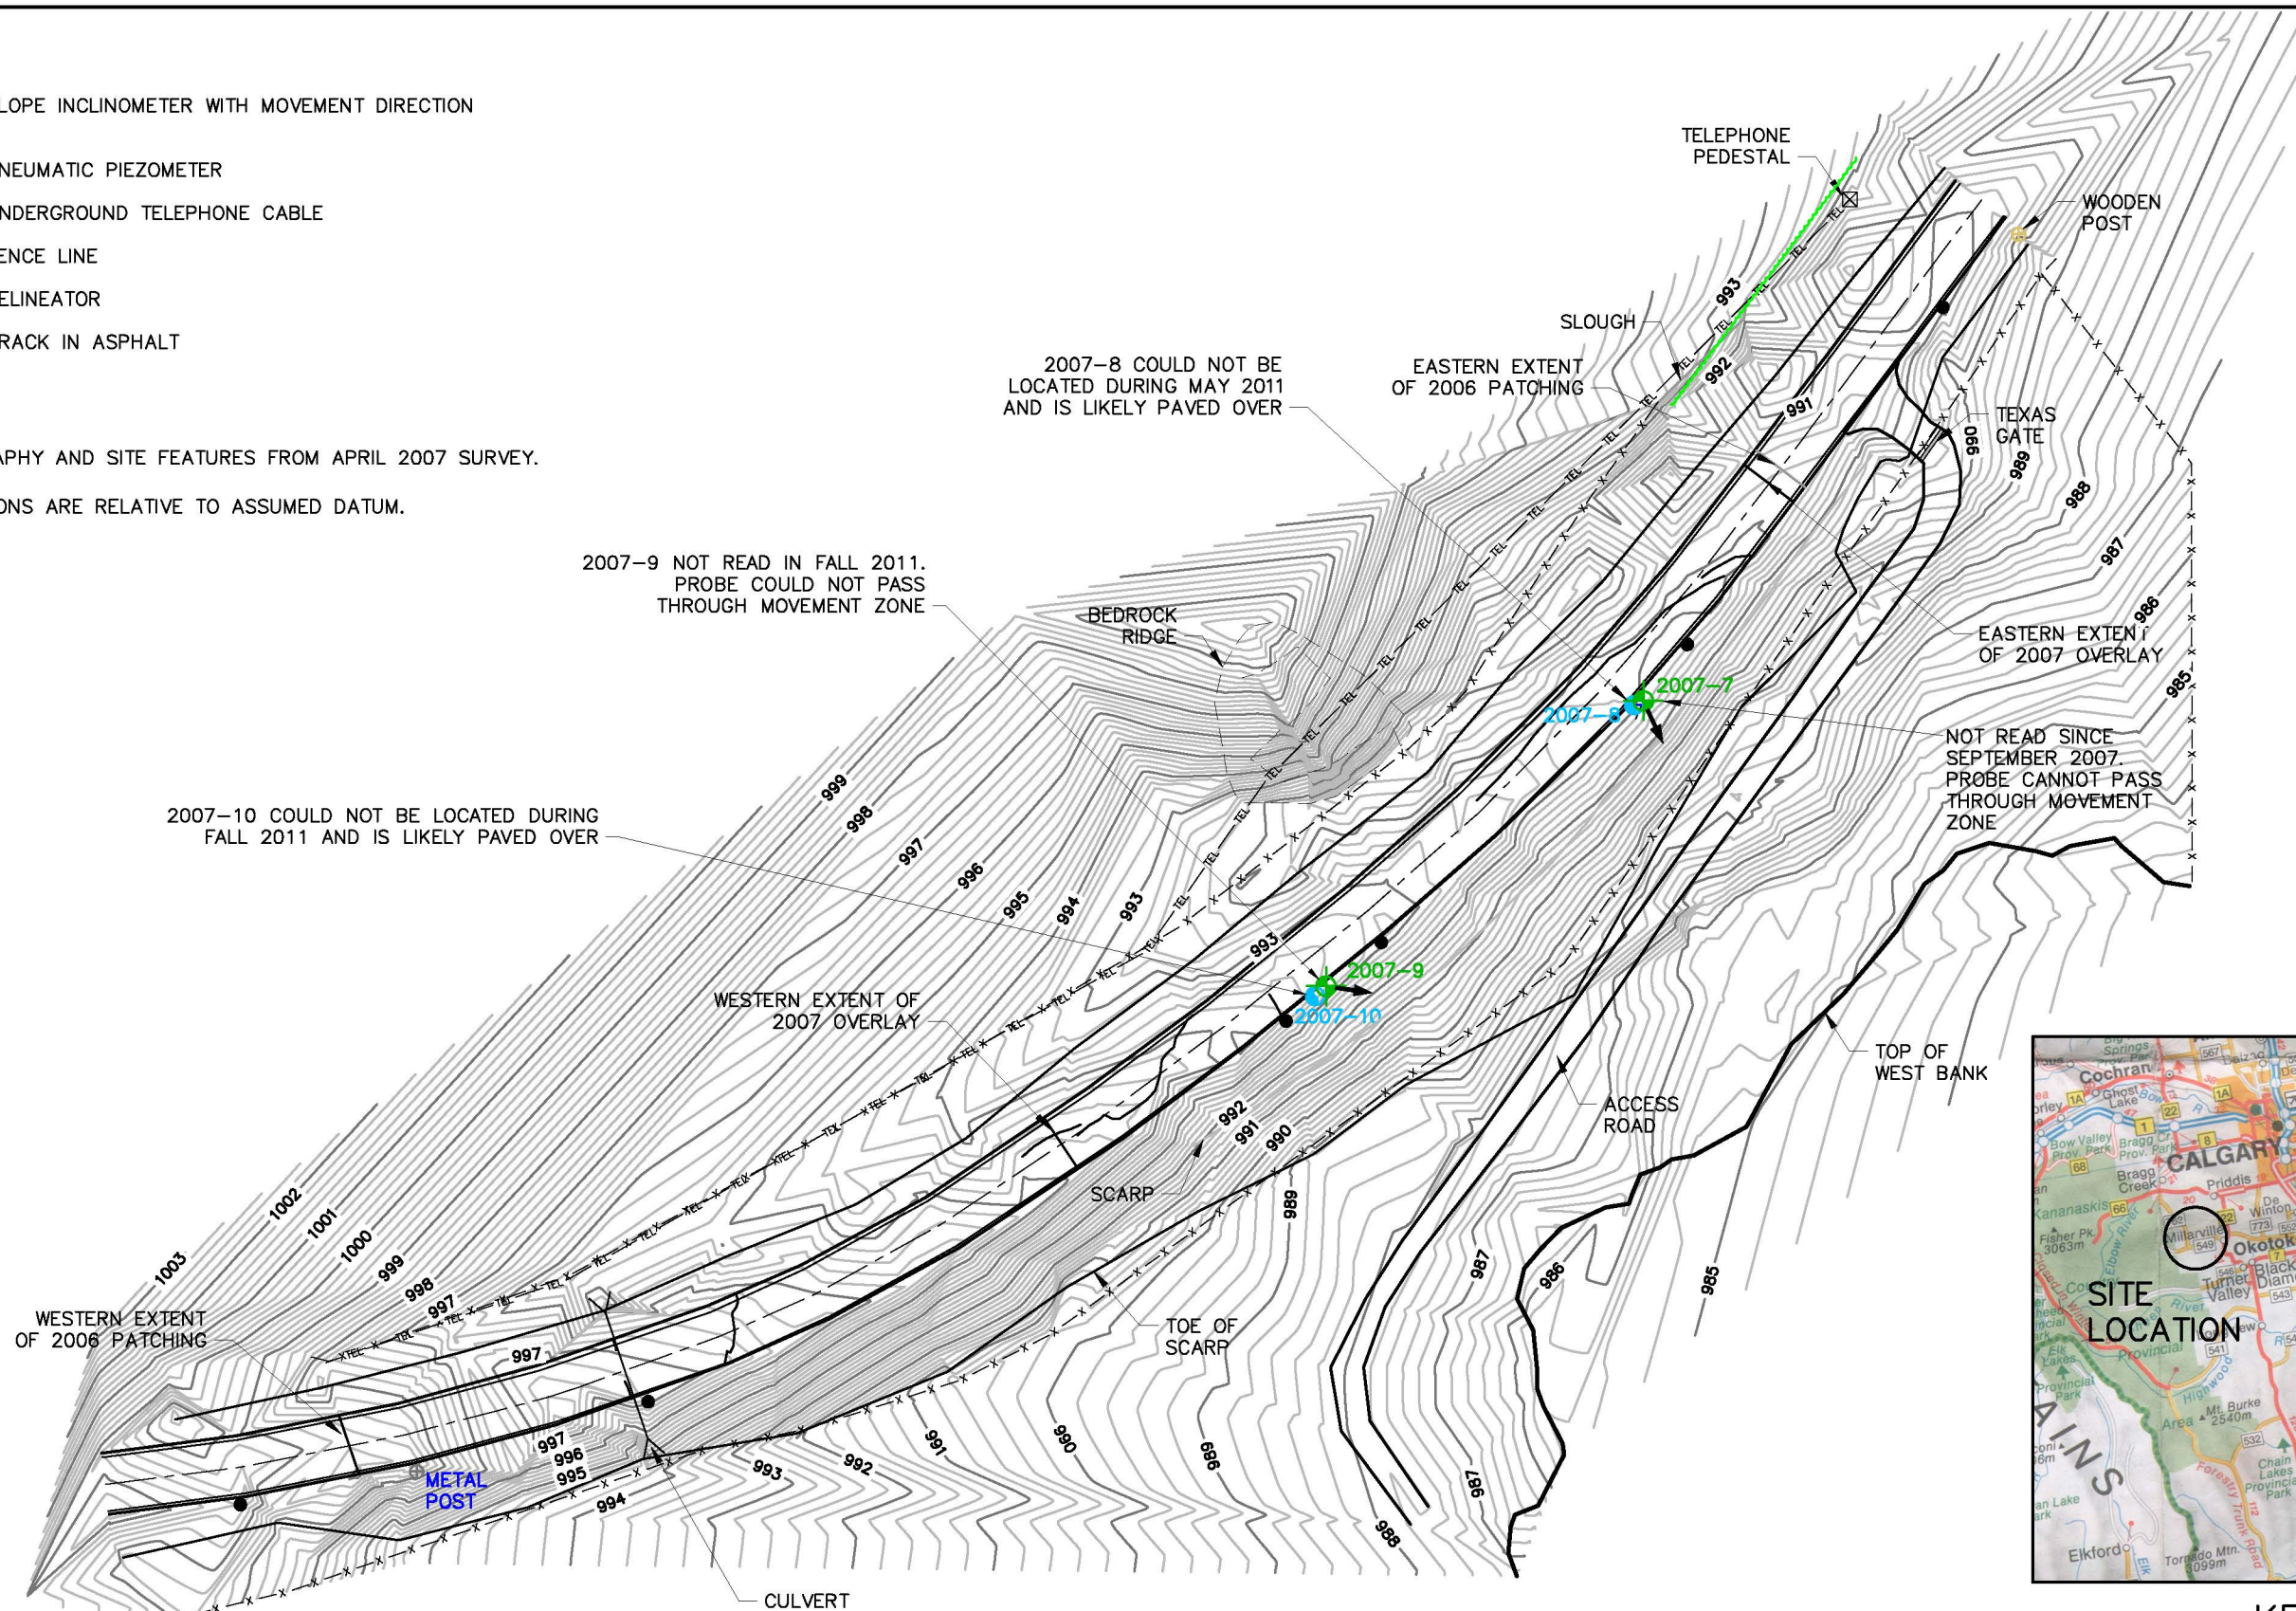
PROJECT: SOUTHERN REGION GEOHAZARD ASSESSMENT AND INSTRUMENTATION MONITORING				
	TITLE: SITE S22 - SH 762 - S CURVE				
CLIENT:	DATE: DECEMBER 2011	JOB No.: CG25352.300	CAD FILE: 25352N05.dwg	FIGURE No.: FIGURE S22-1	REV. A

The instruments at the site were installed to monitor a landslide that is causing ongoing damage to the road surface. Ongoing damage was evident at the time of the attempted Fall 2011 readings, with pronounced cracks in the road surface resulting in down-drop of the southbound lane, forming the same pattern as was observed during previous site visits. Please refer to Figure S22-1 in Section D for a site plan showing the instrument locations and to Figure S22-2 for a cross-section.

Previous SI data showed that there was ground movement beneath the settled and cracked area along the highway. The movement was occurring around 982.5 to 984 m elevation (approximately 8 to 11 m below the road surface) and was towards the east. The movement elevation was around, or slightly below, the elevation of the creek channel at the base of the valley. The ground movement was judged to be the cause of the ongoing damage to the road surface at this site.

- The semi-annual instrument readings and annual site inspections should be discontinued. Recovery of the piezometers is not recommended, as sufficient information has been obtained to proceed with a repair.
- Construction of drainage trenches into the underlying native soils to lower the groundwater levels at the site and attempt to reduce the rate and magnitude of future landslide movement at this site. AMEC has submitted a repair design and can proceed with the preparation of a draft tender package for the repair at AT's request.

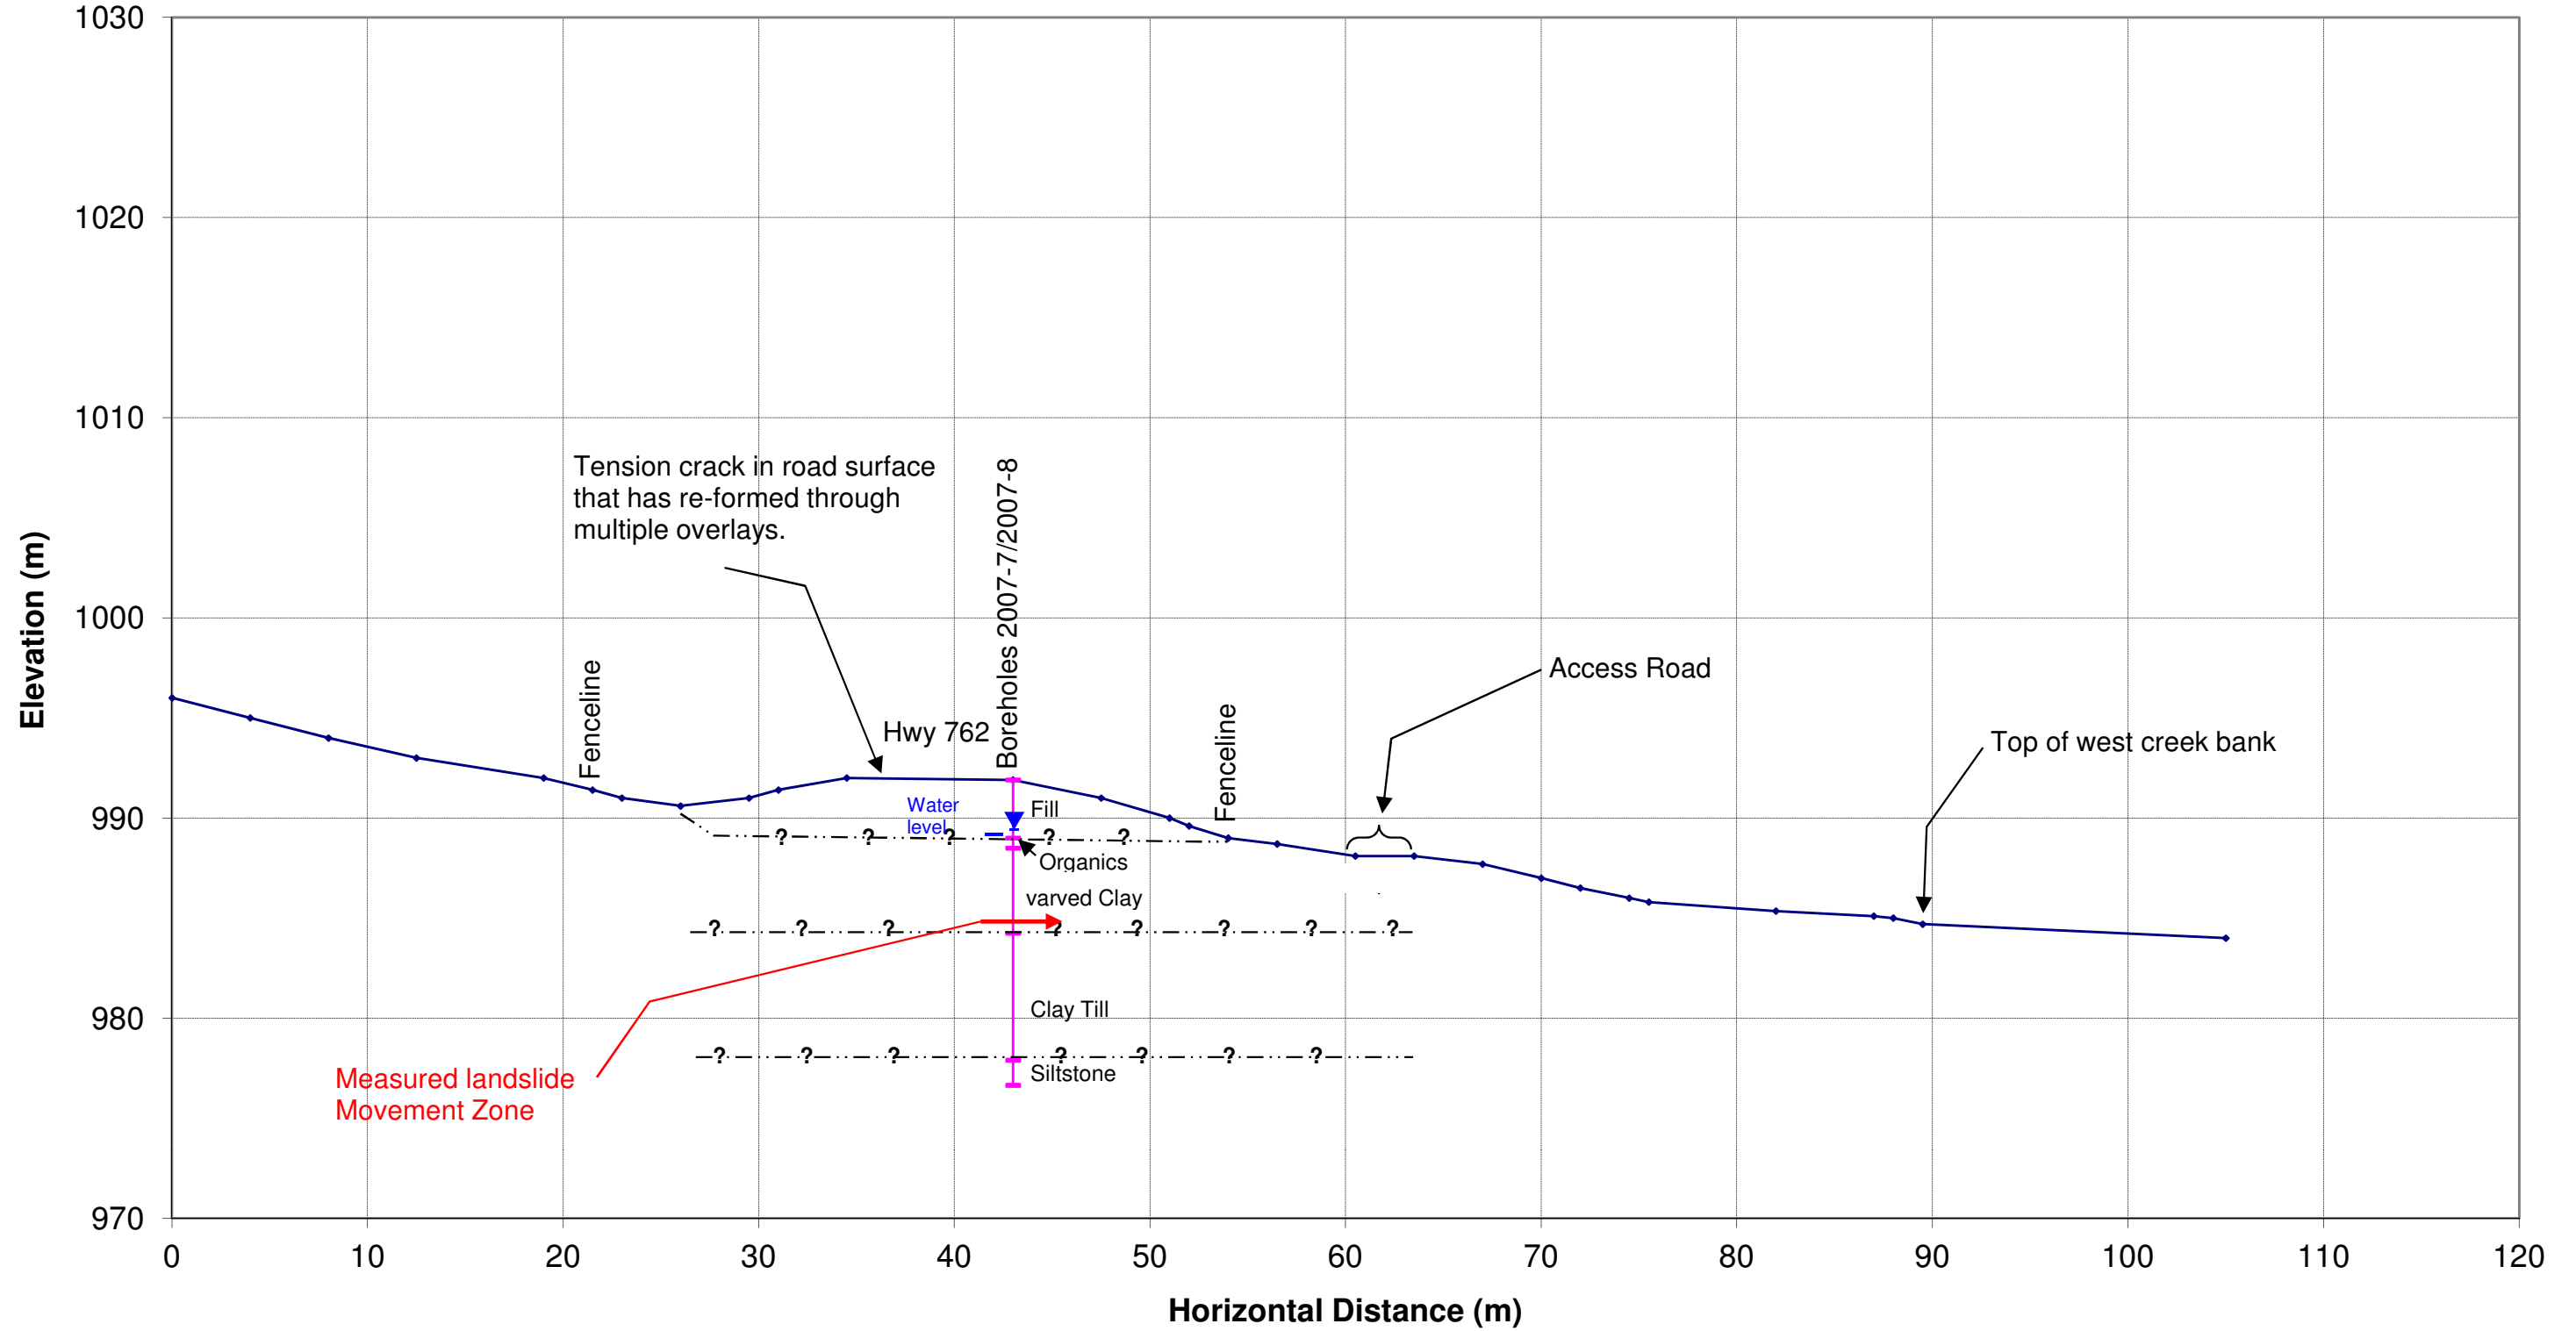
Client	Alberta Transportation		Figure S22-2	
Project	S22 - "S" Curve Slide		Date:	Revision
Slope Cross-Section at Boreholes 2007-7/2007-8			Dec-11	
			Job No. CG25352.300	
			File No.:

The ground movement was occurring around the contact between the clay/varved silt and clay soils and the underlying clay till. The ground movement may have been triggered by the load of the road fill embankment and the numerous overlays that had been placed to repair the damage from the cracking and settlement. The relatively high piezometric pressure measured around the elevation of the movement surface in SI 2007-9 also suggested that high groundwater levels were a contributing factor to the movement. Based on the ongoing damage to the road surface as of the Fall of 2011, it is judged that the subsurface conditions leading to the landslide movement have not fundamentally changed since the last readings.
