SITE NUMBER AND NAME <b>S022 S Curve</b>		HIGHWAY & KM: 762:02, 8.187	PREVIOUS INSPECTION DATE: June 14, 2016	INSPECTION DATE <b>April 30, 2018</b>
LEGAL DESCRIPTION NW 27-21-4 W5	NAD 83 COORDINATES 50°48.978'N 114°28.572'W		RISK ASSESMENT PF: <b>9</b> * CF: <b>2</b> = TOTAL: <b>18</b>	
Average Annual Daily Traffic (AADT): 800 (North), (Ref. No. 65170)			Contractor Maintenance Area (CMA): 27

SUMMARY OF SITE INSTRUMENTATION:  None active  LAST READING DATE: N/A	INSPECTED BY: Chris Gräpel (KCB) Peter Roy (KCB) Alex Frotten (AT) Roger Skirrow (AT) Maury Siddons (AT)
PRIMARY SITE ISSUE: Landslide movement below road affecting both north and southbound lanes.	
APPROXIMATE DIMENSIONS: 240 m length along highway. Embankment slope is approximately 4 m high, sloped approximately 4H:1V. Natural slope (below toe of embankment) of approximately 3 m high, approximately 10H:1V, continues to creek.	
DATE OF ANY REMEDIAL ACTION: Highway repair completed in Fall 2017. Repair included a new road embankment constructed using Cematrix fill.

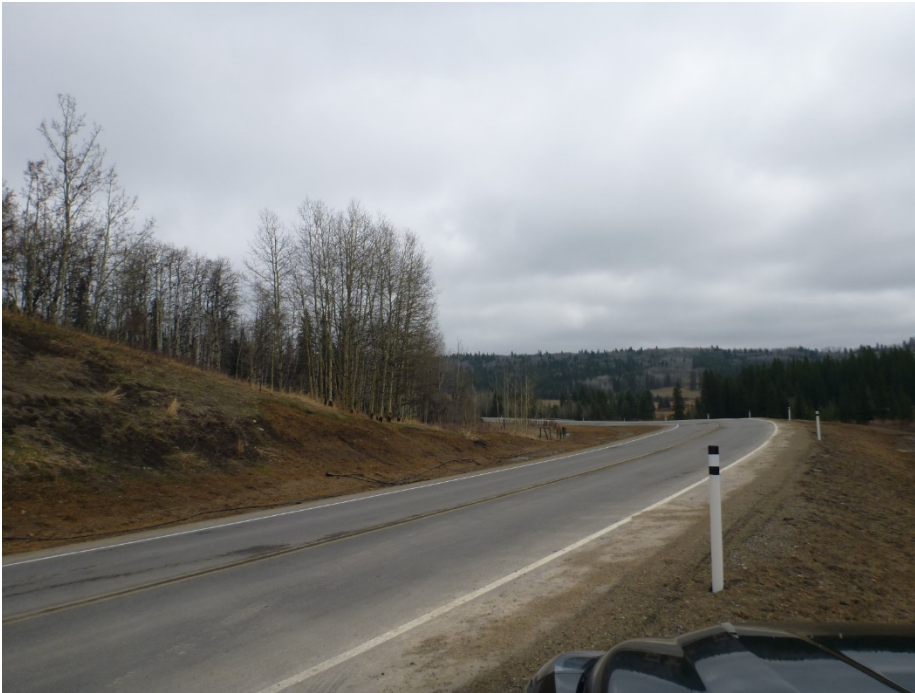
**Photo 1** Highway repair completed in Fall 2017. Photo taken facing northeast on April 30, 2018.

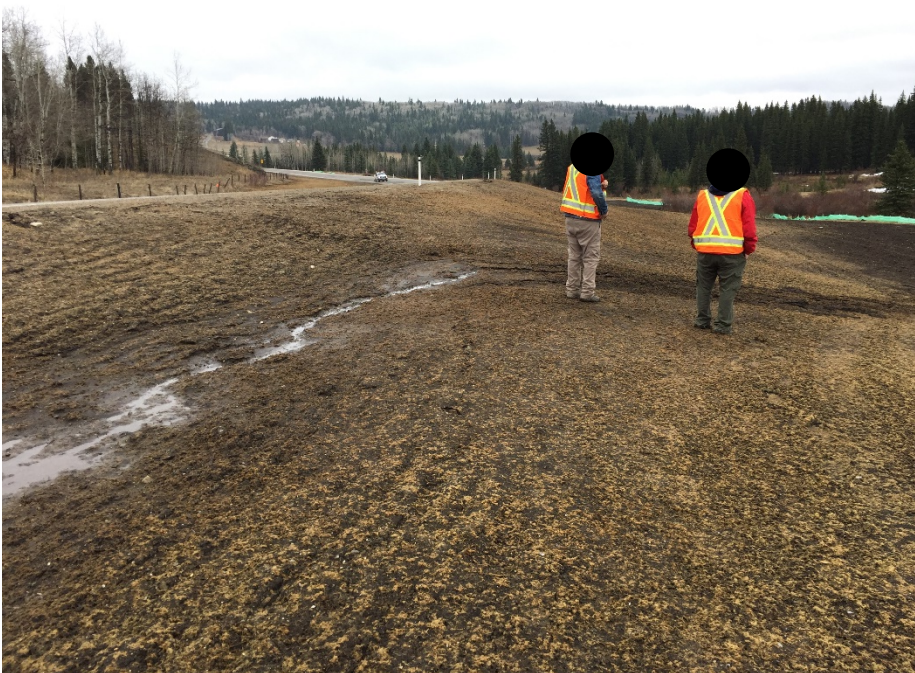
<b>COMMENTS</b>
Shallow failure in field, south of highway. The shallow failure was noticed after stockpiles of fill were placed on the slope during the recent construction work. Cracks noted to extend approximately 50 m from north extents of site. Field fenced off to avoid livestock injury due to the large cracks.
Vegetation not growing on embankment slopes and in ditch, causing erosion.
Rolled erosion control product not used in ditch bottom. Ditch may experience erosion during spring and early summer runoff until vegetation is established in the ditch.
Area south of highway was very wet. The ditch south of the highway ends along the embankment and is draining into the field below.

**Photo 2** Surface water from ditch draining into adjacent field, causing erosion. Vegetation not established at time of inspection. Photo taken facing southeast on April 30, 2018.

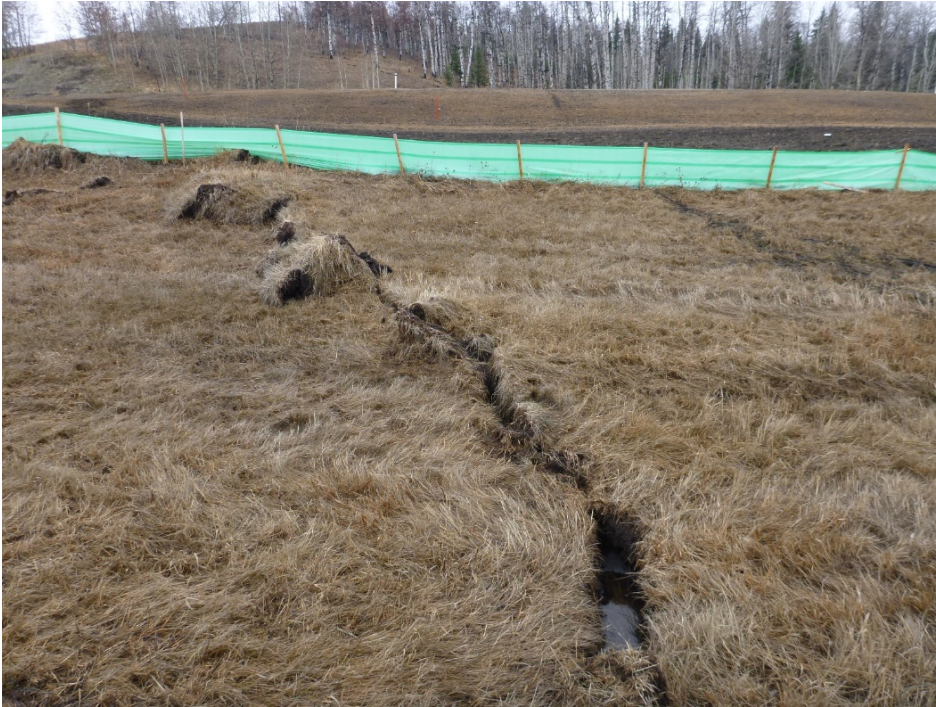
**Photo 3** Large surface cracking in the field south of the highway. Cracking caused by construction of a stockpile during construction. Photo taken facing north on April 30, 2018.

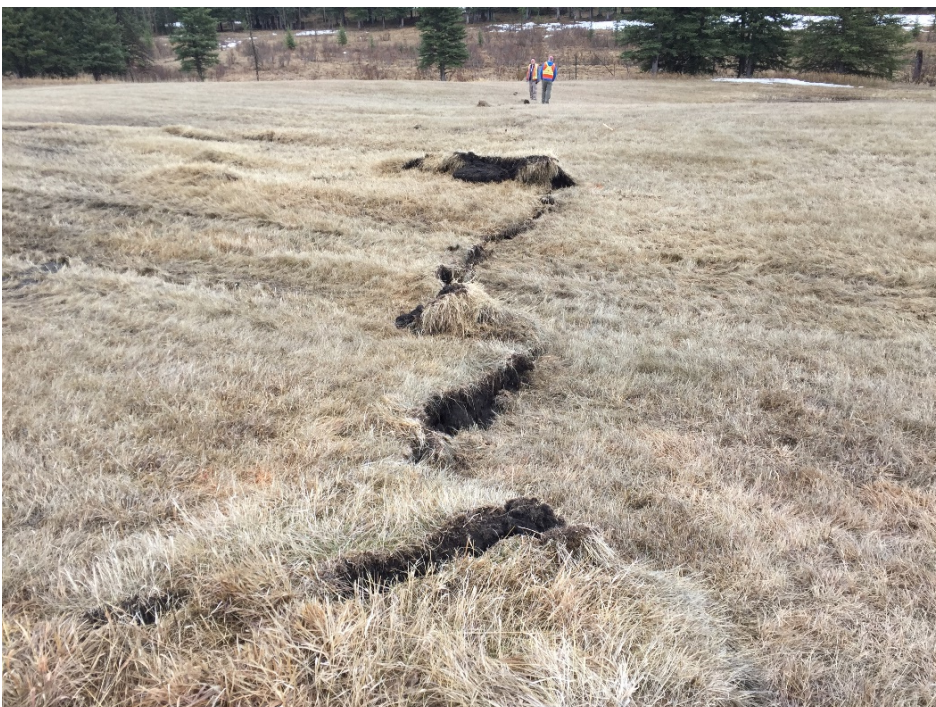
**Photo 4** Cracking in field south of highway. Cracks noted to extend about 50 m into the field from highway. Photo taken facing south on April 30, 2018.
