| <b>SITE NUMBER AND NAME</b><br>S022 S Curve | | <b>HIGHWAY &amp; KM:</b><br>762:02, 8.187 | <b>PREVIOUS INSPECTION DATE:</b><br>April 30, 2018 | <b>INSPECTION DATE</b><br><b>July 8, 2020</b> |

| <b>PRIMARY SITE ISSUE:</b> Landslide movement below road affecting both north and southbound lanes. | |

| NOTES:<br>1. HORIZONTAL DATUM: NAD83<br>2. GRID ZONE: UTM Zone 11N<br>3. IMAGE SOURCE: World Imagery, ESRI ArcGIS Online,<br>Source date January 15, 2015 | CLIENT<br> | PROJECT<br>SOUTHERN REGION GEOHAZARD RISK MANAGEMENT PROGRAM |
| | | TITLE<br>Site Plan<br>S022 - S Curve<br>Hwy 762:02, km 8.187 |

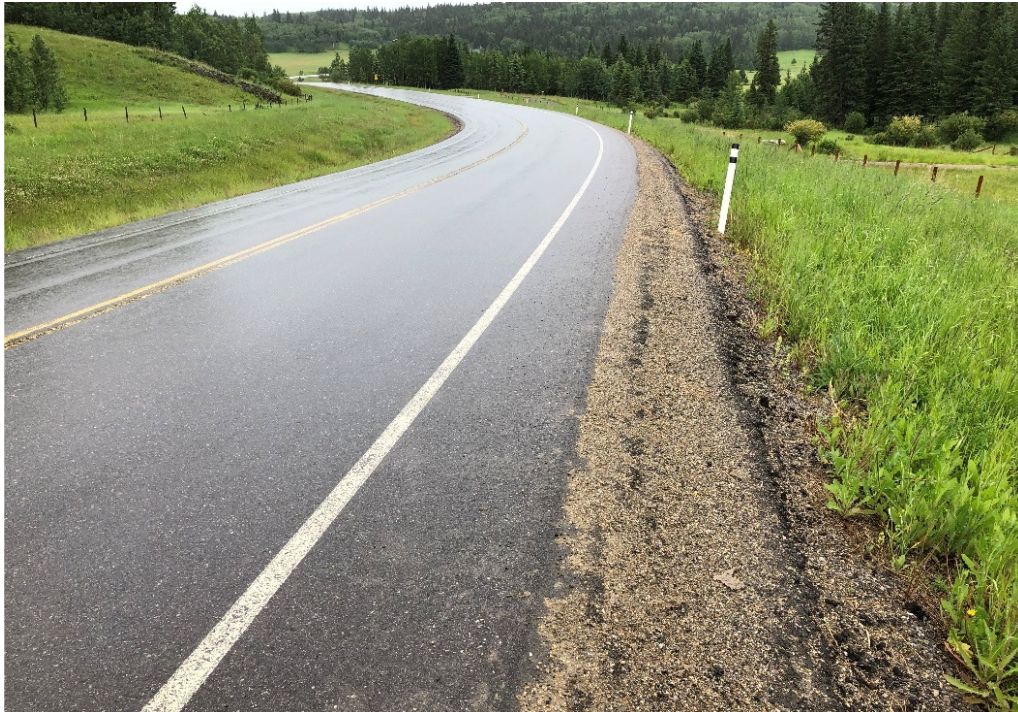
**Photo 1 Highway repair completed in Fall 2017. Photo taken facing northeast on July 8, 2020**

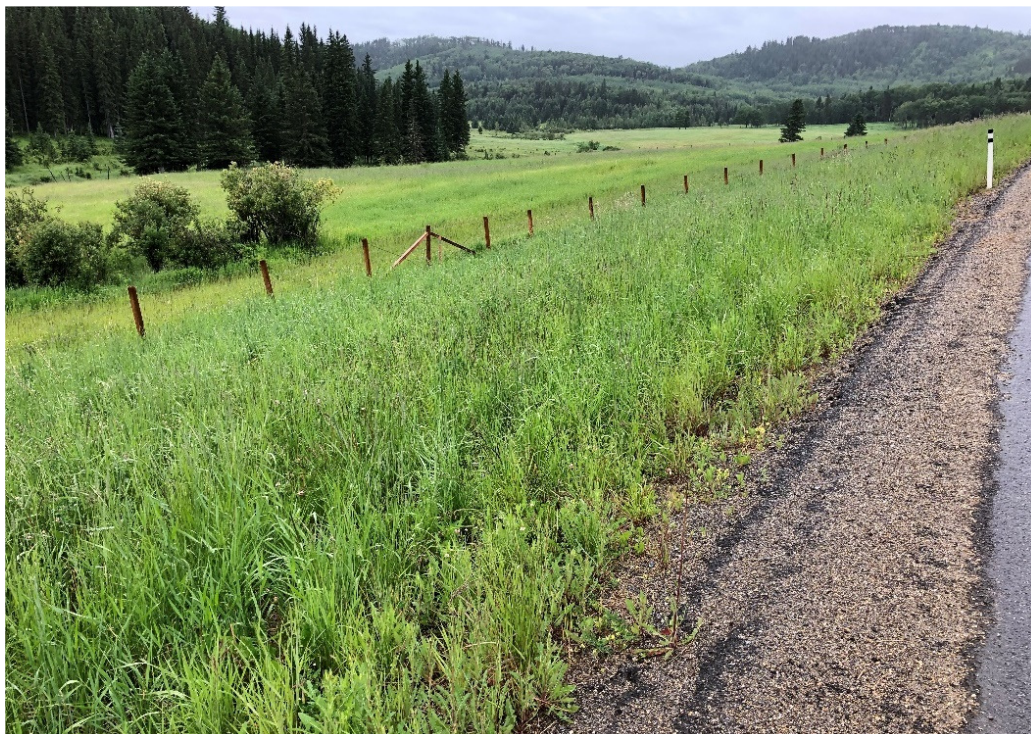
| Embankment was well vegetated in 2020. No concerns observed. Visit the site every 2 years. |

**Photo 2 Vegetation well established at time of inspection. Photo taken facing west on July 8, 2020.**
