July 19, 2010
CG25332.300

**Re: Southern Region Geohazard Assessment
Spring 2010 Instrumentation Monitoring Results
Site S31: Highway 762:02, "Mystery Culvert" Site**

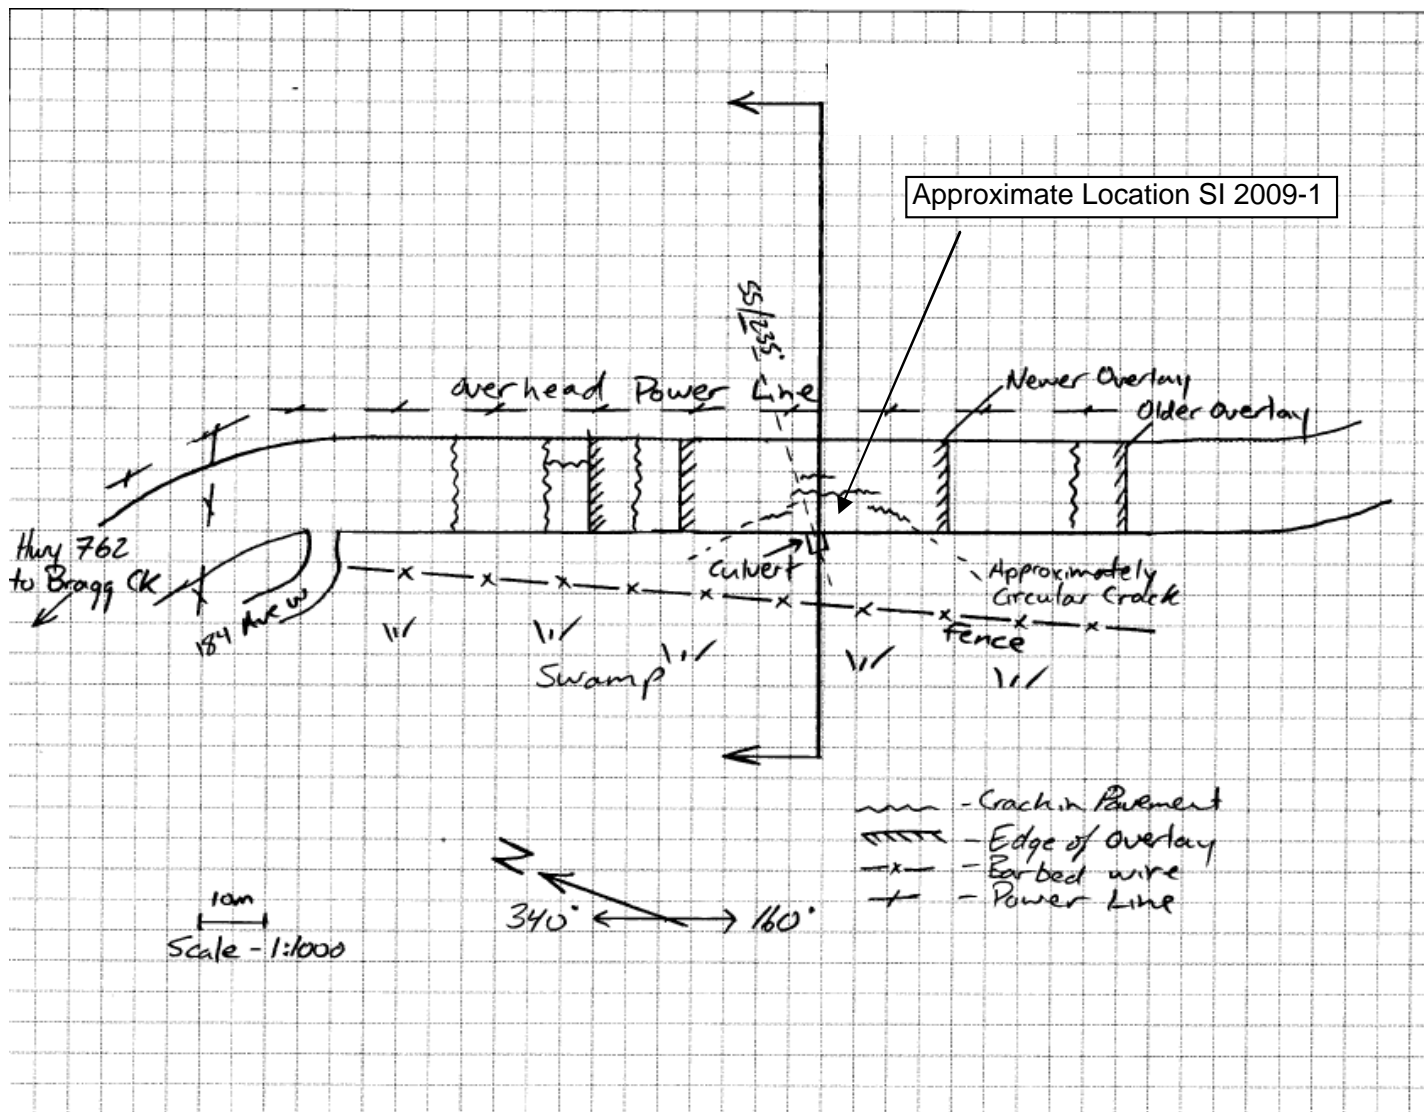
Client	Alberta Transportation		Figure S31-1	
Project	Southern Region Geohazard Assessment		Date:	Revision
	SITE S31 - "MYSTERY CULVERT"		Jun-10	
	HIGHWAY 762:02		Job No.	
	SCHEMATIC SITE PLAN		CG25332.300	
			File No.:

Please refer to Figure S28-1, attached, for a site plan showing the instrument location.
