SITE NUMBER AND NAME: <b>S031-I &amp; II Mystery Culvert</b>		HIGHWAY & KM: 762:02, 8.187	PREVIOUS INSPECTION DATE: May 9, 2019	INSPECTION DATE: <b>July 8, 2020</b>
LEGAL DESCRIPTION: 07-19-022-04 W5M	NAD 83 COORDINATES: UTM Northing Easting 11 5639613 672917		RISK ASSESSMENT: PF: 1 CF: 1 TOTAL: 1 (Site I) (Not visited) PF: 11 CF: 4 TOTAL: 44 (Site II)	
AVERAGE ANNUAL DAILY TRAFFIC (AADT): 720 (north) (Ref No. 65170), 1420 (south) (Ref. No. 60180)			CONTRACTOR MAINTENANCE AREA (CMA): 27

PRIMARY SITE ISSUE: Monitoring of two repaired embankment failures. Prior to repair, the embankment failures were impacting the southbound lane at both site I and II.

PROJECT SOUTHERN REGION GEOHAZARD RISK MANAGEMENT PROGRAM		
TITLE Site Plan S031-2 Mystery Culvert Hwy 762:02		
SCALE 1:1,000	PROJECT No. A05115A03	FIG No. 1

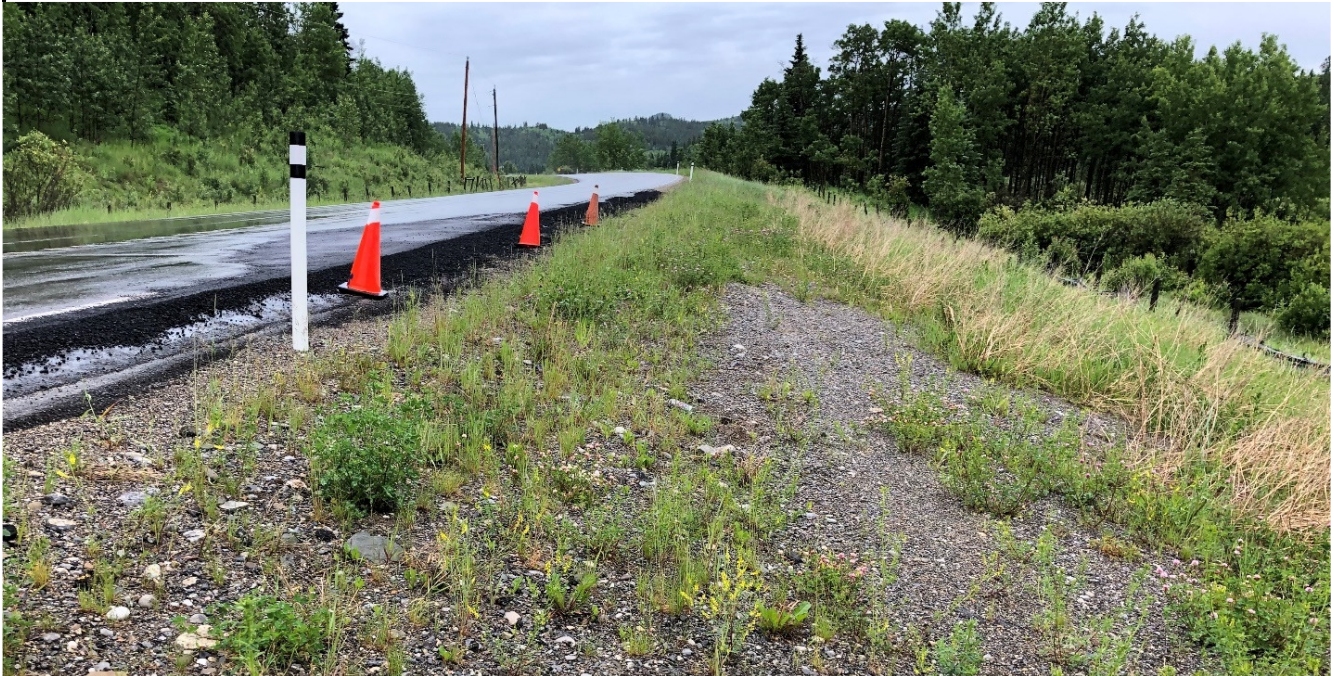
Site II appears to have ongoing movement. The site was repaired in 2017 using a toe berm and repaving, and the pavement cracked within the warranty period. A tension crack in the pavement was observed in 2019 and had continued to enlarge. In mid 2020, the MCI reported that the pavement had settled approximately 200 mm vertically and required patching in June 2020. Mid-slope tension cracking was noted along the west embankment between the north and south culverts.

**Photo 1** S031 Site II – West shoulder of highway where slide was repaired and new pavement patch. Photo was taken facing north on July 8, 2020.

Site II should be visited annually.

Candidate repair options for this site include: gravel-backfilled finger drains (with geotextile wrapped perforated drainage pipe), an H-pile wall, or a reinforced-earth slope with shear key.

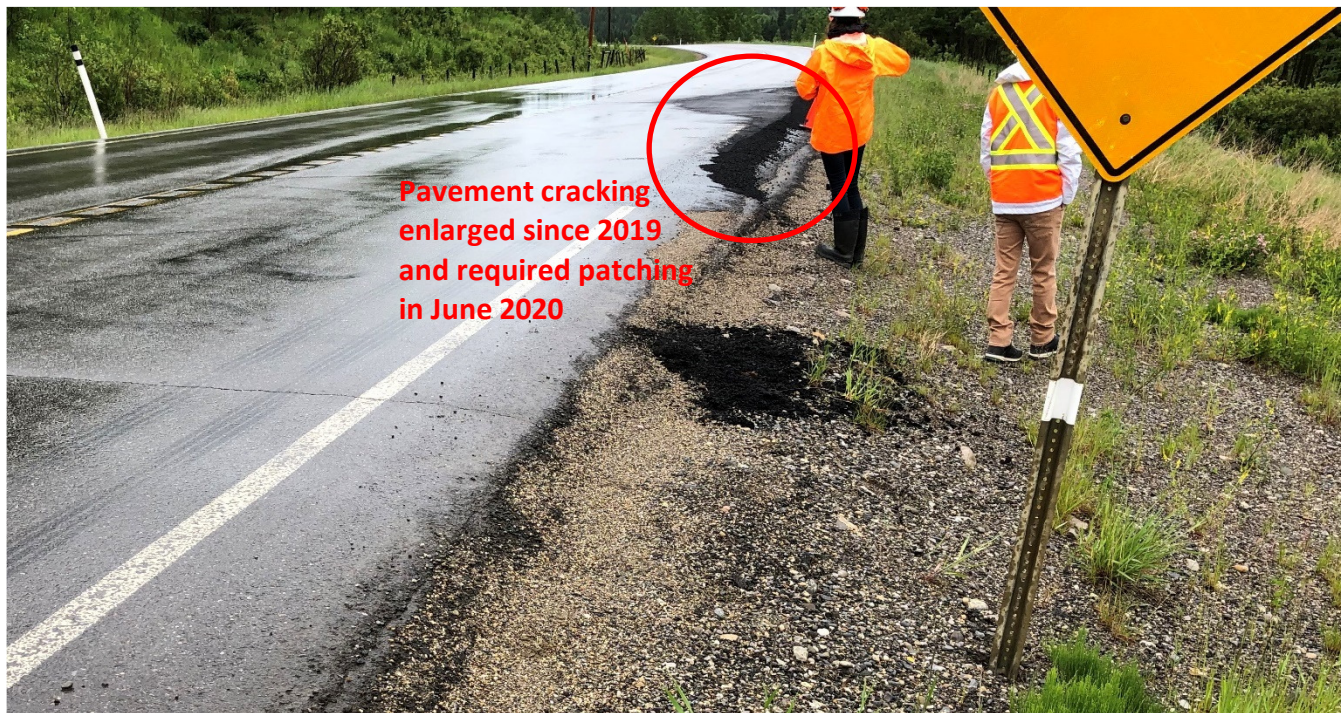
**Photo 2** S031 Site II – Pavement cracking north of slide repair. Photo was taken facing east on July 8, 2020.

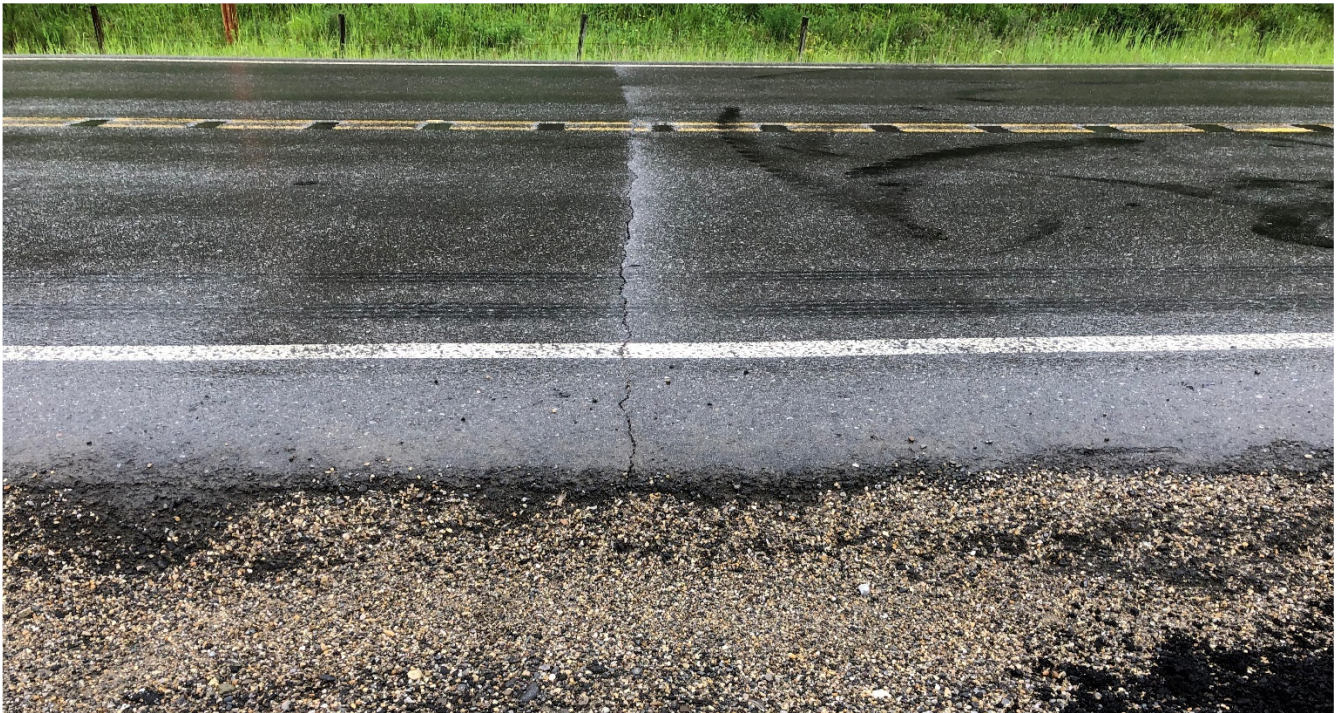
**Photo 3** S031 Site II – Pavement cracking north of slide repair. Photo was taken facing east on July 8, 2020.

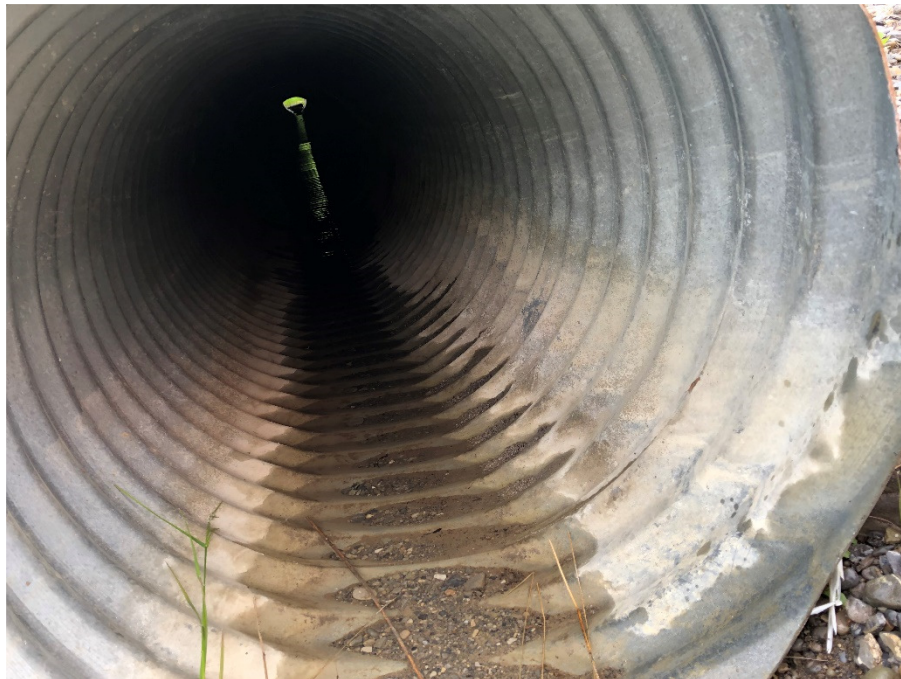
Two culverts were noted at Site II. The southernmost culvert was replaced as part of the 2017 repair work, and the north culvert is outside the site limits. Both culverts appeared deformed and bowed beneath the highway embankment.

**Photo 4** S031 Site II – Culvert appears bowed beneath highway. Photo was taken facing east on July 8, 2020.
