SITE NUMBER AND NAME: S031 I & II Mystery Culvert		HIGHWAY & KM: 762:02, 8.187 & 17.660	PREVIOUS INSPECTION DATE: July 8, 2020	INSPECTION DATE: July 5, 2021
LEGAL DESCRIPTION: 07-19-022-04 W5M	NAD 83 COORDINATES: UTM Northing Easting 11 5639613 672917		RISK ASSESMENT: PF: 1 CF: 1 TOTAL: 1 (Site I) (Not visited) PF: 11 CF: 4 TOTAL: 44 (Site II)	
AVERAGE ANNUAL DAILY TRAFFIC (AADT): 720 (north) (Ref No. 65170), 1420 (south) (Ref. No. 60180)			CONTRACTOR MAINTENANCE AREA (CMA): 27

PRIMARY SITE ISSUE: Monitoring of two repaired embankment failures. Prior to repair, the embankment failures were impacting the southbound lane at both site I and II.

PROJECT
 SOUTHERN REGION GEOHAZARD RISK MANAGEMENT PROGRAM

TITLE
 Site Plan
 S031-2 - Mystery Culvert
 Hwy 762.02

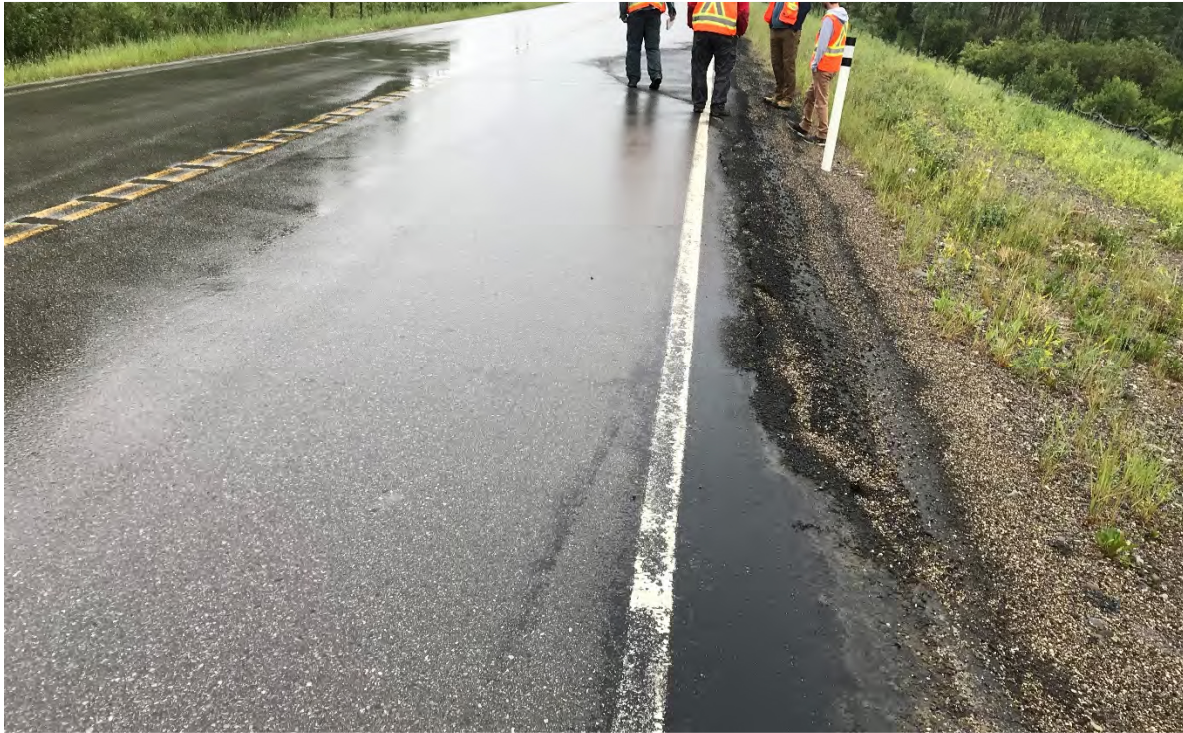
During the 2021 inspection, it was noted that the patched area at Site II had settled approximately 1 to 1.5 cm. Cracking of the pavement in the southbound lane is offset 1.7 m from the white line on the shoulder. The length of the tension crack appears to have extended to the north and south, by up to 10 m. Site II should be visited annually.

Photo 1 S031 Site II – Minimal change visible to pavement patch placed in June 2020. Photo was taken facing south on July 5, 2021.

Candidate repair option for Site II: excavate and replace embankment fill with geogrid reinforced granular fill with a shear key. Could reduce embankment loading using lightweight fill (Cematrix or polystyrene) in the upper third of the slope. Repair work could be completed by the maintenance contractor using a memo prepared by KCB.

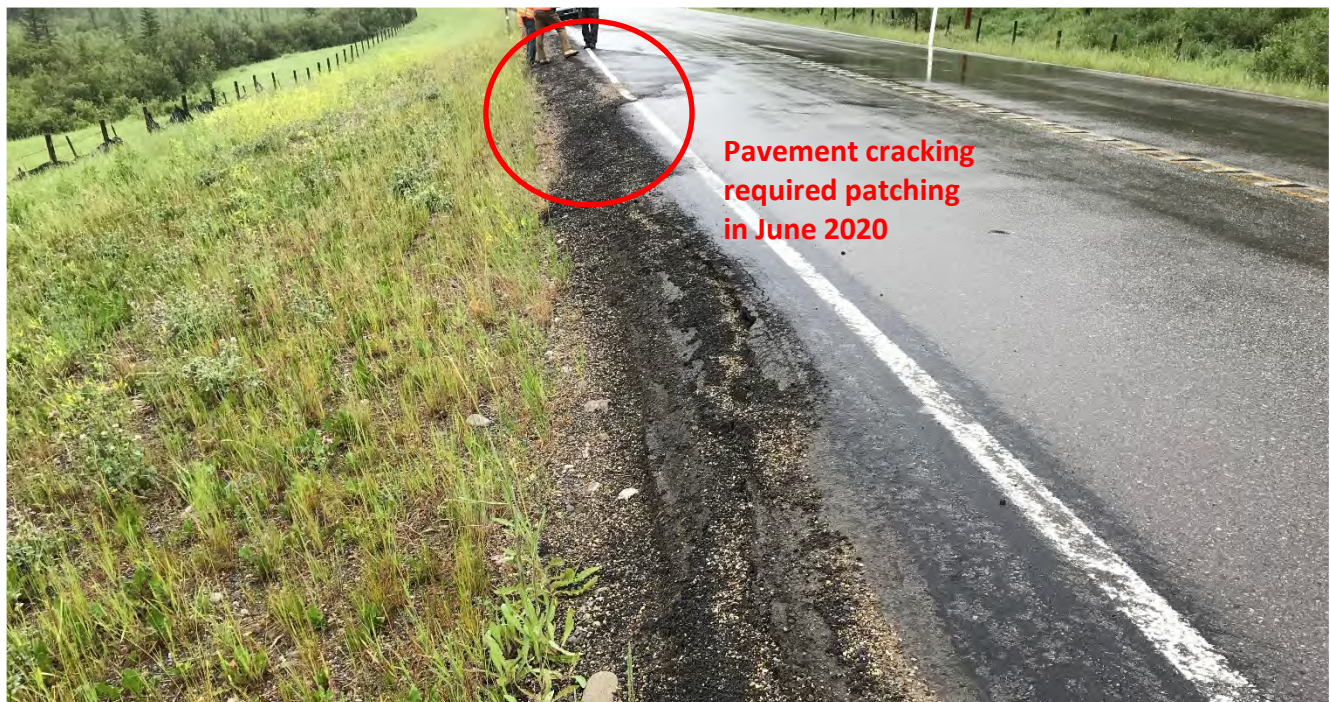
Site II appears to have ongoing movement. The site was repaired in 2017 using a toe berm and repaving, and the pavement cracked within the warranty period. In 2019, a tension crack was observed in the pavement and has continued to enlarge. The MCI reported that the pavement had settled approximately 200 mm vertically and required patching in June 2020. During the 2020 inspection, mid-slope tension cracking was noted along the west embankment between the north and south culverts. The side slopes appear well vegetated. There is a slight bulge in the slope but no apparent change from the 2020 inspection.

Photo 2 S031 Site II – Pavement cracking north of slide repair. Photo was taken facing southwest on July 5, 2021.

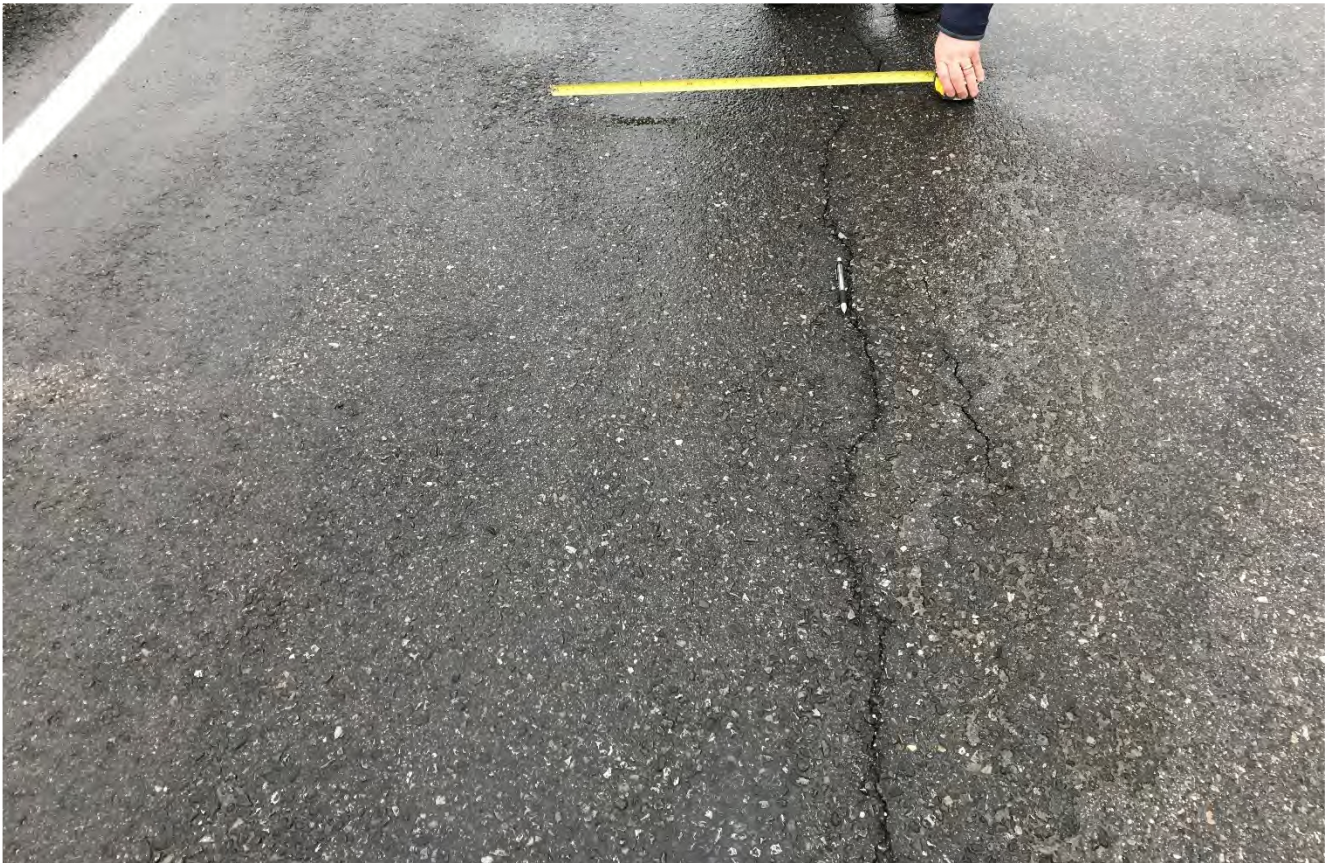
Photo 3 **S031 Site II – Pavement cracking halfway into the southbound lane. Photo was taken on July 5, 2021.**
