SITE NUMBER AND NAME: S031-II Mystery Culvert		HIGHWAY & KM: 762:02, 17.660	PREVIOUS INSPECTION DATE: July 5, 2021	INSPECTION DATE: May 16, 2022
LEGAL DESCRIPTION: 07-19-22-04-W5M	NAD 83 COORDINATES: UTM Northing Easting 11 5639613 672917		RISK ASSESMENT: S031-I: PF: 1 CF: 1 TOTAL: 1 S031-II: PF: 11 CF: 4 TOTAL: 44	
AVERAGE ANNUAL DAILY TRAFFIC (AADT): 720 (north) & 1420 (south) (Reference No. 65170 & 60180)			CONTRACTOR MAINTENANCE AREA (CMA): 27

PRIMARY SITE ISSUE: Monitoring of two repaired embankment failures. Prior to repair, the embankment failures were impacting the southbound lane at both site I and II.

PROJECT SOUTHERN REGION GEOHAZARD RISK MANAGEMENT PROGRAM		
TITLE Site Plan S031-2 - Mystery Culvert Hwy 762:02, km 97.660		
SCALE 1:1,500	PROJECT No. A05116A03	FIG No. 1

Inspection Photographs

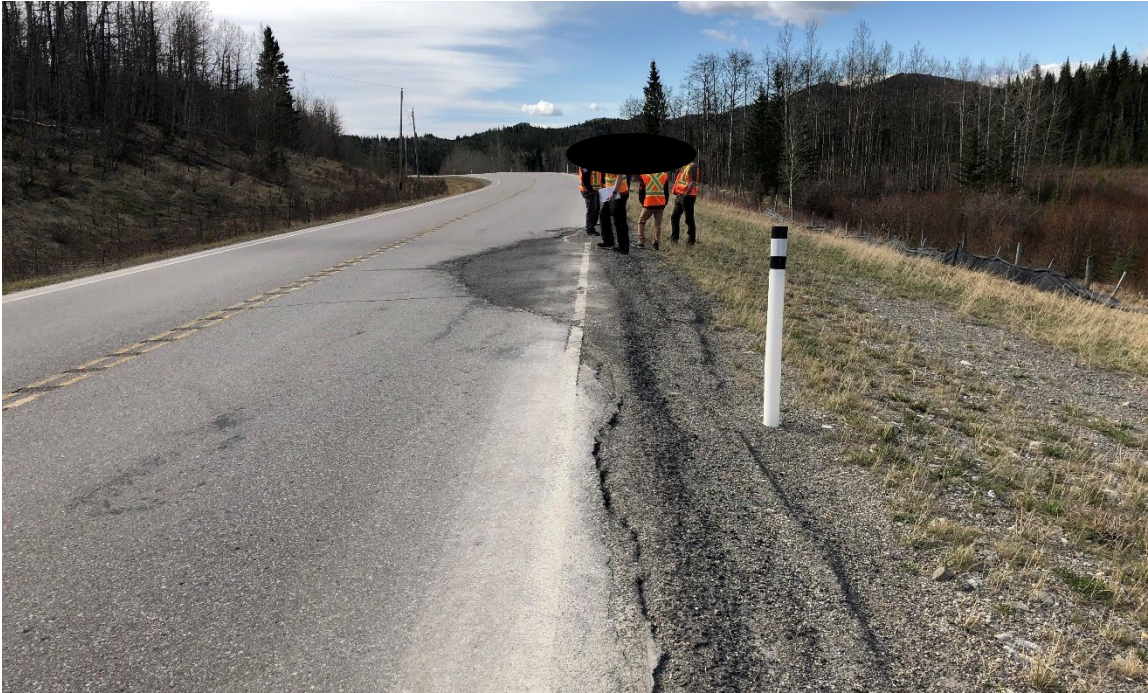
- During the 2022 inspection it was noted that the patched area had settled approximately 20 mm (the settlement was approximately 10 mm to 15 mm in 2021) (Photo 1 and 2).

- The tension crack appears to have increased in length by 10 m (extending north and south). The total length of the tension crack is approximately 40 m. Longitudinal cracks up to 10 mm wide were observed through the patch and at the north end of the site (Photos 1 through 4).

Photo 1 Pavement cracking and settlement in the west (southbound) lane. The location was patched in June 2020. Photo was taken May 16, 2022, facing southeast.

- Candidate repair options for the S031-II site include: (i) a driven steel H-pile wall (ii) excavate and replace the embankment fill with geogrid reinforced granular fill, including a shear key near the toe of the highway embankment. (iii) Reduce embankment loading using lightweight fill (e.g., cematrix or polystyrene) in the top third of the slope.

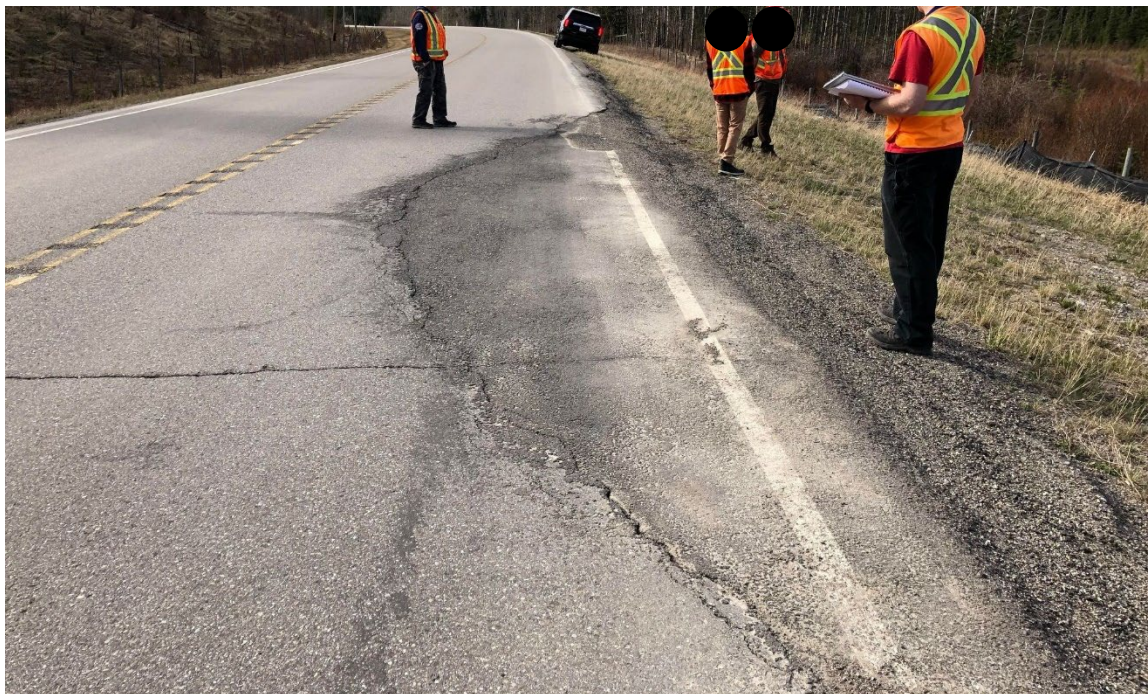
Photo 2 Pavement patch north of the slide repair area where there has been pavement cracking and settlement. Photo was taken May 16, 2022, facing southeast.

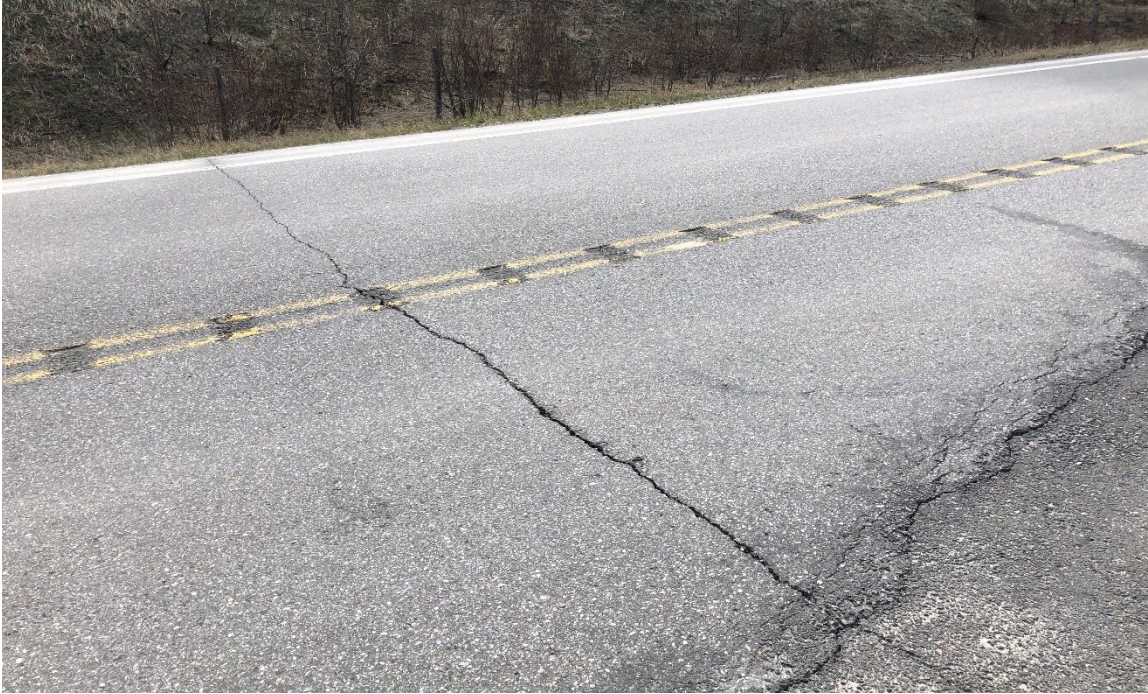
Photo 3 Transverse and longitudinal pavement cracking at the location of the pavement patch. The longitudinal crack is along the contact between new and old pavement. Photo was taken May 16, 2022, facing northeast.

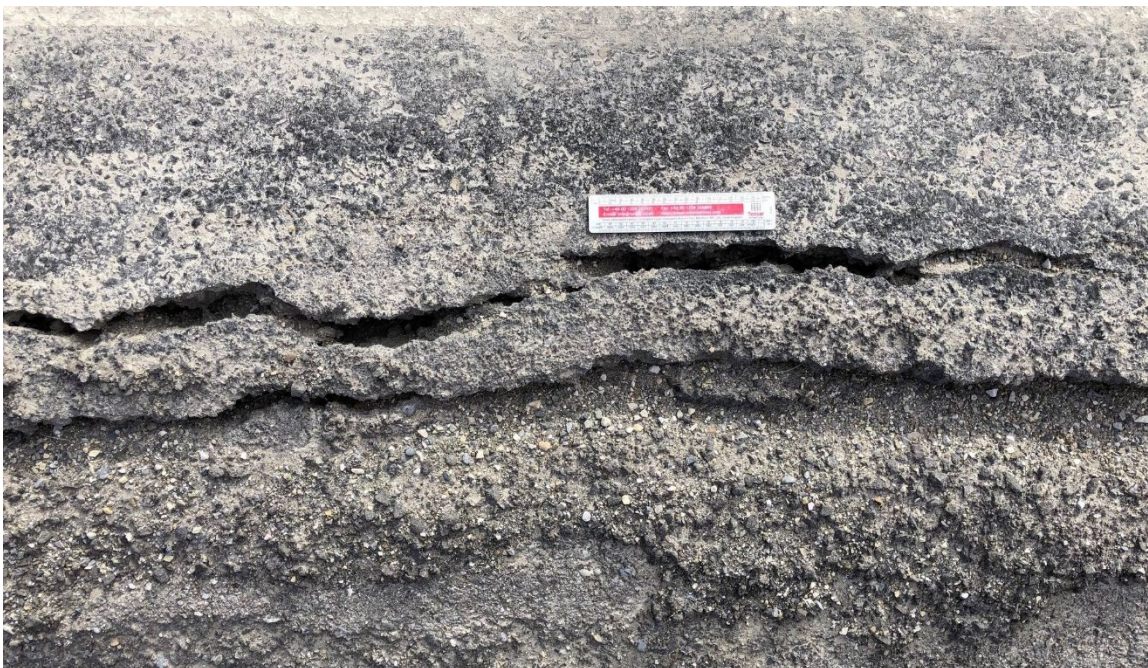
- There appears to be ongoing settlement and/or slope movement at the site. However, and the pavement cracked within the 1-year warranty period. In 2019, a tension crack was observed in the pavement and has continued to enlarge (Photo 4).

- Pavement cracking in the west (southbound) lane is offset 1.9 m from the white line on the shoulder (offset 1.7 m in 2021), and the east (northbound) lane has started to be impacted.

Photo 4 Longitudinal pavement crack in the west (southbound) lane. Photo taken May 16, 2022, facing east.

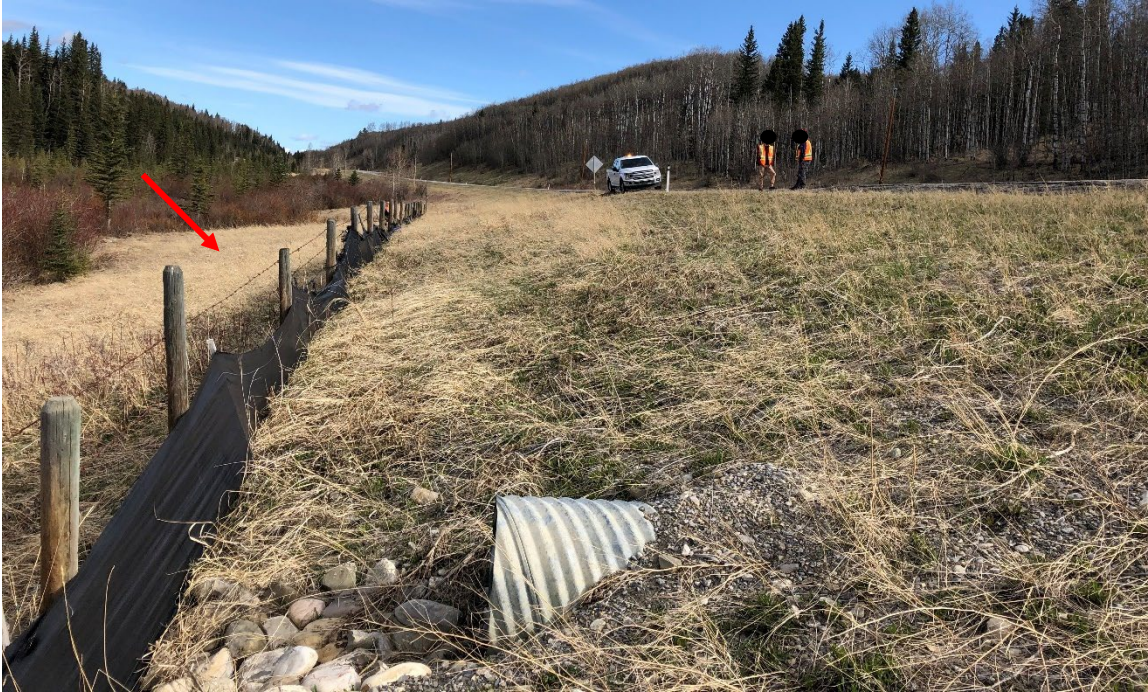
- Two CSP culverts are present at S031-II site that are underlying the highway (oriented east-west) (Photo 5 and 6). The south culvert was replaced as part of the 2017 repair work, and the north culvert is outside the site limits. Both culverts appeared deformed and bowed beneath the highway embankment. An asphalt apron is at the outlet of the north culvert (Photo 6).

Photo 5 The west (southbound) ditch, CSP culvert inlet, and the approximate location of the 2017 toe berm repair (indicated by red arrow). Photo was taken May 16, 2022, facing north.

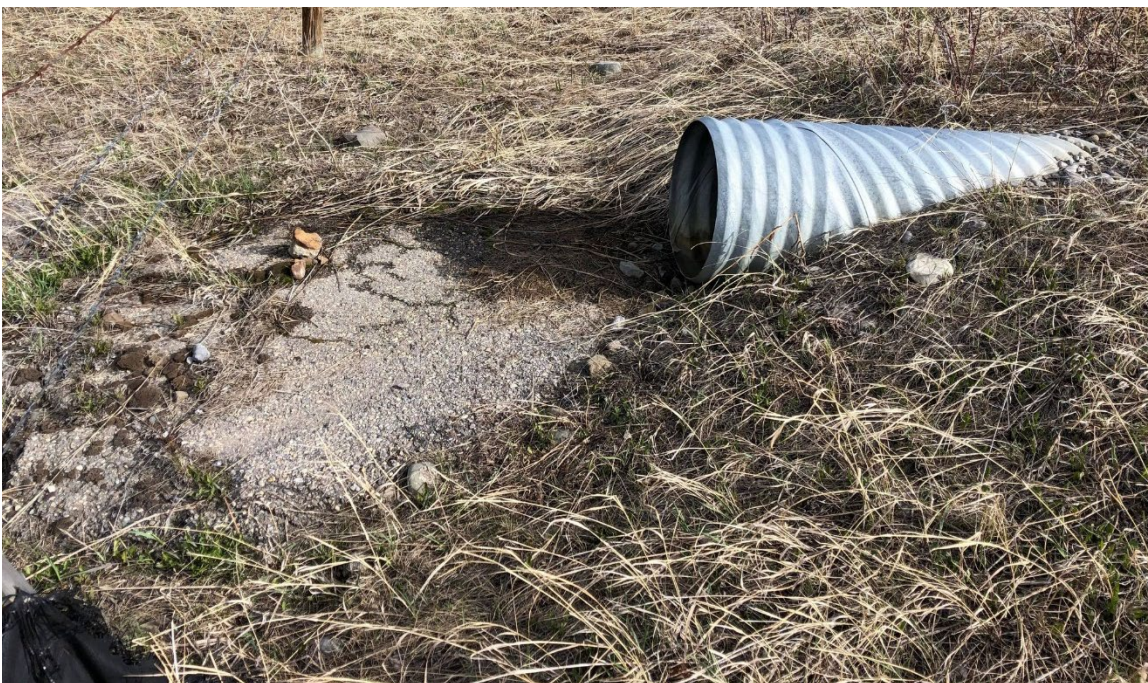
Photo 6 Asphalt apron at the outlet of the north CSP culvert. Photo taken May 16, 2022, facing north.
