SITE NUMBER AND NAME: <b>S031-II Mystery Culvert</b>		HIGHWAY & KM: 762:02, 17.660	PREVIOUS INSPECTION DATE: May 16, 2022	INSPECTION DATE: <b>May 9, 2023</b>
LEGAL DESCRIPTION: 07-19-22-04-W5M	NAD 83 COORDINATES: UTM Northing Easting 11 5639613 672917		RISK ASSESMENT: <b>S031-I:</b> PF: 1 CF: 1 TOTAL: 1 (Not visited) <b>S031-II:</b> PF: 8 CF: 4 TOTAL: 32	
AVERAGE ANNUAL DAILY TRAFFIC (AADT): 700 (north) & 1320 (south) (Reference No. 65170 & 60180)			CONTRACTOR MAINTENANCE AREA (CMA): 27

**PRIMARY SITE ISSUE:** Monitoring of two repaired embankment failures. Prior to repair, the embankment failures were impacting the southbound lane at both site I and II.

PROJECT SOUTHERN REGION GEOHAZARD RISK MANAGEMENT PROGRAM		
TITLE Site Plan S031-2 - Mystery Culvert Hwy 762.02, km 97.660		
SCALE 1:1,500	PROJECT No. A05116A03	FIG No. 1

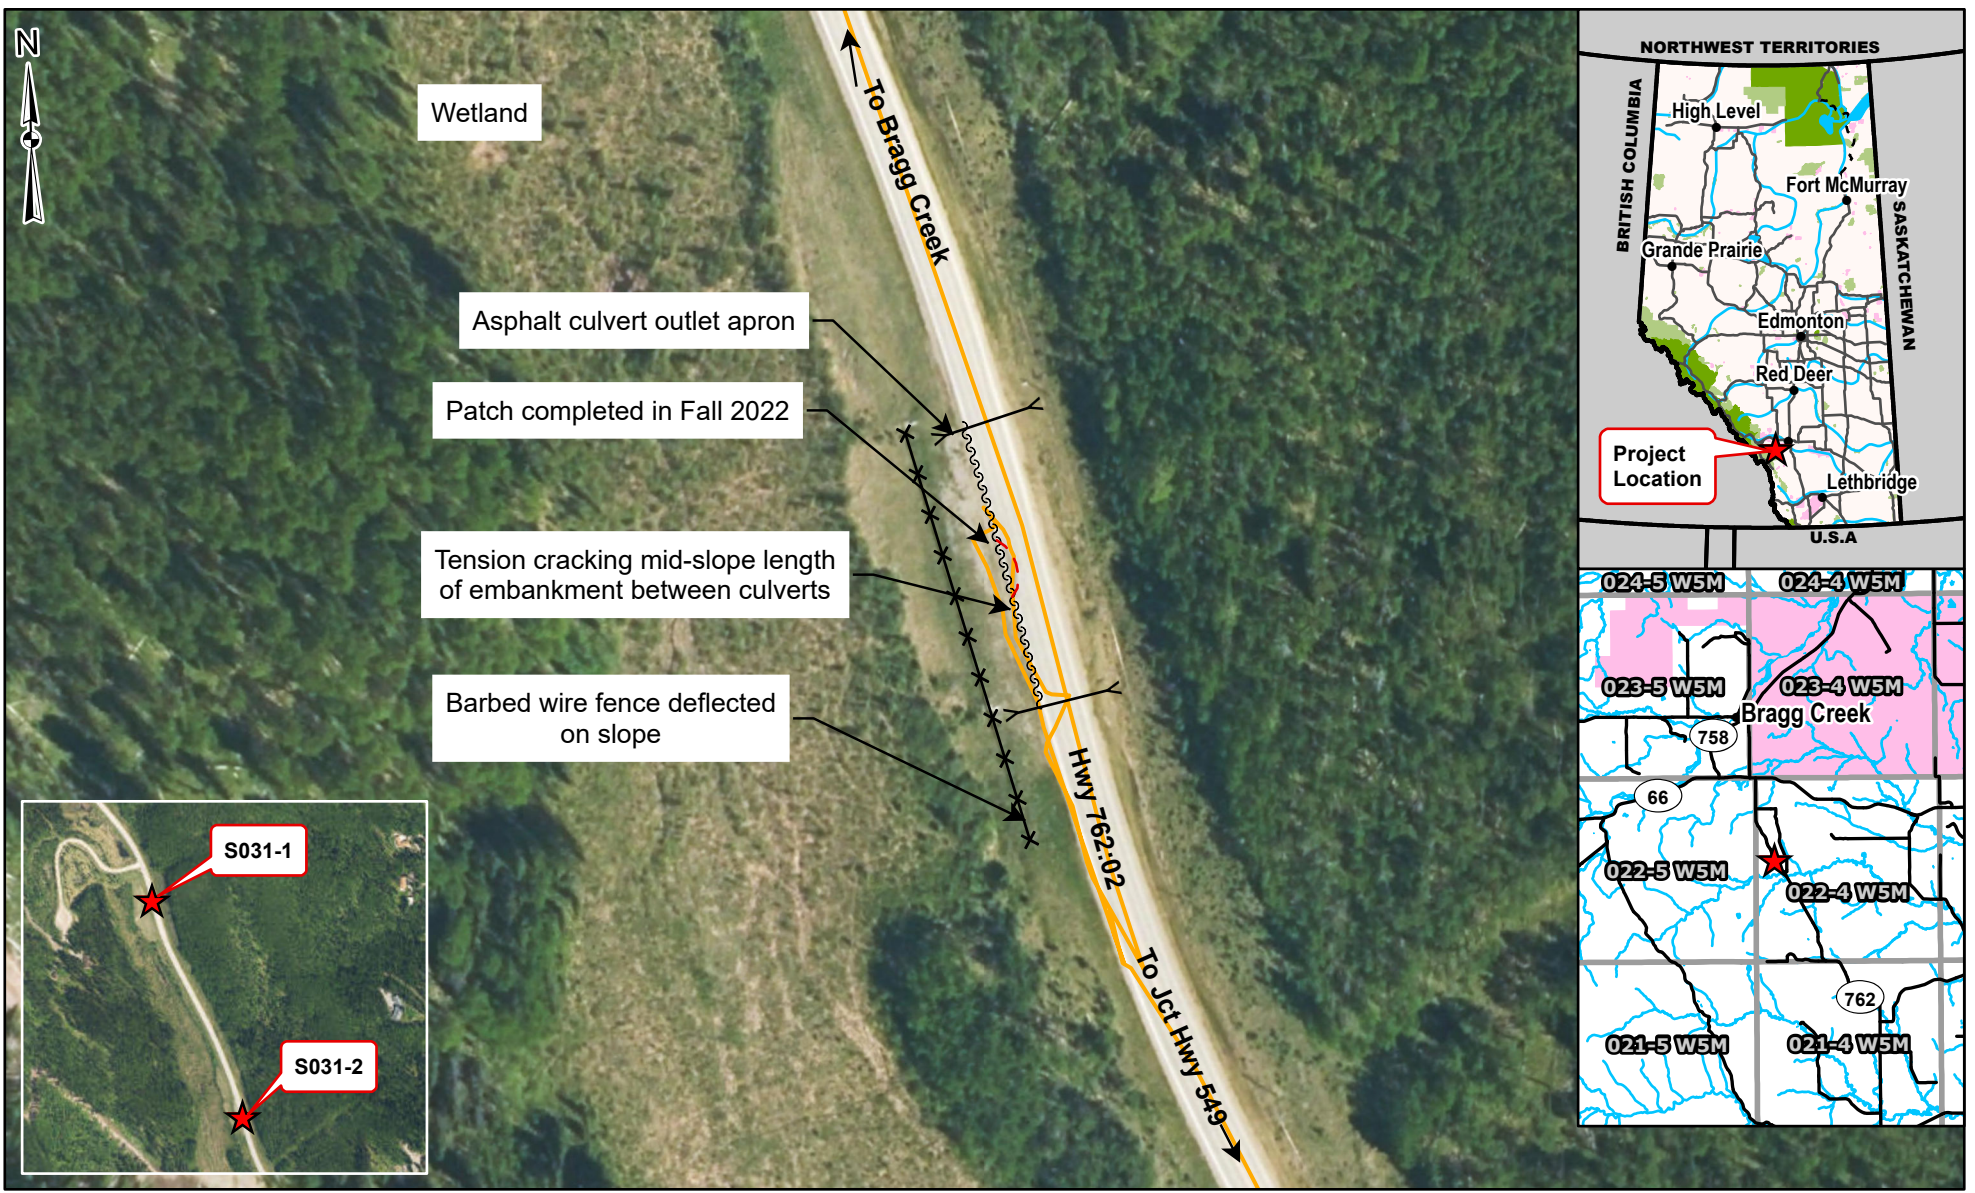
- The total length of the tension crack on the highway surface is approximately 40 m. Longitudinal cracks up to 10 mm wide were observed at the north end of the site close to the west shoulder (this area was not patched and appears unchanged since the previous inspection).

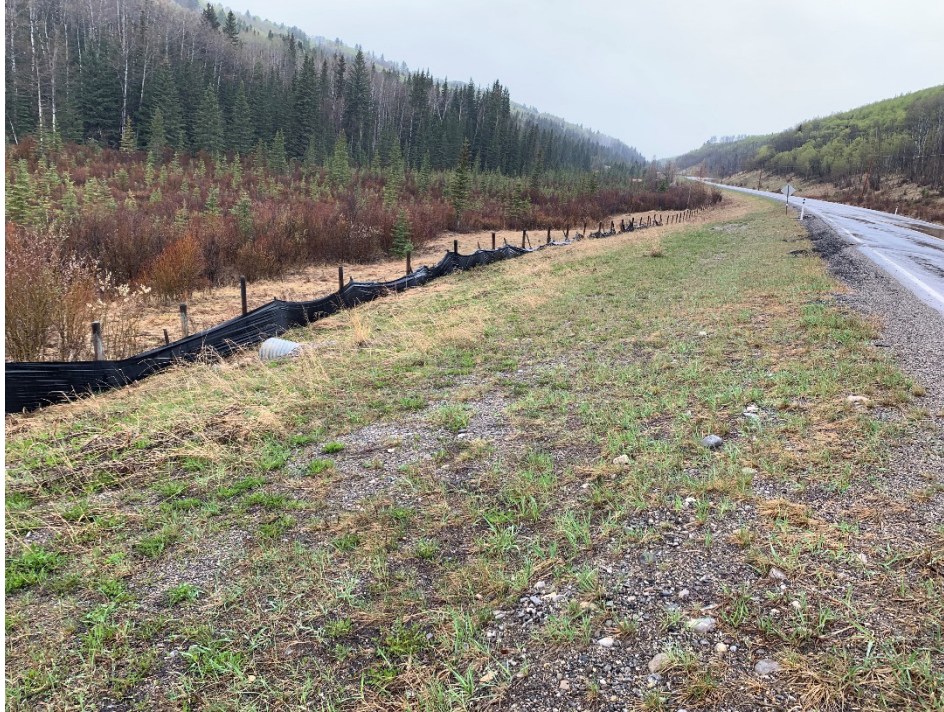
- Two CSP culverts are present at S031-II site that are underlying the highway (oriented east-west). The south culvert was replaced as part of the 2017 repair work, and the north culvert is outside the site limits. Both culverts appeared deformed and bowed beneath the highway embankment. An asphalt apron is at the outlet of the north culvert.

**Photo 1** West ditch, and a CSP culvert inlet. Photo taken facing north on May 9, 2023.

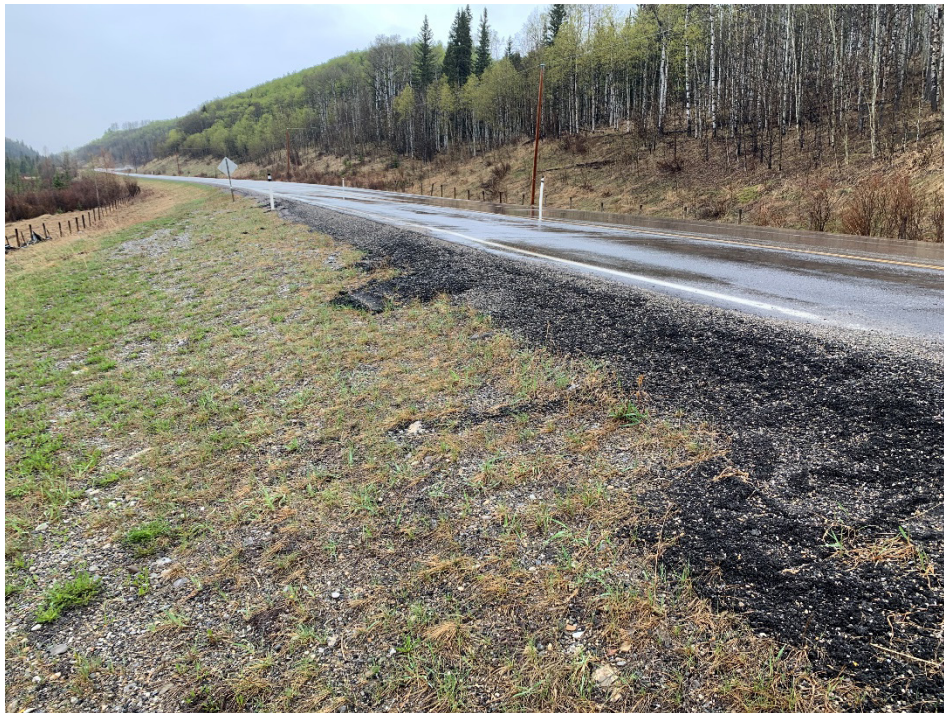
- The MCI reported that the pavement had settled approximately 200 mm vertically and required patching in June 2020. During the 2020 inspection, mid-slope tension cracking was noted along the west embankment between the north and south culverts. There is a slight bulge in the slope but no discernible change between the 2021, 2022 and 2023 inspections.

**Photo 2** West slope. Photo taken facing northeast on May 9, 2023.

- Candidate repair options for the S031-II site include: (i) a driven steel H-pile wall (ii) excavate and replace the embankment fill with geogrid reinforced granular fill, including a shear key near the toe of the highway embankment. (iii) Reduce embankment loading using lightweight fill (e.g., cematrix or polystyrene) in the top third of the slope.

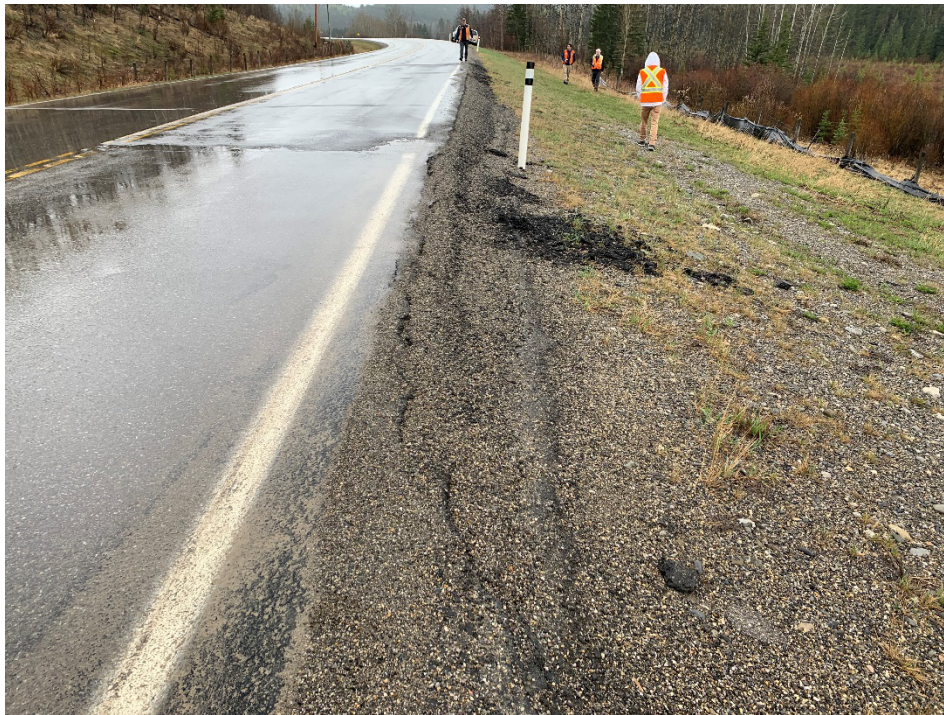
**Photo 3** Cracking on the shoulder of the southbound (west) lane. Photo taken facing south on May 9, 2023.

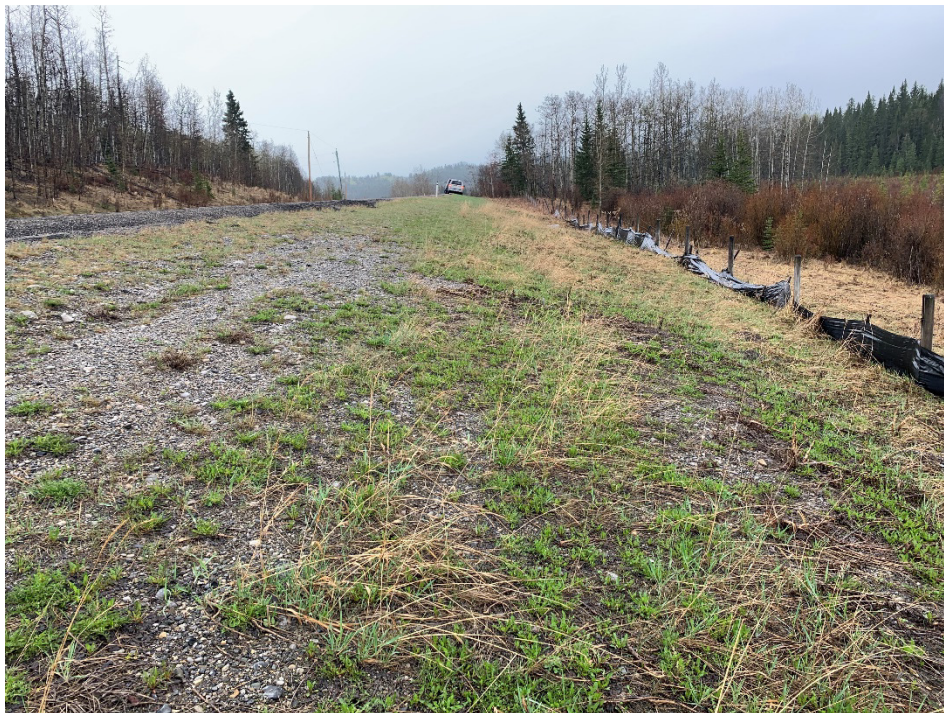
**Photo 4** Slope on the west side of the road. Photo taken facing south on May 9, 2023.
