| SITE NUMBER AND NAME: S031-II Mystery Culvert | | HIGHWAY & KM: 762:02, 17.660 | PREVIOUS INSPECTION DATE: May 9, 2023 | INSPECTION DATE: May 28, 2024 |

| PRIMARY SITE ISSUE: Embankment failure impacting the southbound lane. | | |

SOUTHERN REGION GEOHAZARD RISK MANAGEMENT PROGRAM

Site Plan
 S031-2 - Mystery Culvert
 Hwy 762.02, km 97.660

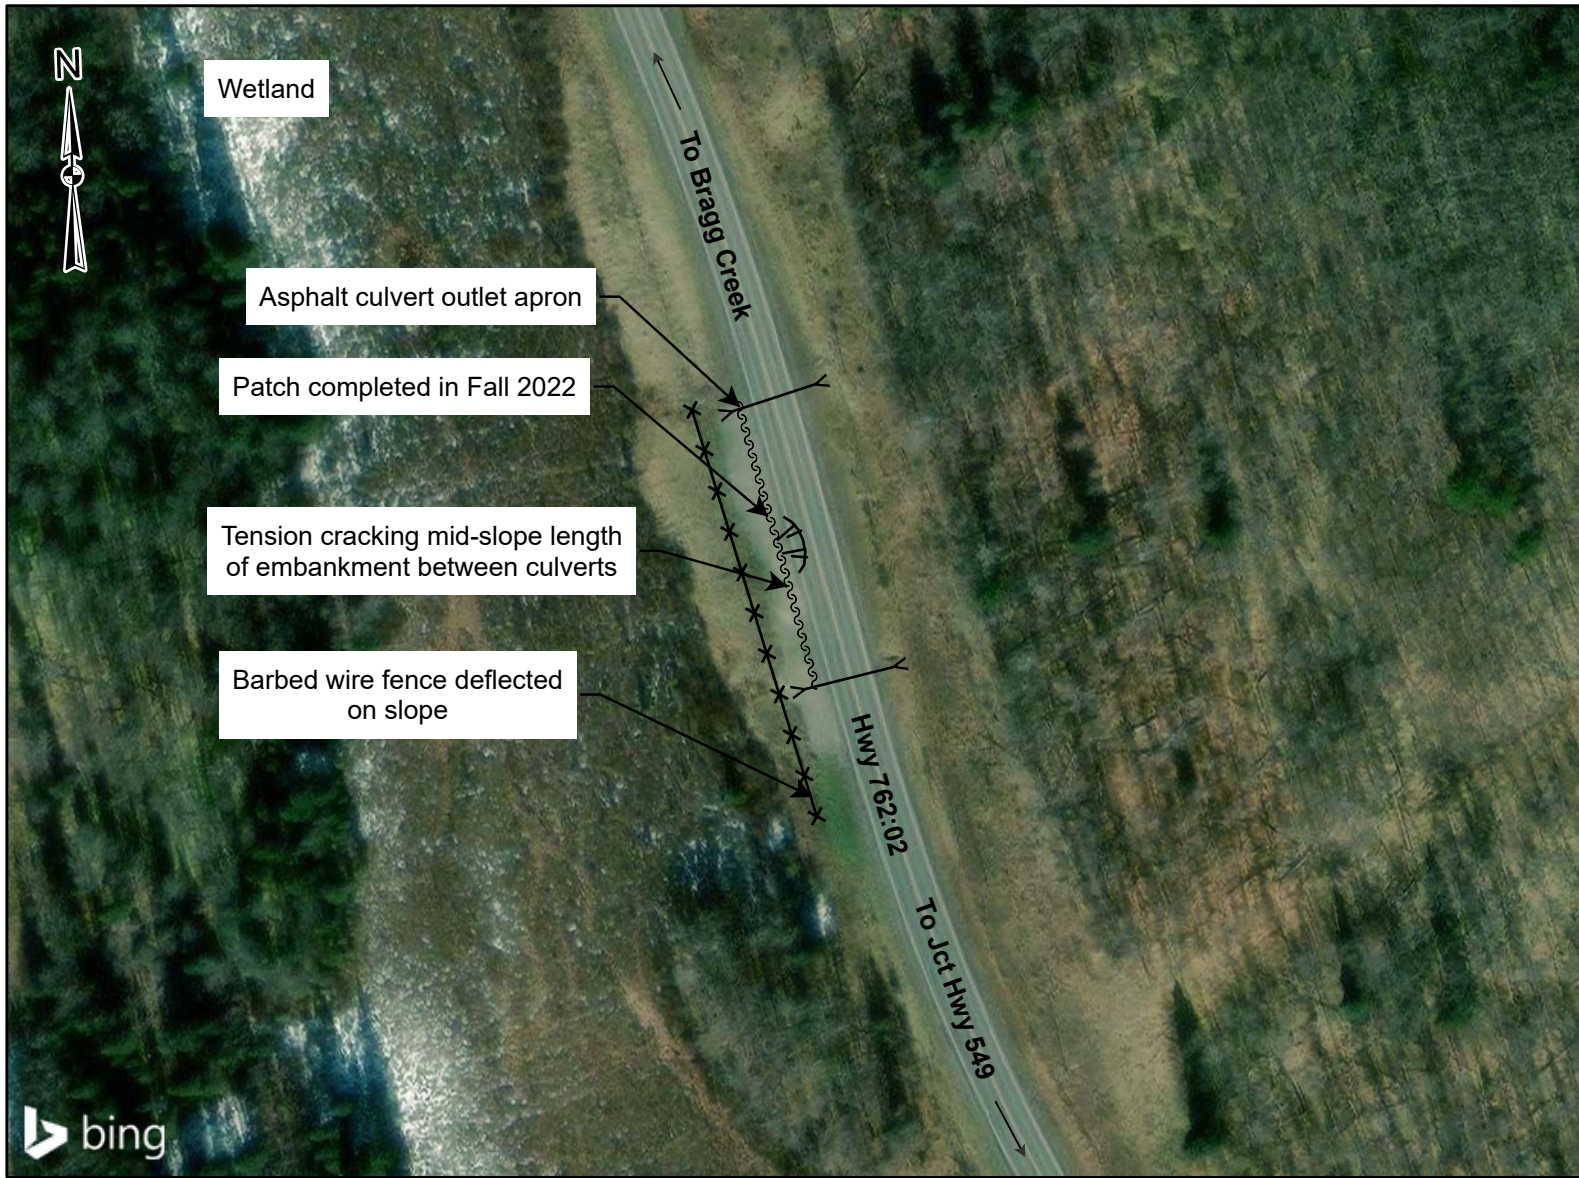
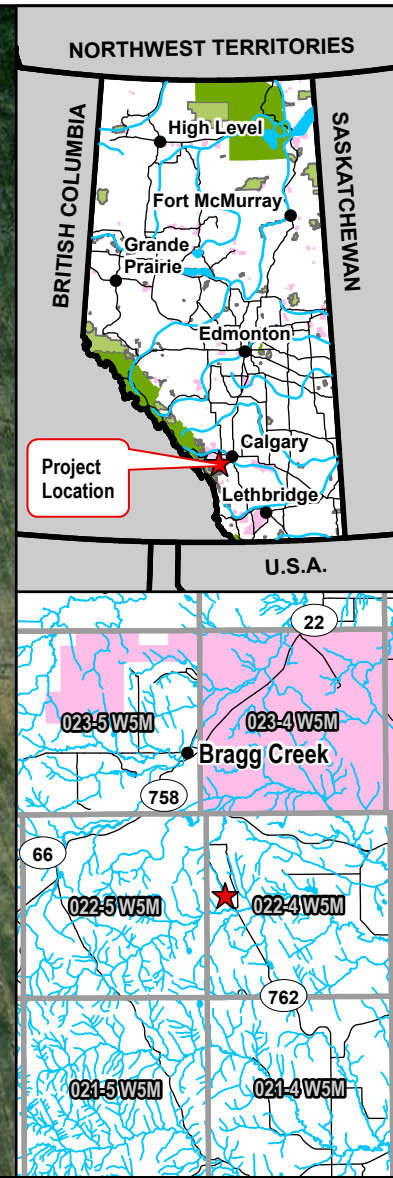
| APPROXIMATE DIMENSIONS: Slide approximately 40 m wide, up to 2 m into the highway. Most of the cracking was observed on the west shoulder. The height of the highway embankment is approximately 4 m to 5 m. | | |

| ITEM | CONDITION EXISTS | | DESCRIPTION AND LOCATION | NOTICABLE CHANGE FROM LAST INSPECTION | |
|---|---|---|--|---|---|
| Slope Movement | X | | Slight bulge in slope and cracking at the head of the slide. | | X |

- Candidate repair options for the S031-II site include: (i) a driven steel H-pile wall (ii) excavate and replace the embankment fill with geogrid reinforced granular fill, including a shear key near the toe of the highway embankment. (iii) Reduce embankment loading using lightweight fill (e.g., cematrix or polystyrene) in the top third of the slope.
- One borehole could be drilled at the S031-II site to assess the ground conditions. A slope inclinometer should be installed in the borehole to assess the depth of movement at the site and to help determine the depth of a potential pile wall repair. A proposal for this work was submitted on December 15, 2022.
- The repair work at the S031-II site could be completed by Alberta Transportation's Highway Maintenance Contractor (HMC). A design memo (including repair sketches and quantity estimates) could be prepared by KCB to assist the HMC.

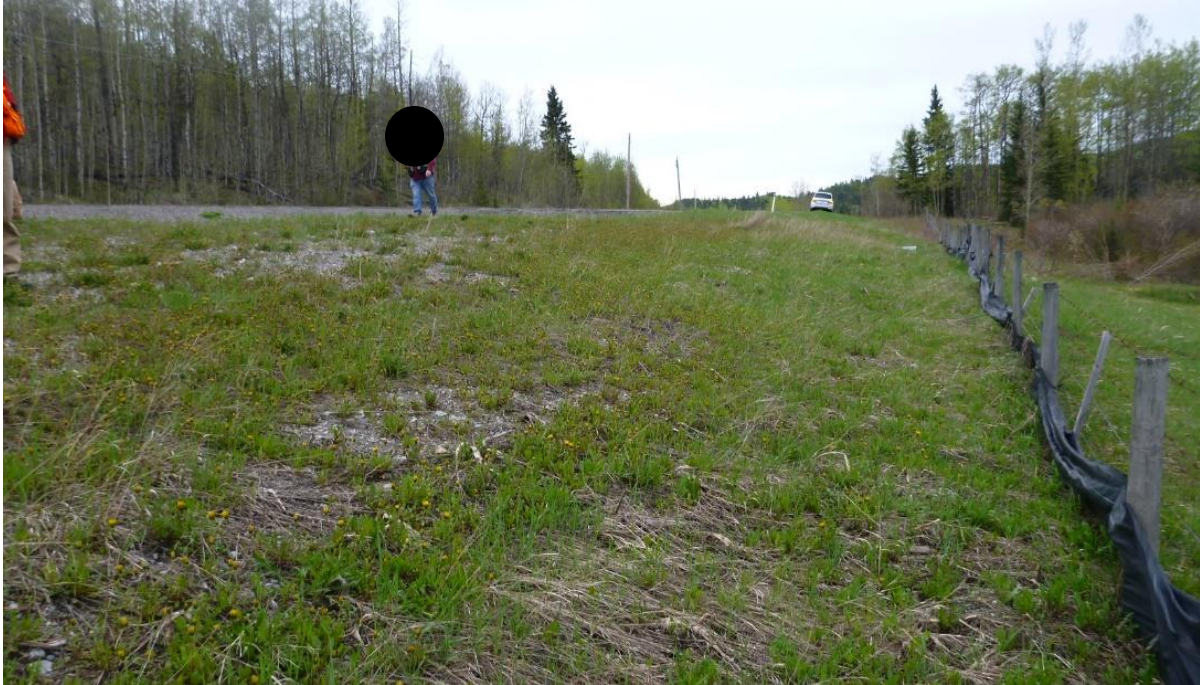
| ITEM | CONDITION EXISTS | | DESCRIPTION AND LOCATION | NOTICABLE CHANGE FROM LAST INSPECTION | |
|---|---|---|--|---|---|
| Culvert Distress | X | | The CSP culverts appear rusted and deformed | | X |

Photo 1 West ditch, and a CSP culvert inlet. Photo taken facing south on May 28, 2024.

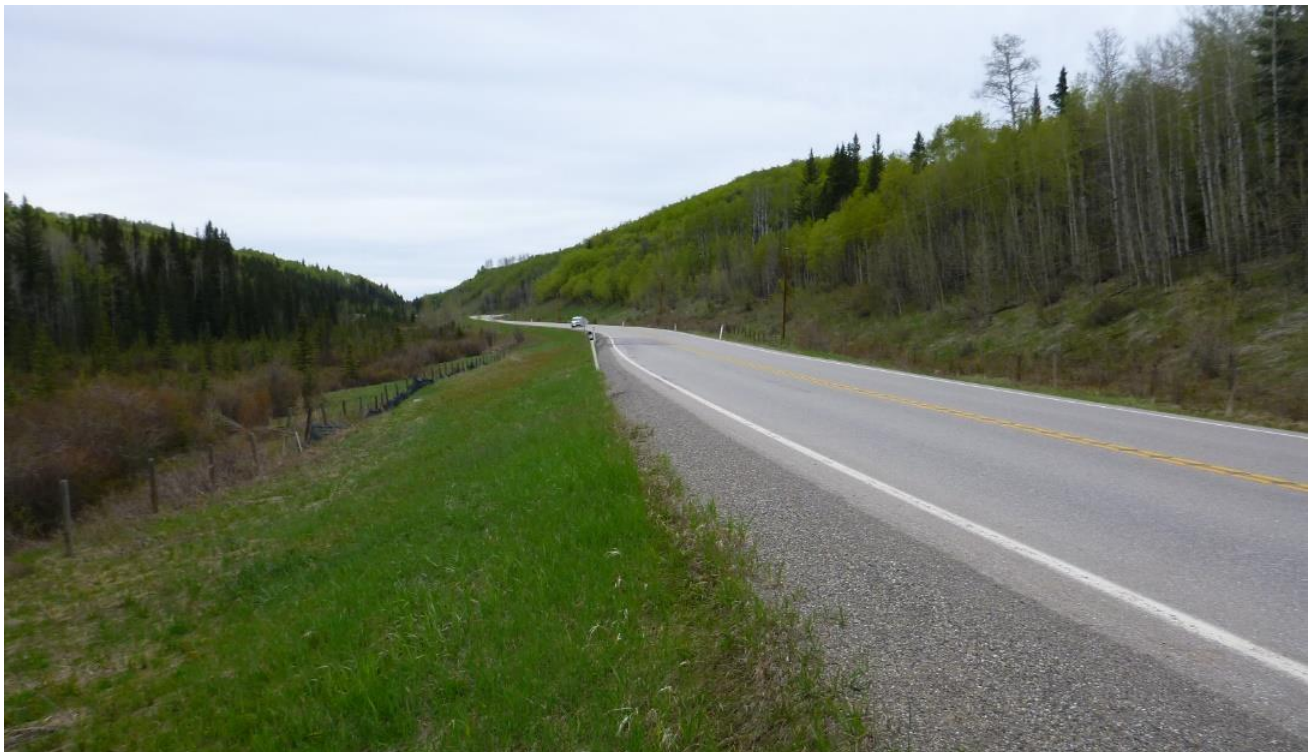
Photo 2 West slope. Photo taken facing north on May 28, 2024.

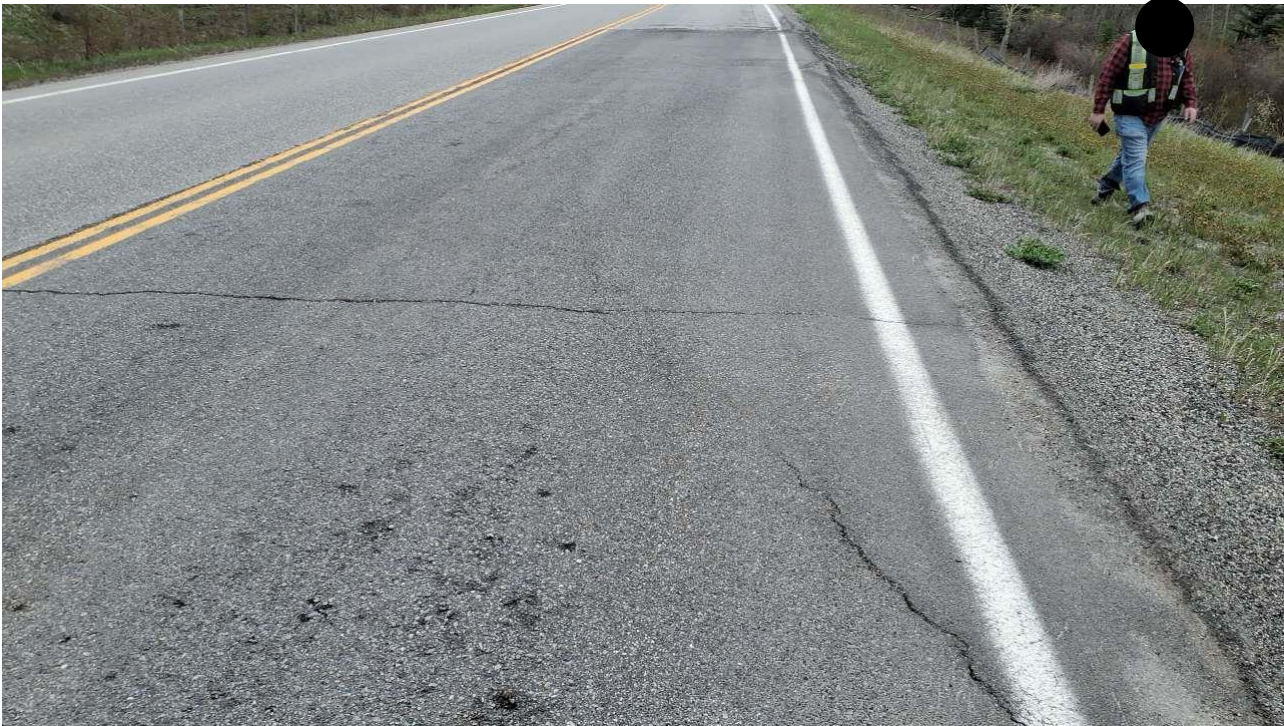
| ITEM | CONDITION EXISTS | | DESCRIPTION AND LOCATION | NOTICABLE CHANGE FROM LAST INSPECTION | |
|---|---|---|--|---|---|
| Pavement Distress | X | | Pavement patch placed in 2022 has settled, with cracking starting to come through at north and south ends. | X | |

Photo 3 Cracking and settlement through patch placed in fall 2022 in the southbound lane. Photo taken facing south on May 28, 2024.

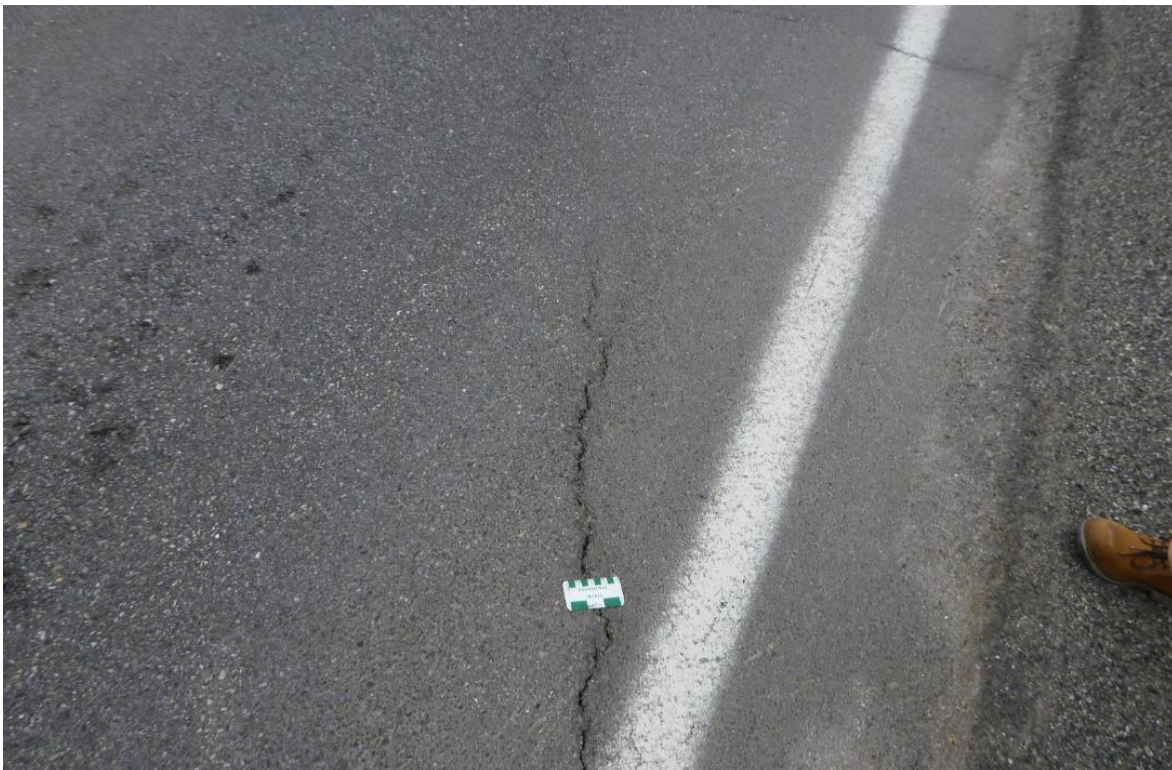
Photo 4 Cracking on the shoulder of the southbound lane. Photo on May 28, 2024
