SITE NUMBER AND NAME: S061 Hwy 762 Embankment Erosion North of Junction 549		HIGHWAY & KM: 762:02, 0.346	PREVIOUS INSPECTION DATE: July 8, 2020	INSPECTION DATE: July 5, 2021
LEGAL DESCRIPTION: 09-03-021-04 W5M	NAD 83 COORDINATES: UTM Northing Easting 11 5626018 678916		RISK ASSESSMENT: PF: 8 CF: 5 TOTAL: 40	
AVERAGE ANNUAL DAILY TRAFFIC (AADT): 720 (north) (Ref No. 65170), 1420 (south) (Ref. No. 60180)			CONTRACTOR MAINTENANCE AREA (CMA): 27

PRIMARY SITE ISSUE: Cracking and settlement on the highway surface due to instability caused by embankment erosion from a creek at the east toe.

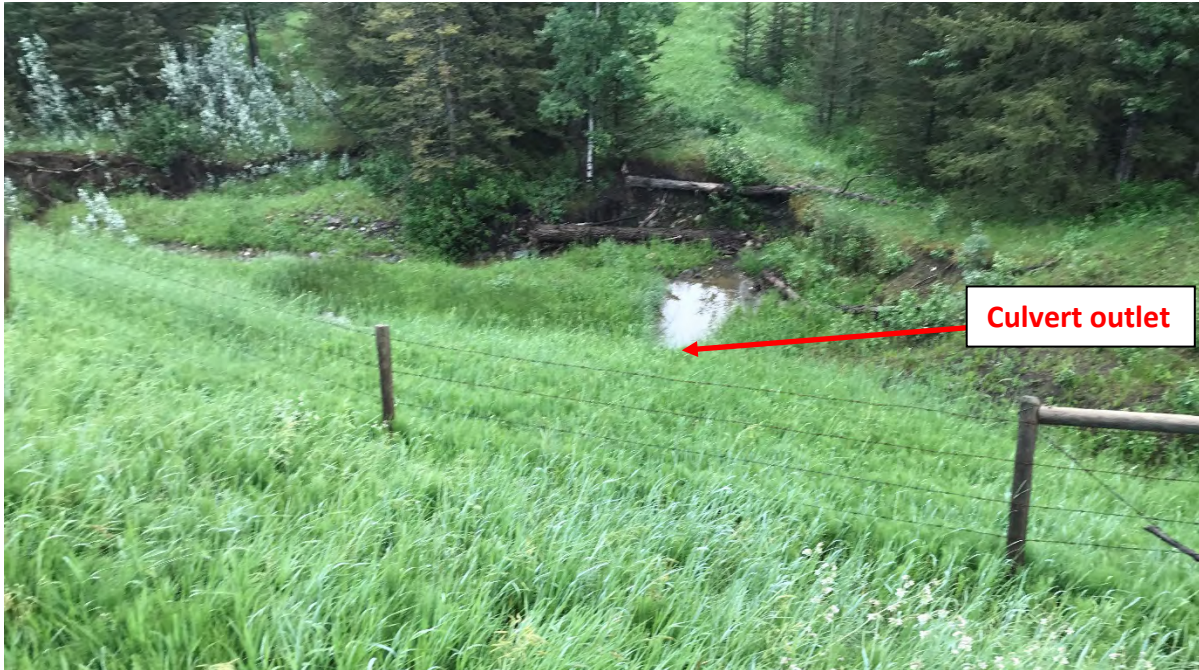
High flow water comes out of culvert on east side of highway during periods of heavy rainfall. The water hits the bank directly downstream of culvert and changes direction, about 65° to the north, and is eroding toe of embankment supporting the highway.

Photo 1 Erosion at downstream end of culvert (east side). Culvert outflows are deflected back towards the highway embankment. Photo was taken facing east on July 5, 2021.

Mitigation measures could include sealing the existing culvert and constructing a new culvert in an alignment that cuts off the corner and discharges away from the toe of the embankment.

If required, the embankment can be reconstructed with geosynthetic reinforced fill.

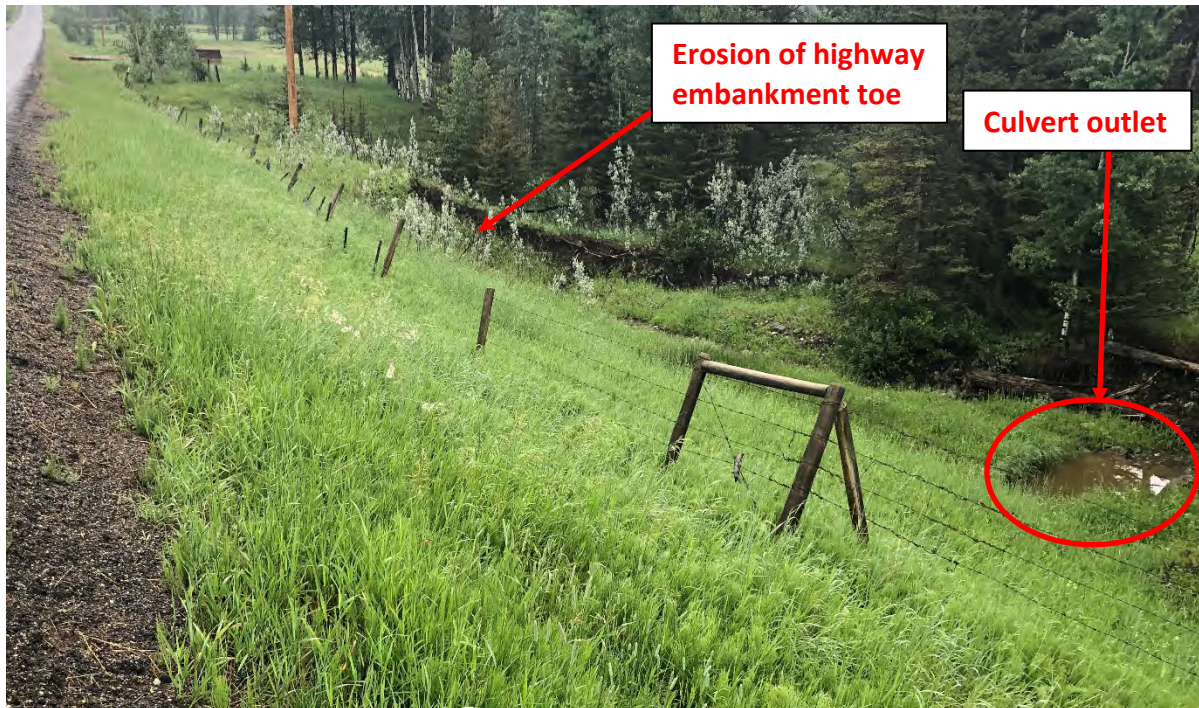
Photo 2 Toe erosion and fence deflection on embankment slope. Photo taken facing north on July 5, 2021.

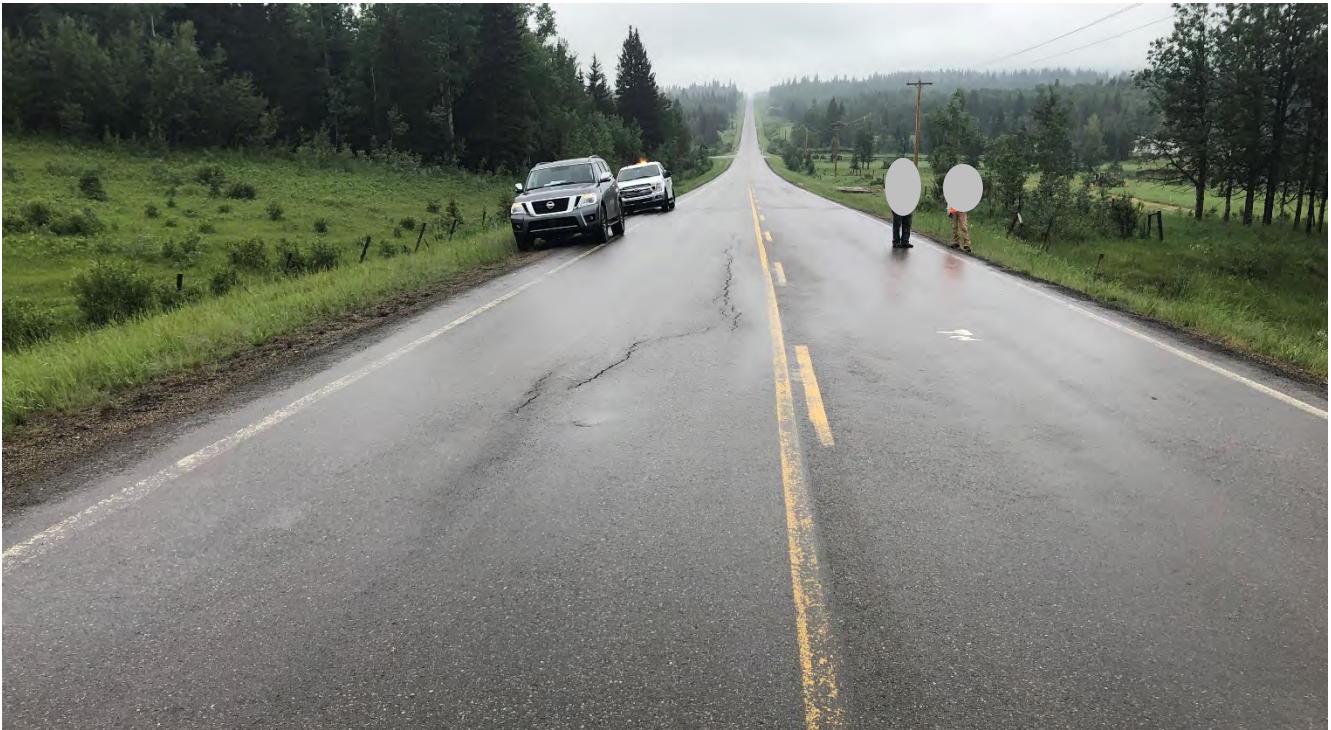
When compared to 2020 observations, longitudinal pavement cracking has extended, and transverse cracking has widened. Crack width is approximately 10 mm. A dip in both lanes is starting to form.

Photo 3 Longitudinal pavement cracking. Photo was taken facing north on July 5, 2021.

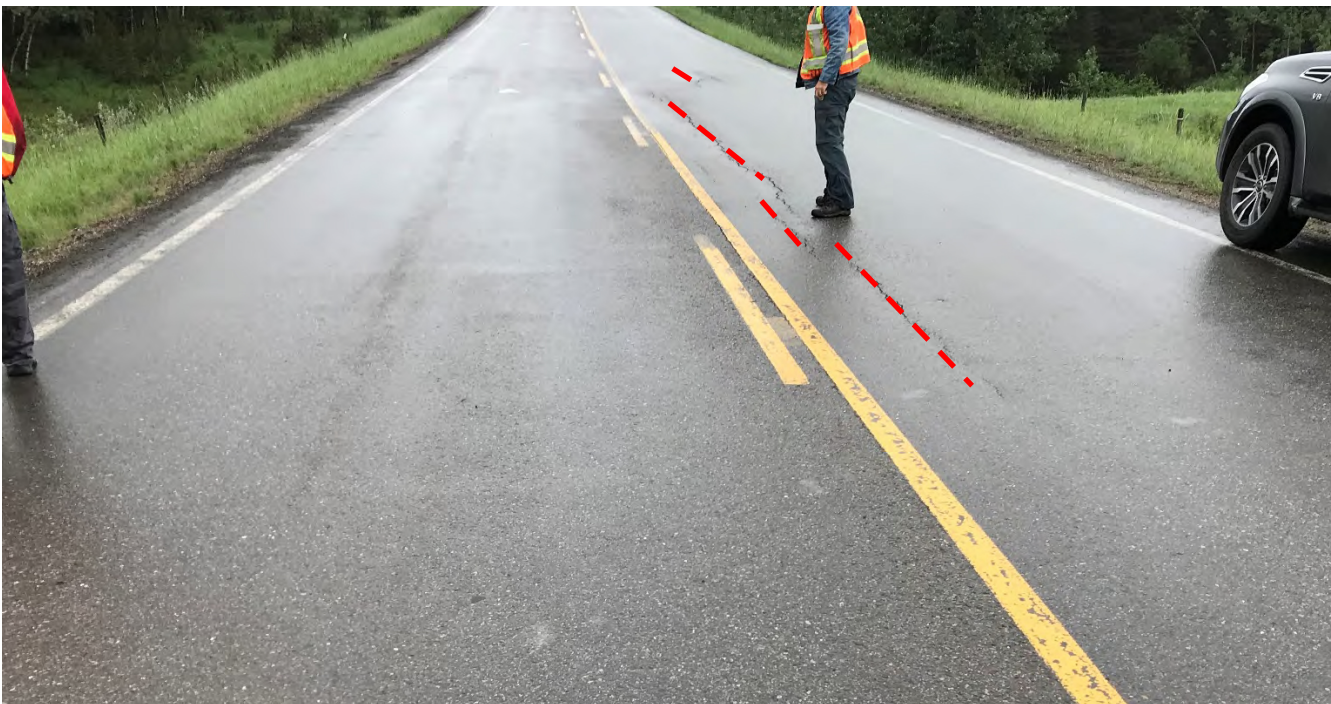
Photo 4 Longitudinal pavement cracking. Photo was taken facing south on July 5, 2021.
