SITE NUMBER AND NAME: S061 Hwy 762 Embankment Erosion North of Junction 549		HIGHWAY & KM: 762:02, 0.346	PREVIOUS INSPECTION DATE: July 5, 2021	INSPECTION DATE: May 16, 2022
LEGAL DESCRIPTION: 09-03-21-04 W5M	NAD 83 COORDINATES: UTM Northing Easting 11 5626018 678916		RISK ASSESMENT: PF: 8 CF: 3 TOTAL: 24	
AVERAGE ANNUAL DAILY TRAFFIC (AADT): 720 (north) & 1420 (south) (Reference No. 65170 & 60180)			CONTRACTOR MAINTENANCE AREA (CMA): 27

PROJECT SOUTHERN REGION GEOHAZARD RISK MANAGEMENT PROGRAM		
TITLE Site Plan S061 - Hwy 792 Embankment Erosion N of Junction 549 Hwy 762:02, km 0.346		
SCALE 1:1,250	PROJECT No. A05116A03	FIG No. 1

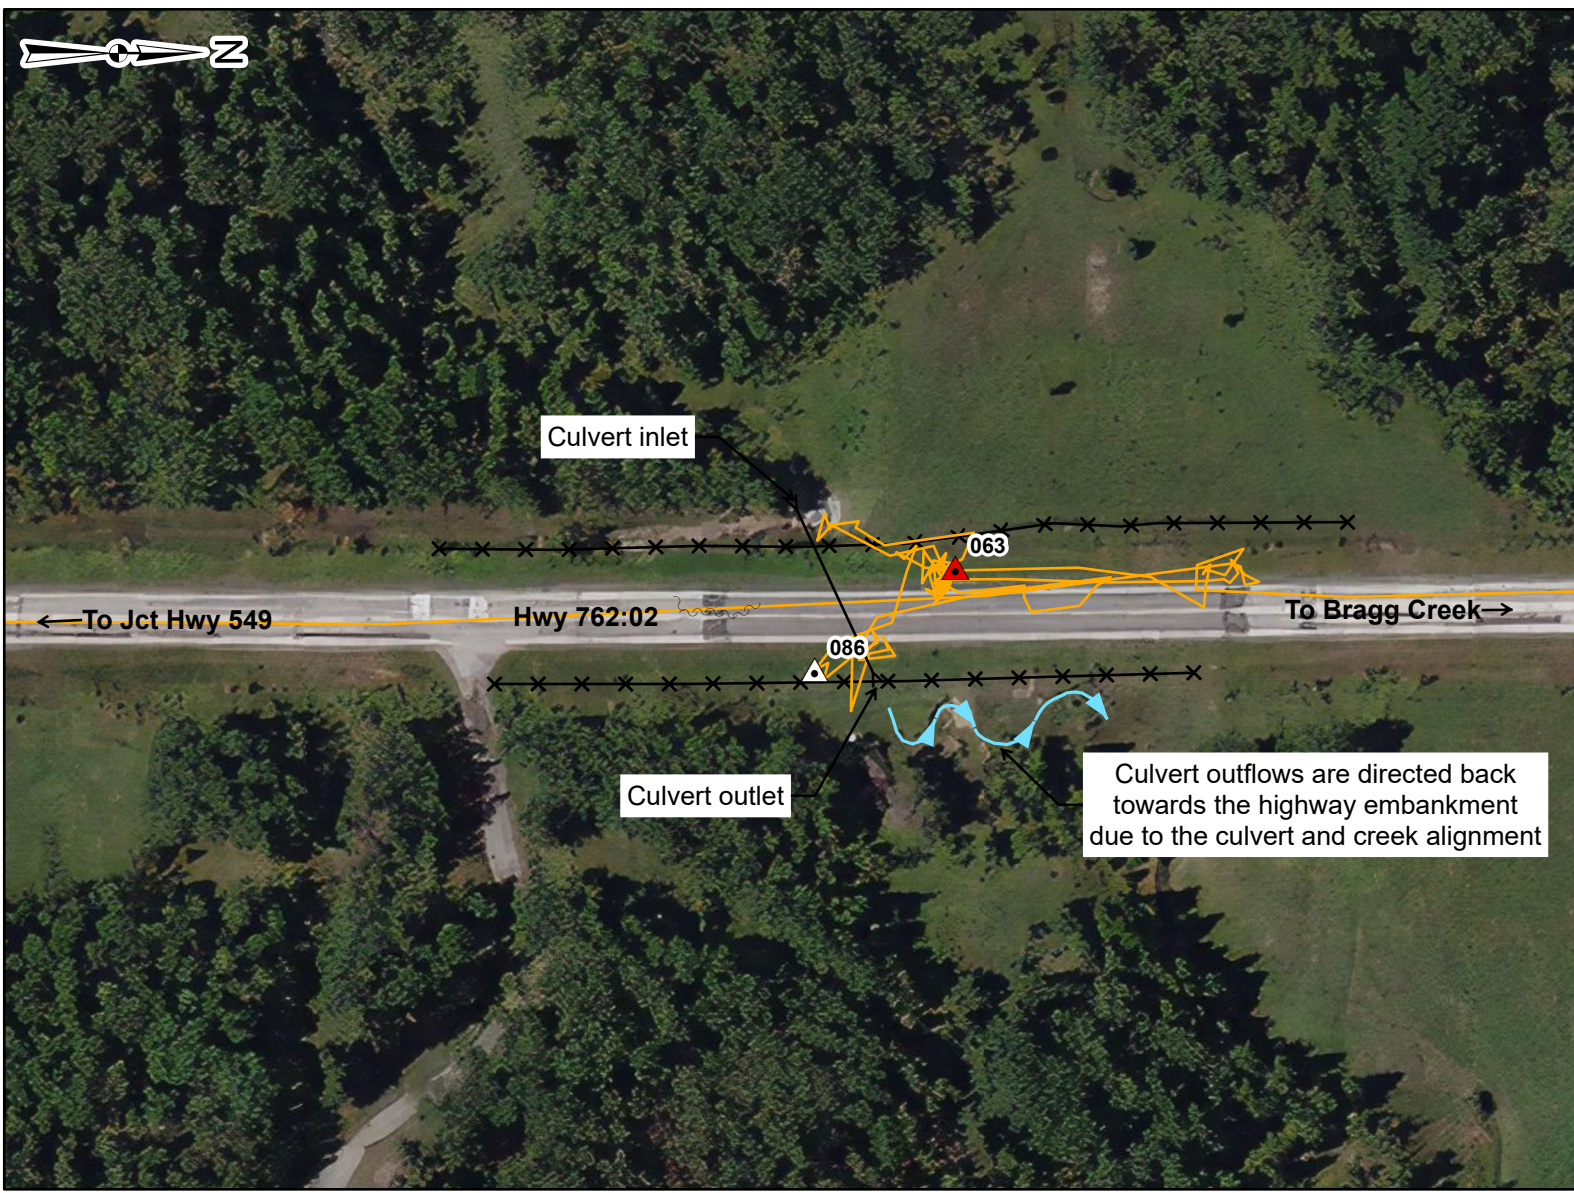
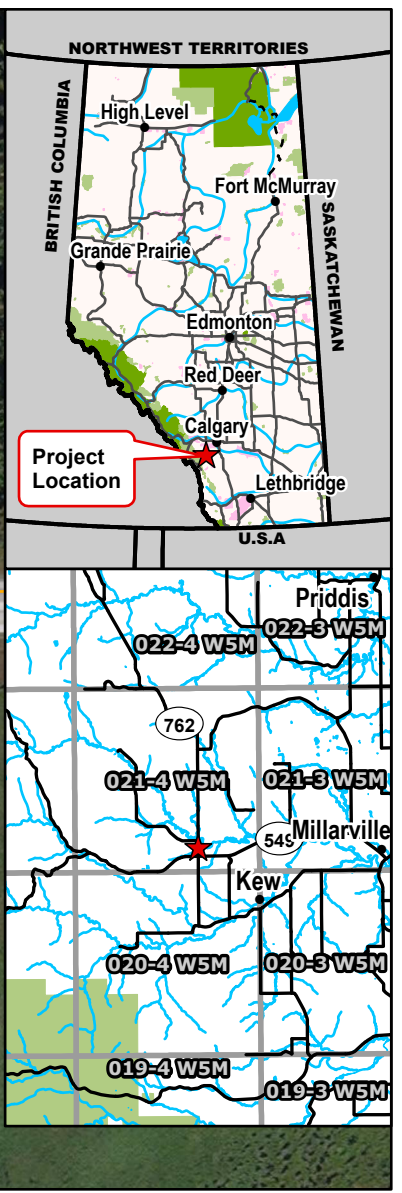
Culvert outflows are directed back towards the highway embankment due to the culvert and creek alignment

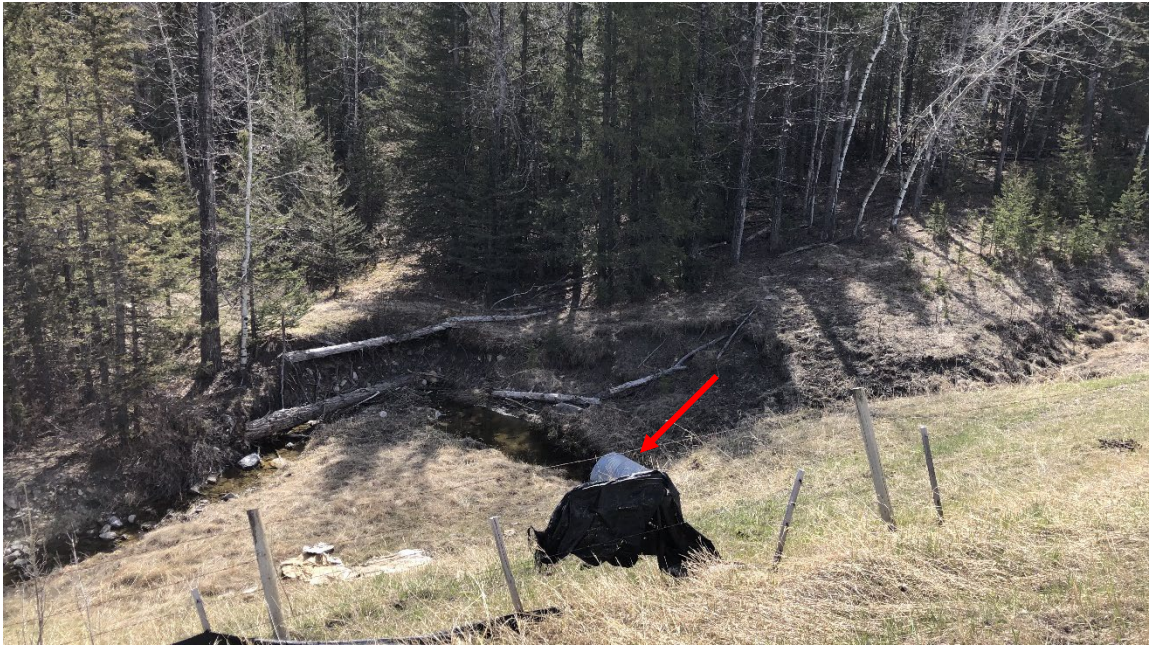
COMMENTS
The site was previously inspected as part of the S008 Fisher Creek Pile Wall site and referred to as "South of S008". In 2021, the site was numbered and named "S061 Hwy 762 Embankment Erosion North of Junction 549".
The highway embankment is in a creek valley and downslope of a hill.
The highway embankment slopes are well vegetated.
High flow water comes out of the culvert on the west side of highway during periods of heavy rainfall. The water hits the bank directly downstream of the culvert and is eroding the west highway embankment toe. Standing water was observed at the culvert outlet during the 2022 inspection (Photo 1 and 2).

Photo 1 Erosion downstream of the CSP culvert outlet (indicated by red arrow). Culvert outflows are deflected back towards the highway embankment. Photo taken May 16, 2022, facing west.

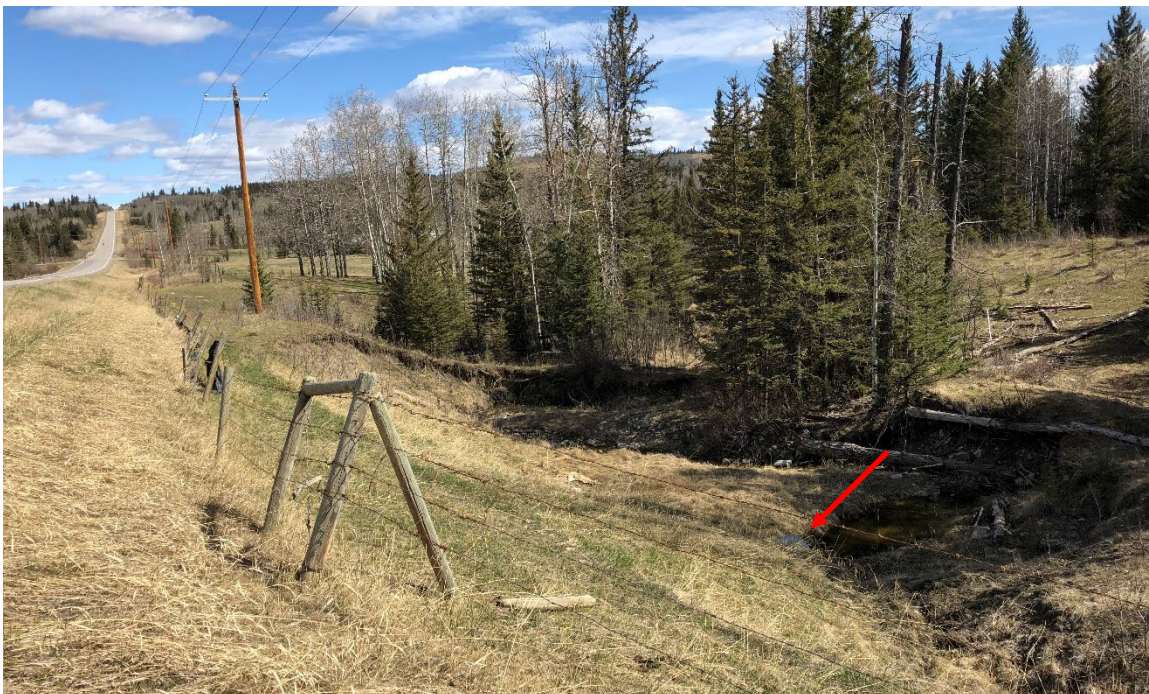
The fence on the west side of the embankment has deflected and is leaning towards the toe of the highway embankment (Photo 2).

Photo 2 Toe erosion and fence deflection on east highway embankment slope. CSP culvert outlet is indicated by red arrow. Photo taken May 16, 2022, facing north.

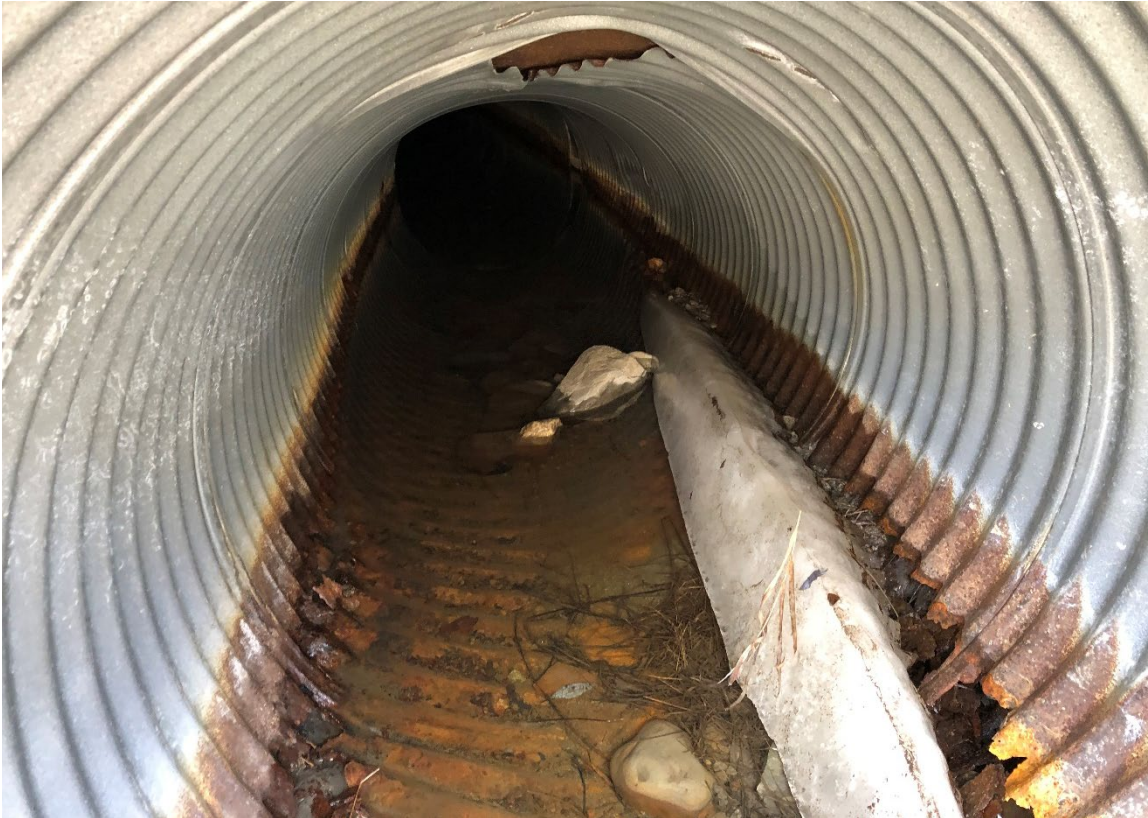
The creek flow entering the culvert appears to be flowing faster than discharge from the outlet of the culvert (i.e., backing up). The culvert is corroded and may be partially blocked (Photo 3). Corrosion of the invert may be leading to leakage from the culvert into embankment fill beneath highway, increasing the groundwater level and destabilizing the embankment. KCB and AT could not inspect the inside of the 900 mm diameter CSP culvert during the 2022 inspection.

Photo 3 The base of the 900 mm diameter CSP culvert is corroding. Photo taken May 16, 2022, facing east.

- A camera inspection should be completed to assess the condition of the 900 mm diameter CSP culvert. If irreparable, the culvert could be sealed and a new culvert could be built with an alignment that allow water to flow away from the highway embankment at the culvert outlet.
- The embankment could be stabilized by reconstructing the embankment with geogrid reinforced granular fill.

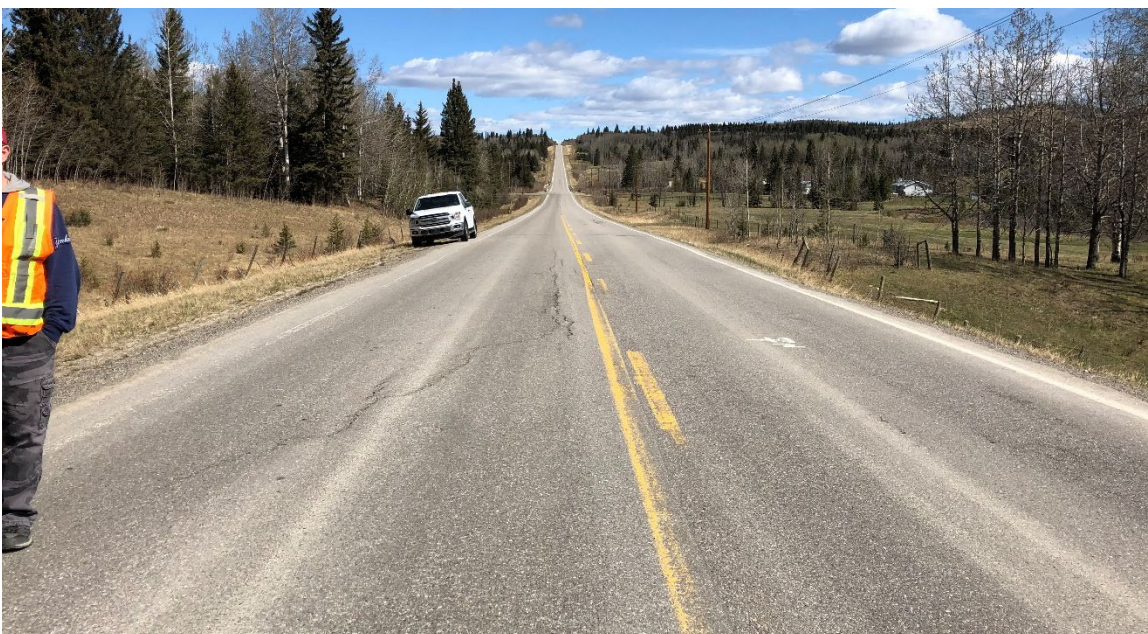
The longitudinal pavement cracking appears to have lengthened since the 2021 inspection (Photo 4) and the transverse pavement cracking has widened to approximately 30 mm to 40 mm (Photo 5). The pavement cracking (believed to be caused by settlement in the west (southbound) lane) has dropped by approximately 20 mm to 25 mm over its 23 m length and could suggest that the slide is moving to the west.

Photo 4 Longitudinal pavement cracking in the west (southbound) lane. Photo taken May 16, 2022, facing north.

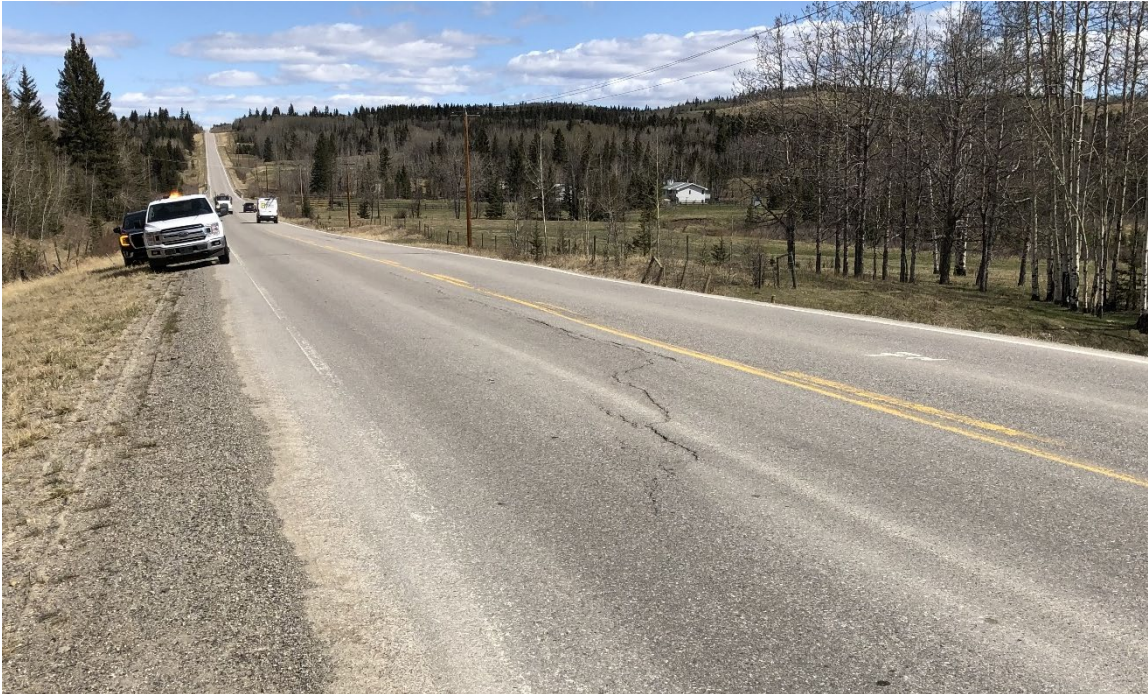
Photo 5 **Longitudinal pavement cracking in the west (southbound) lane. Photo taken May 16, 2022, facing north.**
